# SwitcherBv2.1 bumping

# SwitcherBv2.1 bumped at IZM

# Status of the modules as of today

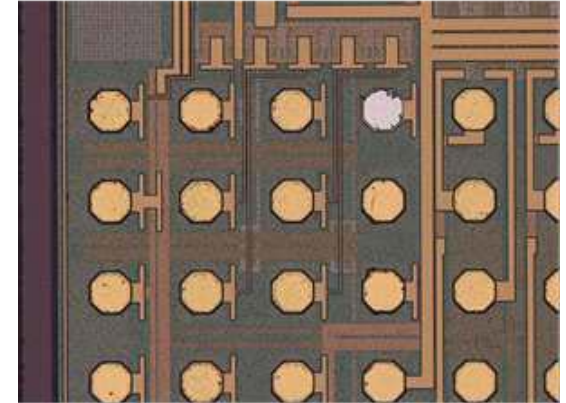
- ▷ Bumping (UBM process) causes problems with the new Switcher
- ▷ On one pad – the substrate pad – and only on this pad
  - ↳ Very little or no Nickel deposition
- ▷ Main difference to old Switcher
  - ↳ Different passivation (1µm Nitride/Oxide <-> PI)
  - ↳ Guard ring of the chip exposed, connected to bulk

- ▷ Different electrochemical potential causes reduced Ni growth on substrate
- ▷ **Trials** with isolated edge **failed** in batch process, workaround(s) **failed/not reliable**

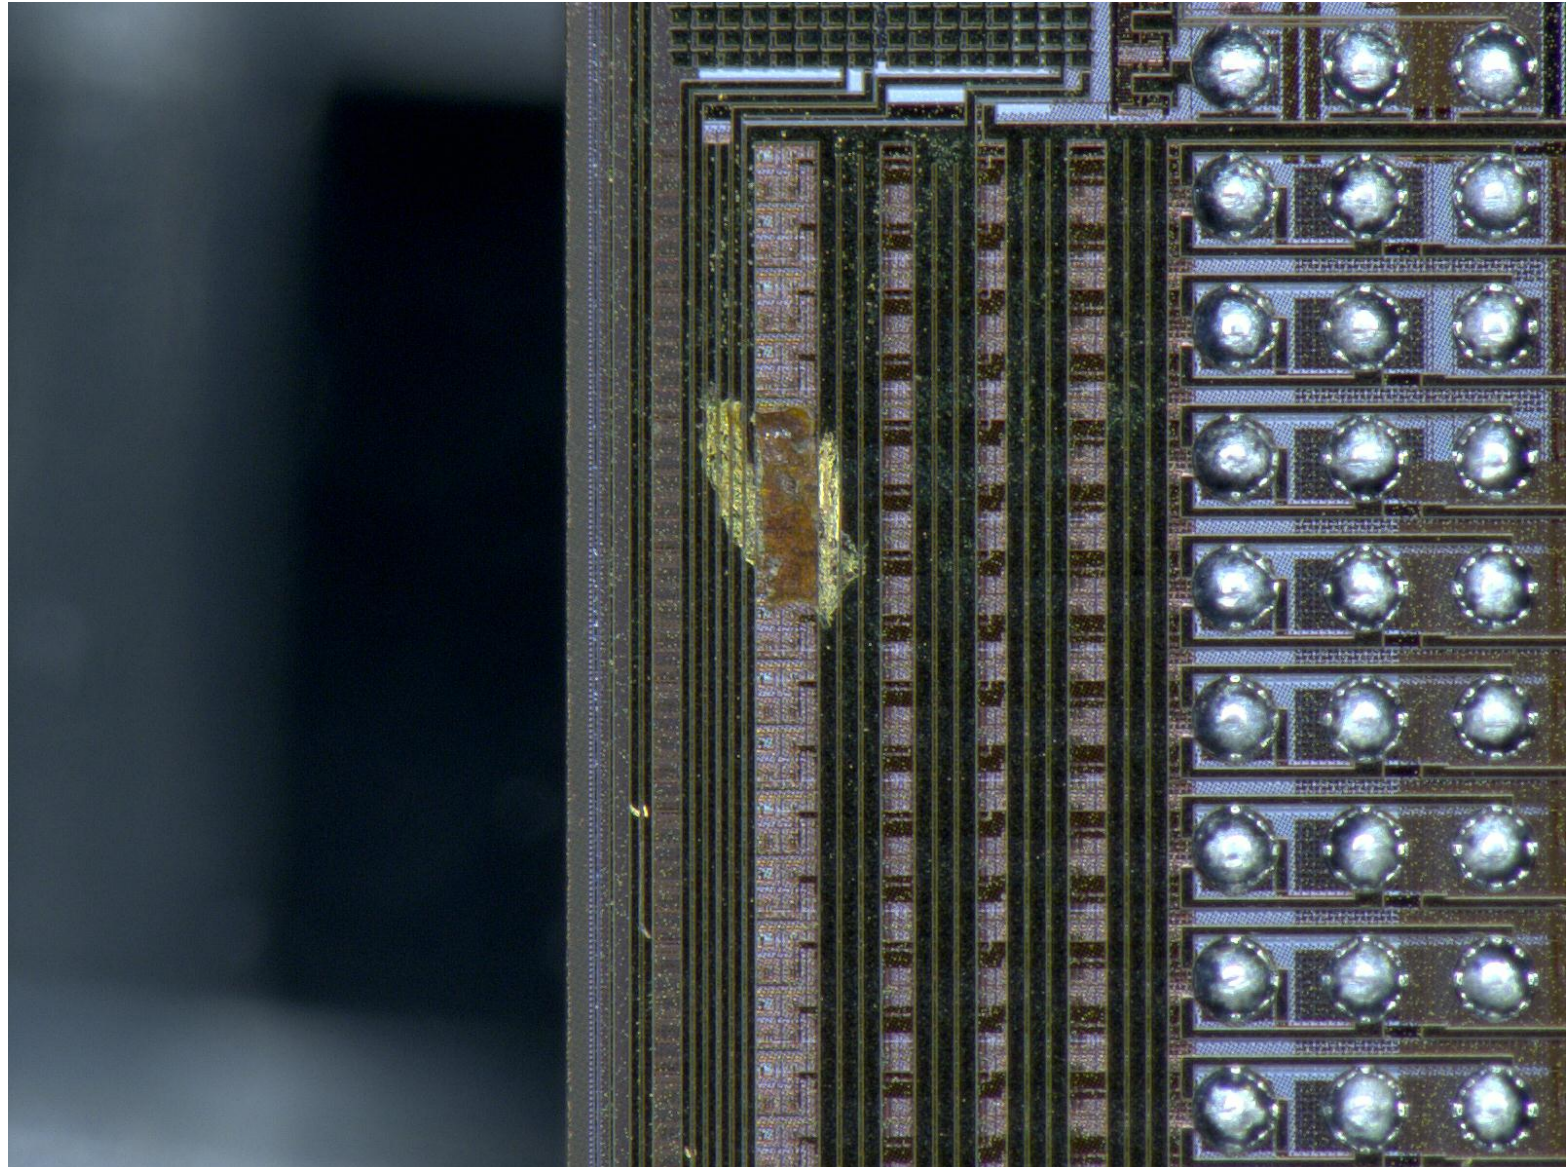
# Residues from electro-plating?

Not clear, under investigation

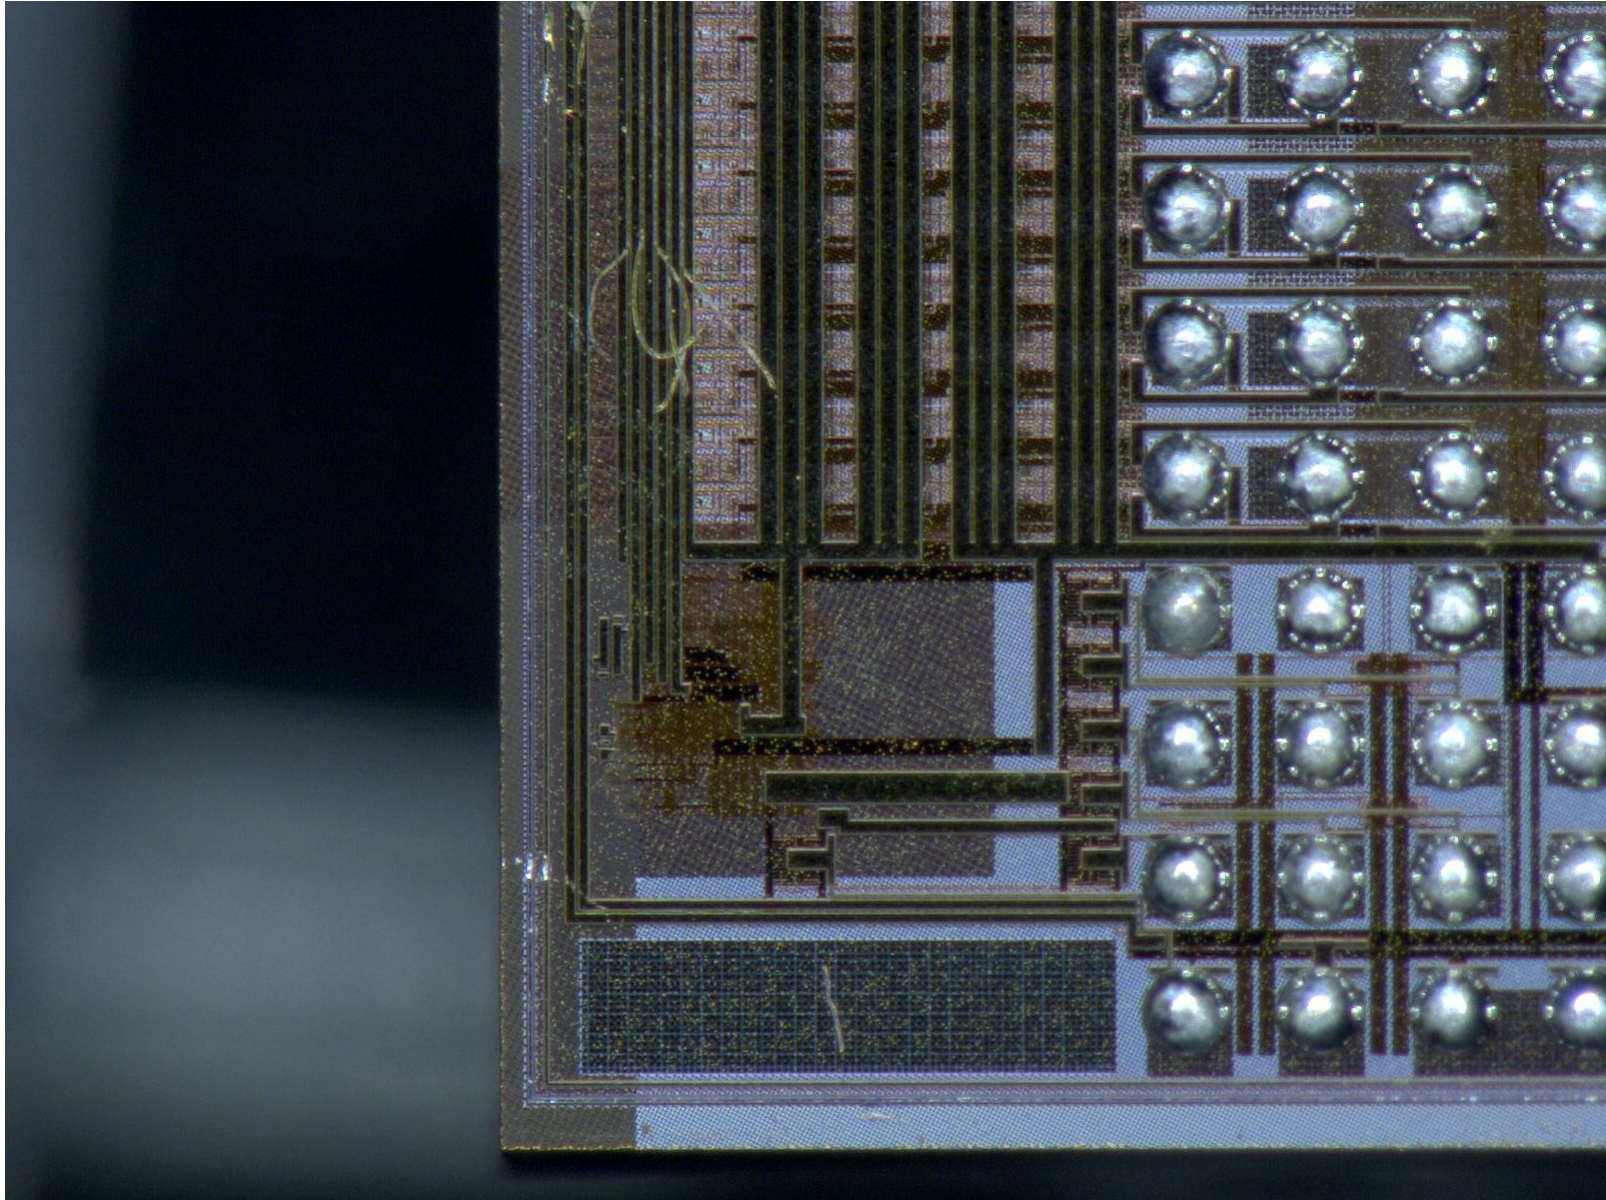
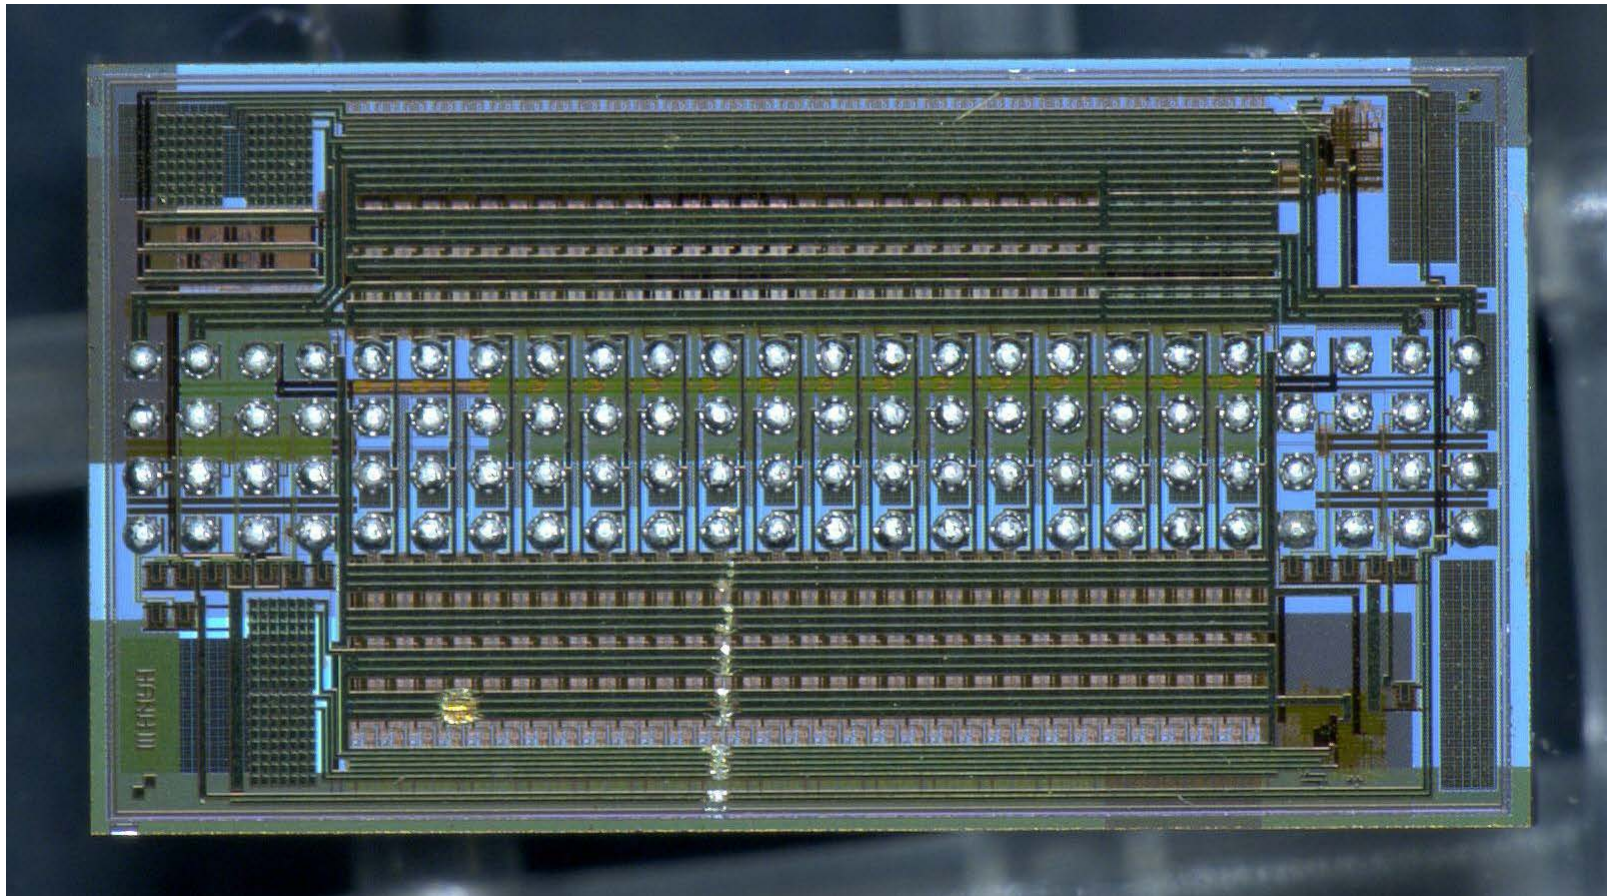
- ▷ Scratches from tweezers,  
most likely from our side
- ↳ Re-packing, probing...
- ▷ **Needs improvement, is probably the main yield killer**

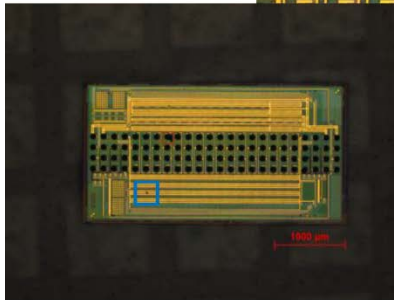
Switcher 1

# "fishy" Switchers, though tested okay

Modul W31-IB

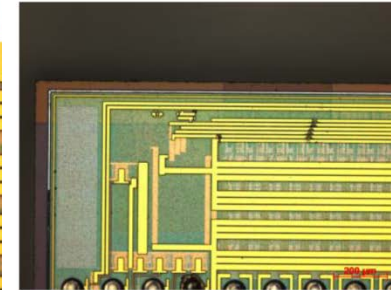
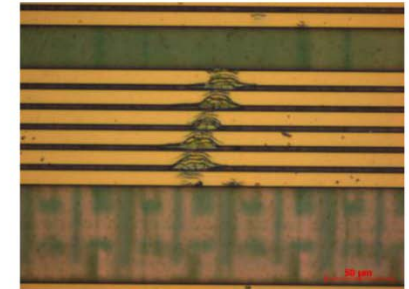
Switcher 5

Modul W31-IF

Leiterbahn beschädigt

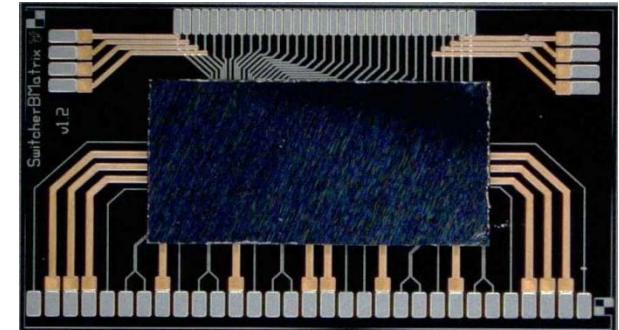
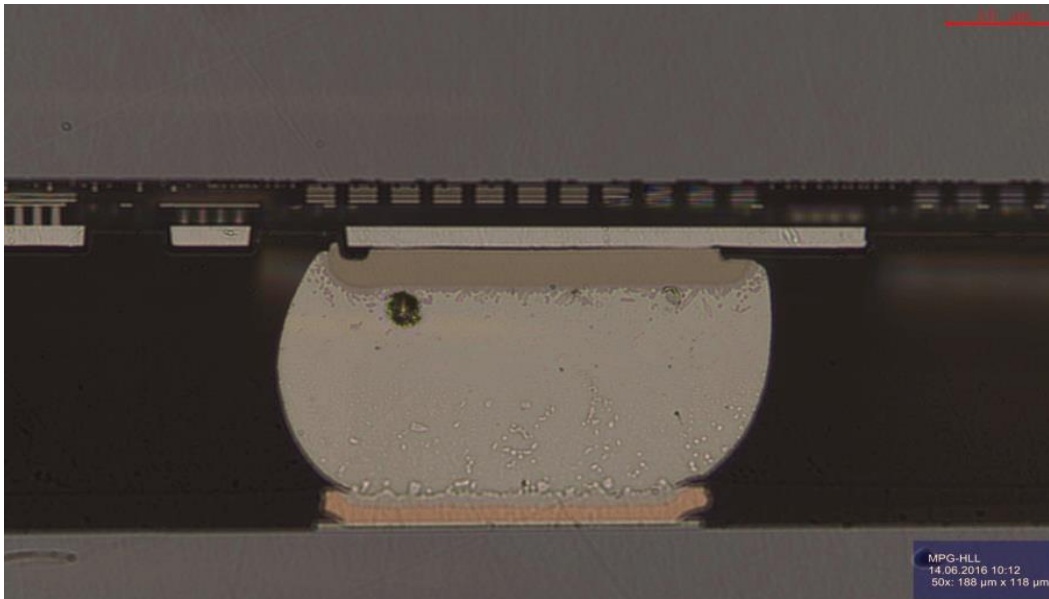
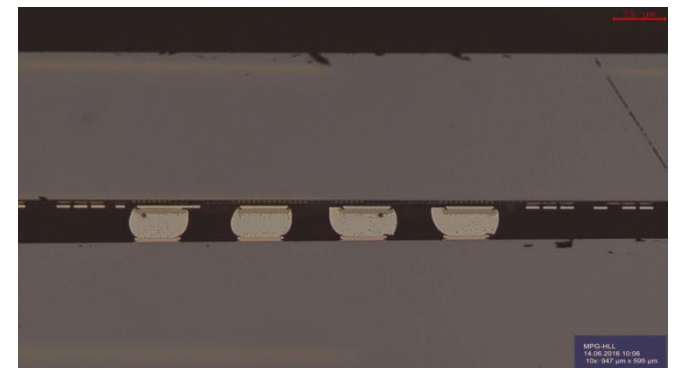
- ▷ Adapters assembled for SWB testing on hybrid level
  - ↳ Three adapters assembled
  - ↳ One assembly done with bad chip (bumping problems)
- ▷ Cross-section

- ▷ Delamination between SWB Alu and Ni?
  - ↳ Not certain that is this real
  - ↳ Could be due to contamination before UBM....
