Status of MARCO

Luigi Li Gioi

13th International Workshop on
DEPFET Detectors and Applications
Ringberg Castle, 14th June 2013

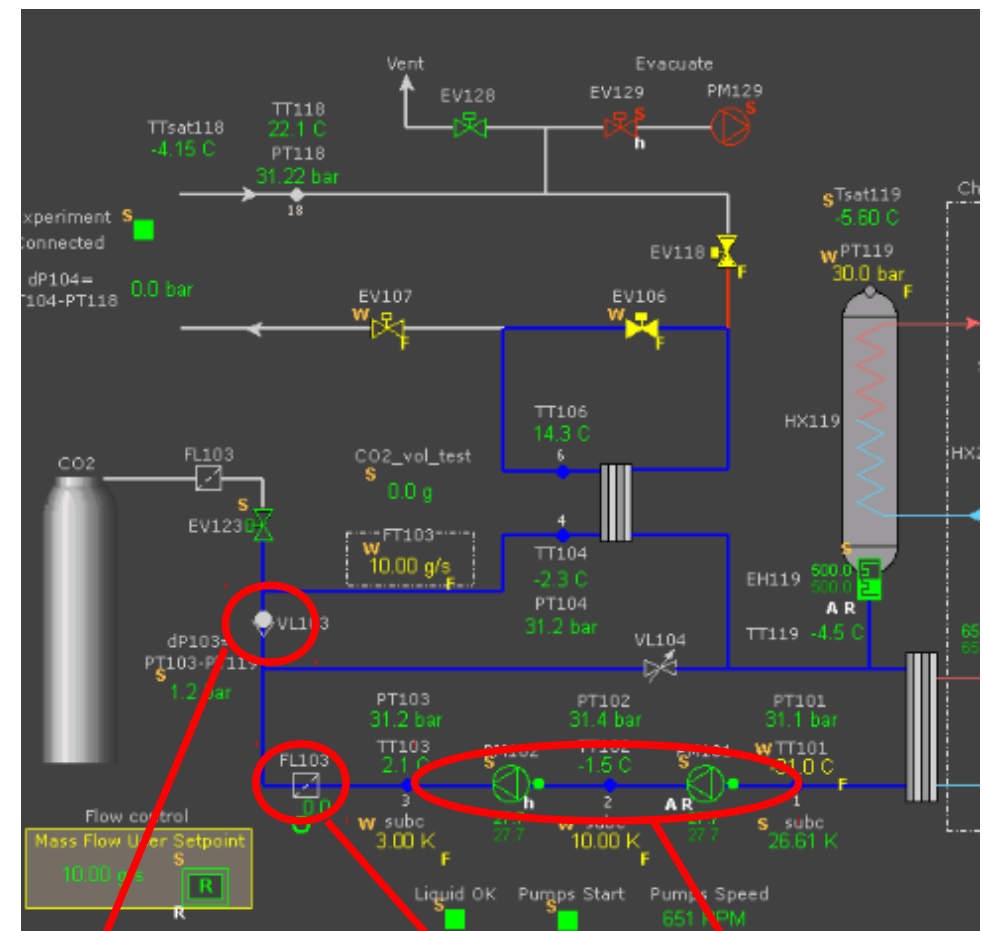
- Pressure increase at the filter
 - Filter covered with black powder
 - Filter replaced 3 times
- One way valve not working
 - Flux inversion during filling procedure
 - CO2 mass measurement not reliable
- Pumps problem
 - Degradation of the gears

One-way valve

Filter

Pumps

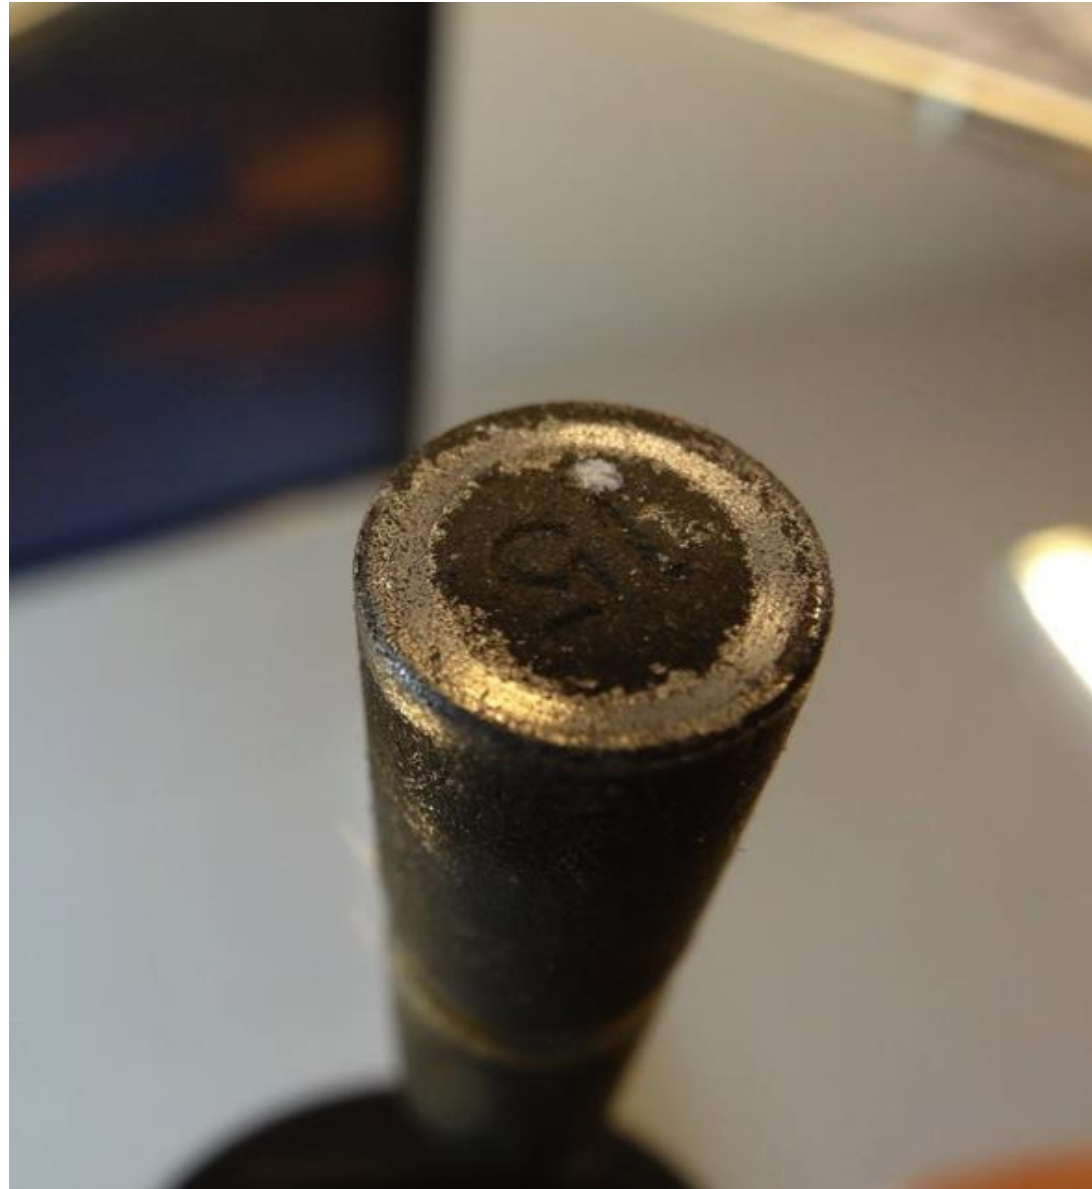
Filter replacement: December 12

- During testing in December, a big pressure drop (around 10 bars) was observed across the filter
- Filter has been opened and cartridge was found covered with black powder
 - Analysis: mainly Silicon and Oxygen.
- New cartridge (40 μm pores instead of the 15 μm) has been installed.
- A new alarm has been created
 - “if $\Delta P_{\text{filter}} > 5\text{bar}$ then STOP”

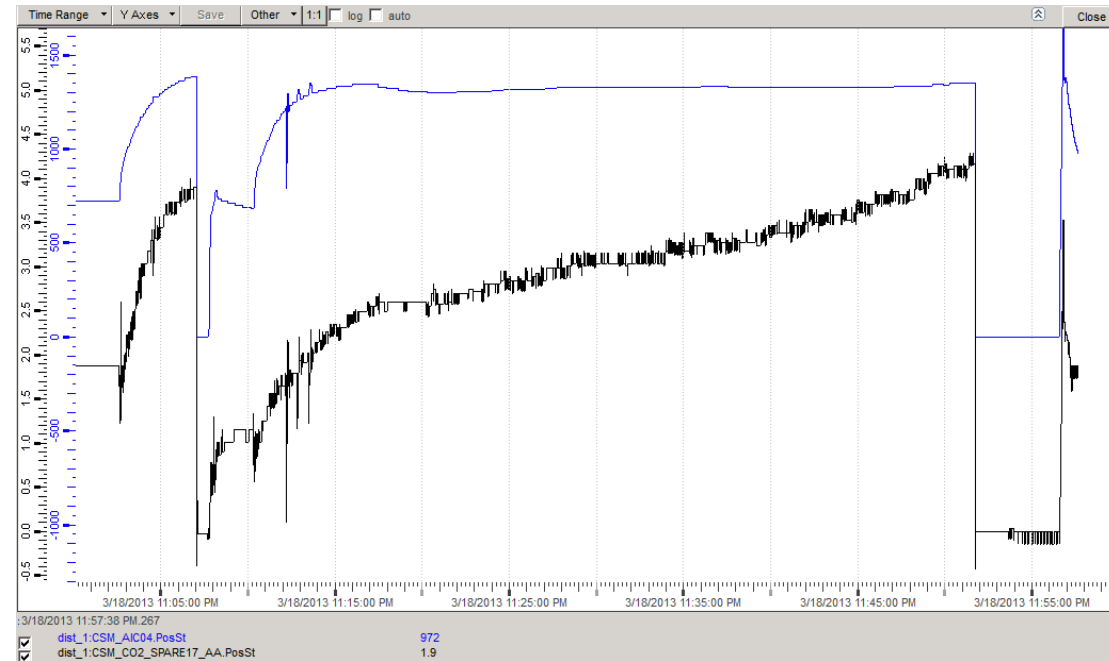
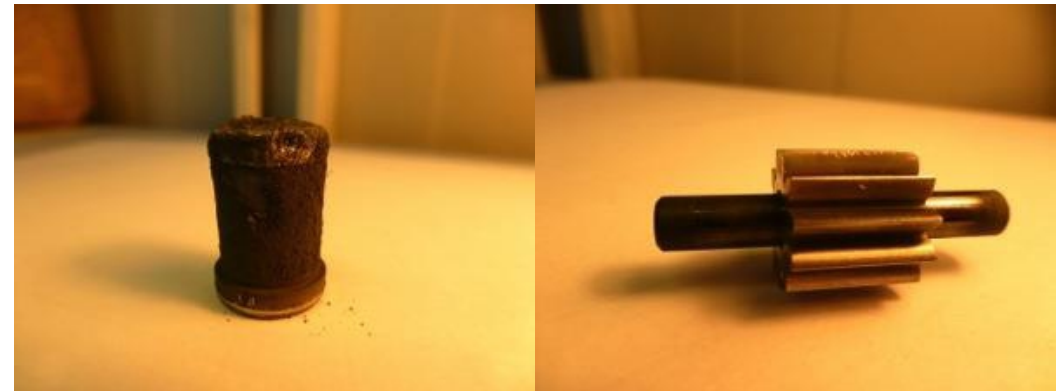
Filter replacement: March 13

- ΔP across the filter increased again up to 4.0 bar (0 bar when the filter is clean) during normal operation
- Filter and pumps were opened
 - ➔ Filter covered with a thick layer of black powder
 - ➔ Pumps bearings and case looks fine
 - ➔ Very small scratches starts to appear on the gears
- The analysis of the powder shows:
 - ➔ Still a significant fraction of Si, O and C
 - ➔ A large fraction of Ni and a lower fraction of Cr, Mo (molybdenum), Sn (tin)
- After this filter replacement a pump characteristics measurement was done to check the pumps performances
 - ➔ Compared to the same measurement done in December, the pump showed even better performances

- Nickel alloy (W88) for the gears
- Antimony impregnated carbon for the bearings

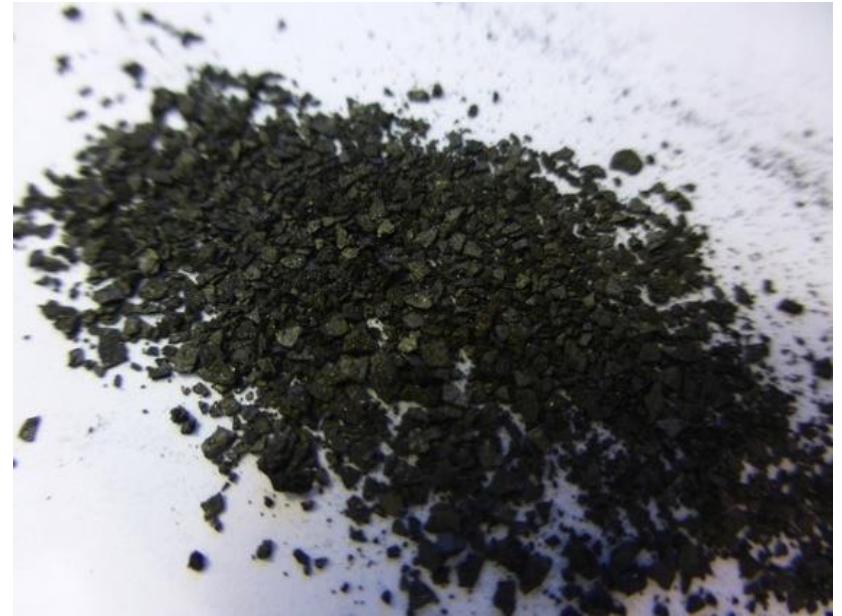
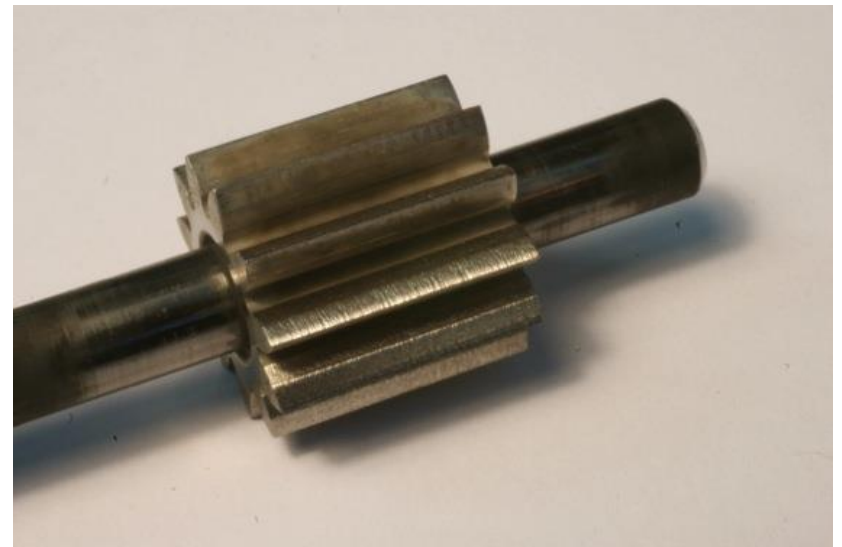
Filter replacement: April 13

- Few days after the filter replacement in March (and the pump scan...), the ΔP across the filter was again critical (4-5 bar)
- Same black powder was found on the filter
- This time, a clear degradation is visible on the gears

- Some evidences of the degradation of the gears
 - Presence of a large fraction of Ni
- In a smaller proportion a degradation of the bearings
 - Presence of C in the analysis
 - But no antimony (Sb).
- And a contamination of MARCO with Si and O
 - Not yet understood
- Comparison with the pumps in other systems, failure experience doesn't show a clear pattern of the failure mode
 - The pump's characteristics measurement (done twice on MARCO) could be an accelerating factor of the pump's failure
- To prevent further failure, a new filter will also be installed this week in front of the pumps.
 - The leaking one-way valve (could be responsible of a back flow bringing filter dust to the pumps when filling) changed to a manual valve.

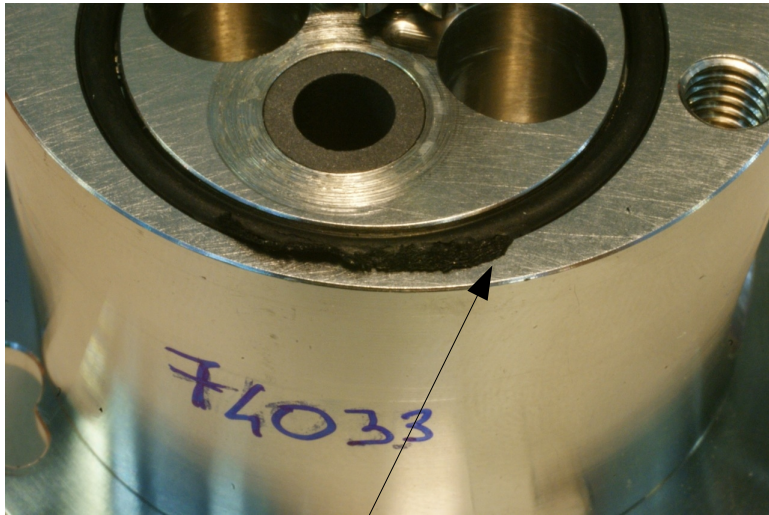
Gasket crushed

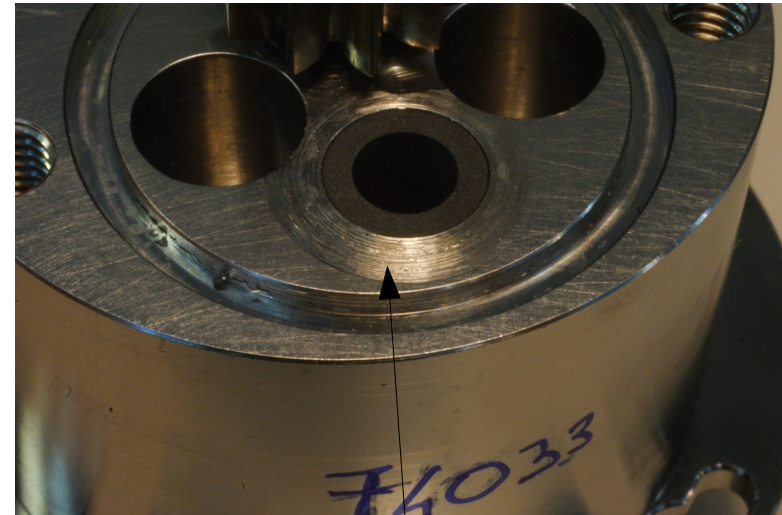
Surface scratched

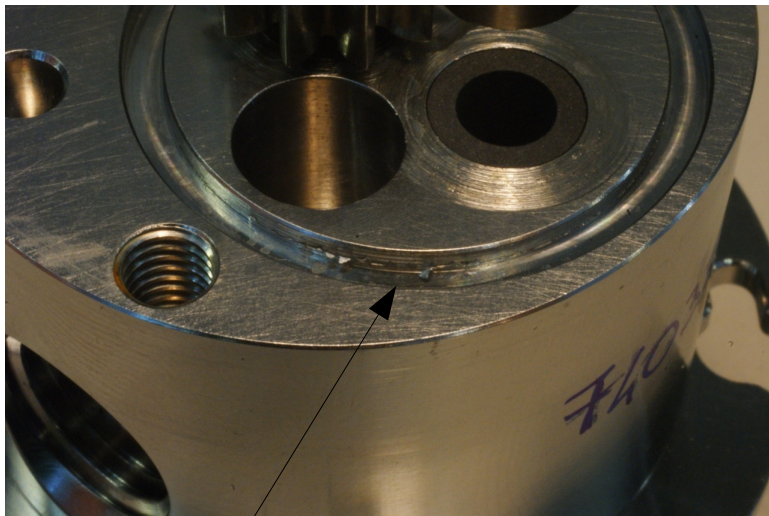
Metal flakes

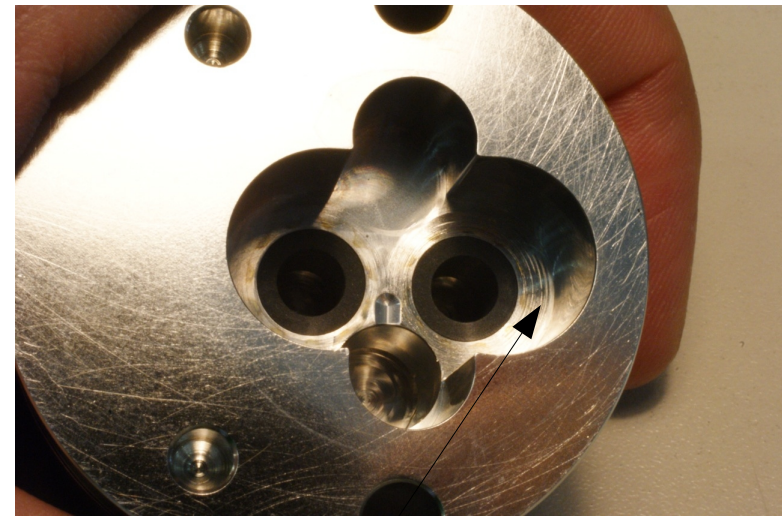
Surface scratched

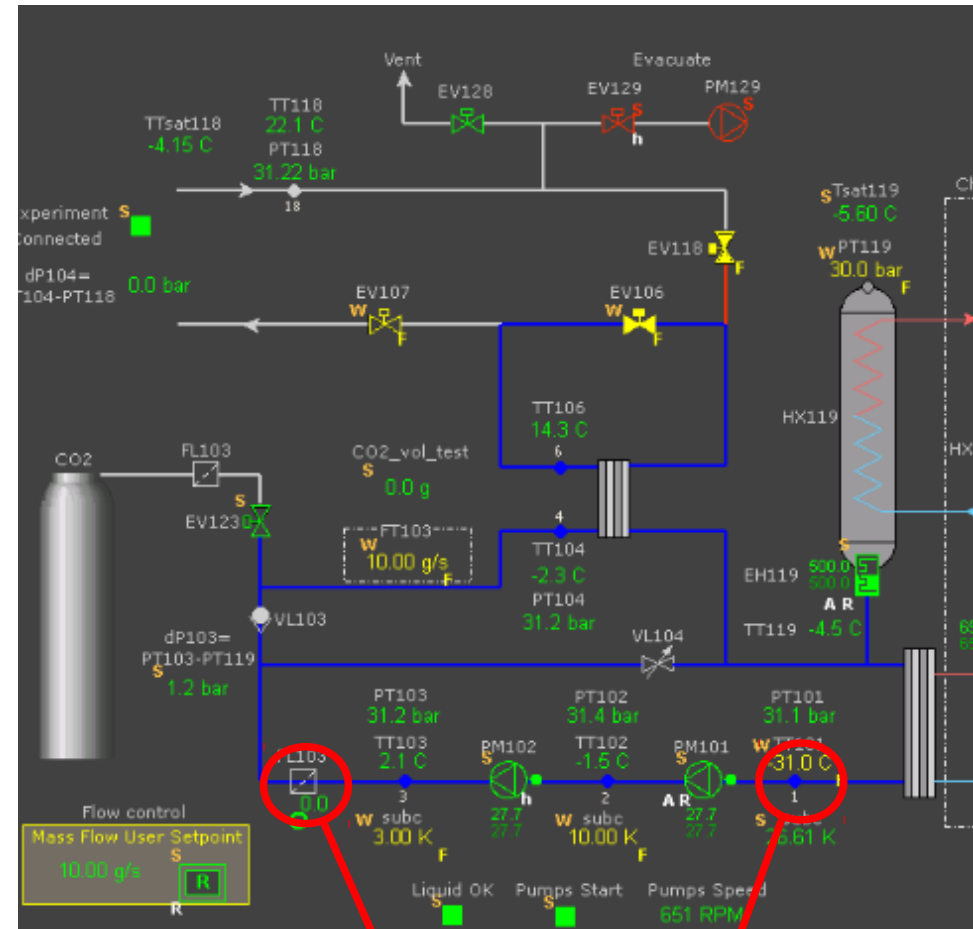
Filters: pressure drop

- 15mm and 40 mm
- Some powder on the filters
- Pressure drop: 3 bar

Source of the powder not completely understood

- Clean the filters one more times
- Start with the automatic tests
