DEPFET

# Electrical Test of EMCM

May 25 - 28, 2014  
Kloster Seeon  
Bavaria, Germany

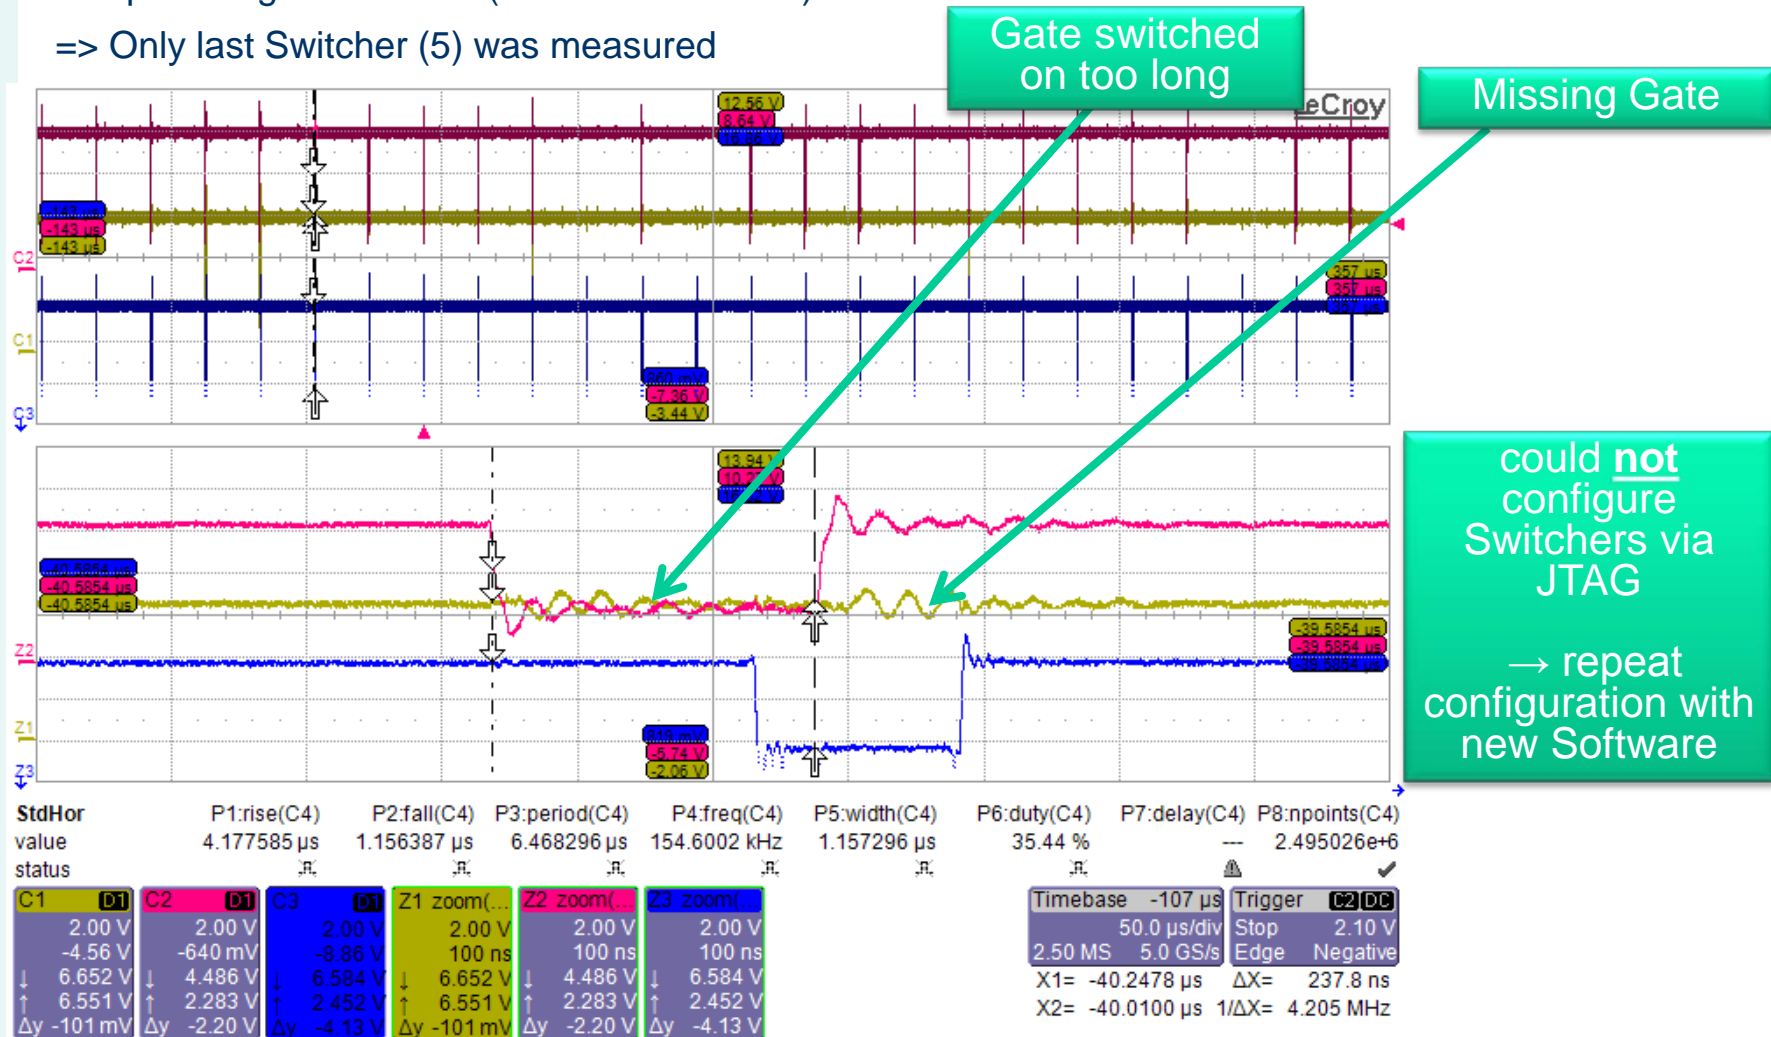
Switcher: Output signals; falling edge of the gate signal is much too slow after problems with the powering of the SWB (bond wires melted)

=> Only last Switcher (5) was measured

timing problems

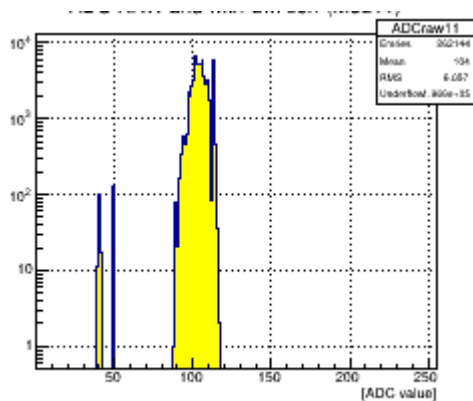
DCD0,  
EnMonIn off,  
VNSubIn 2, VNSubOut 10,  
SMU: 4uA, 1.8V,  
ADC-channel 128

DCD0 and DCD3 seem to work

In addition, only if EnMonIn is off, one can see a test current 'peak'. One can see a double structure => is it an artifact of odd and even ADCs ? (has to be further investigated)

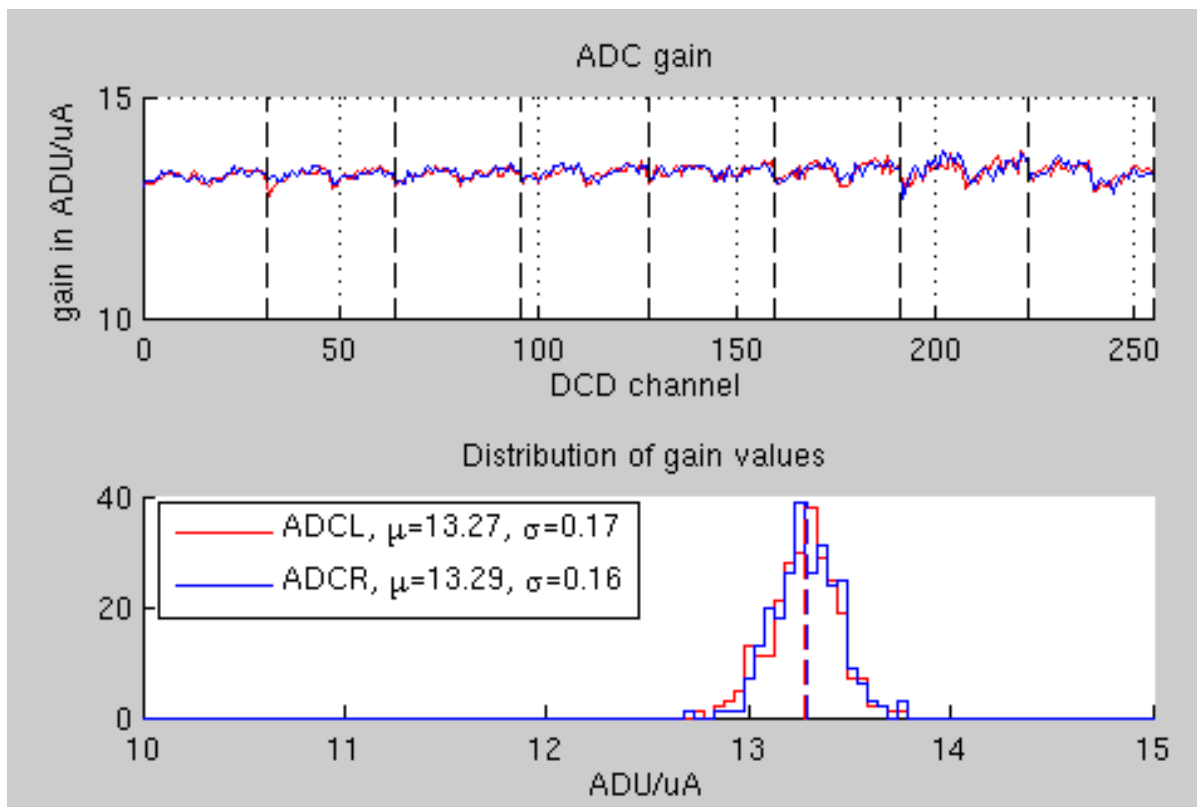
periodic structure w.r.t. half columns

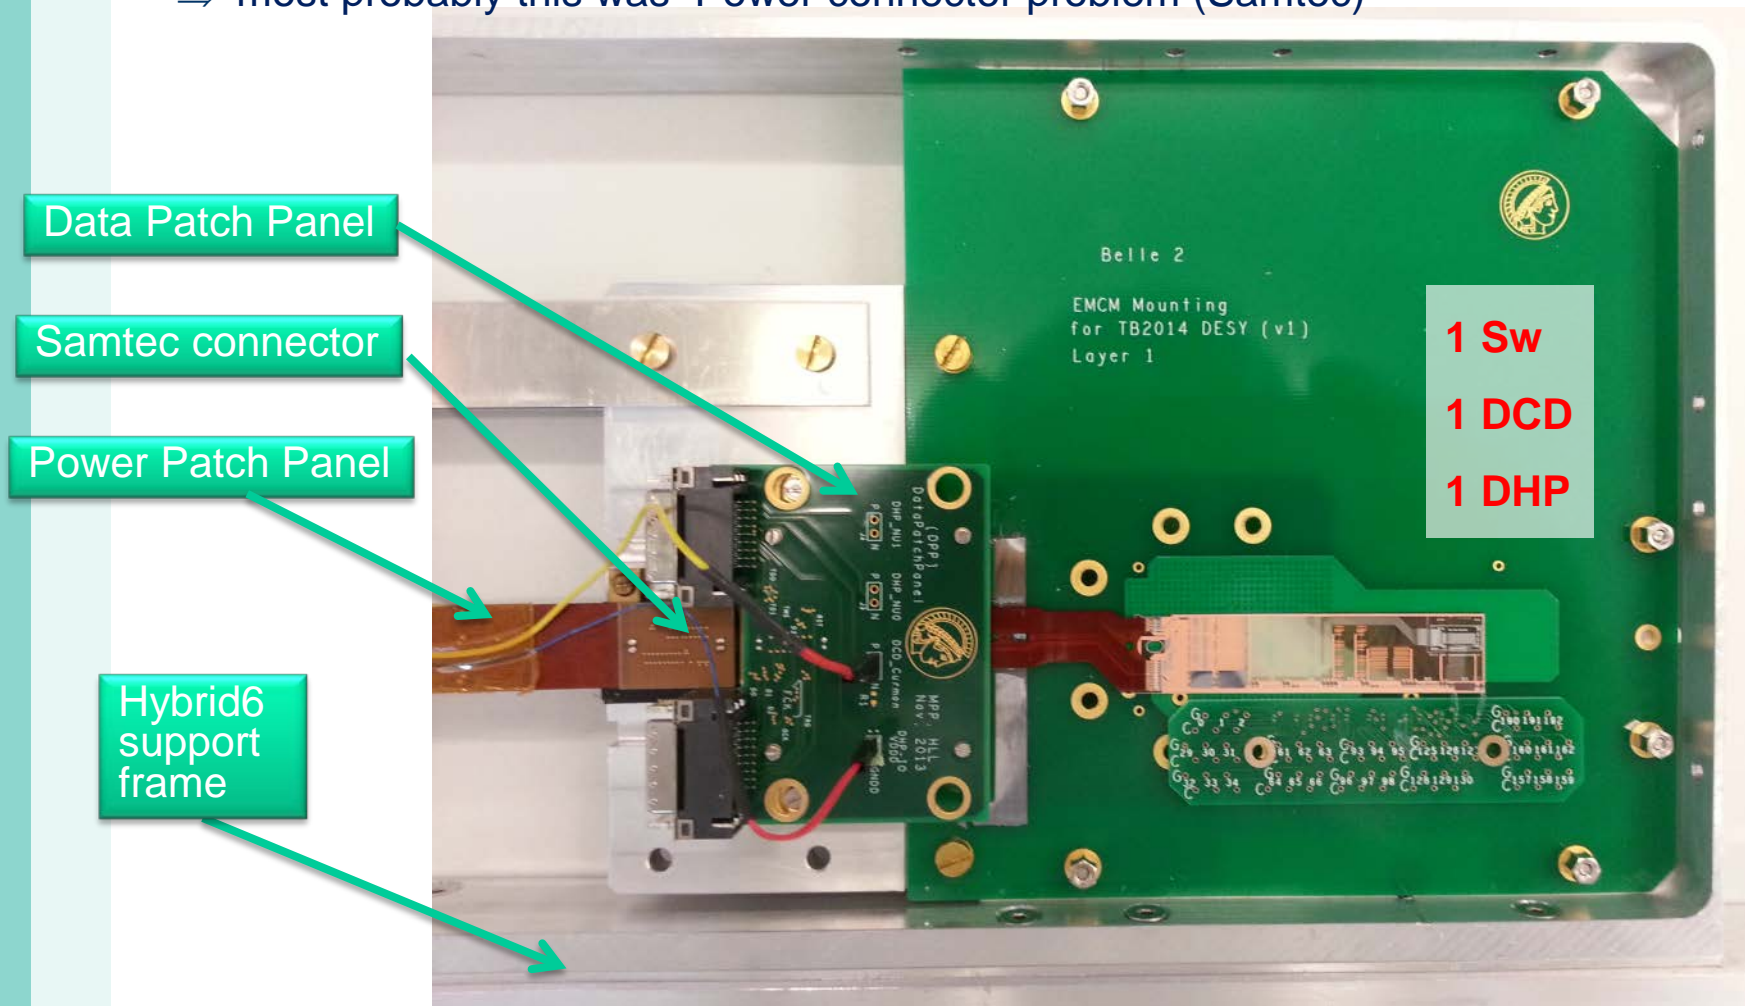
Backup solution for Beam Test in January

- ⇒ was brought untested to DESY (due to missing test devices in MUC)
- ⇒ showed strange voltages & currents (Clear, Gate)
- ⇒ most probably this was Power connector problem (Samtec)

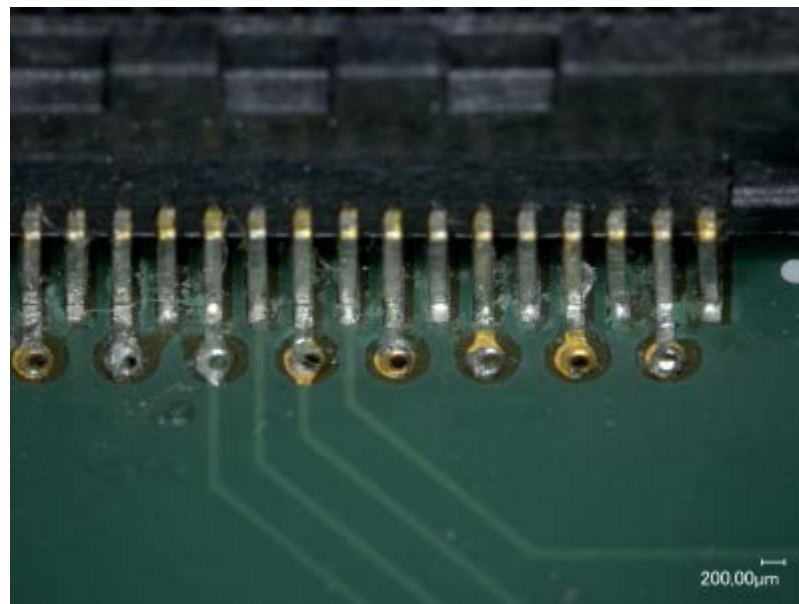
SWB: output signals don't toggle, Clear channels are stuck to ClearOn potential

⇒ Repair of Samtec Power Connector

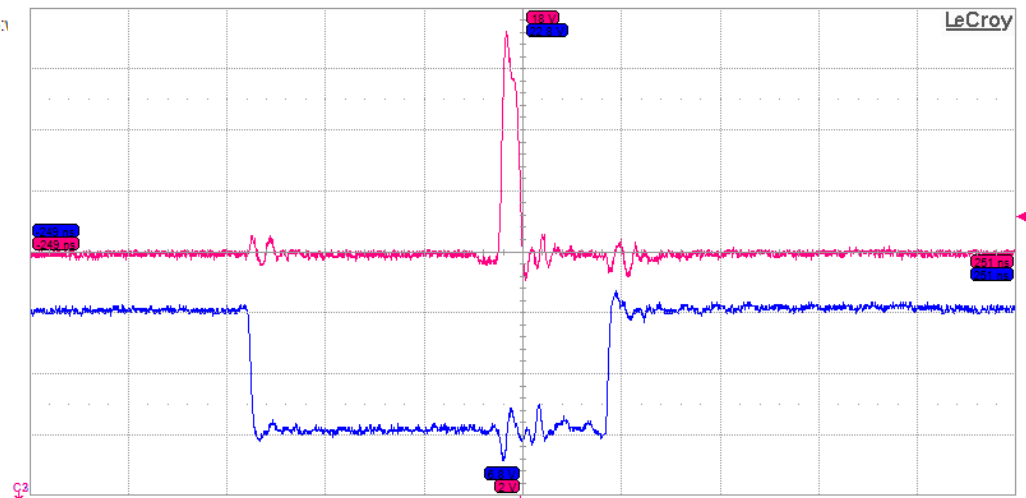
## Shorts of Termination Resistors of LVDS Switcher Signals

=> does not work

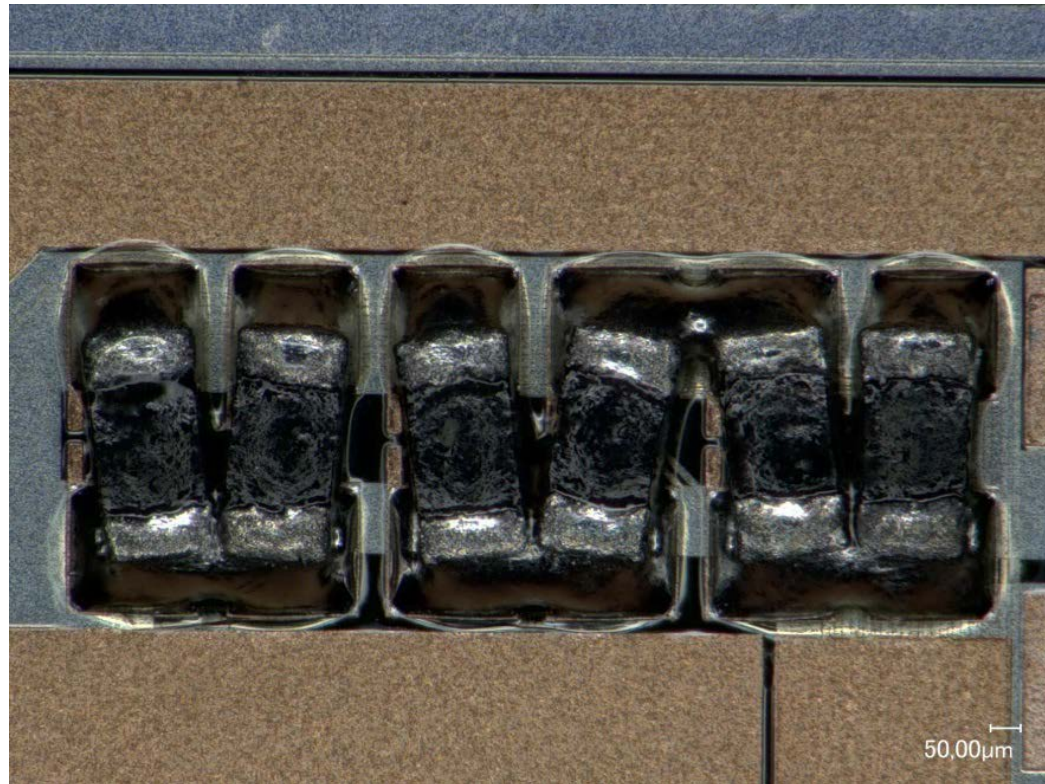
DCD: RefIn is shorted to GNDA

=> not suited for matrix since DCD cannot work properly

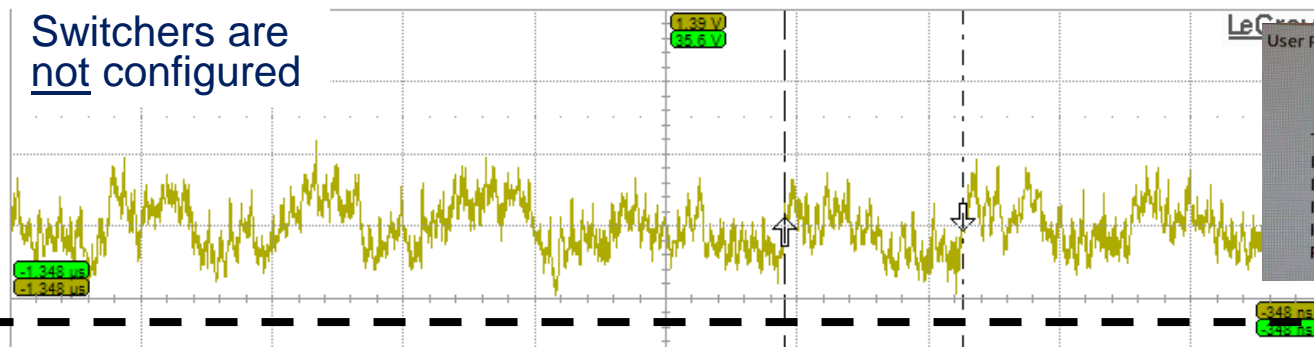
Switchers are not configured

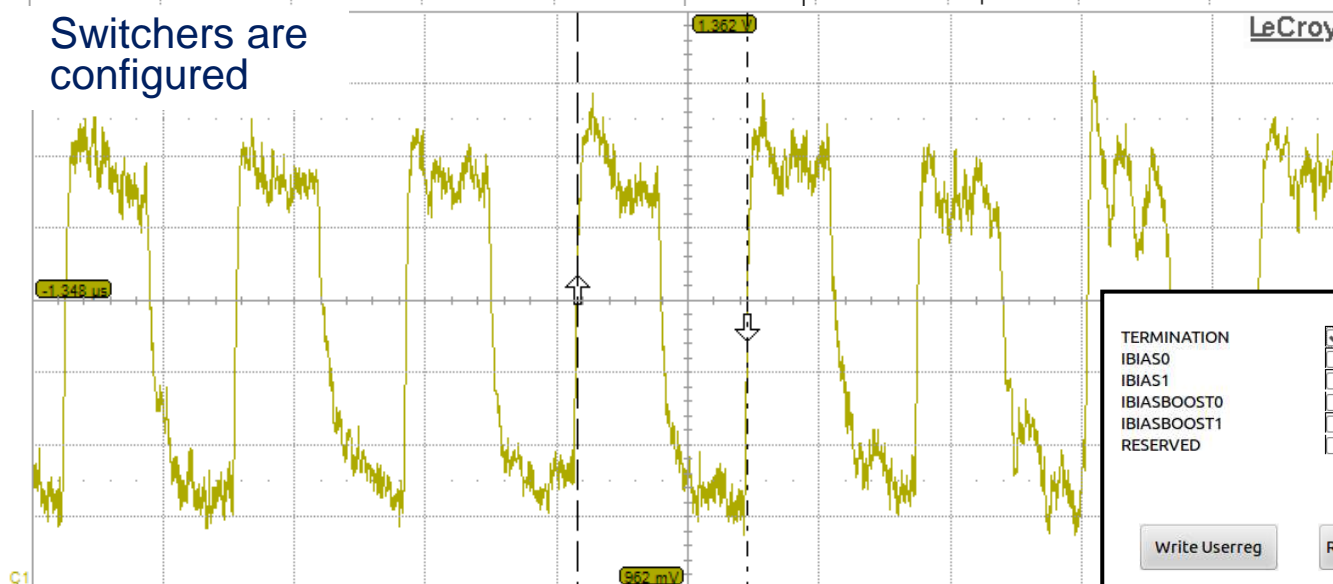
Switchers are configured
