Testing of PXD9 sensors from W30

8th Belle II VXD workshop

Paola Avella, Daniel Klose, Christian Koffmane, Jelena Ninkovic, Rainer H. Richter
for the **MPP/HLL team**

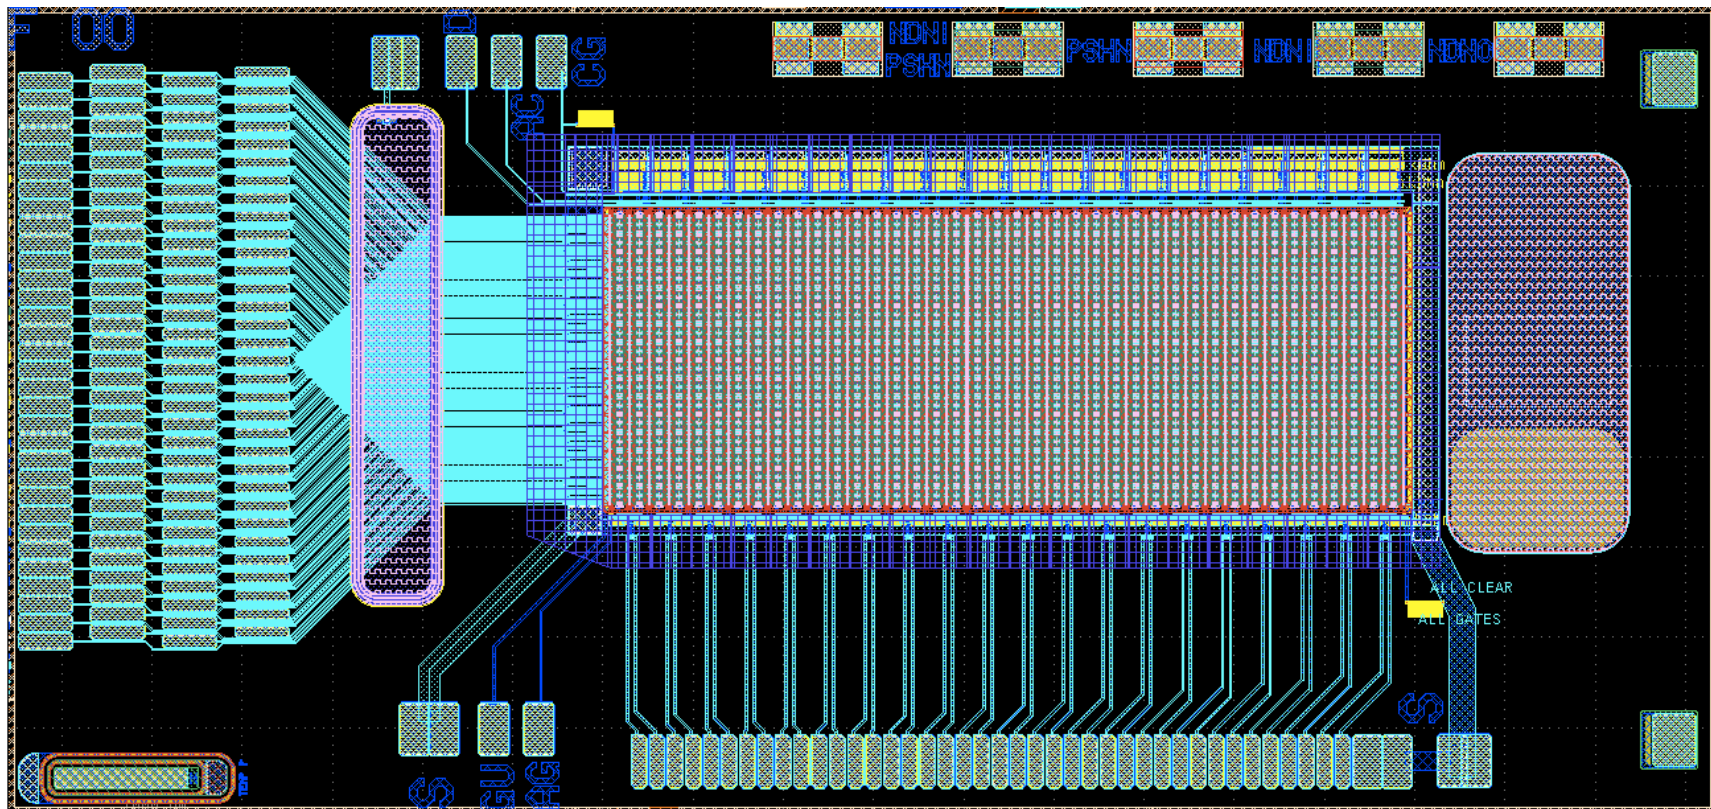
Small matrix F00/W30

- 128 drain lines
- 20 gate rows
- 2560 total pixels

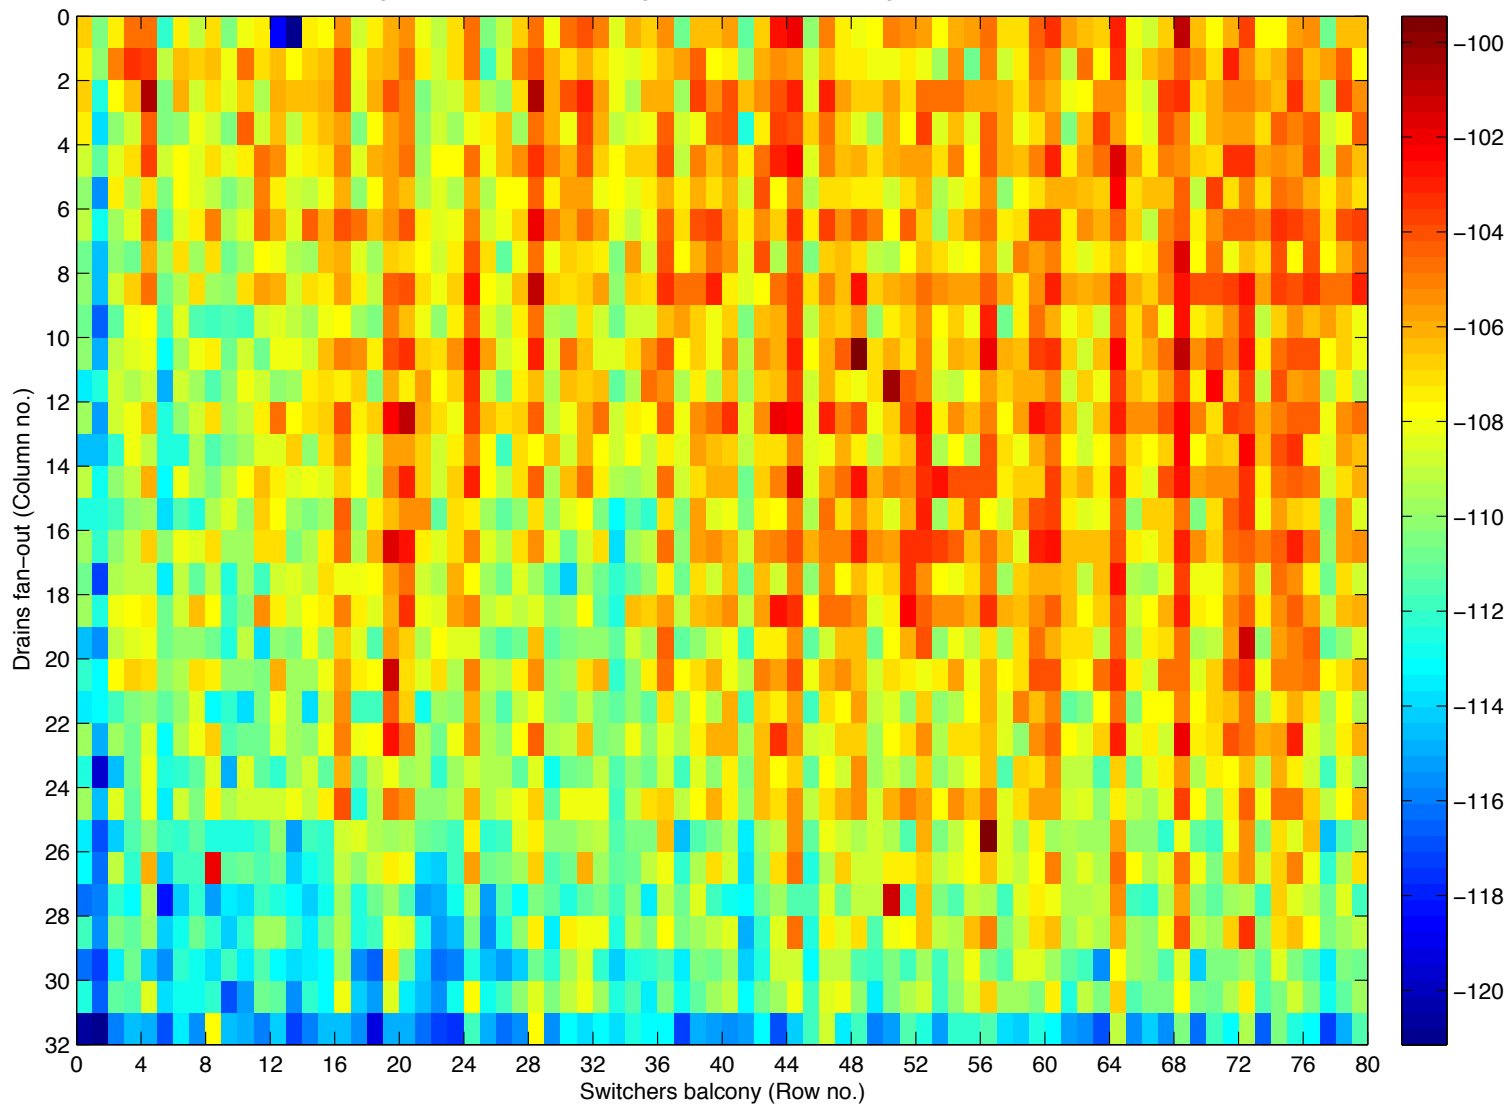
Map of small matrix F00/W30

Drain currents at $V_{GS} = -3V$ for chip F00/W30 (STD, $L = 5 \mu m$, $Z = 55 \mu m$)
 $|I_{DS}^{max}| = 121.15 \pm 0.04 \mu A$, $|I_{DS}^{min}| = 99.45 \pm 0.03 \mu A$, $|I_{DS}^{avg}| = 108.11 \pm 0.04 \mu A$

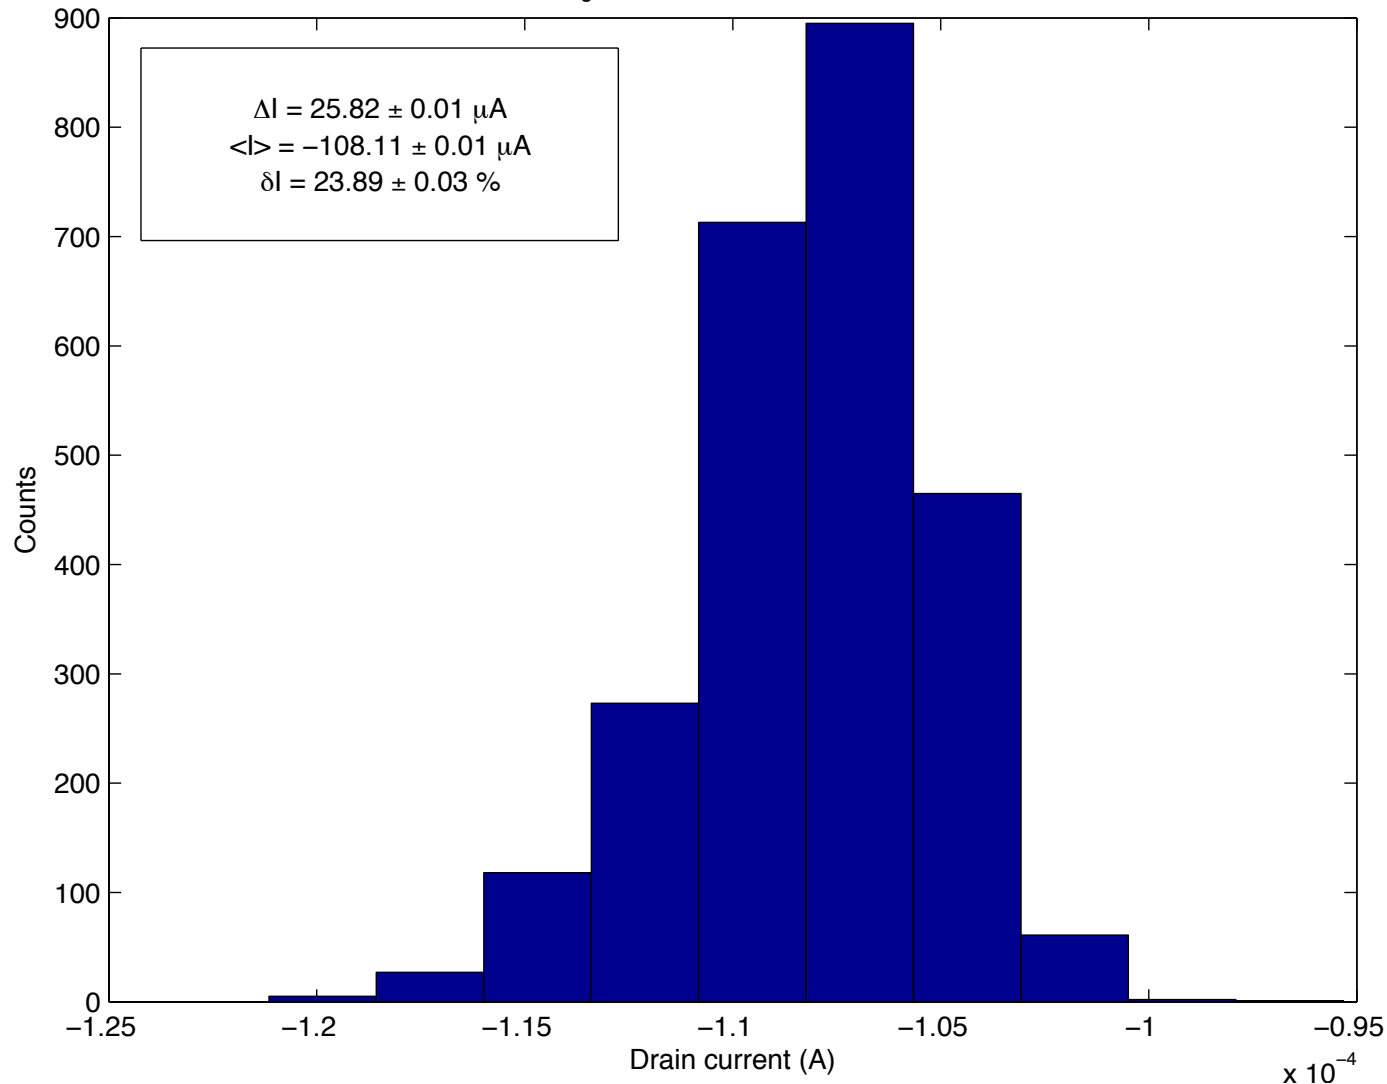
Spread of F00/W30

Histogram of the current at $V_{gs} = -3$ V of all the 2560 pixels of the matrix F00/W30
