- Charge collection of PXD9 Depfets

Charge loss mechanisms  
Ring pattern  
Operation windows  
Recommendations

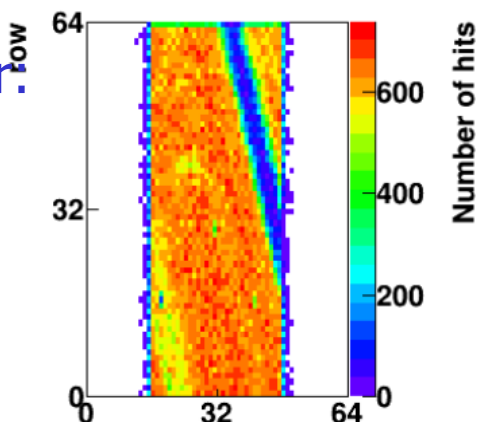
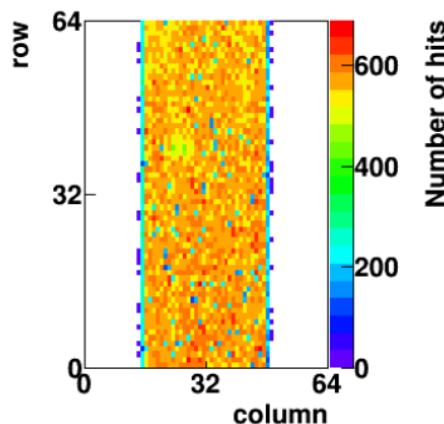
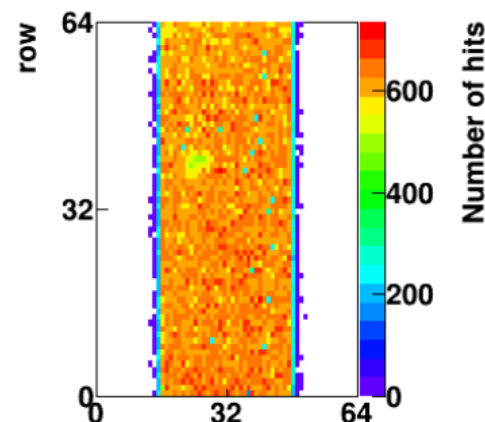
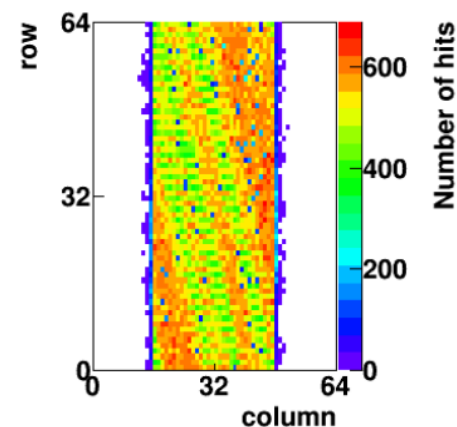
● But we see strips in the charge collection

Strips change their behavior.

Dead strips at low HV show  
best charge collection  
on very high HV  
and vice versa

Strips are inclined:  
cannot be assigned, neither to  
columns nor to rows

Must be a sensor property

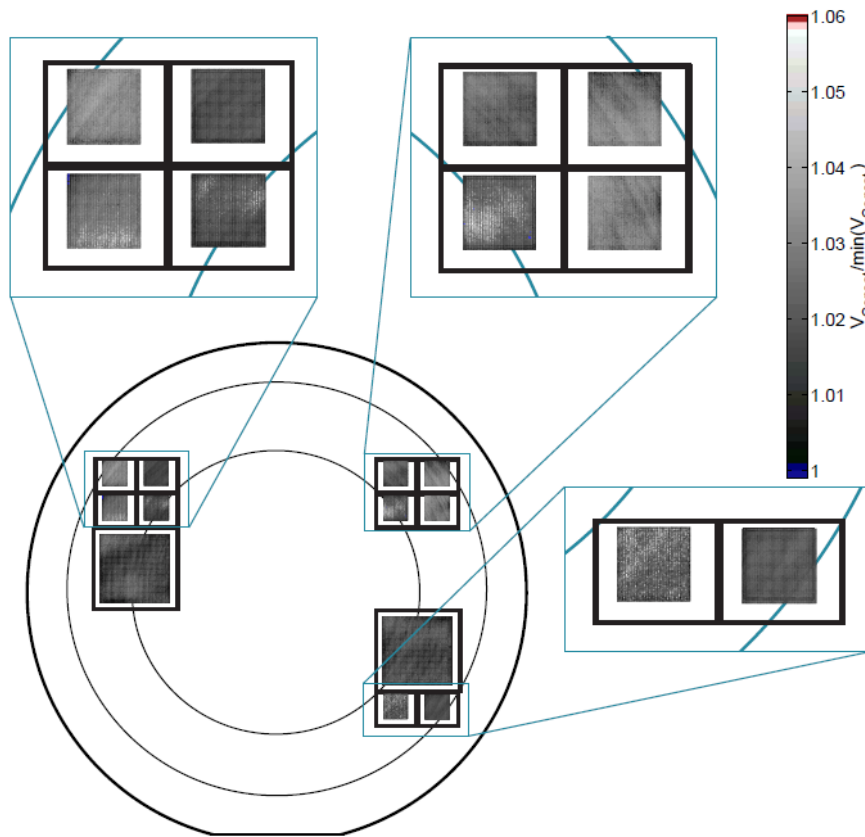
Chip number: PXD9-6 W30 A05

**variations in the bulk doping**

- Idea: variation of bulk doping in concentric rings around wafer center

- yellow area on wafer: tb sensor

- hit occupancy mirrored to match orientation of chip on wafer.

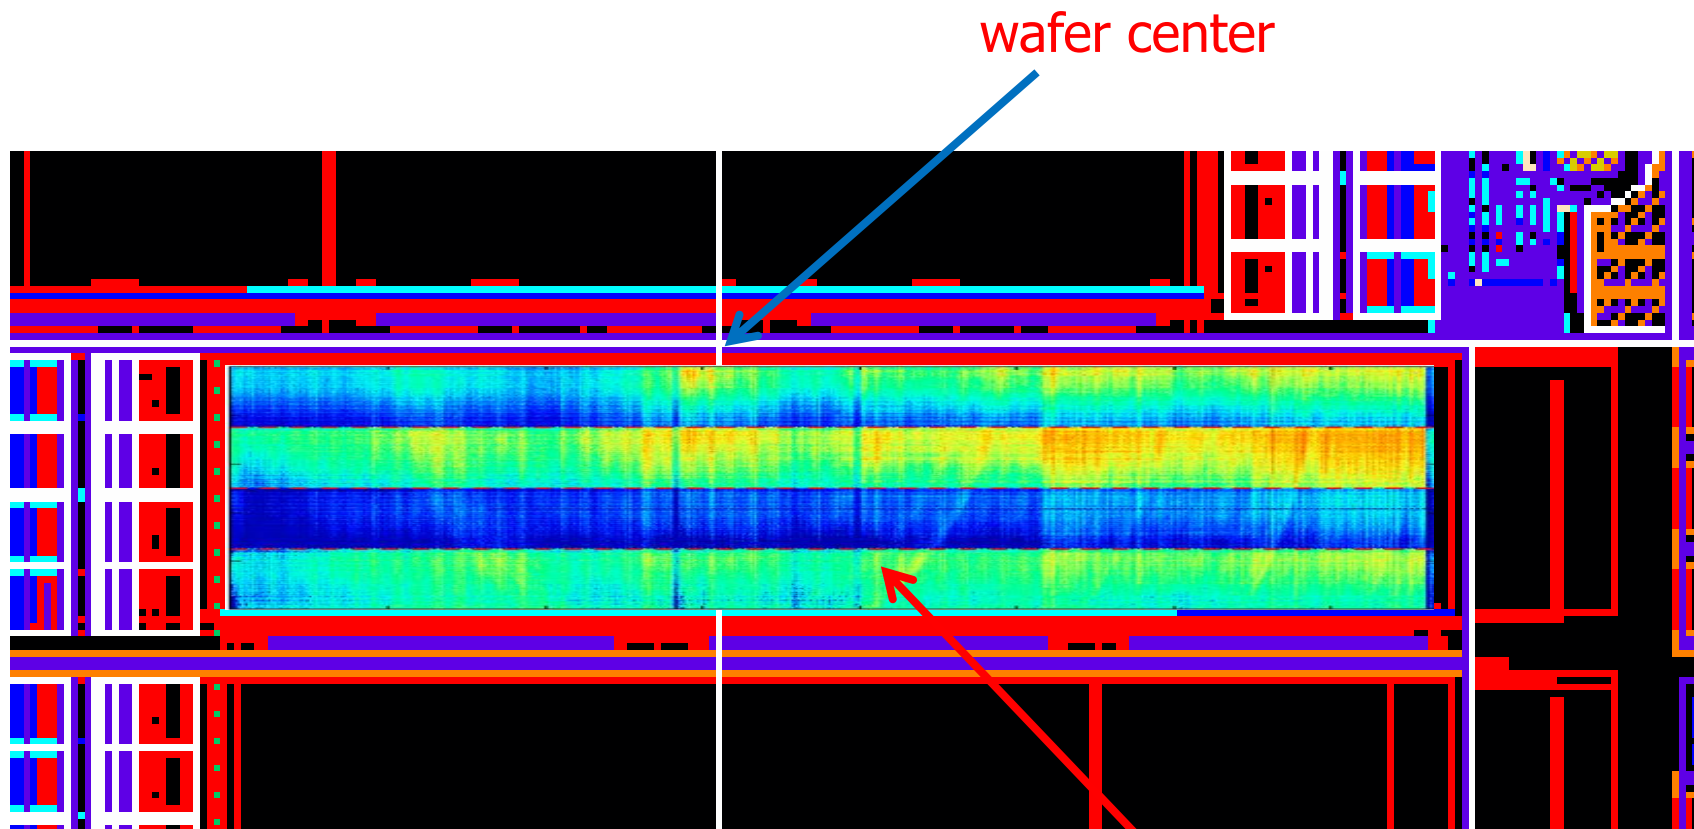
Variations of the clear behavior

But also concentric

Figure 3.3.29.: Maps of the onset voltage of the clear  $V_{Conset}$  for two MIXS macropixel matrices and the surrounding 10 IS prototypes with respect to their position on the wafer 35.  $V_{Conset}$  is normalized to the minimum value for every die. A concentric structure is visible due to the resistivity variation of the high ohmic float zone silicon wafer material [9].

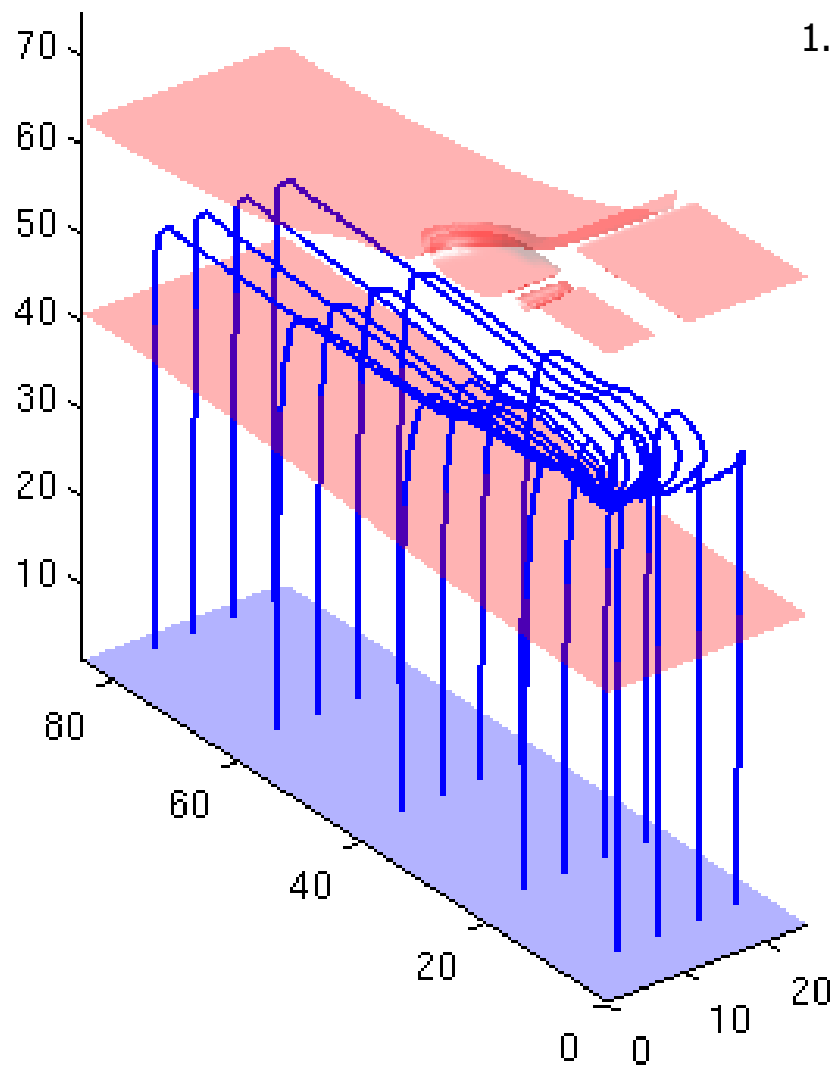
Saddle point pinches off the Internal Gate

- No charge collection possible

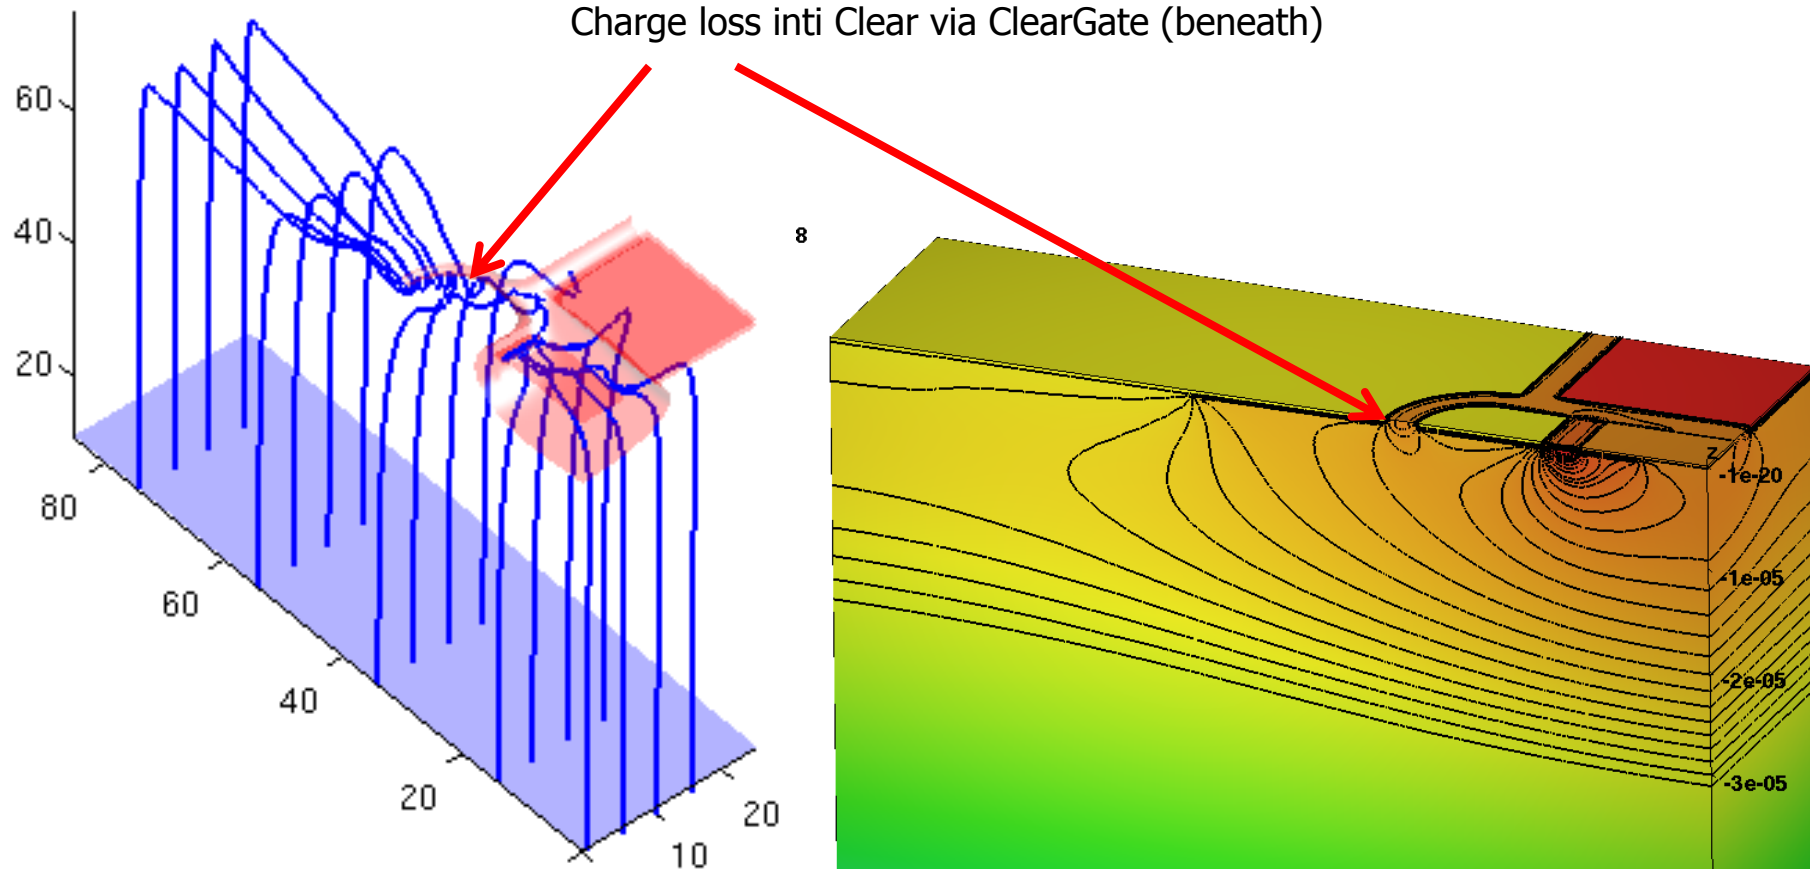
2. Charge loss mechanism

Charge loss into Clear via ClearGate (beneath)

A local bulk doping increase of 50% cannot be compensated by a more neg. bias voltage

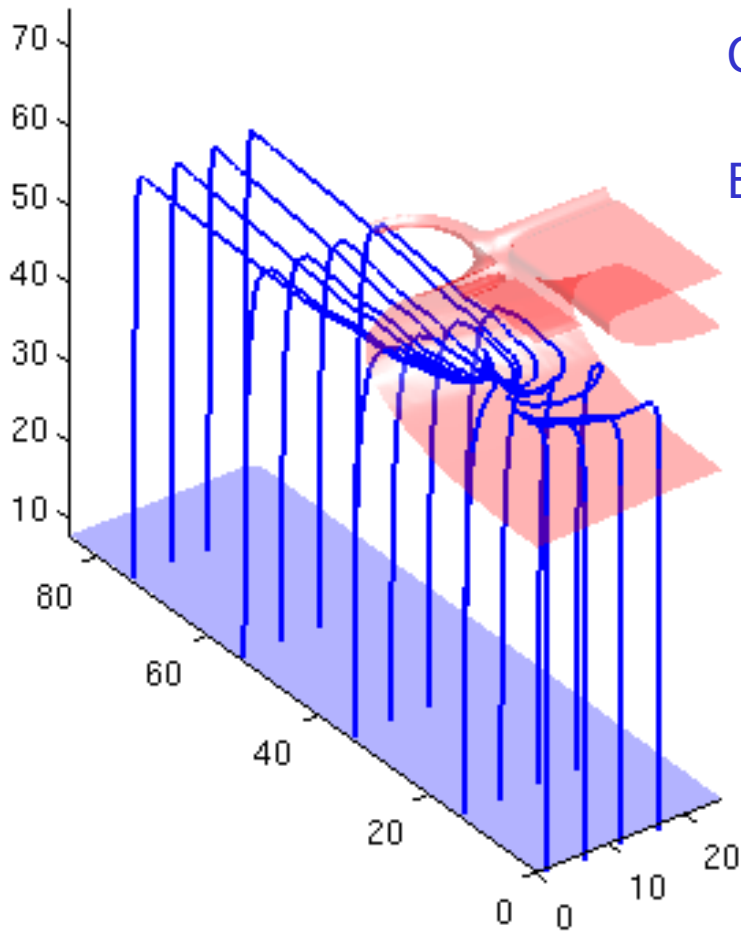
Good charge collection

But strange drift path

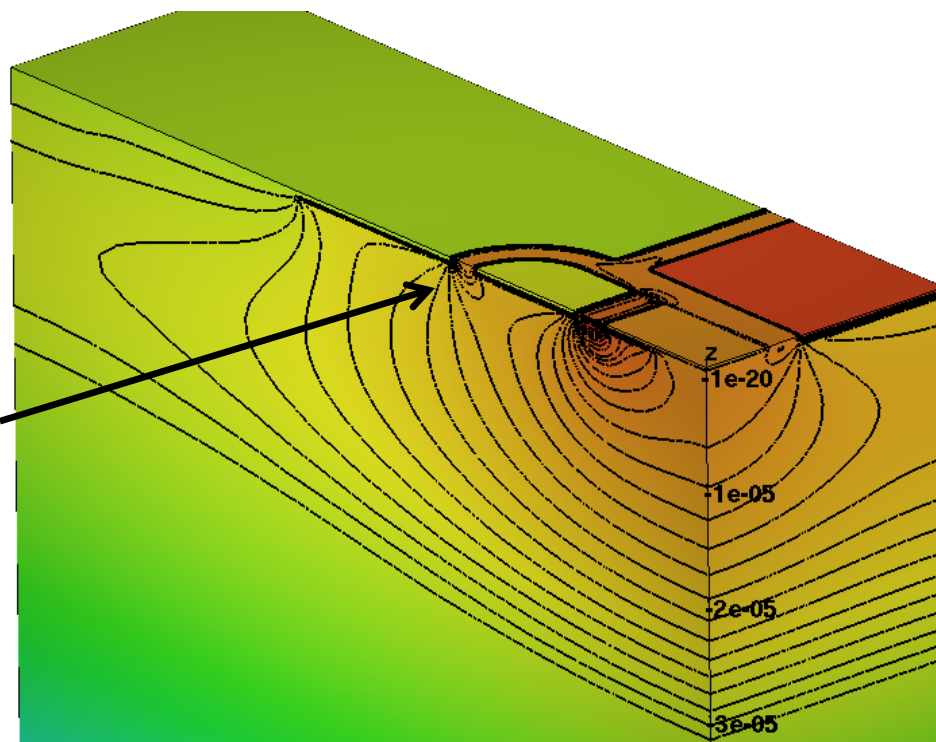
Normally doped regions have to run with more neg. backside

Drift path is pushed toward the topside

Electrons could be trapped by ClearGate regions

But contrary to the opld bias conditions we don't see charge loss in the simulations – due to lower  $V_{\text{clear}}$  (charge does not go into the Clear)

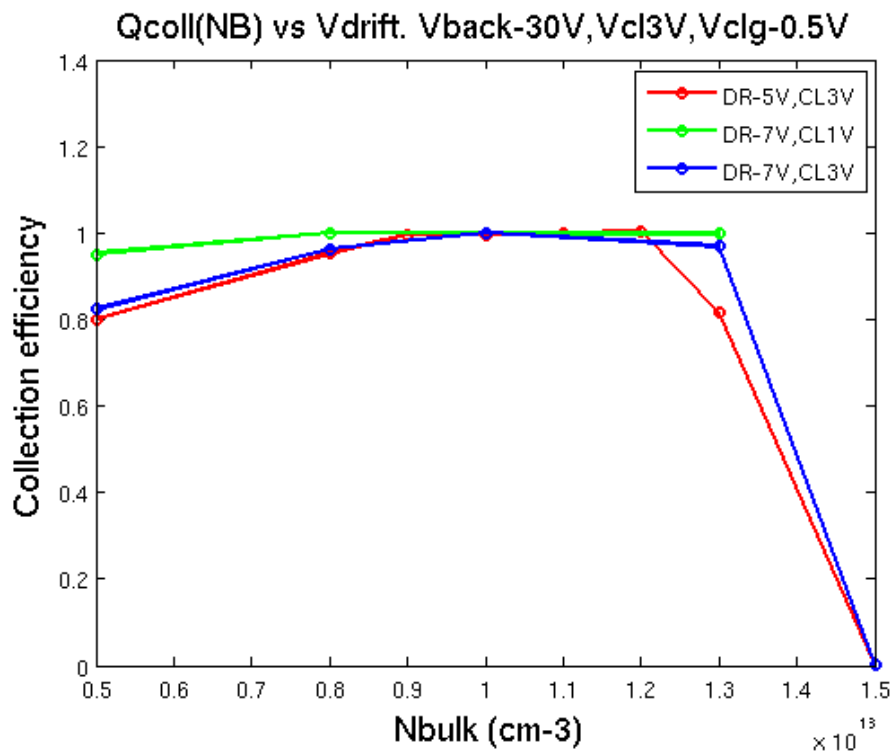
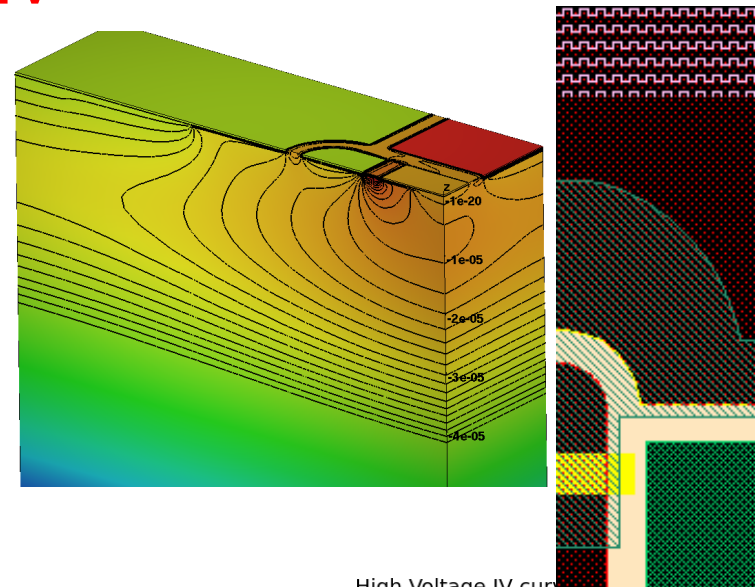
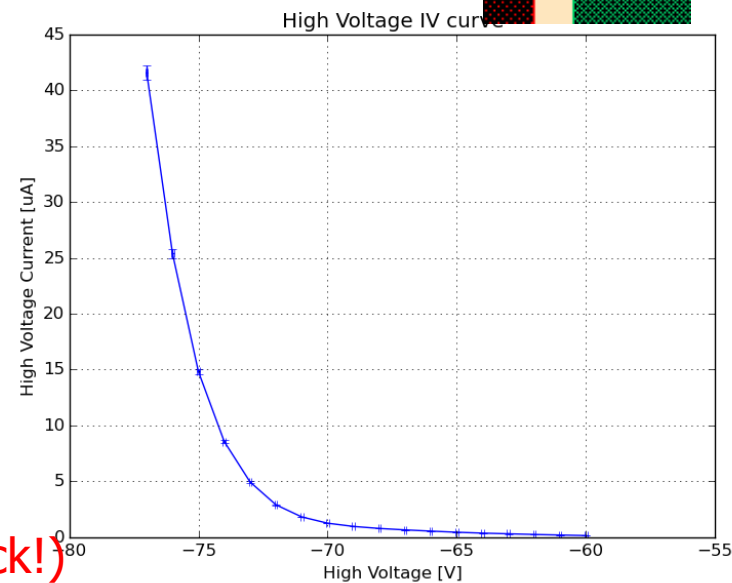
The lower Vclear the earlier the onset of hole emission from Source to Back  
No Problem as long it does not affect the power consumption (measurement of Iback!)

**Vclear\_low** has to be lowered from 5V -> 3V (or even lower but look at backside currents)

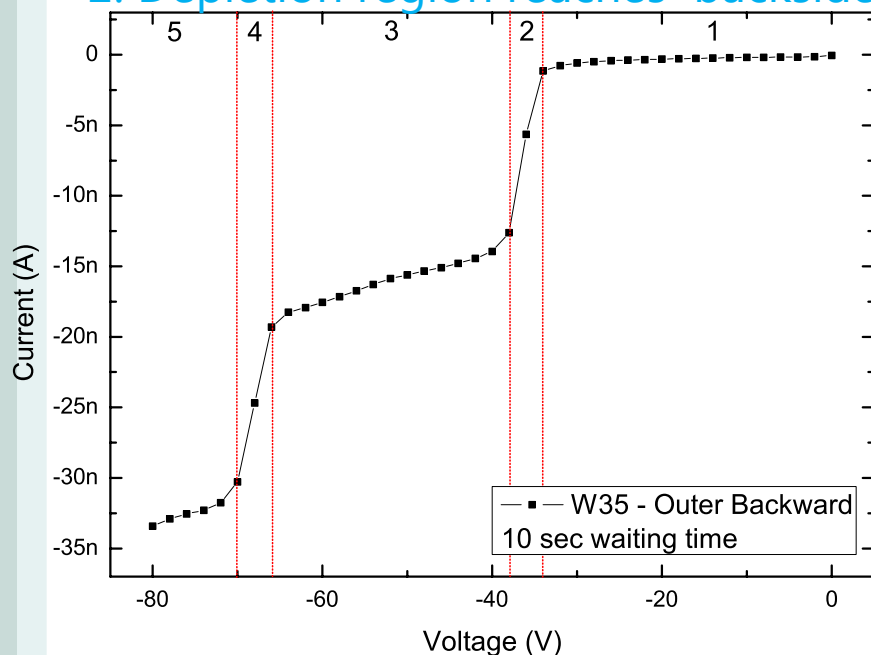
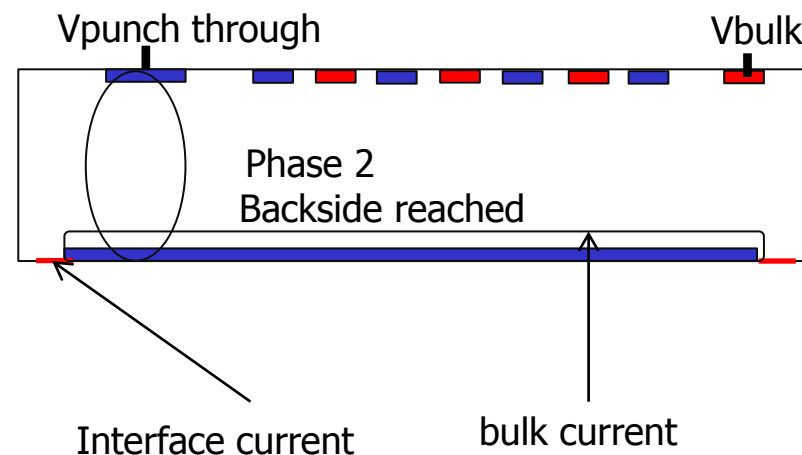
About 35V of HV drops over the punchthrough structure (this is constant if  $I_{back}$  is in an acceptable range. Another (about) 25-30V is required for depletion of the sensor region

Any further increase of HV increases directly  $V_{back}$  of the sensor

Keep in mind: a HV change has to be referred to -30V( $V_{back}$ ) not to HV

Please use smaller steps for HV optimization (2V instead of 5V) !
