# Switcher Bumping Status

# The new SwitcherB18v2.1

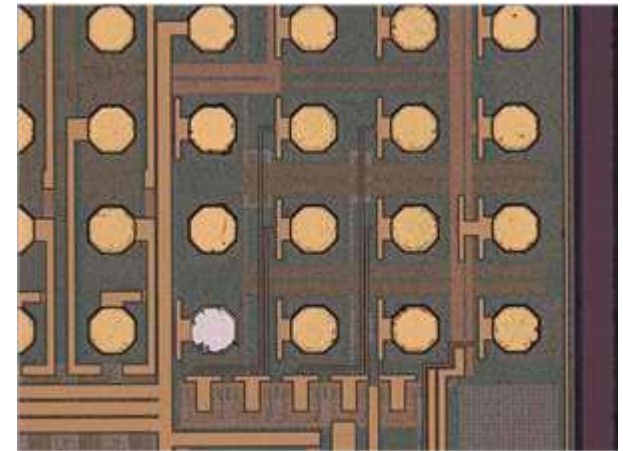
- ▷ Bumping (UBM process) causes problems with the new Switcher
- ▷ On one pad – the substrate pad – and only on this pad
  - ↳ Very little or no Nickel deposition
- ▷ Main difference to old Switcher
  - ↳ Chip is wider...
  - ↳ Different passivation (1µm Nitride/Oxide <-> PI)
  - ↳ Guard ring of the chip exposed, connected to bulk

- Different electrochemical potential causes reduced Ni growth on substrate
- Solution: isolate chip edge! First trials by manual coating chip by chip ...
  - **Successful but very time consuming process with bad yield**

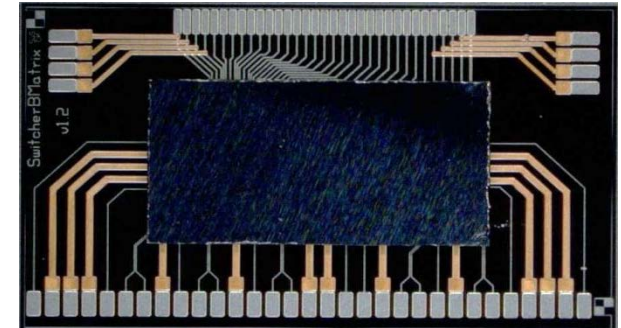
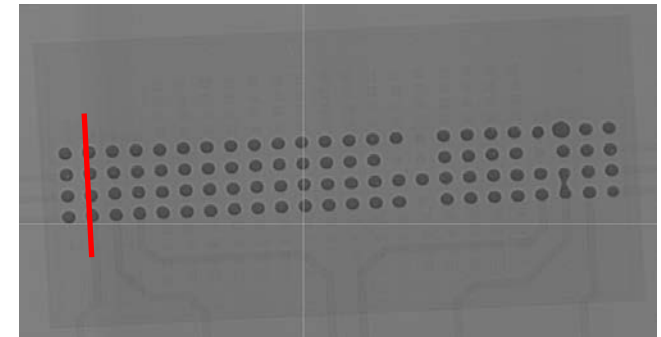
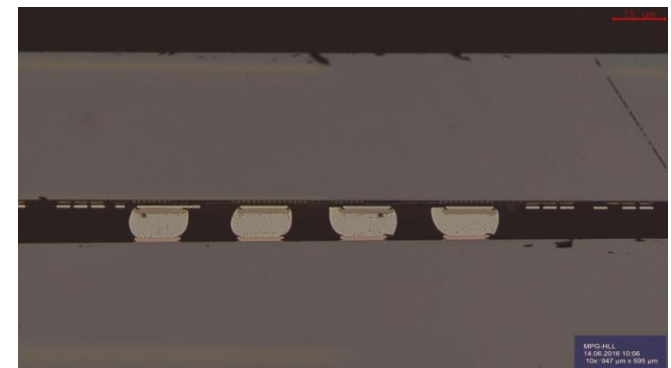
- ▷ Adapters assembled for SWB testing on hybrid level
  - ↳ Three adapters assembled
  - ↳ One assembly done with bad chip (bumping problems)
- ▷ Cross-section

- ▷ Too much solder ....

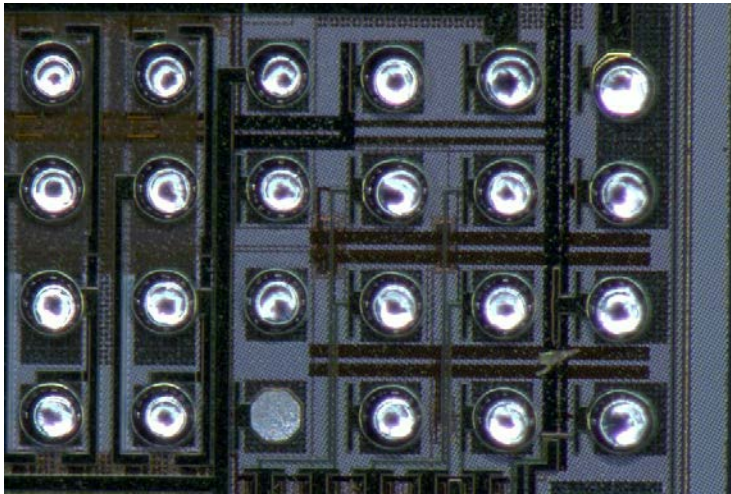
- ▷ “wafer” assembled with 29/100 remaining unbumped chips
- ▷ Sent to PacTech for bumping
  - ↳ Agreed to use smaller solder balls (70  $\mu\text{m}$  and 60  $\mu\text{m}$  instead of 80  $\mu\text{m}$  now)
- ▷ **Failed!**
  - ↳ **Almost on all chips, the UBM was not deposited**

Bad UBM → no ball

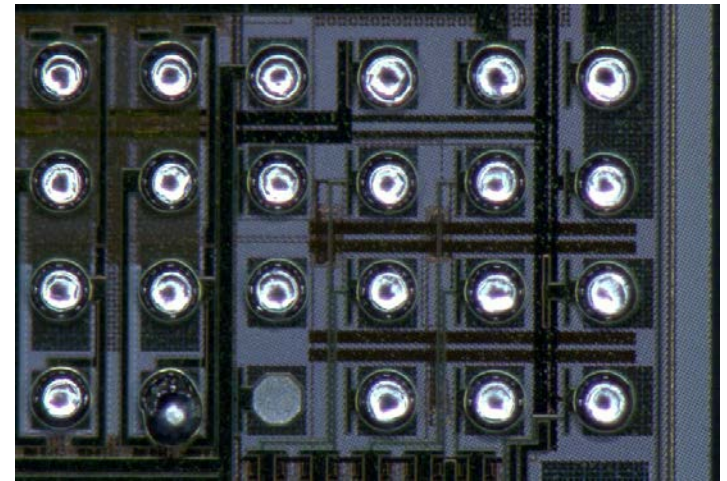
Bad UBM → no ball and double ball on neighbour

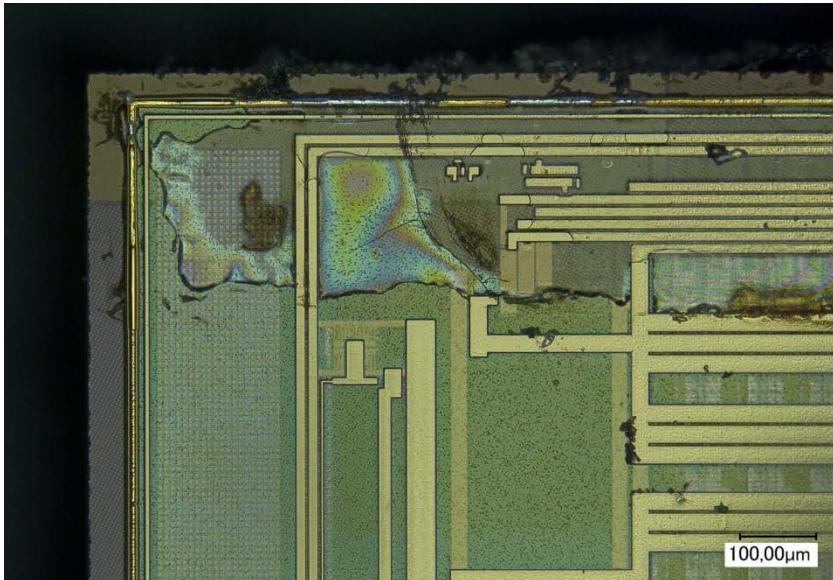
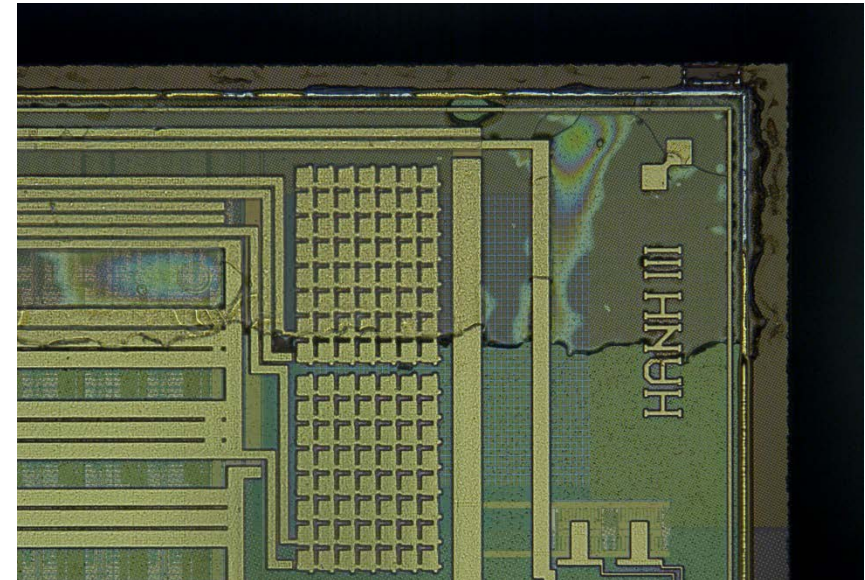
- ▷ According to PacTech, the chemistry for the UBM is very aggressive (with little control over it) and attacks the photo resist ("occasionally")
- ▷ Isolation of the edge is compromised

- ▷ Process is unstable, may work after some more trials (different PR ...)
- ▷ But because of manual single chip handling (wafer assembly, PR removal ..) high loss expected

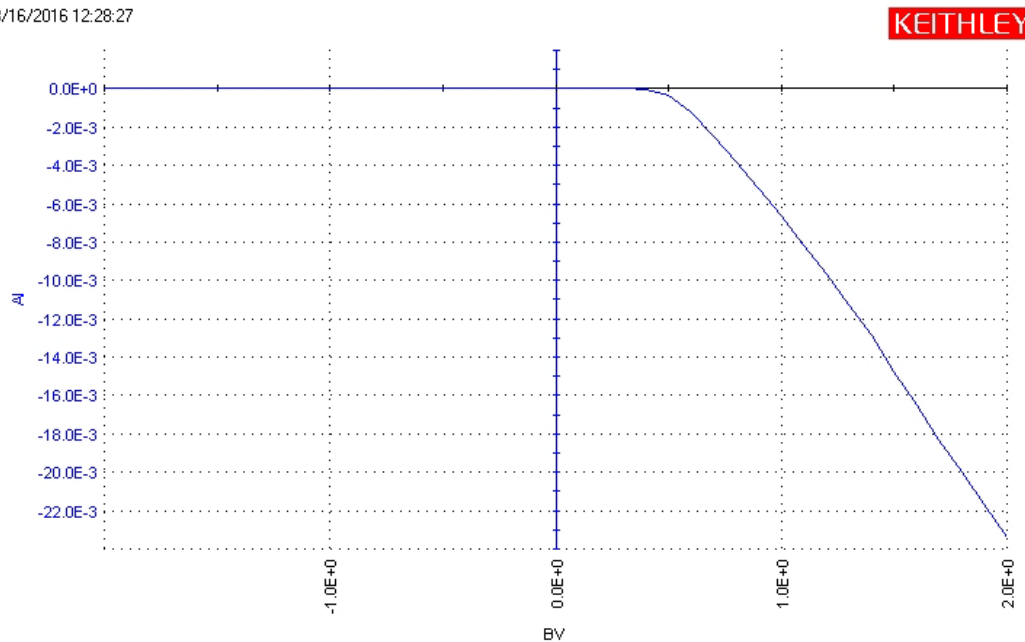
- ▷ Provide  $V_{\text{sub}}$  via backplane of the chip
  - ↳ Would be the most straight-forward solution
  - ↳ Unfortunately did not work (bad contact and diode structure between backplane and  $V_{\text{sub}}$ )

I(V) between  $V_{\text{sub}}$  and backplane,  
GND on back

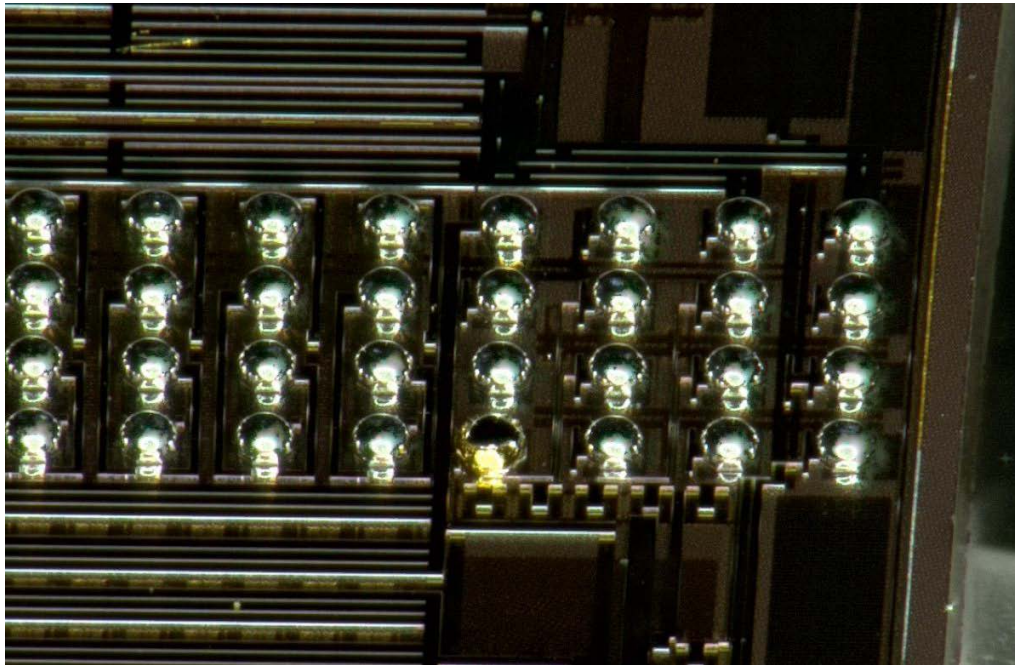
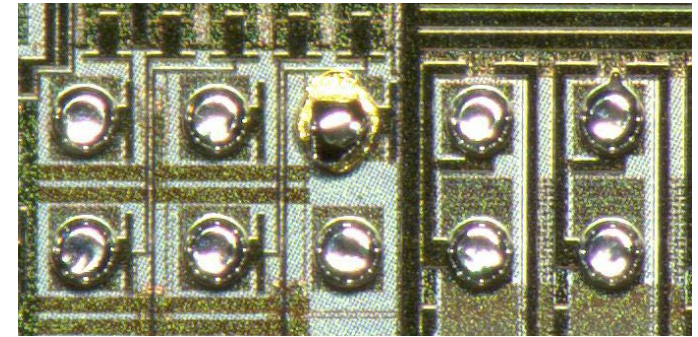
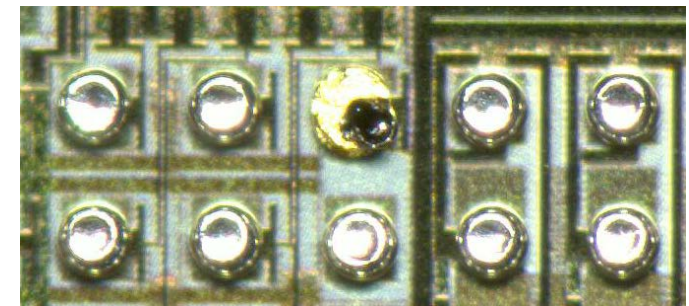
- ▷ Selected optically good chips
- ▷ It worked – sort of...

- ▷ Balls are all about 40-50  $\mu\text{m}$ , as the others
- ▷ Mostly central ....
- ▷ Need for testing → KIT
- ▷ Have now: 16 Au-stud chips, 12 from first batch w/ manual PR coating

- ▷ Place Au stud on missing UBM pad and deposit small solder ball on it
  - ↳ Au stud at HLL, solder ball jetting at PacTech

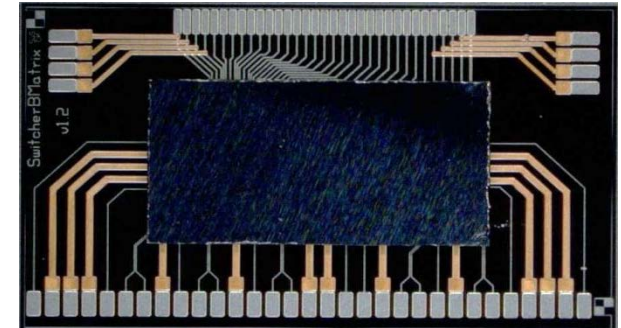
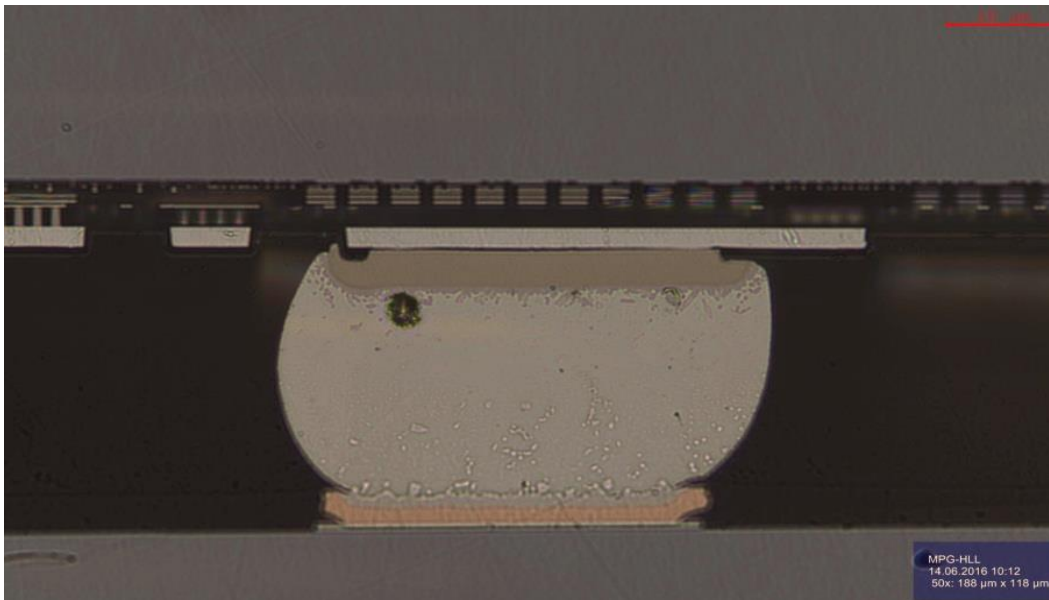
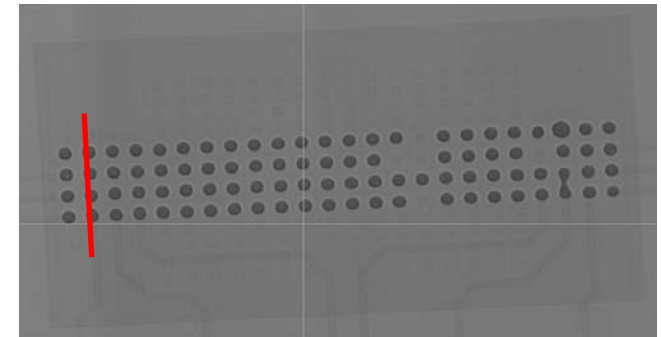
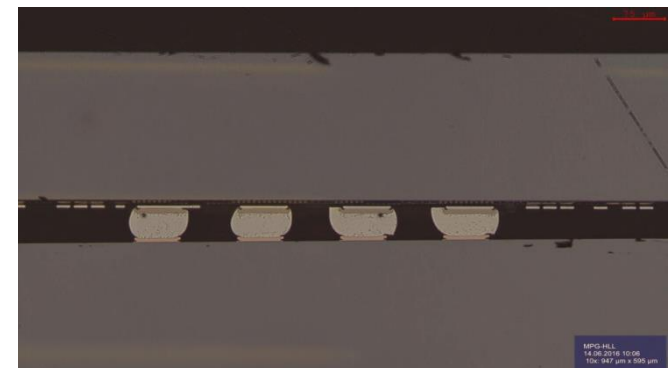
- ▷ Adapters assembled for SWB testing on hybrid level
  - ↳ Three adapters assembled
  - ↳ One assembly done with bad chip (bumping problems)
- ▷ Cross-section

- ▷ Delamination between SWB Alu and Ni?
