# DHPT 1.2 Status

DEPFET-TB  
Sep 27. 2016

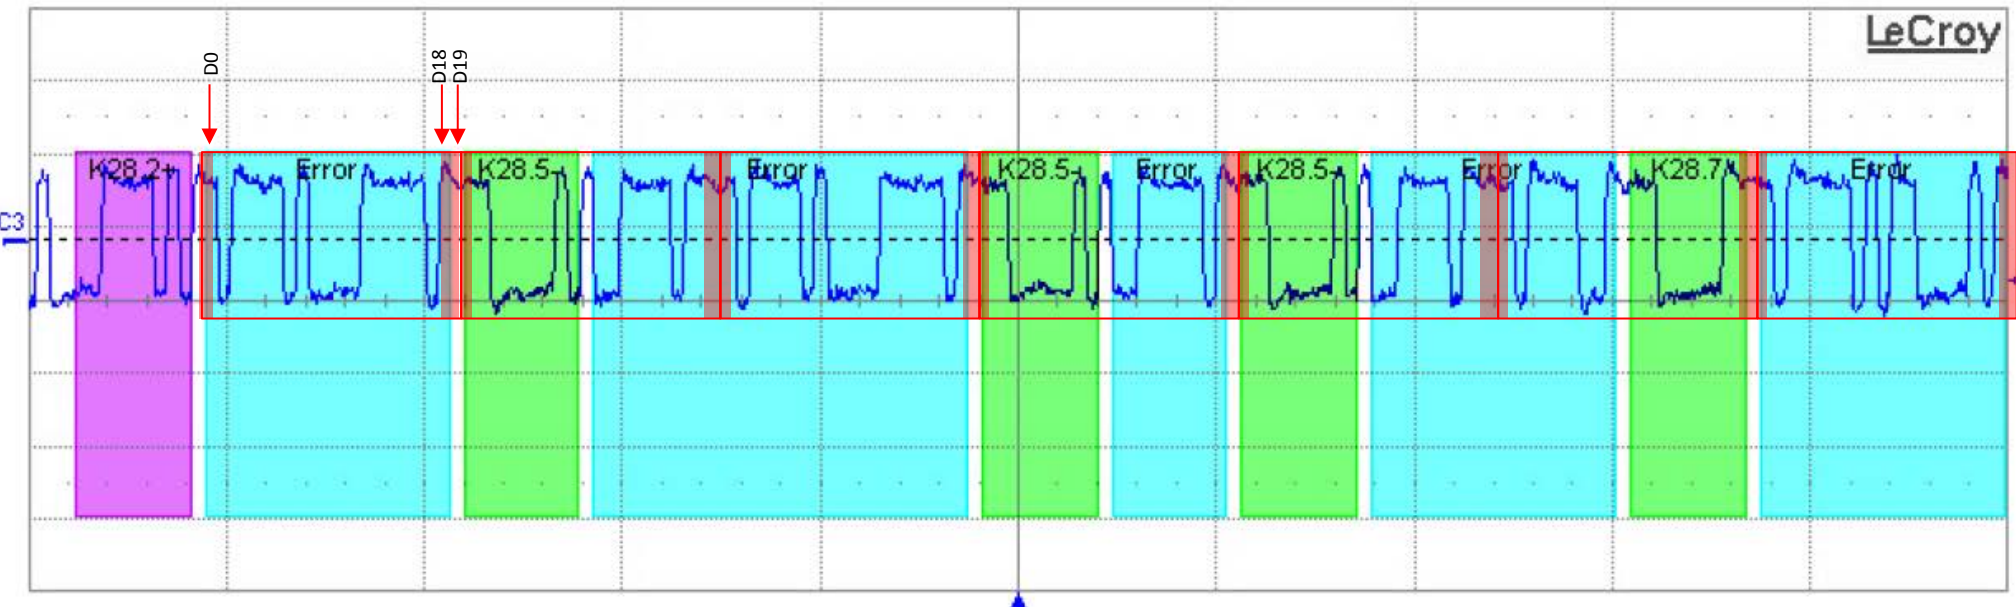
- DHPT 1.2 has a major bug: On the 20 bit data bus connecting the core to the serializer bits D[0], D[18], and D[19] are shorted to ground.
- The data link puts out invalid symbols rendering the DHHPT 1.2 unusable

DHPT 1.2 data link output: D[0], D[18], and D[19] of a 20 bit group are always 0 (inverted waveform)

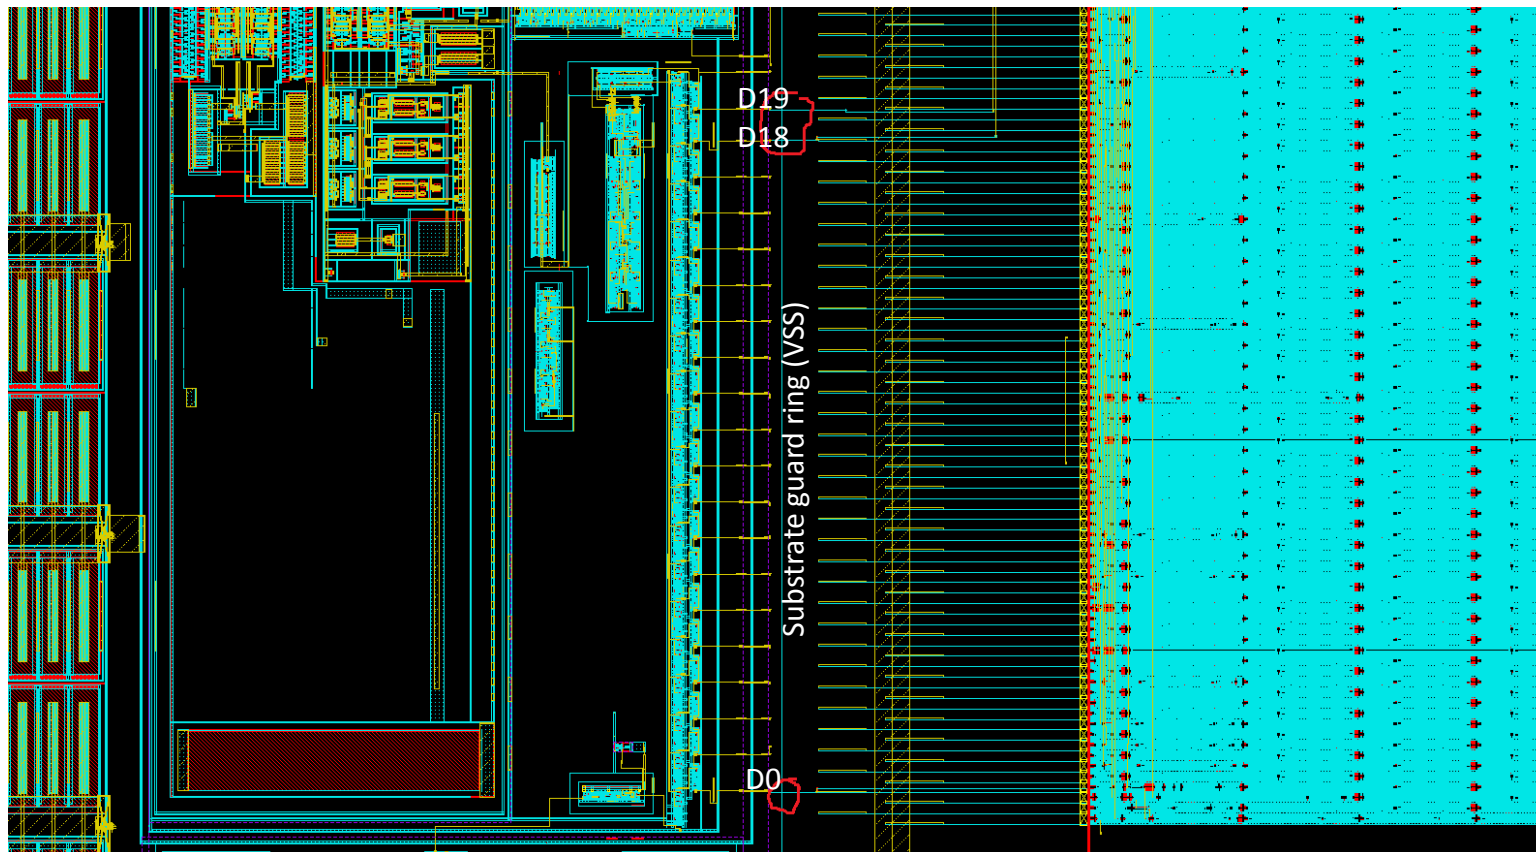
- The **auto routed data** lines are part of the **synthesized core**. Only D[0], D[18], and D[19] are routed on M1, all other bits use higher metal levels.
- The **substrate guard ring** on M1 was placed by hand in one of the **full custom cells**.
- The cells are combined at a later stage of the integration flow. Need LVS checks to spot and fix shorts.

Layout zoom: Data bus between digital core (right) and serializer (left), only M1 and M2 shown

- Concurrent layout changes in a full custom layout cell containing the substrate guard ring and the synthesized core with routing between serializer and core caused the short.
- A LVS (layout versus schematic) check spotted this error and it was corrected by hand. A LVS clean layout was checked-in to our repository system.
- However, the layout submission was done from another machine (by another designer) where the design was not updated to the latest version from the repository server (human error).

- The correct version of the layout (DHPT1.2B) has to be re-submitted end of September.
- No layout changes needed, since the correct layout has been in our repository all the time.
- However, functional test w/o data link and repeated simulations have been conducted to verify the chip as good as possible
  - The functionality of the data path, which cannot be tested due to the bug, has not been changed from DHPT 1.1 to DHPT 1.2
- Time line
  - DHPT 1.2B available end of December
  - Use DHPT 1.1 for production of beast modules (31pcs. @BN + 30 pcs. @HLL)
  - We could order 100 additional DHPT 1.1 chips. Do we need them (i.e. for ramp-up of pre-production)?

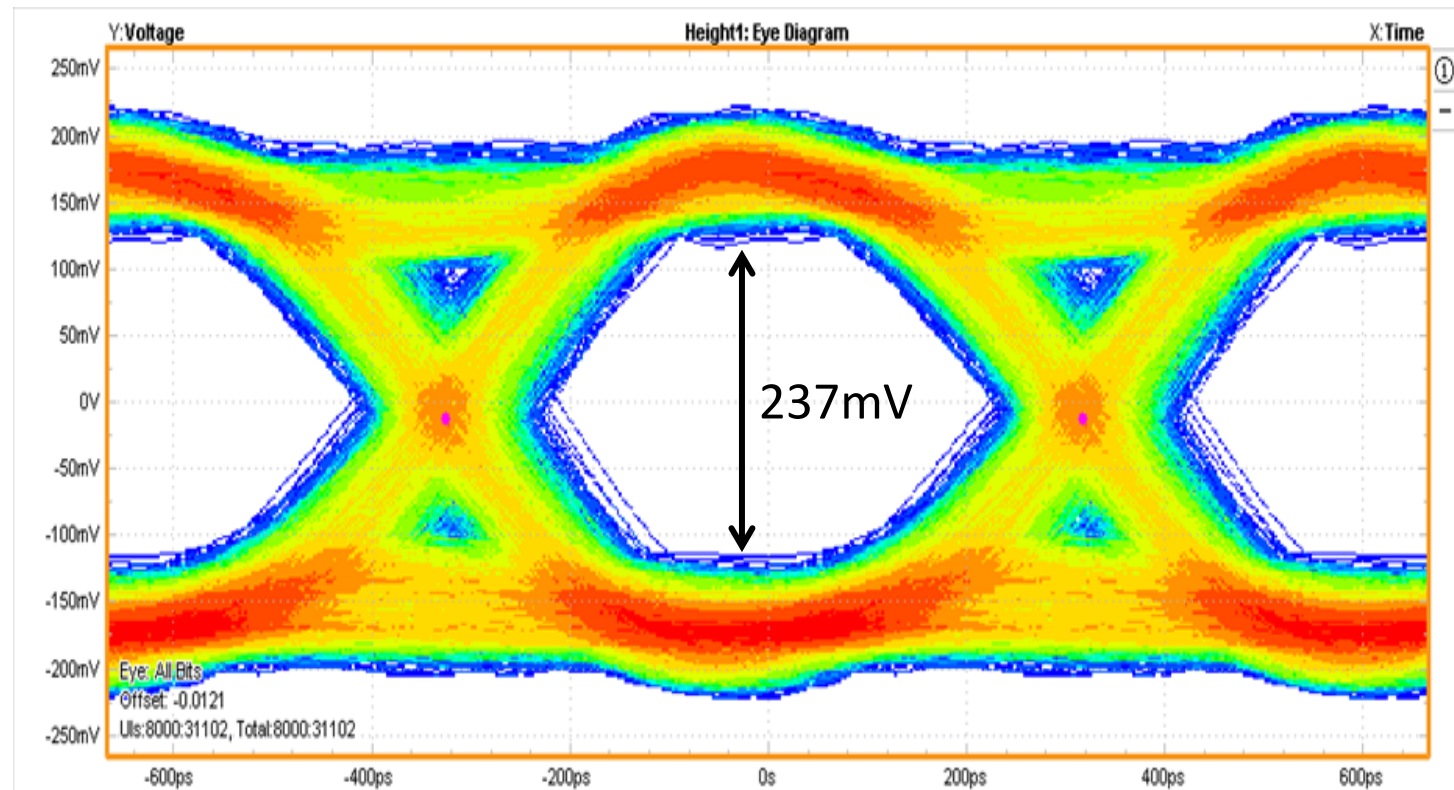
- Eyediagram with 10m Infiniband cable
  - IBIAS = 20, IBIASD = 60, Pll\_cml\_dly =2 (still a lot of headroom)

- CML driver power routing
  - Ground rail (VSS) had a too high wiring resistance ( $\sim 30$  Ohm), parasitic extraction did not spot this because of substrate model
  - Rerouting of power nets  $\rightarrow R_{VSS} < 0.2$  Ohm
- CML driver bias routing
  - Removed ESD resistor in bias connection and reduced parasitic resistance  $\rightarrow$  increase of bias current, less sensitivity to voltage supply
