IB/OB JTAG Puzzle

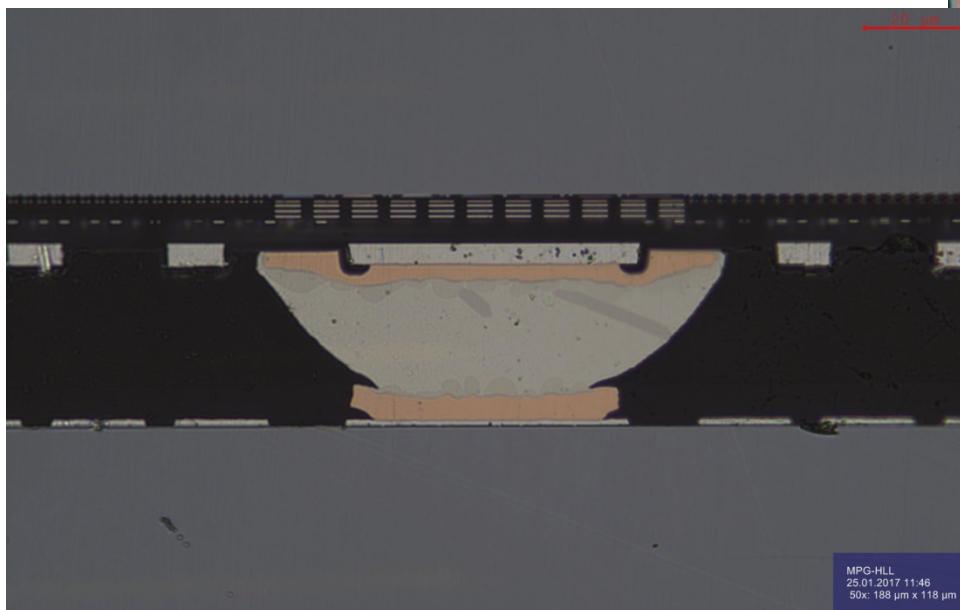
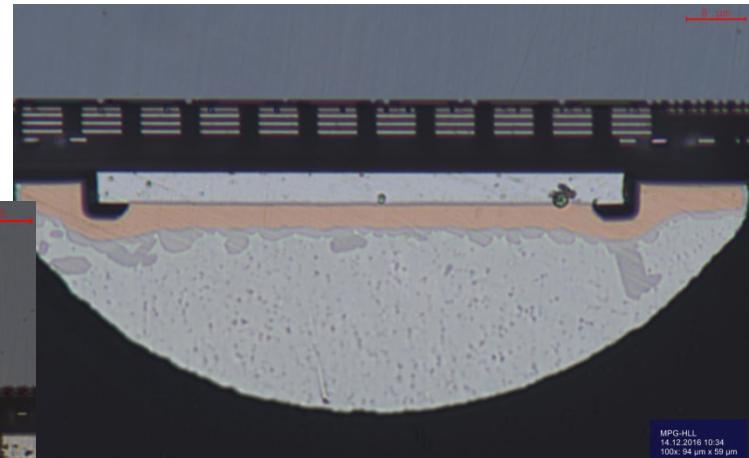
- ▷ After checking all first order suspects (r/o system, PS, grounding, re-test of SWBs ...)
- ▷ Detailed x-ray inspection, cross sections ...
- ▷ No anomalies, no "smoking gun"

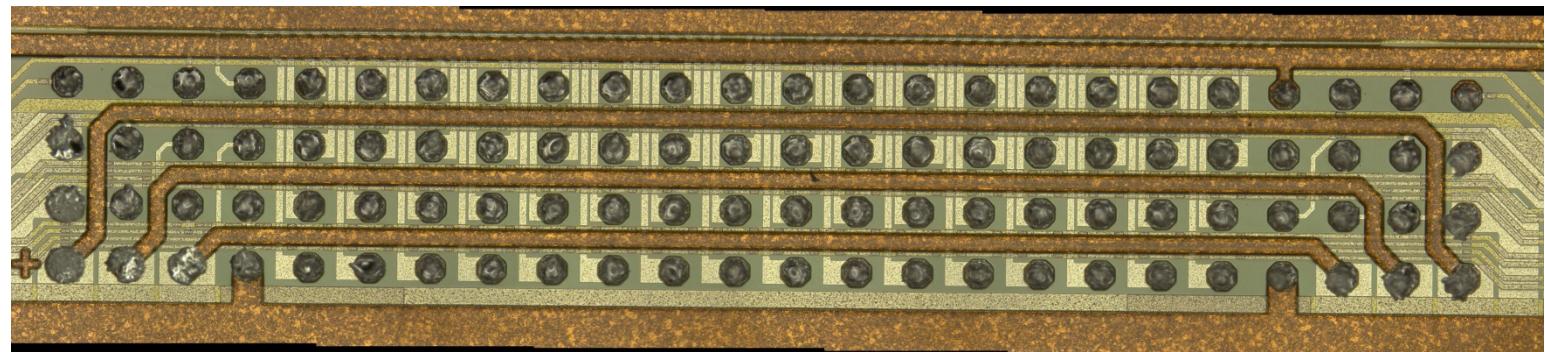
Pads on Module after removal

- ▷ Going from SWB1 → SWB6 wetting gets worse towards SWB3 and 4, then better towards SWB5 and 6
- ▷ Possible reasons
 - ↳ Reflow temperature not reached in the middle of the module due bad contact to the heat plate
 - ↳ talk to IZM....
 - ↳ In this case a second (local) reflow with HCOOH or flux might help
 - ↳ BCB (final passivation, solder stop) residues on the pads
 - ↳ Inhomogeneous „descum“ (plasma process is worse at bottom and at the edge of the wafer..)
 - ↳ Needs cross check,
 - ↳ possibly more descum, currently we remove 300-400 nm of BCB after final passivation

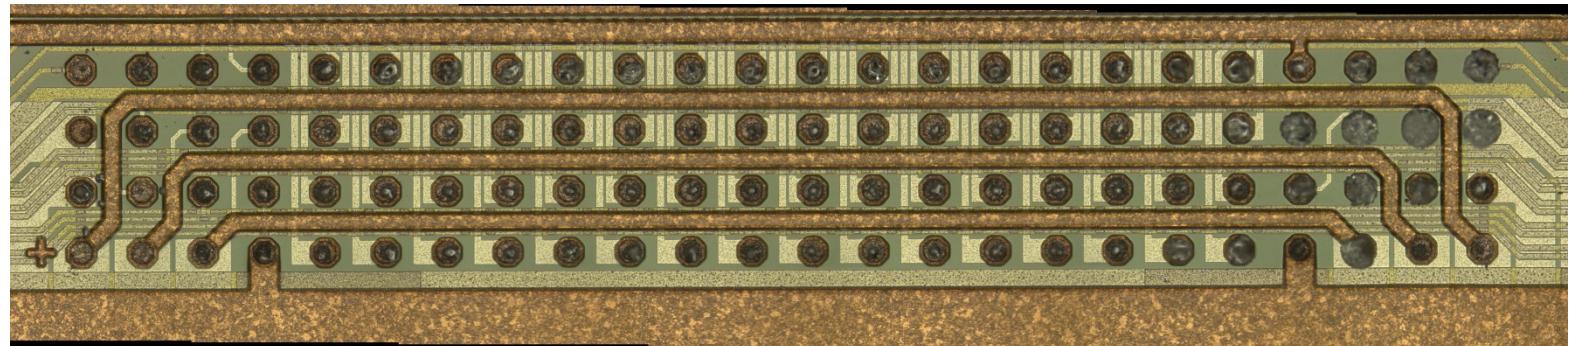
SWB4

Pads on Module after removal
