DEPFET

# Power down sequence meeting

Philipp Leitl, Felix Müller

Jan 9<sup>th</sup>, 2018

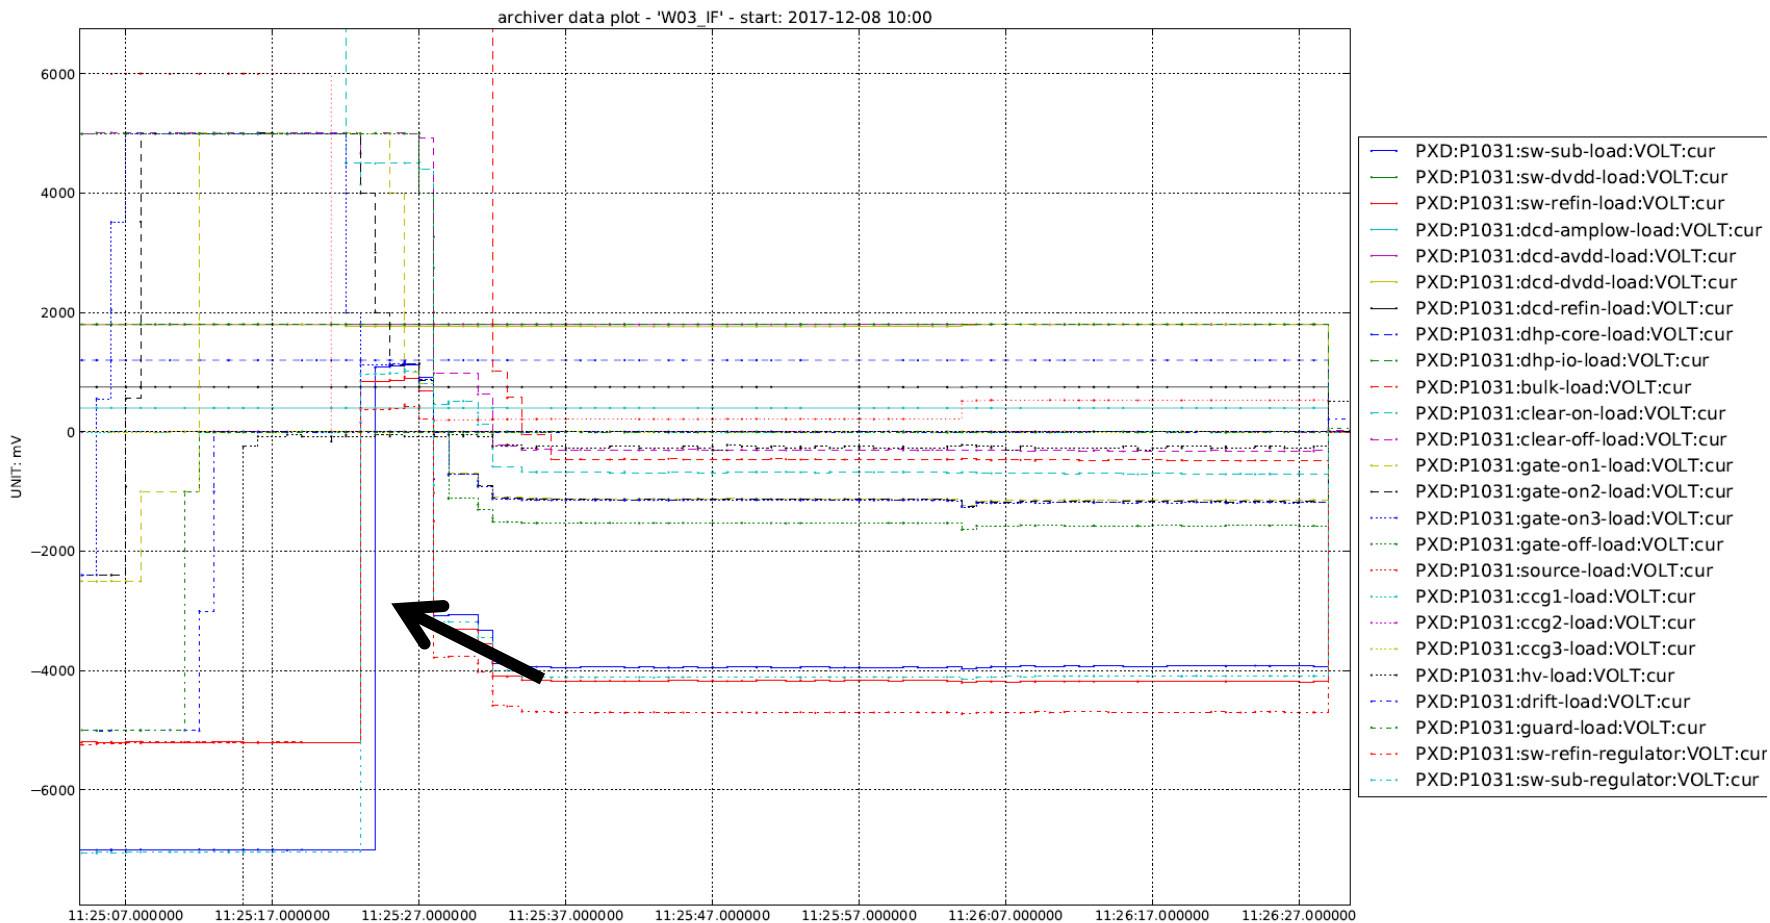
# What happened?

During the power down sequence the current limits of sw-sub and sw-refin were reached. Hence, the voltages raised from -7 V (sw-sub) and -5.2 V (sw-refin) to ~ +1 V. This partially destroyed the switchers.

This behavior occurred at W02\_IF and W03\_IF on Dec 8

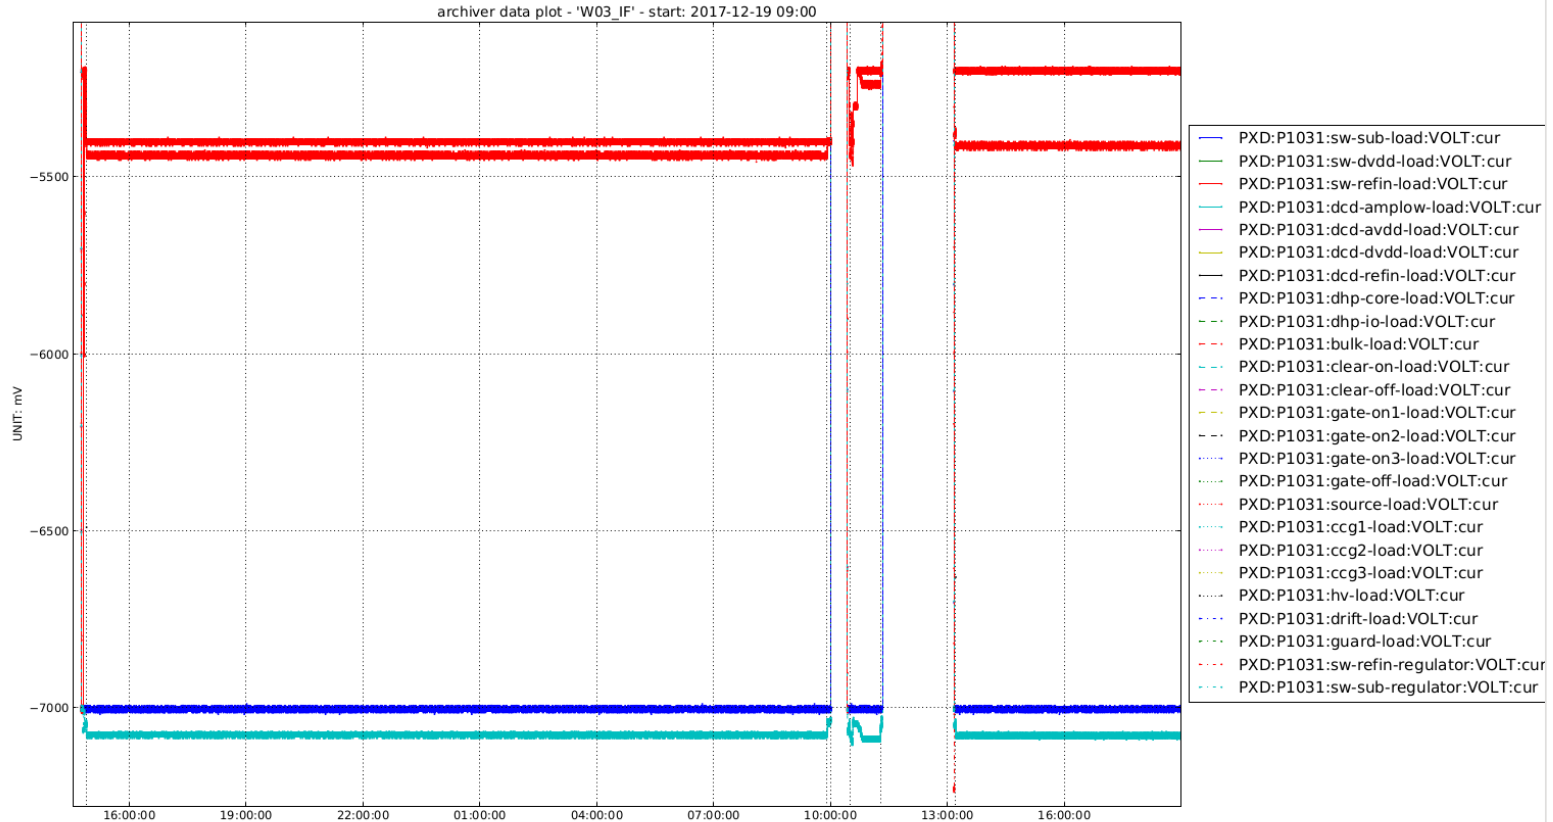
# Observations (1) W03\_IF

Difference of sw-refin @ regulator and @ load is increased from ~40 mV to ~ 200 mV

why is the voltage difference 200 mV although no current is flowing?

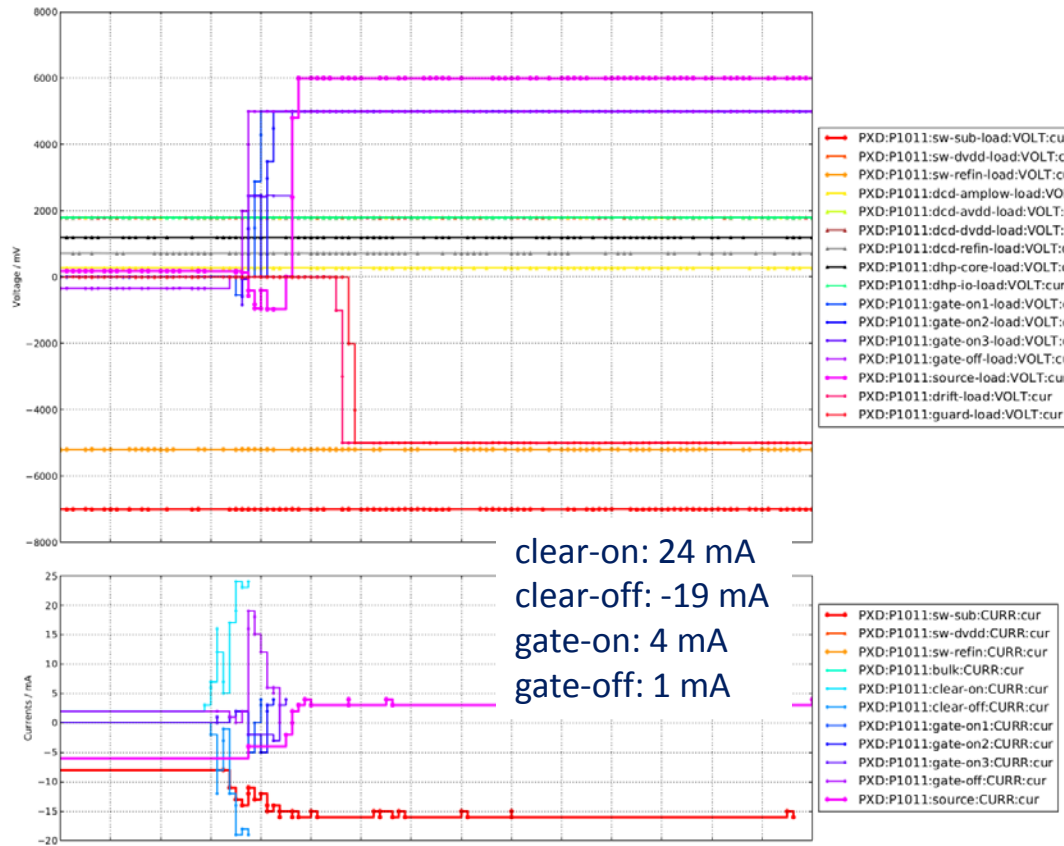
## Increased clear-on, clear-off, gate-on, gate-off currents

past

now

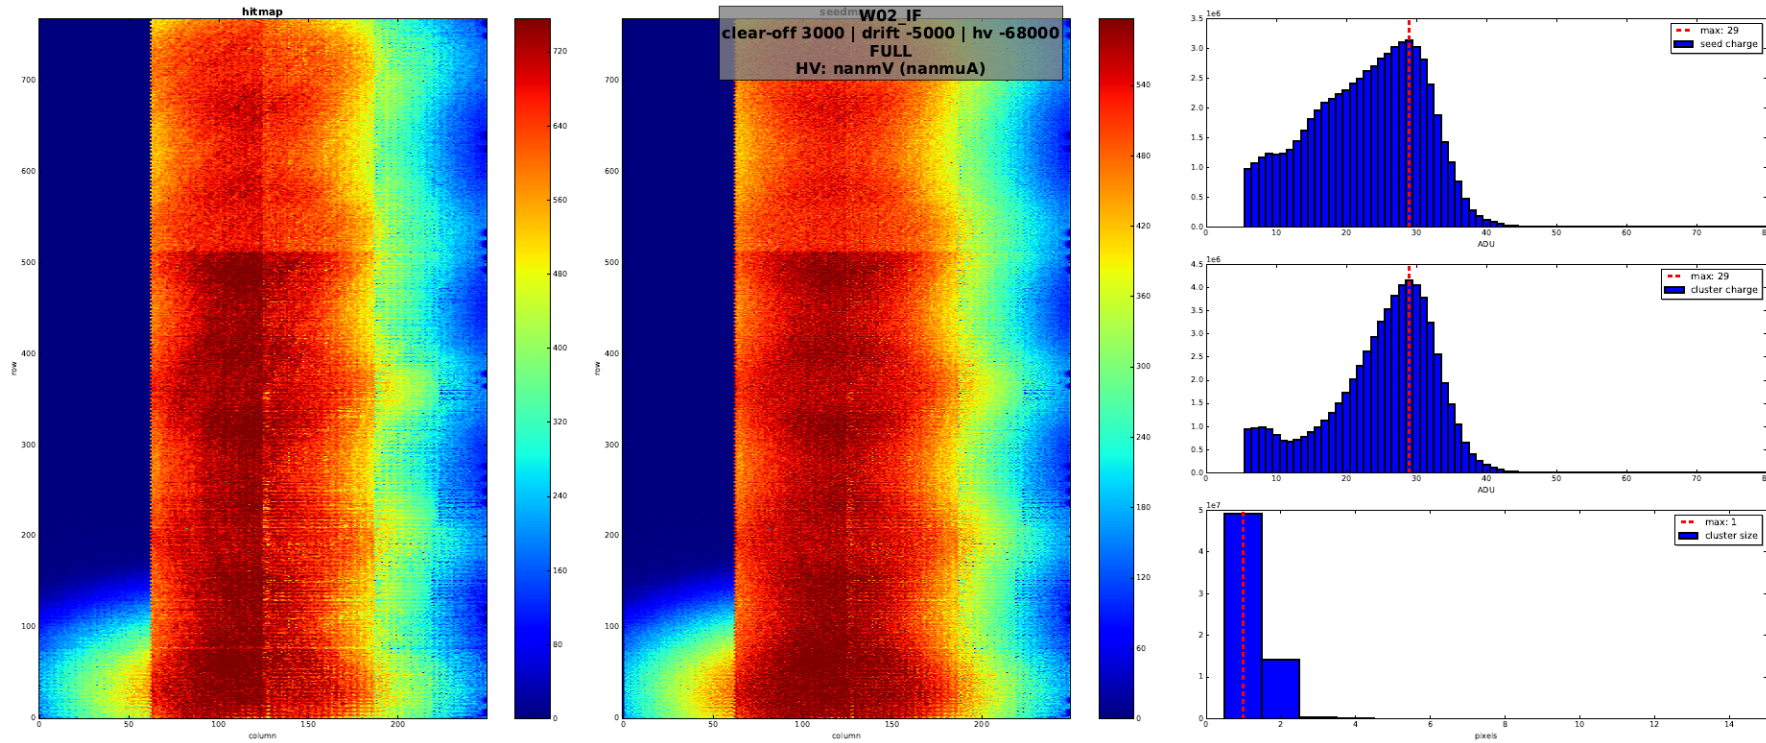
# Comparison W02\_IF (before accident)

one link crashed – accident happend when repeating the scan. Therefore, power cycle should be done

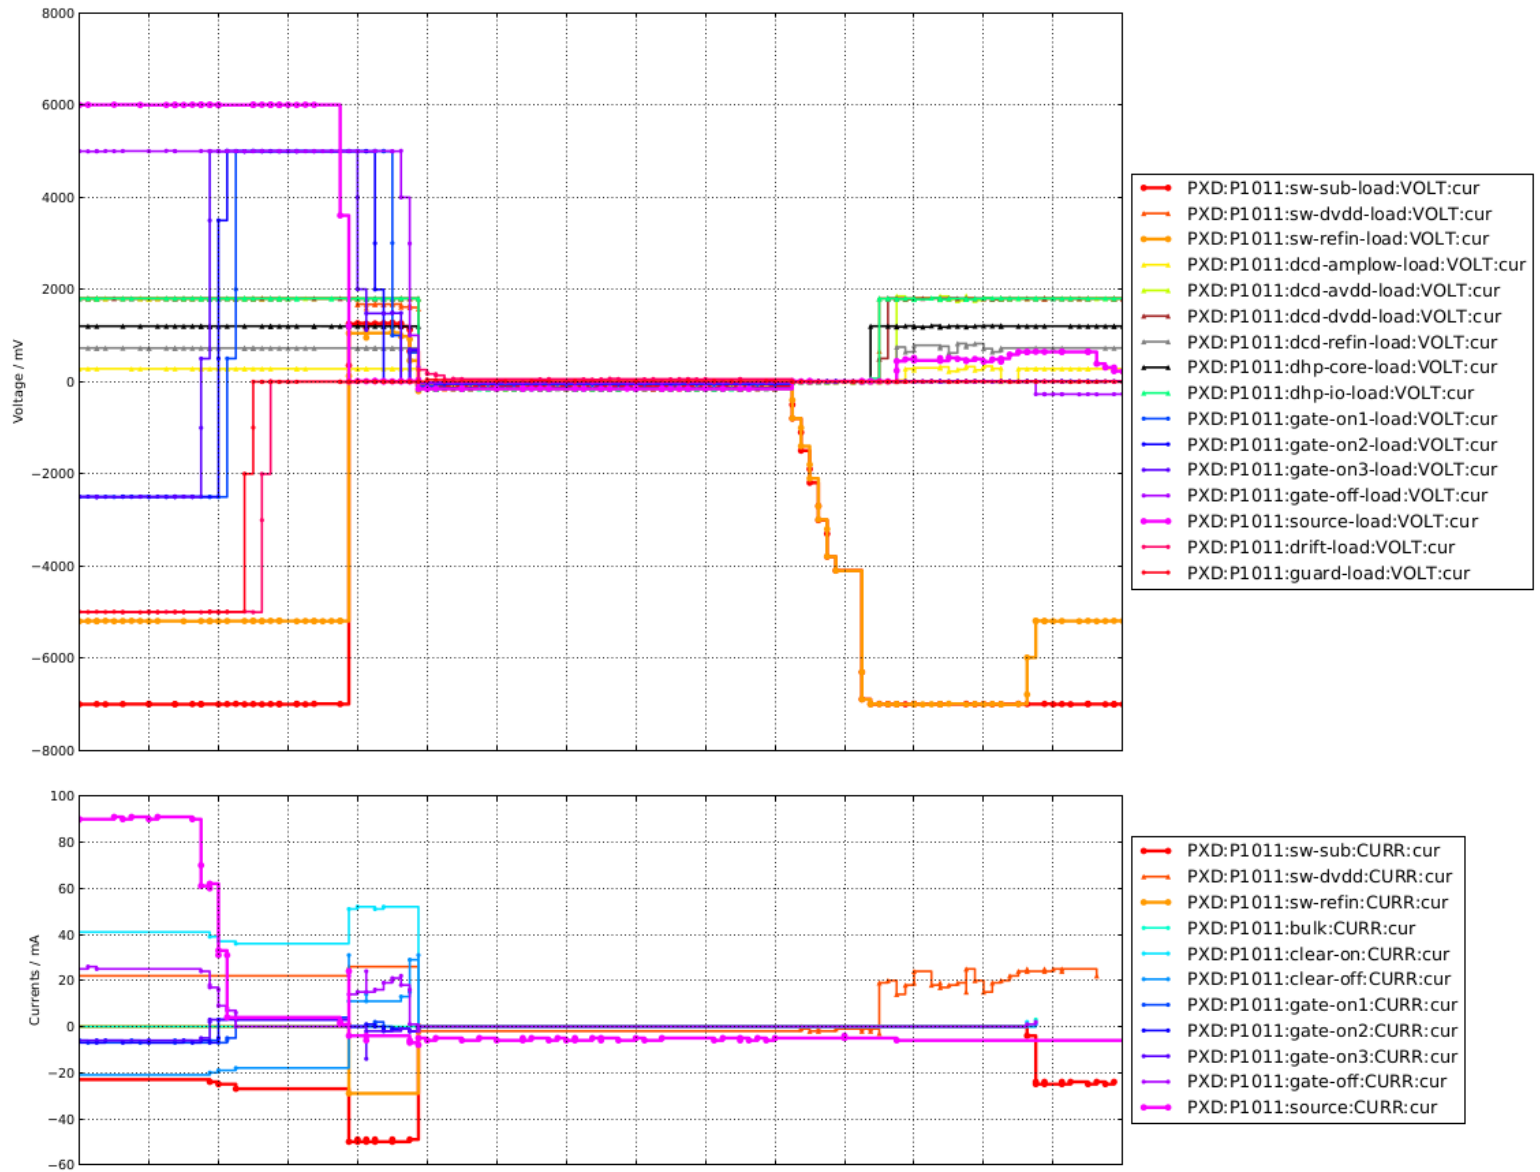
# W02\_IF – Nov 2, 2017 – W08\_IF

After investigations of all power down cycles since the archiver was set up. This switcher behavior occurred once (begin of November) which did not destroy the switcher

Ramp down source slower

Capcitors between sw-sub & source, sw-refin & source on Kaptons ? influences?
