● SOI Wafers ordered at Tracit/Soitec

● The Issue...

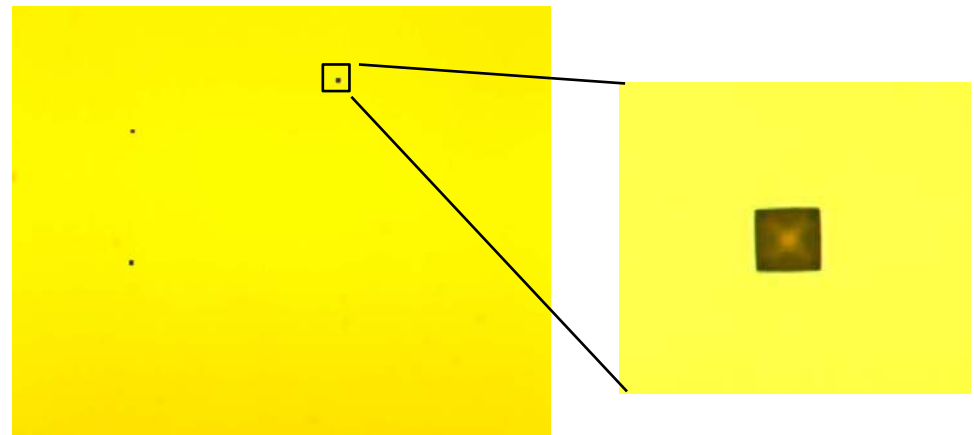
Issue seen during back side photo resist coating:

- : pyramidal pits on the back side,
~20 micron lateral dim., ~ 15 micron deep
- : caused by:
 1. pin holes in the screening oxide during front side thinning
 2. Soitec simply "forgot" to grind back and polish the handle wafer.
Stack is still ~485 micron thick!
