Status update of Beam pipe

S. Tanaka
KEK

Gold peel-off problem: Phase 3 Beam pipe

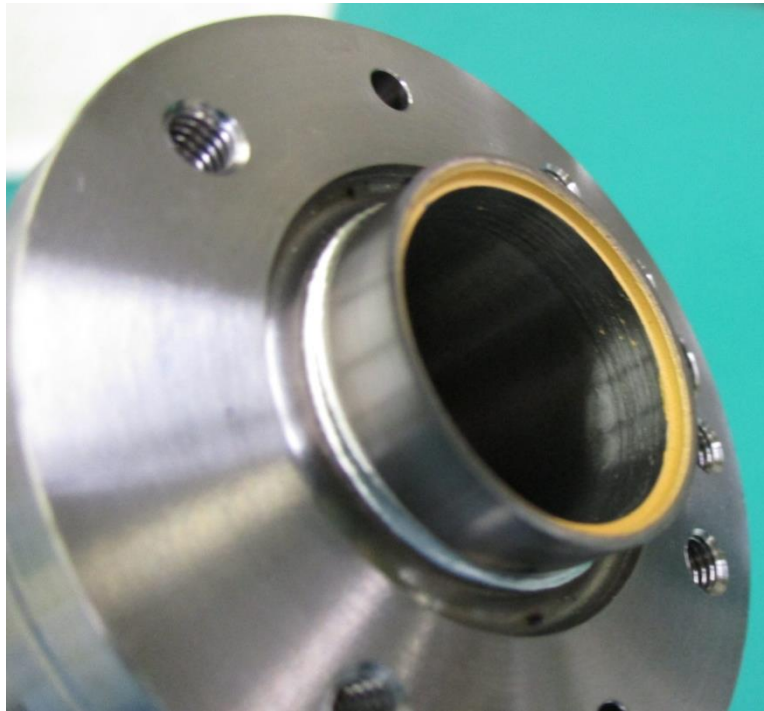
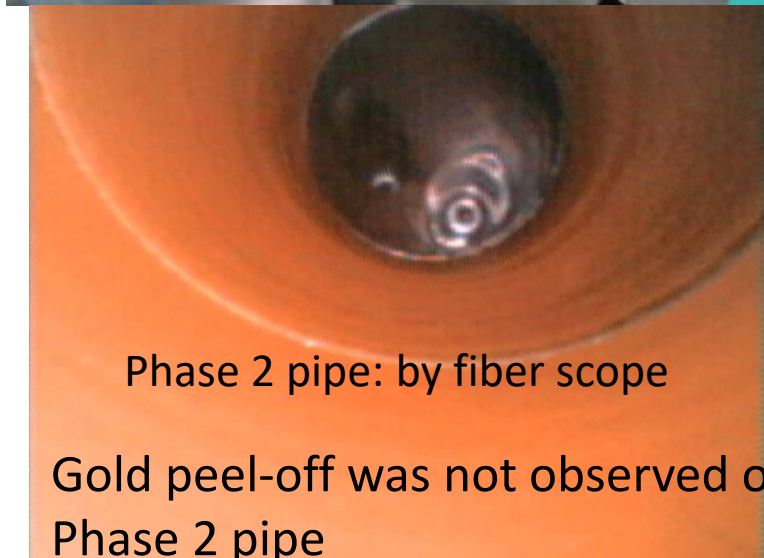
Gold peel-off has discovered after the sputtering.

Considerable reason of this issue

1, The pipe is an double tube with Titanium part and sputtering is applying on vacuum condition

The heating up process might not be enough, as like “thermos structure”.

Remedy plan (3 options):

re-production of IP part,

- It started (preparation process)
 - BP will complete in Apr. 2018 which was expectation of last BPAC

- Gold sputtering inside after removing of Gold.
 - We couldn't remove Au completely
- Gold plating on BP outer surface
 - Most quicker and safe solution but this may gives lower vertex resolution
 - BP Can complete in Mar. 2018

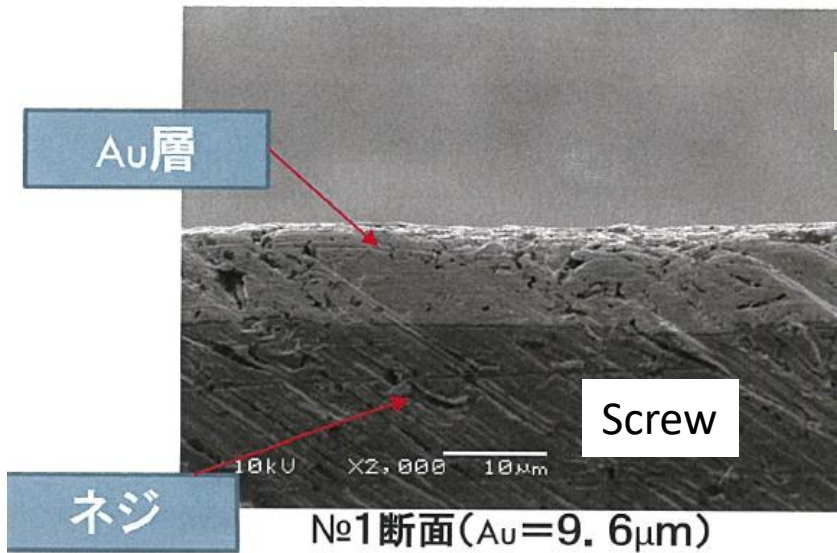
Second test (parameter re-optimized)

No peel-off has observed both for Be, Ti part

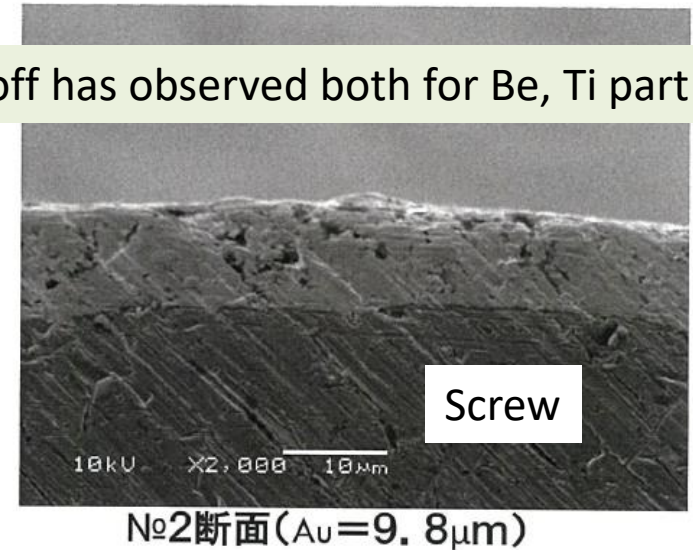
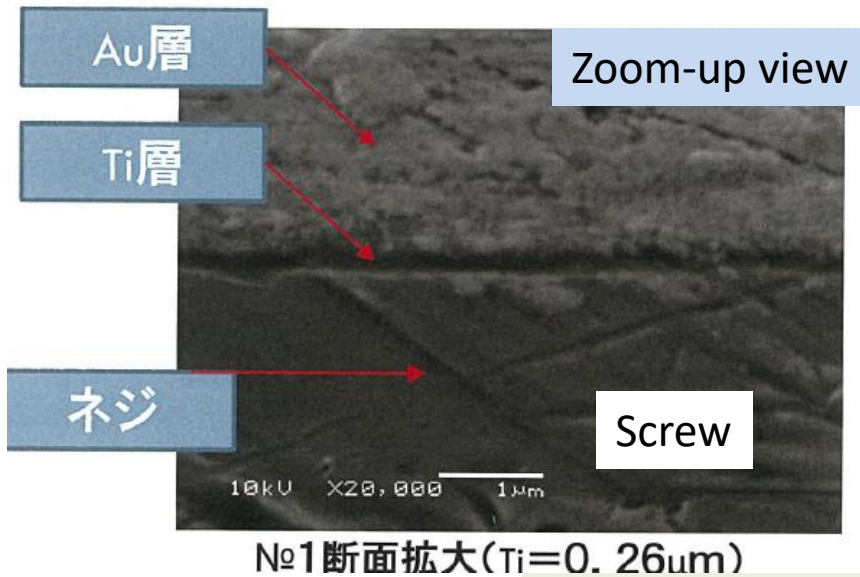
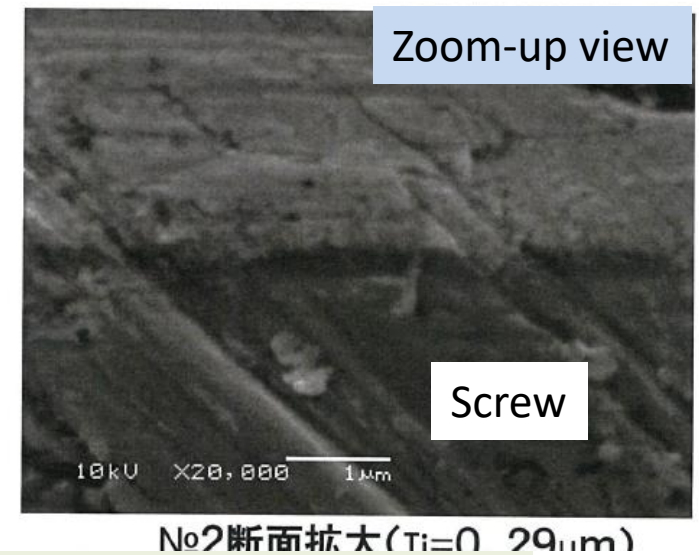
Gold layer seems smoothly connected with Ti layer

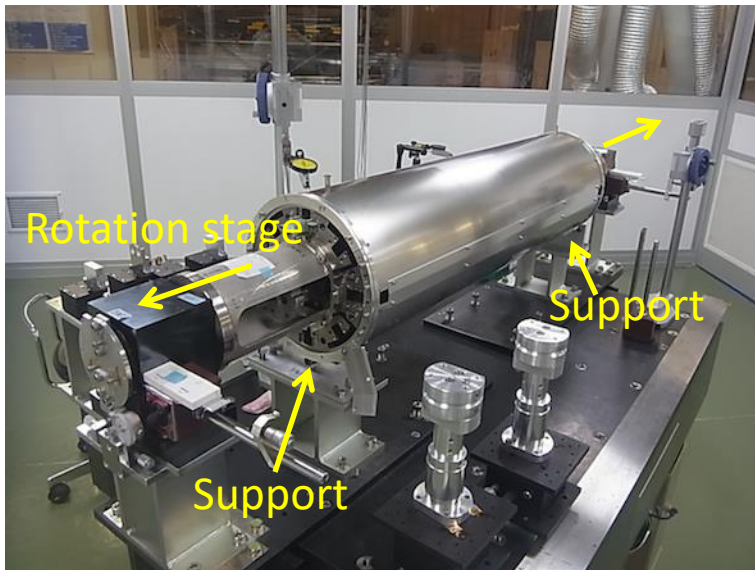
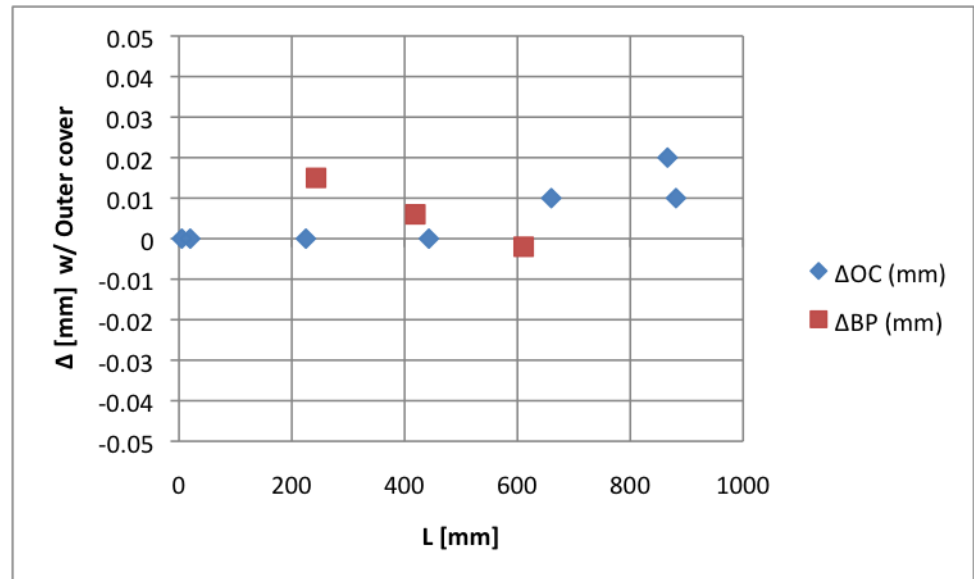
Phase 3 VXD assembly test(3)

- Measuring deformation after PXD outer cover connection
 - ΔOC : Upper position difference before/after disconnecting rotation stage (by height gauge)
 - ΔBP : BP position difference before/after disconnecting rotation stage (by dial gauge)

The difference seems quite small ($< 20\mu\text{m}$)

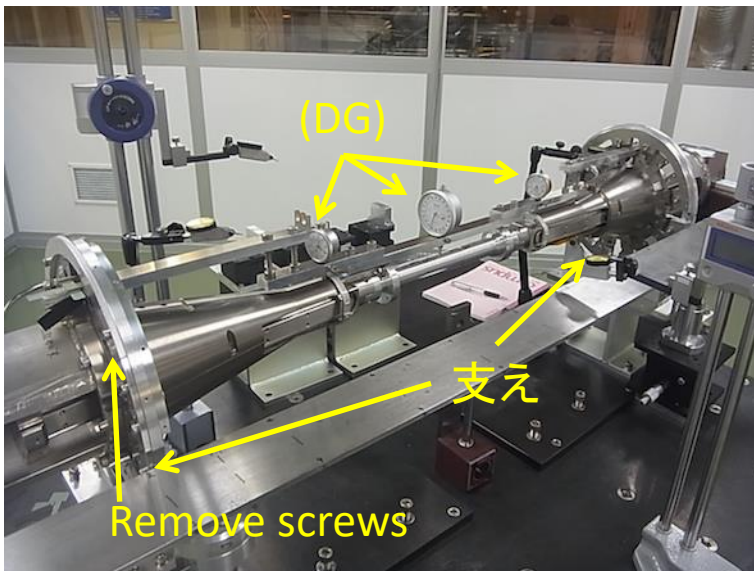
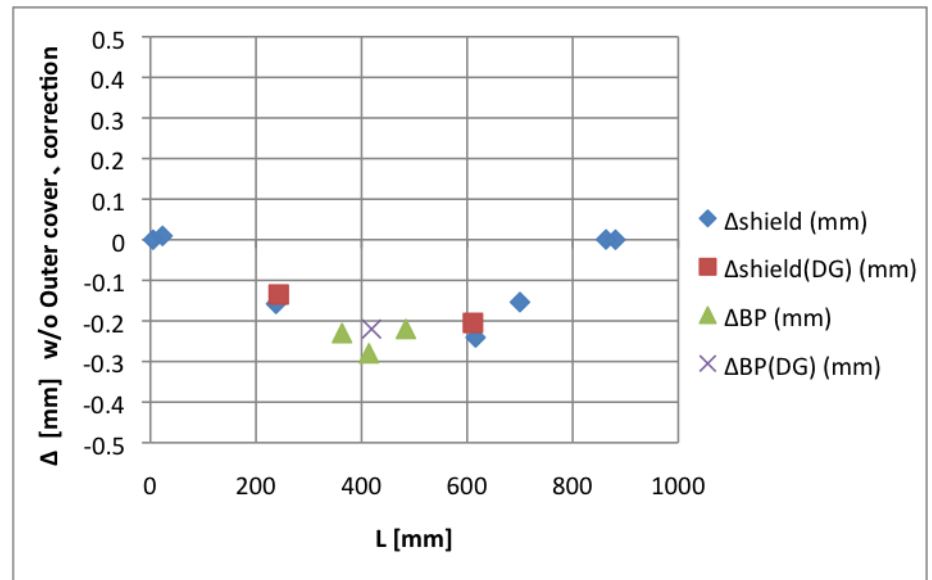
Phase 3 VXD assembly test(4)

- For the comparison, the deformation measurement without outer cover
 - 0.3mm at maximum

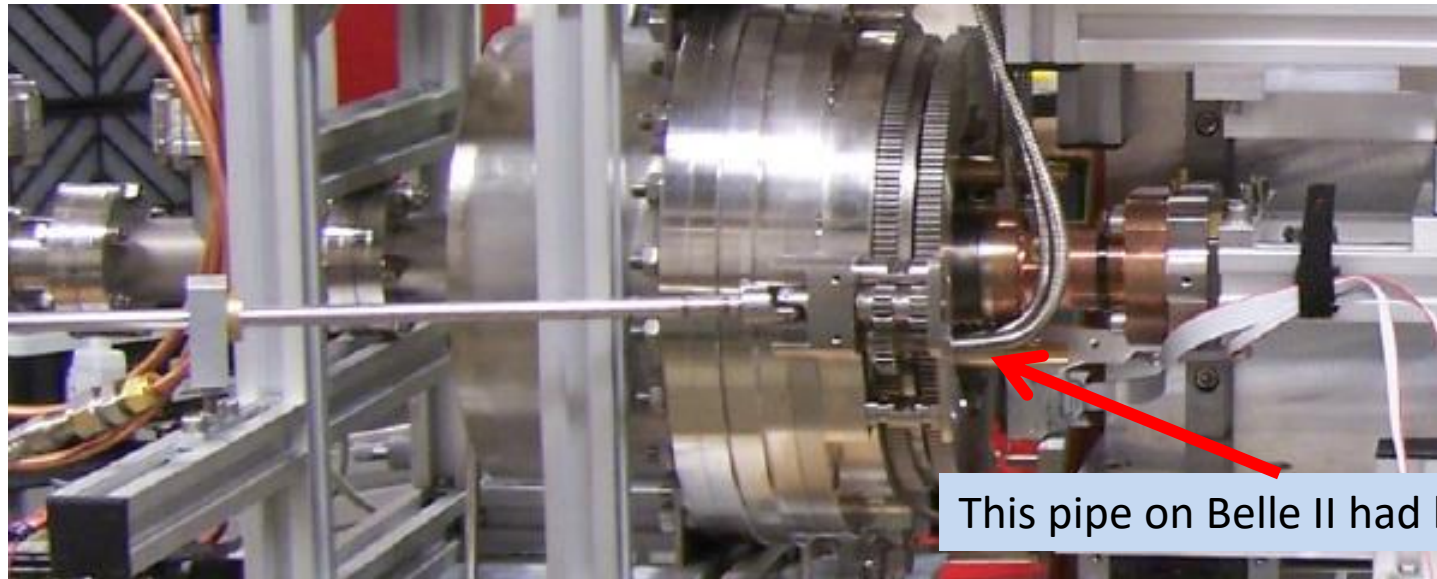
- Water leakage from cooling water pipe of BWD Bellows pipe(HER) has detected on 16th Feb.

We can not access to the leaked area...

- Baseline option
 - Apply N2 gas flow ~(30L/min flow)
- Plan B
 - sealing by resin
 - On second test, we found dropping of resin from leakage point.....(leaked position is just RVC space)
 - Water flow with negative pressure (sucking cooling water)

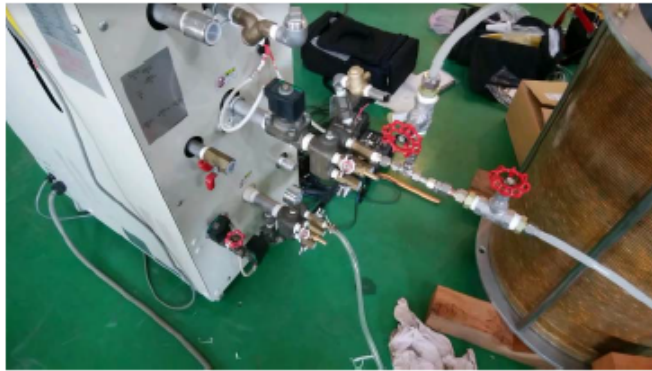
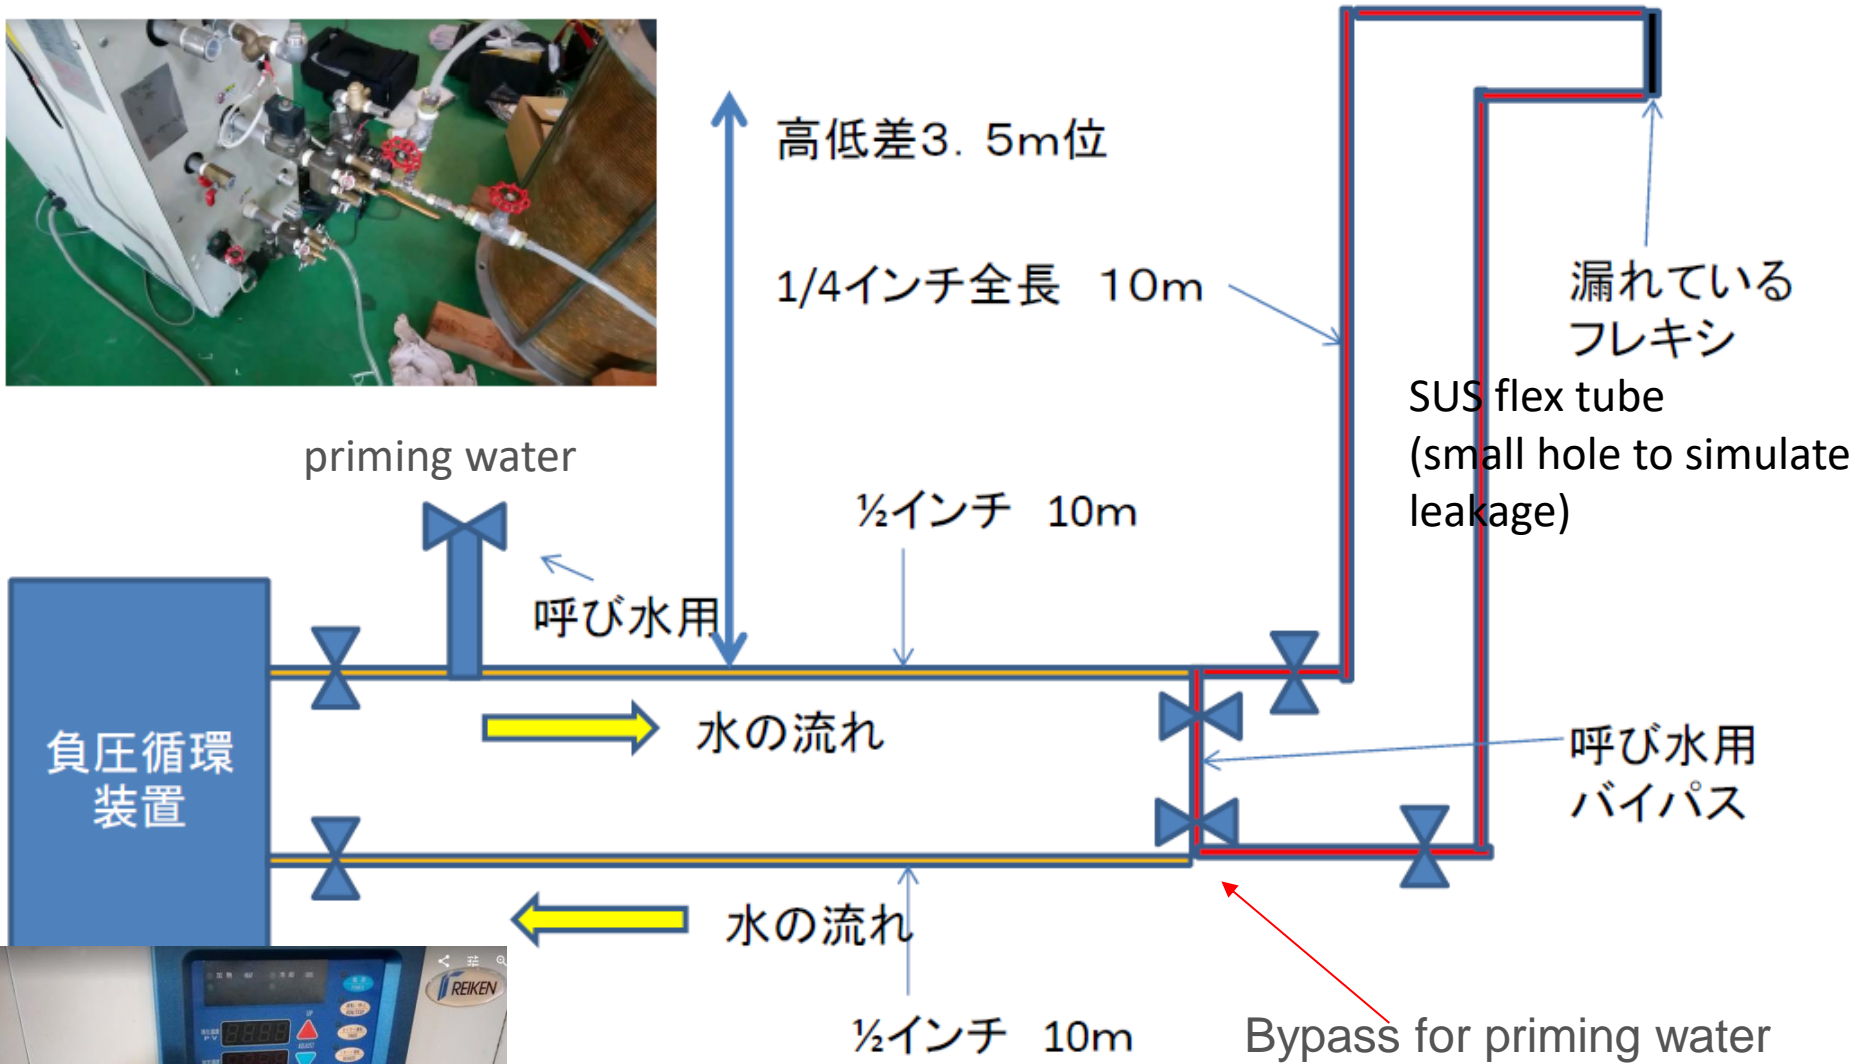
Water circulation test (negative pressure)

On this setup: Water flow was ~0.5 L/min

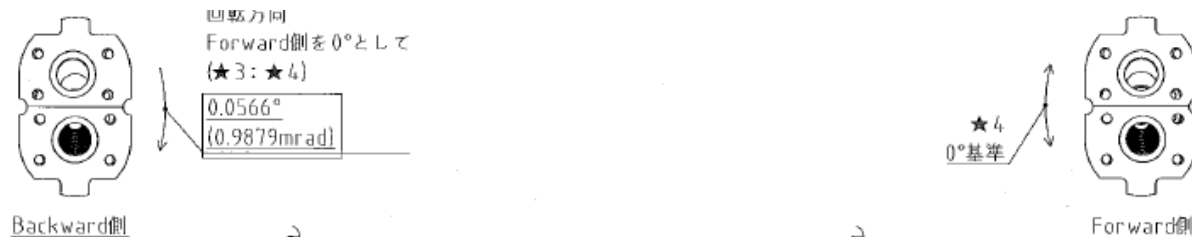
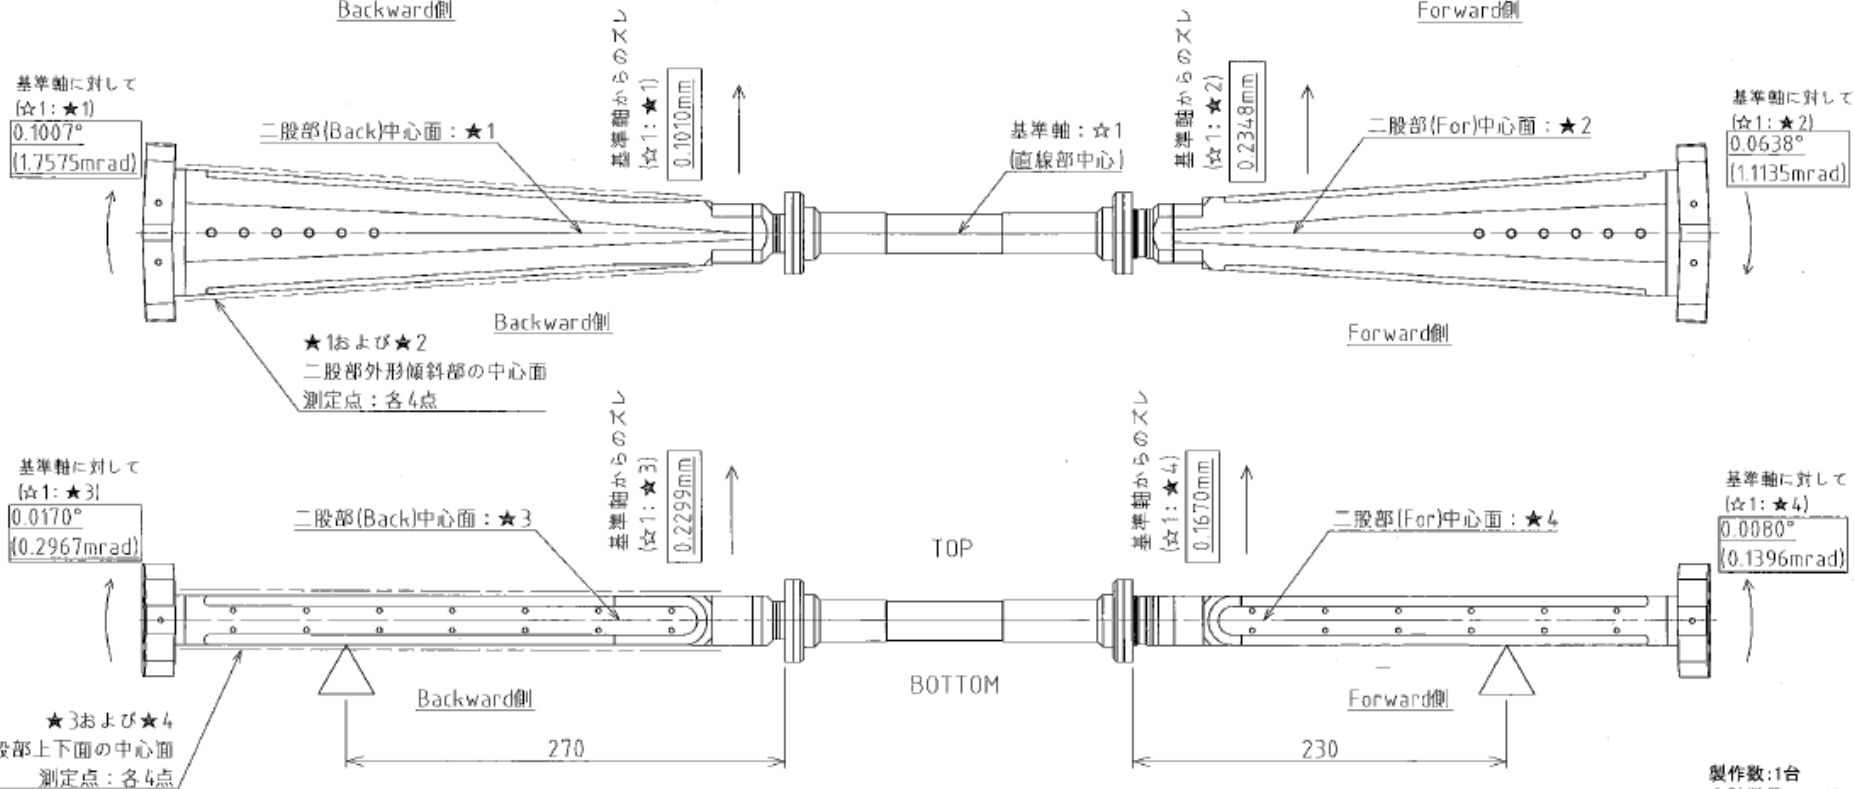
CMM Results

The deformation is our acceptable level (300um at max. is much smaller than phase 2)

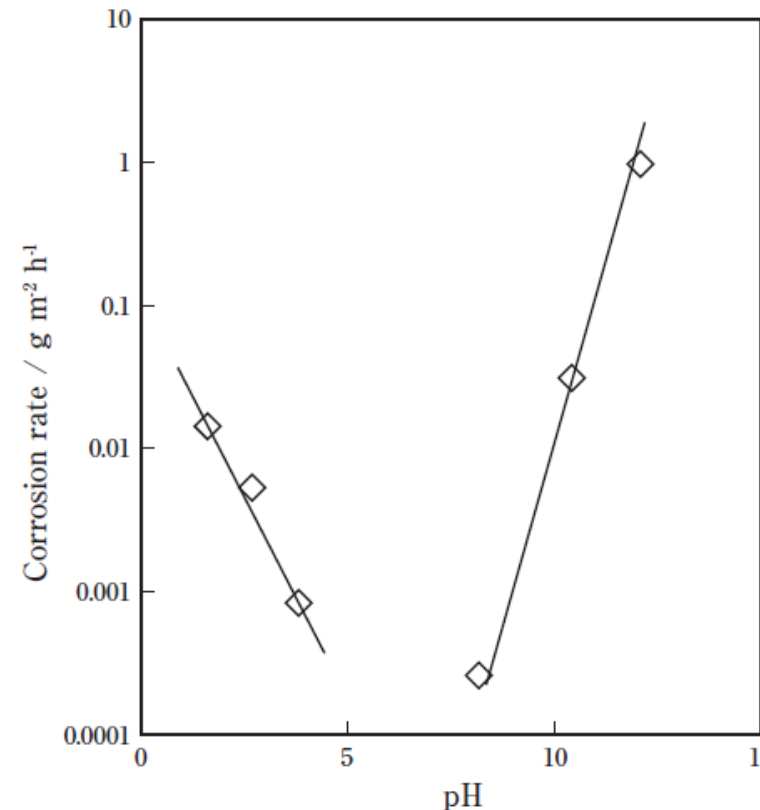
- 0, Aluminum surface is covered by oxide layer which is stable material
 - In order to break this layer, Cathode (Reduction) reaction rate have to be faster than Anode (Oxidation) reaction
- 1, To fulfill above, acid or alkali condition is necessary
- 2, On the case of CO₂ leak with water condensation.

This reaction can be occurred, but equilibrium Constant is 1.7×10^{-3} , which means almost CO₂ molecule do not react.

In order to start AL uniform corrosion, both of Water condensation and CO₂ leak are necessary.

Fig. 2 pH influence on the corrosion rate of the aluminum in buffer solutions.

Ti coating seems better solution
