Status Update at MPP - Module and ladder tests

Philipp Leitl
phleitl@mpp.mpg.de

Max Planck Institute for Physics

2018-04-09

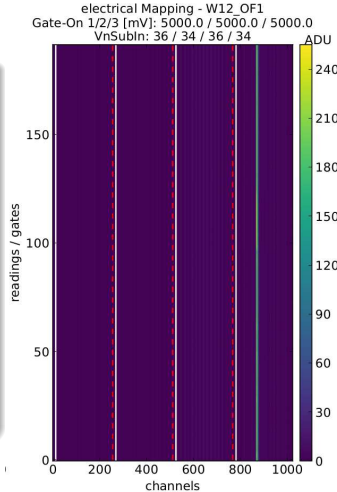
- W12_OF1 and W44_OB1
- digital ok, but both modules had gate supply lines in current limit
- indication of affected drains in pedestal frames

pattern indicated shorts between gate and drain lines

It was possible to identify geometrically matching damages in the matrix:

- attempt to get rid of the shorts by etching the damaged lines at HLL
- gate shorts gone, but problems with hv current now (hidden before)

- effort to clean up the clean room and keep it clean
- new gluing procedure including module and jig cleaning and inspection right before gluing
