# **PXD Commissioning Status and Installation Readiness**

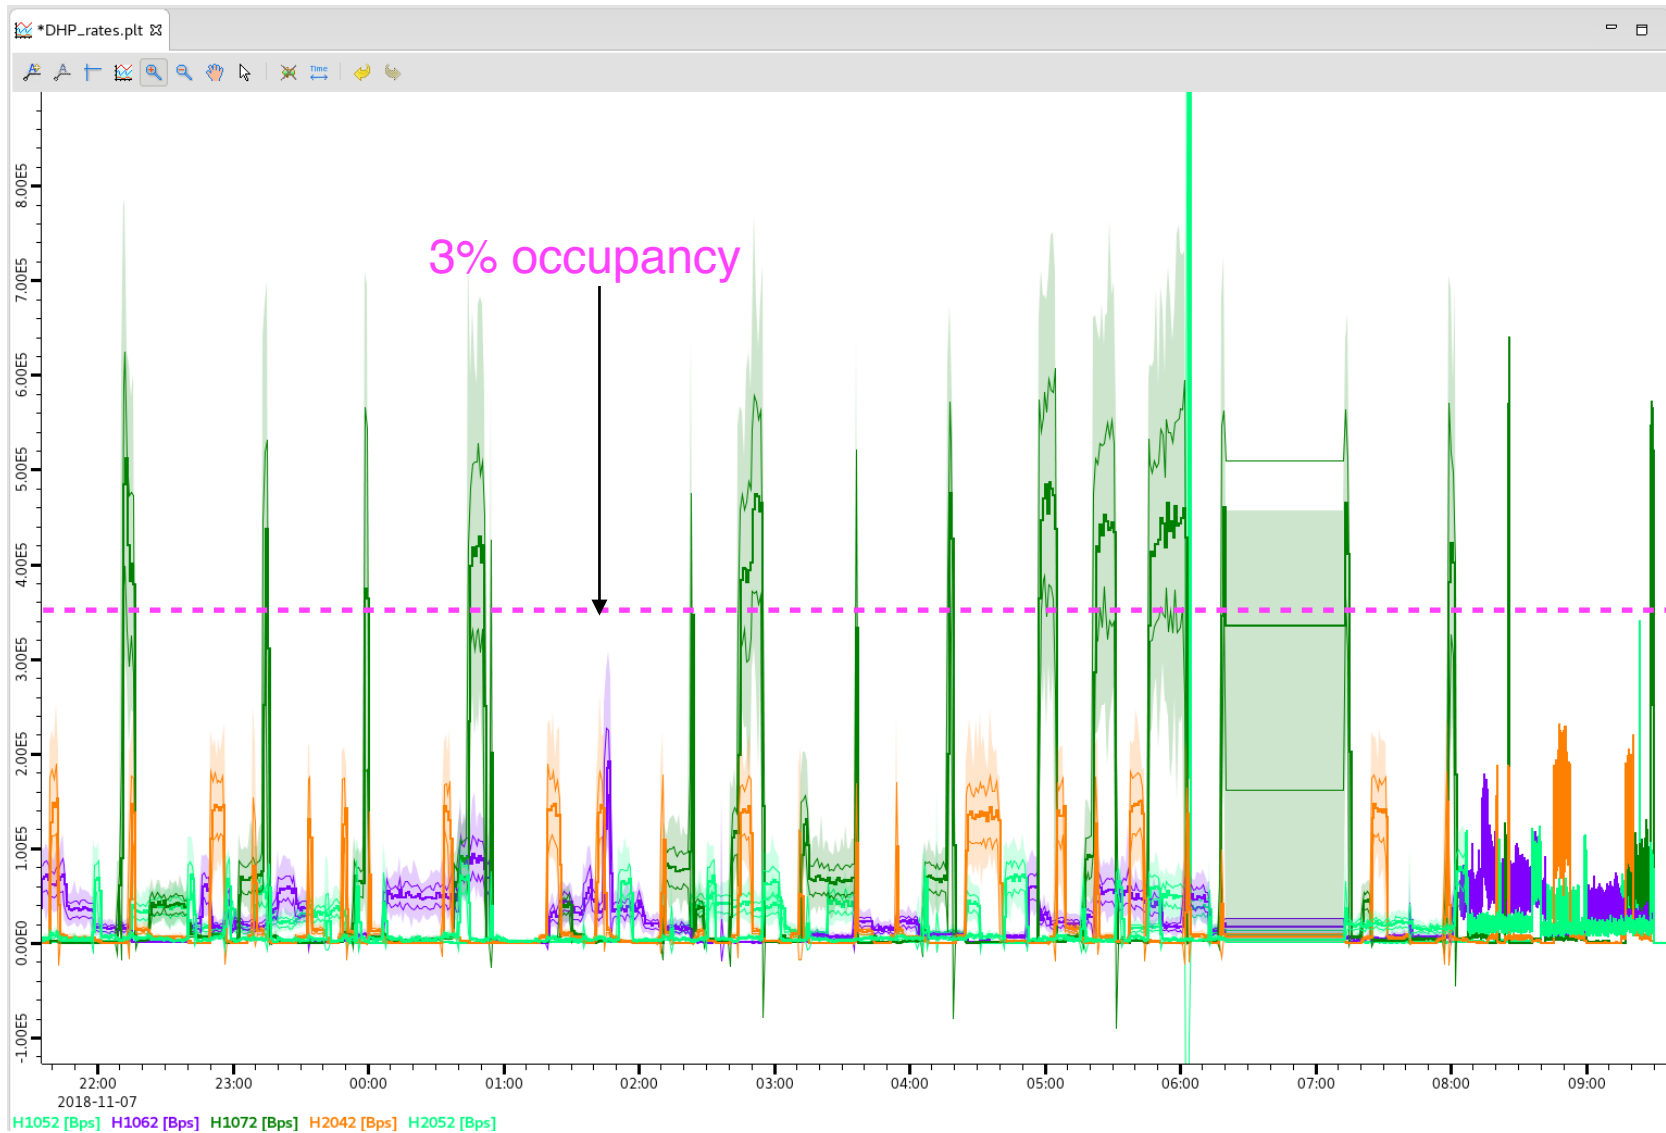
# Sudden Jumps in Data Rate seen in Backward Modules

H1052,1062,1072,2052 are connected to DHH40, 1082,2042 to DHH30

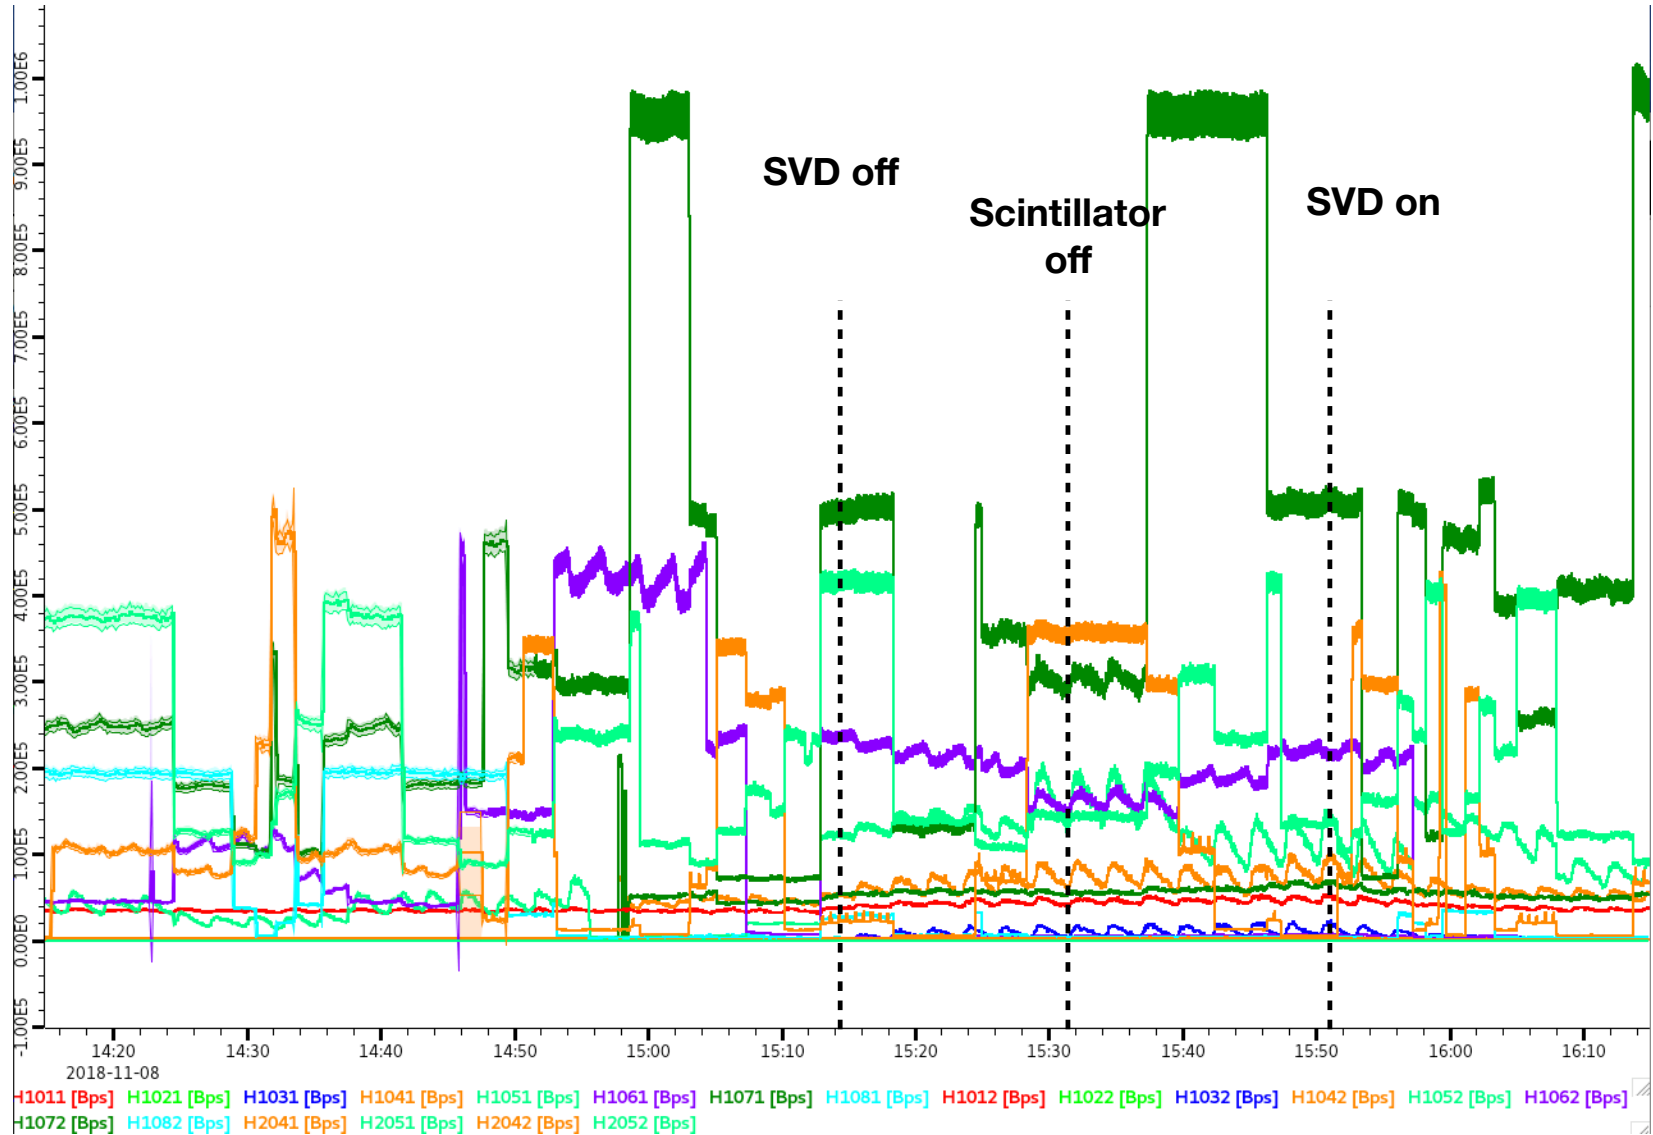
Not correlated to SVD/Scintillator operation

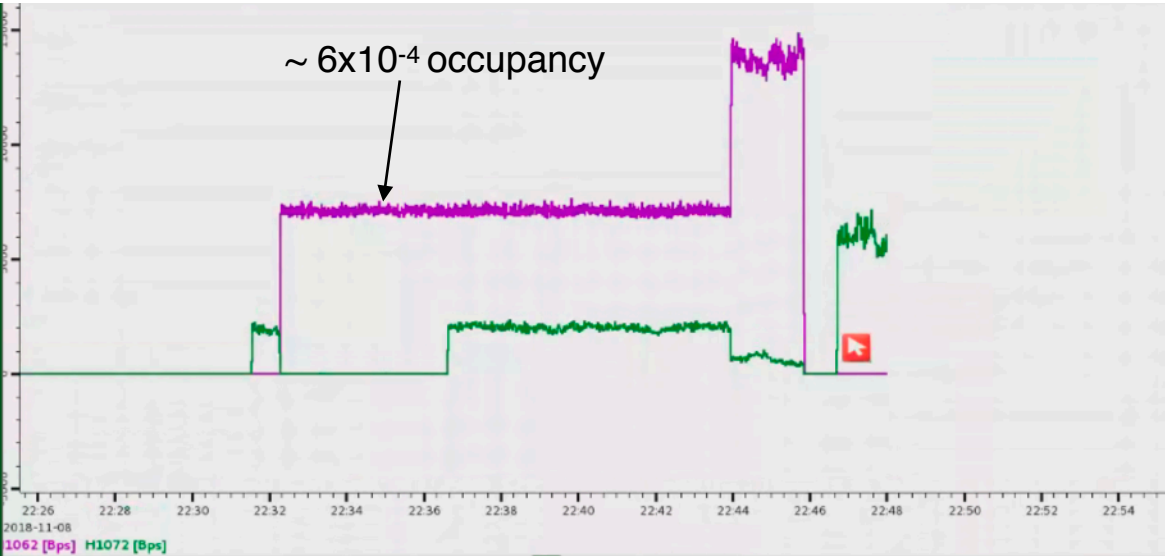
Modules connected to DHH40

$\sim 6 \times 10^{-4}$  occupancy

Jumps occur spontaneously and can also be provoked by DHC reset (only if more than 1 module in operation and not always ...)

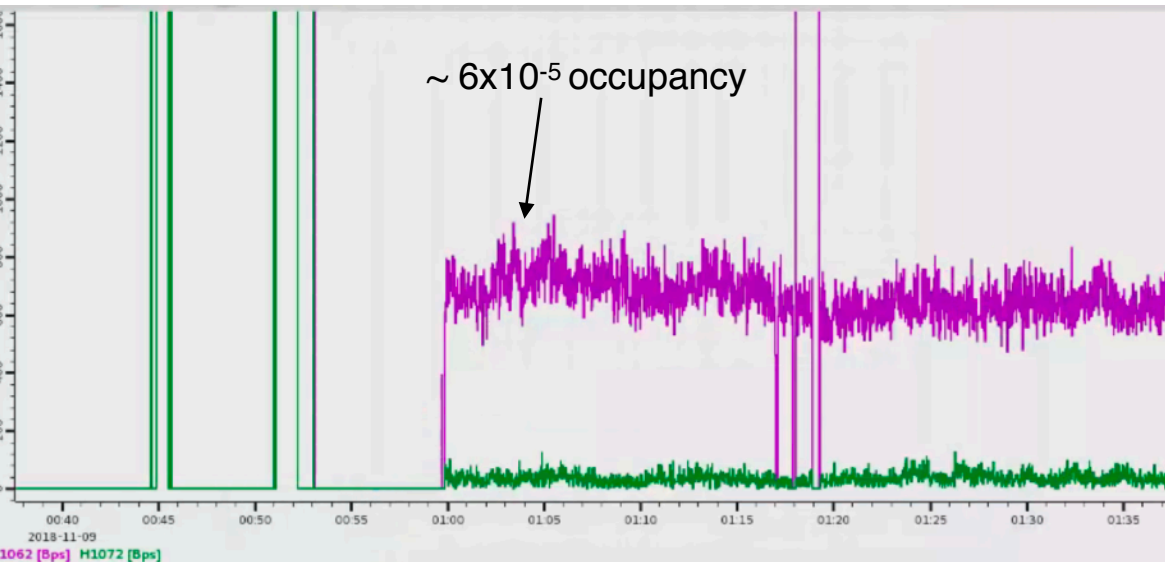
Modules connected to DHH50

$\sim 6 \times 10^{-5}$  occupancy

No jumps observed anymore

Very low data rate in 1072 after re-calibrating/loading offsets and pedestals

Need time to do this for all modules

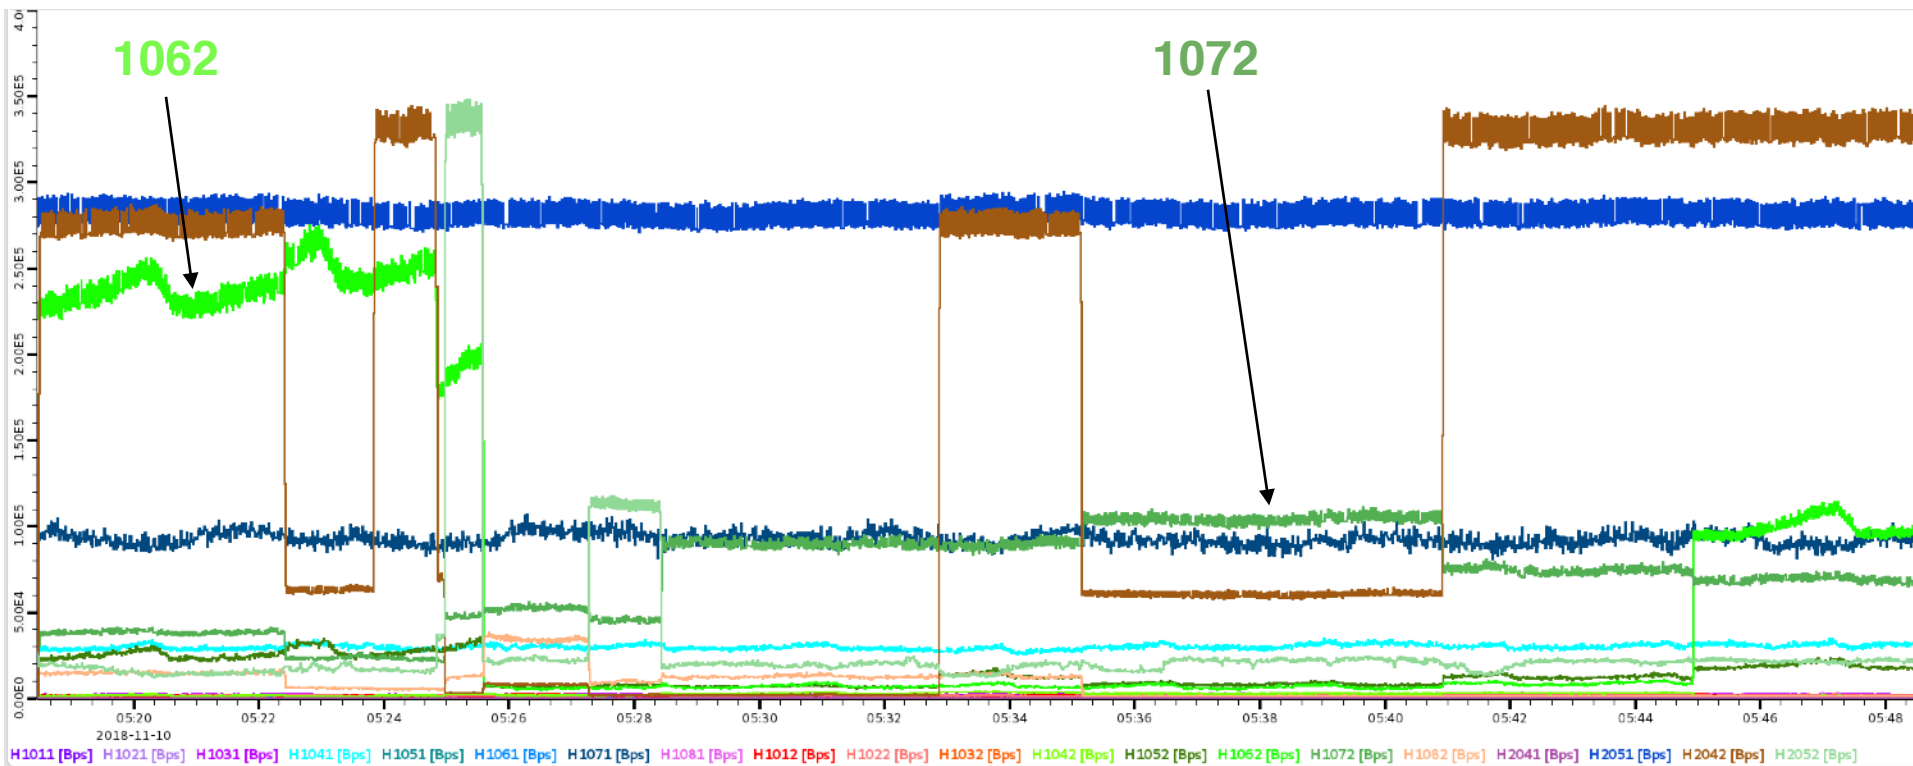
Jumps again seen in both modules and in other modules connected to this DHH

Conclusion: the effect can clearly be associated to specific DHHs  
Will try to reproduce and study behaviour in lab set-up  
Most likely due to some loss of synchronisation  
Might also cause occasional OVP triggers observed in 4 modules

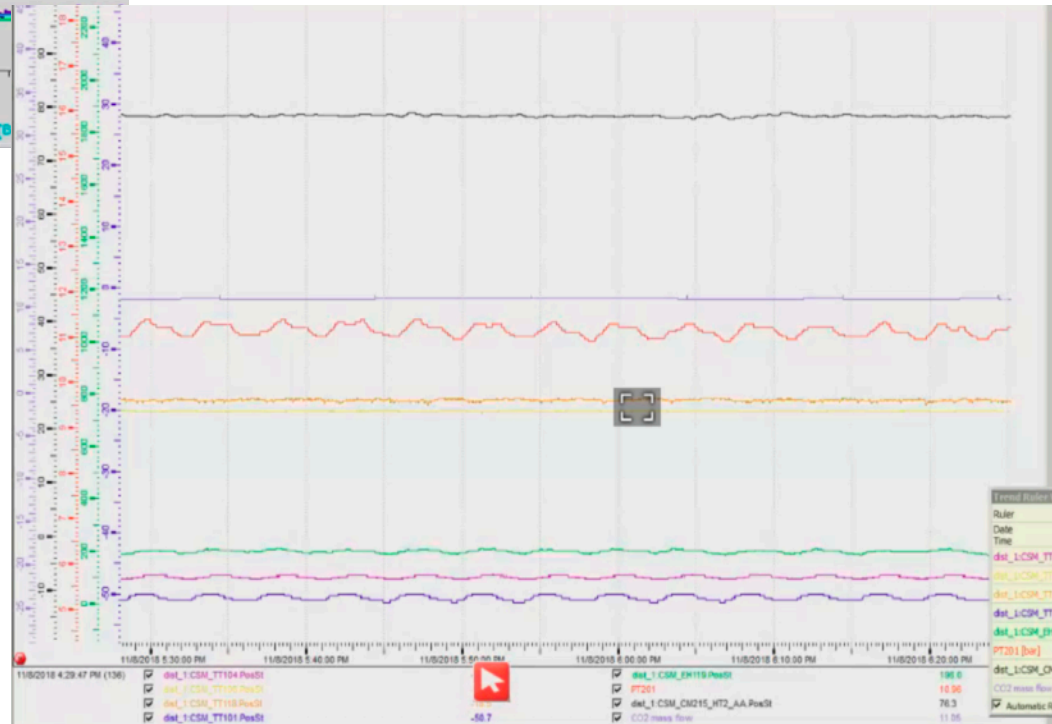
- In the last days MARCO starts behaving somewhat abnormal
  - 3 minutes time constant also observed in chiller regulation
  - amplitude of these oscillations correlated with total heat load
- Unclear how long MARCO will stay operational ...

- Found unintended connection between CO<sub>2</sub> flexlines and VXD end-flange
  - ceramic insulators are effectively by-passed
- Difficult to avoid this contact in B4
- In Belle II CO<sub>2</sub> dock boxes will be electrically insulated from CDC

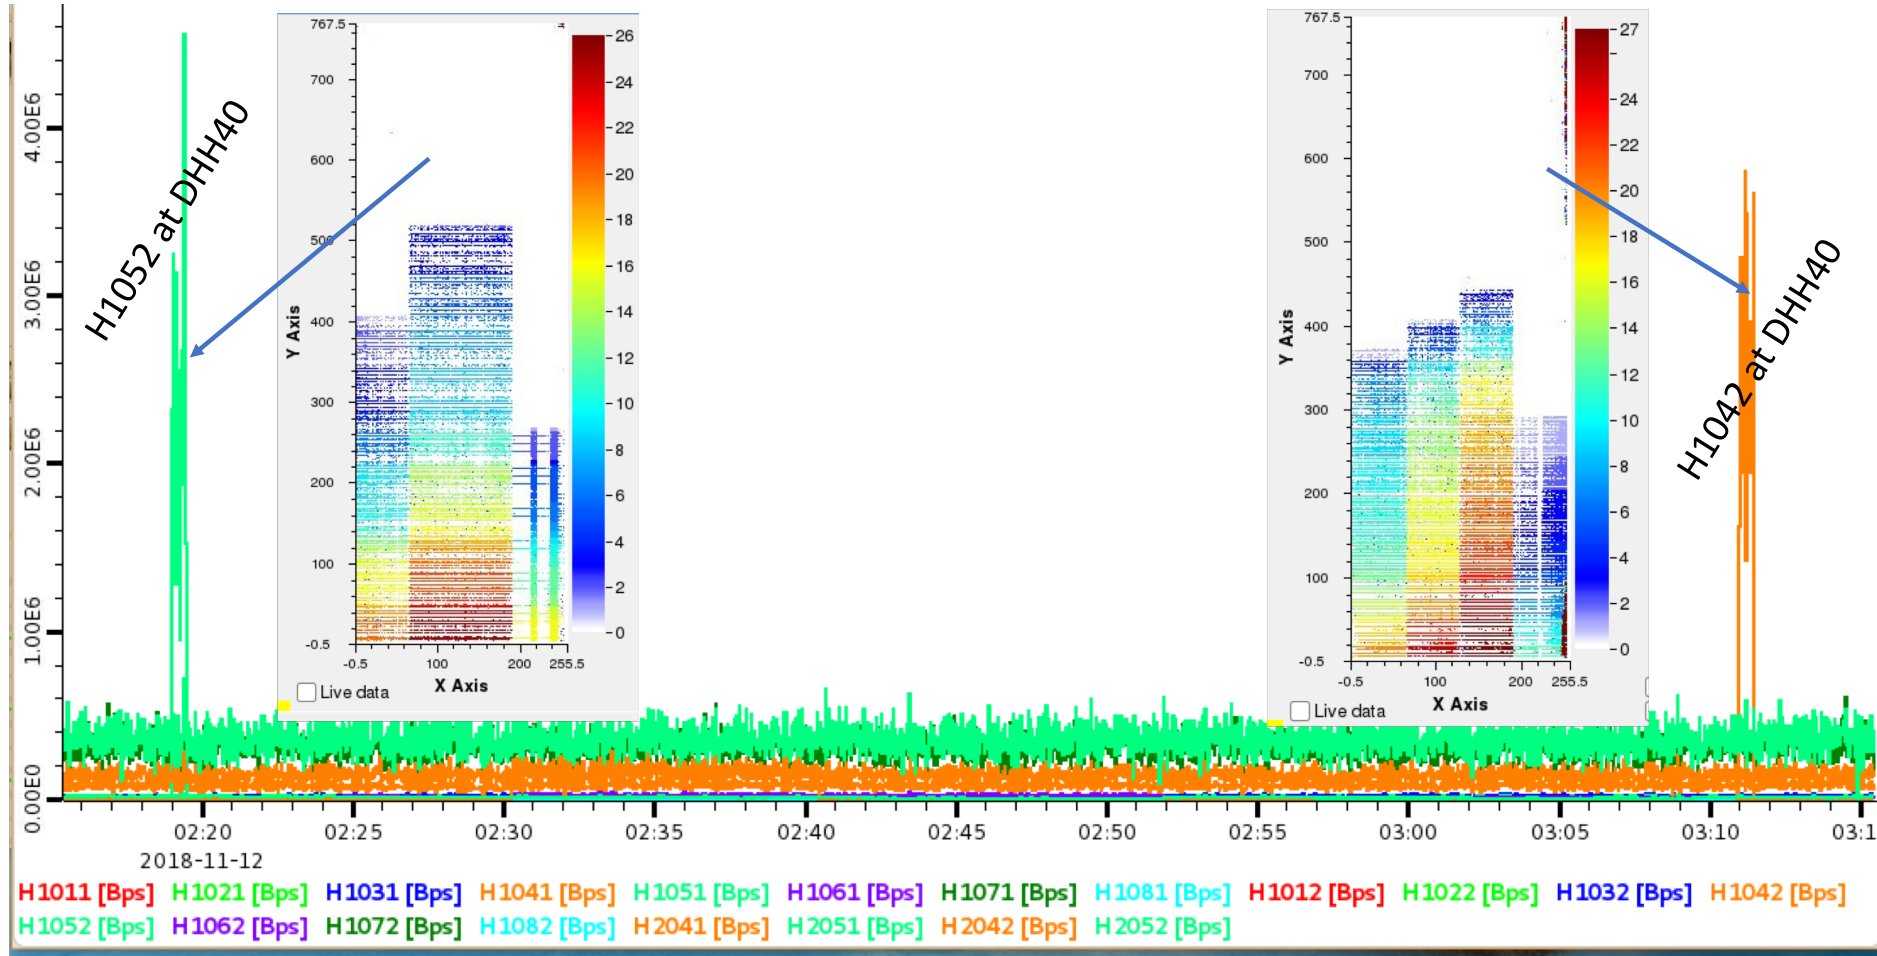
Very distinct pattern should help to find origin of the problem

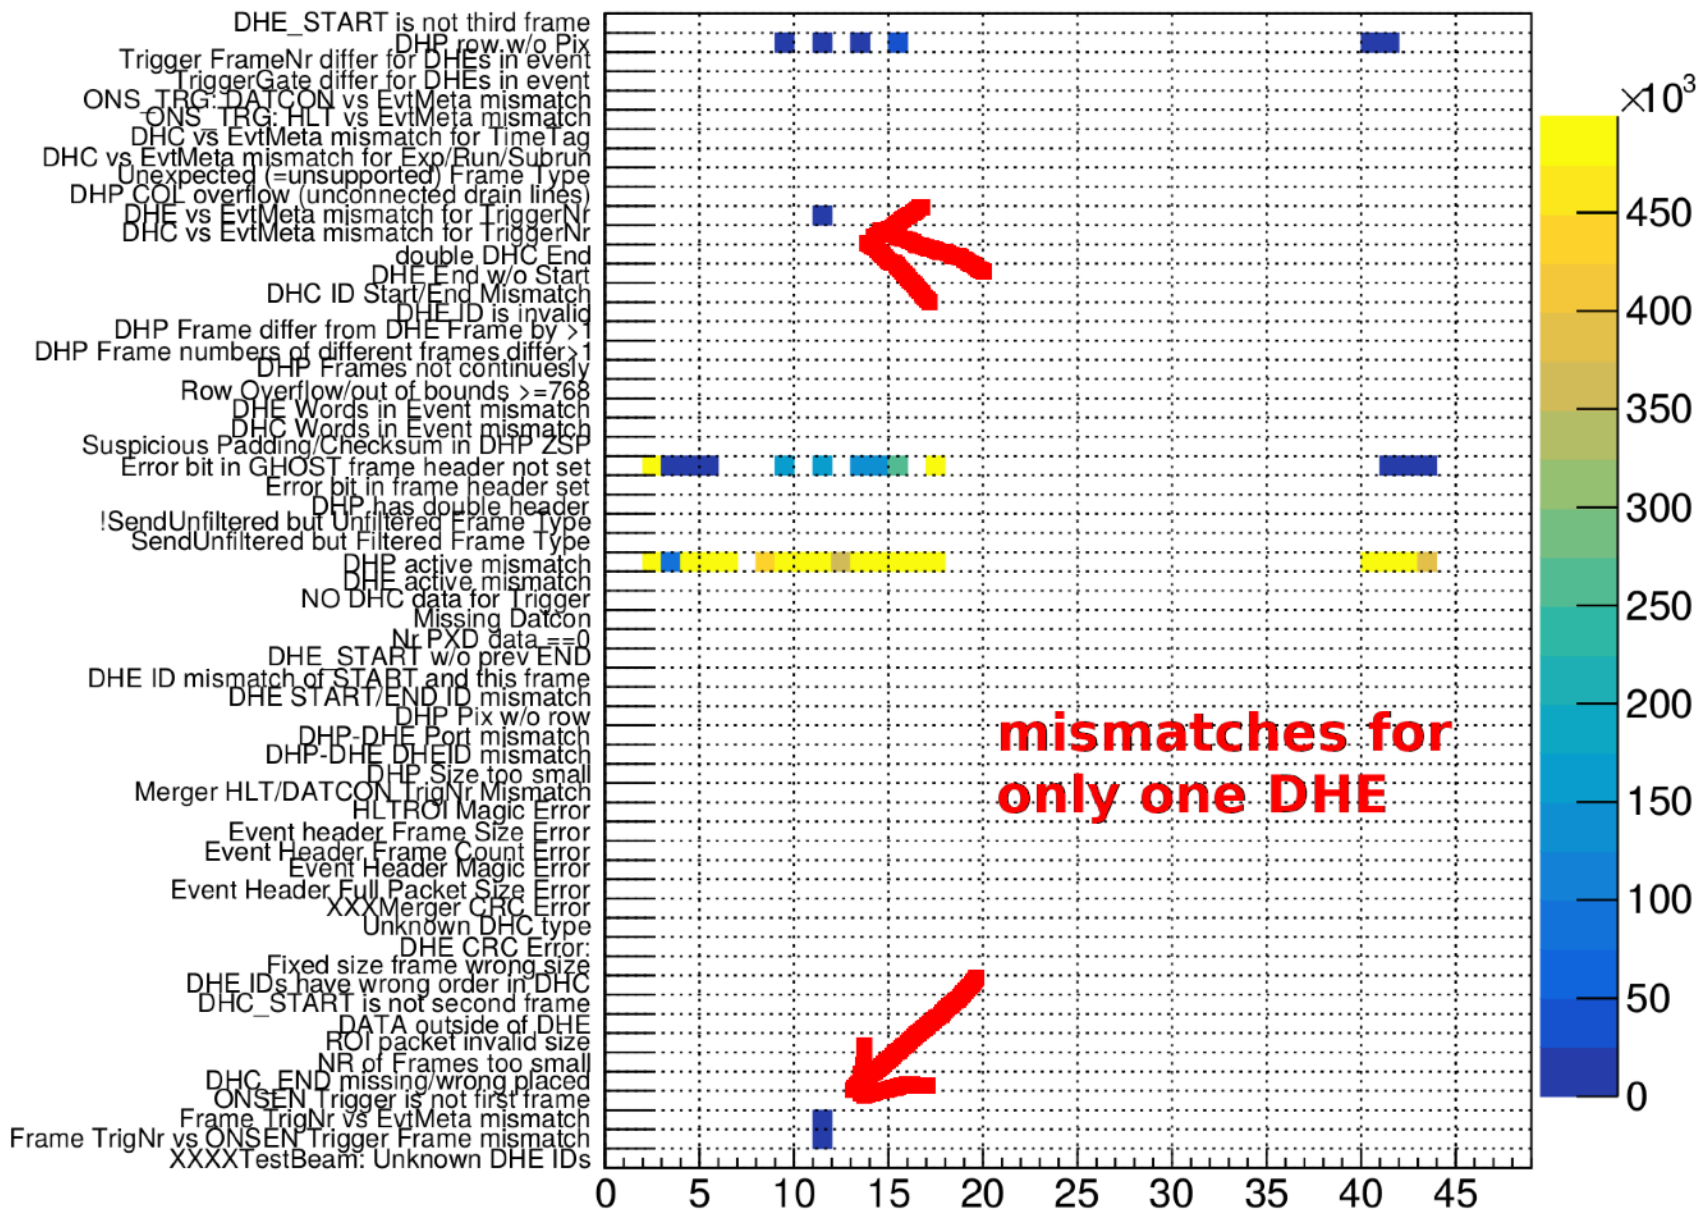
mismatches for only one DHE

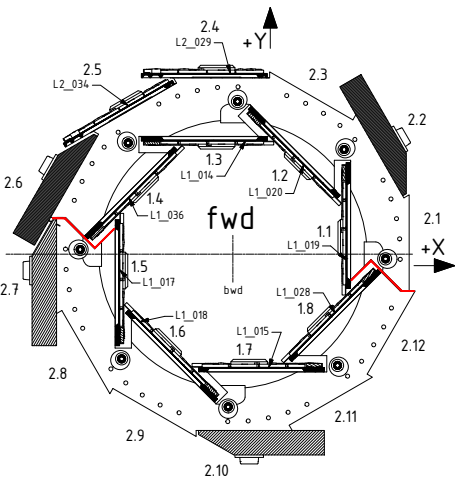
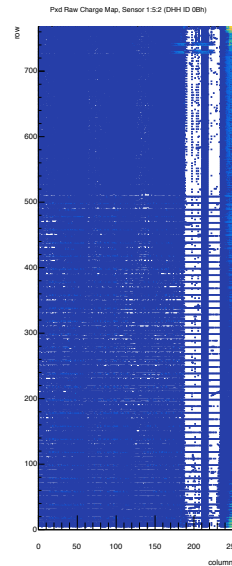
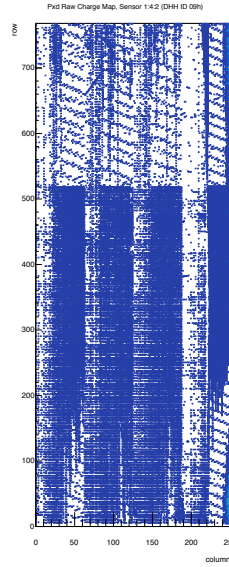
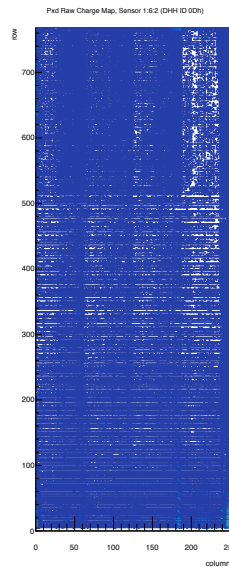
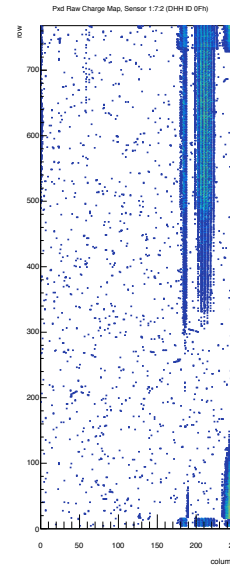
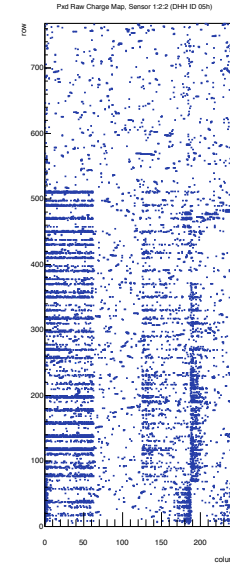
- Charge integral per pixel for ~ 7 hours of data taking
  - ~ 500 k events
  - no masking applied

- A few noisy events can screw up the entire map
