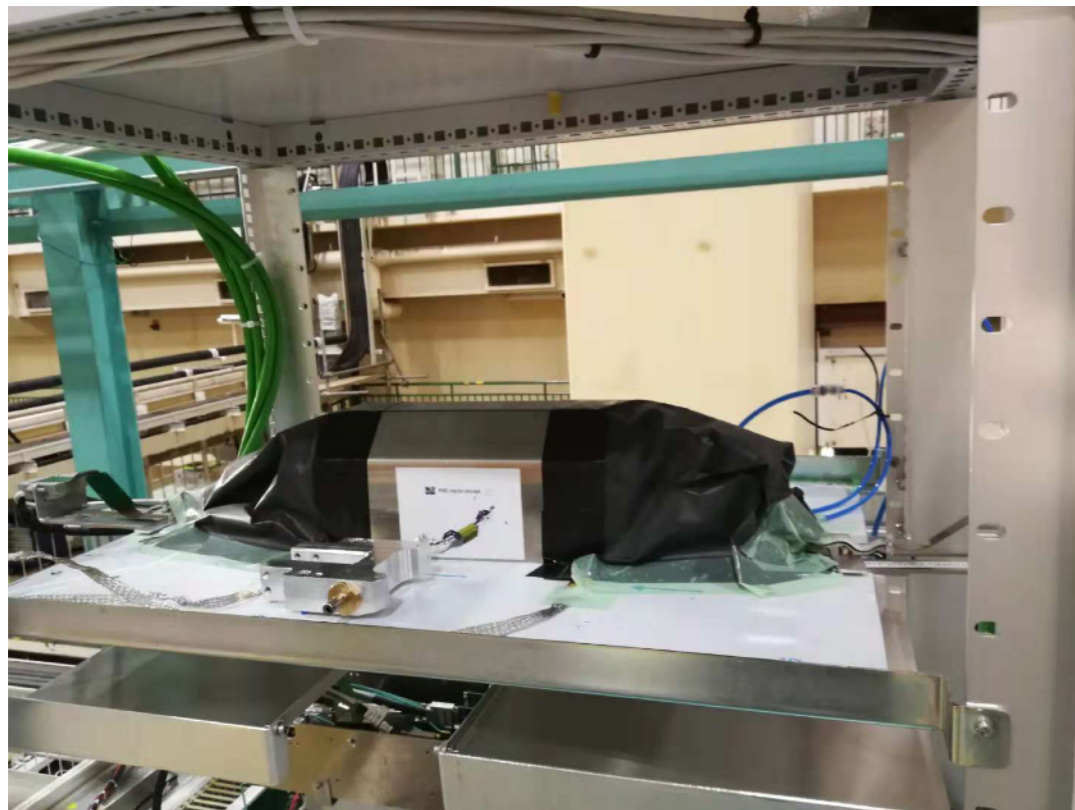
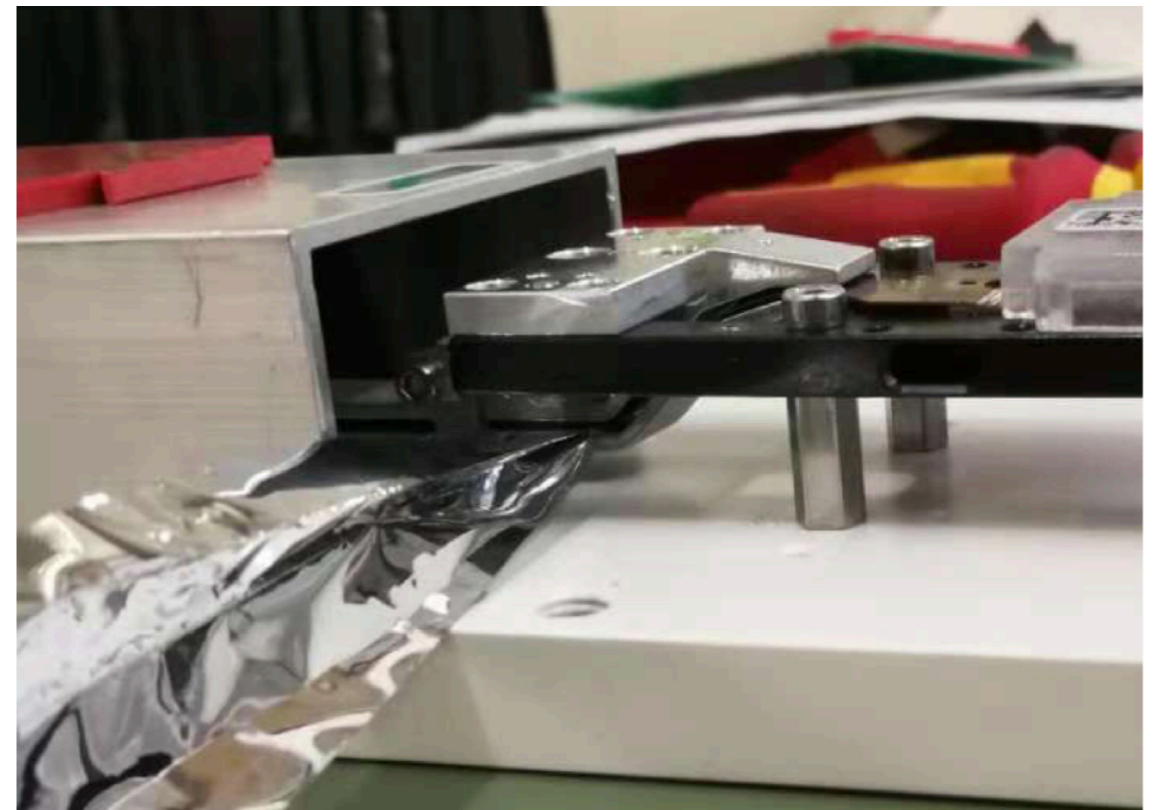
Improving the grounding:

The AGND/DGND (from Kapton) is grounded to the rack, which is the common grounding point.

The cooling block is also grounded to the rack

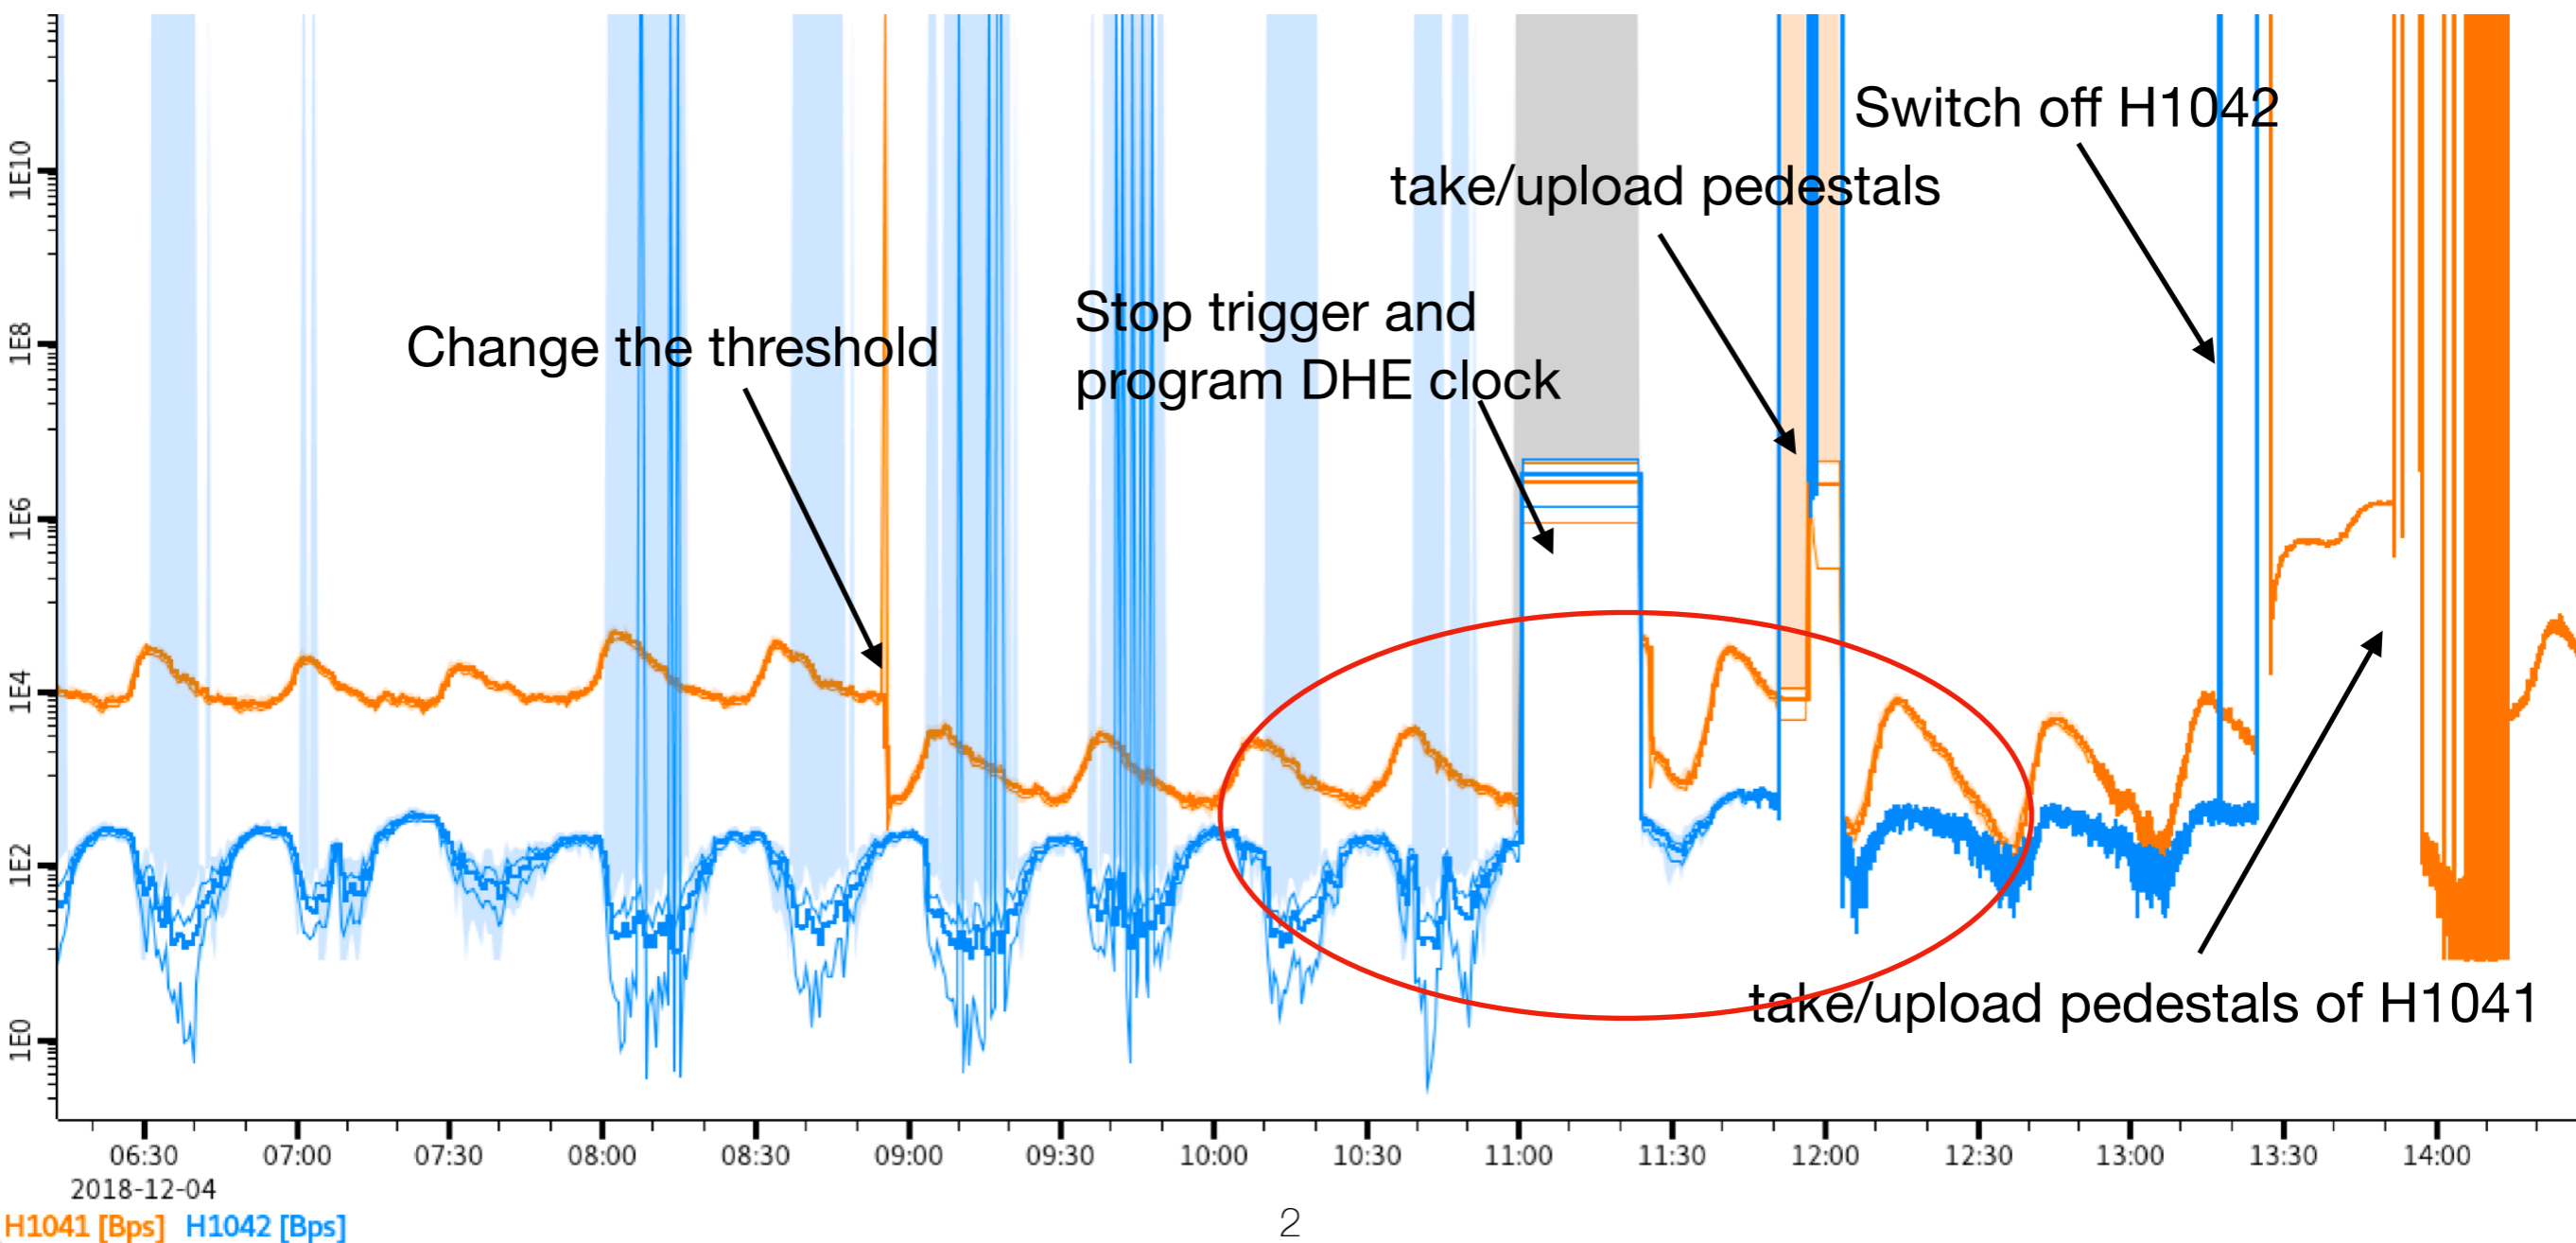
H1041 -> DHE53  
H1042 -> DHE54

In the beginning, the oscillation of both modules has a 180deg shift in phase, then we notice the clock of several other DHEs are not correctly programmed, after DHEs clock were programmed, the shift disappeared.

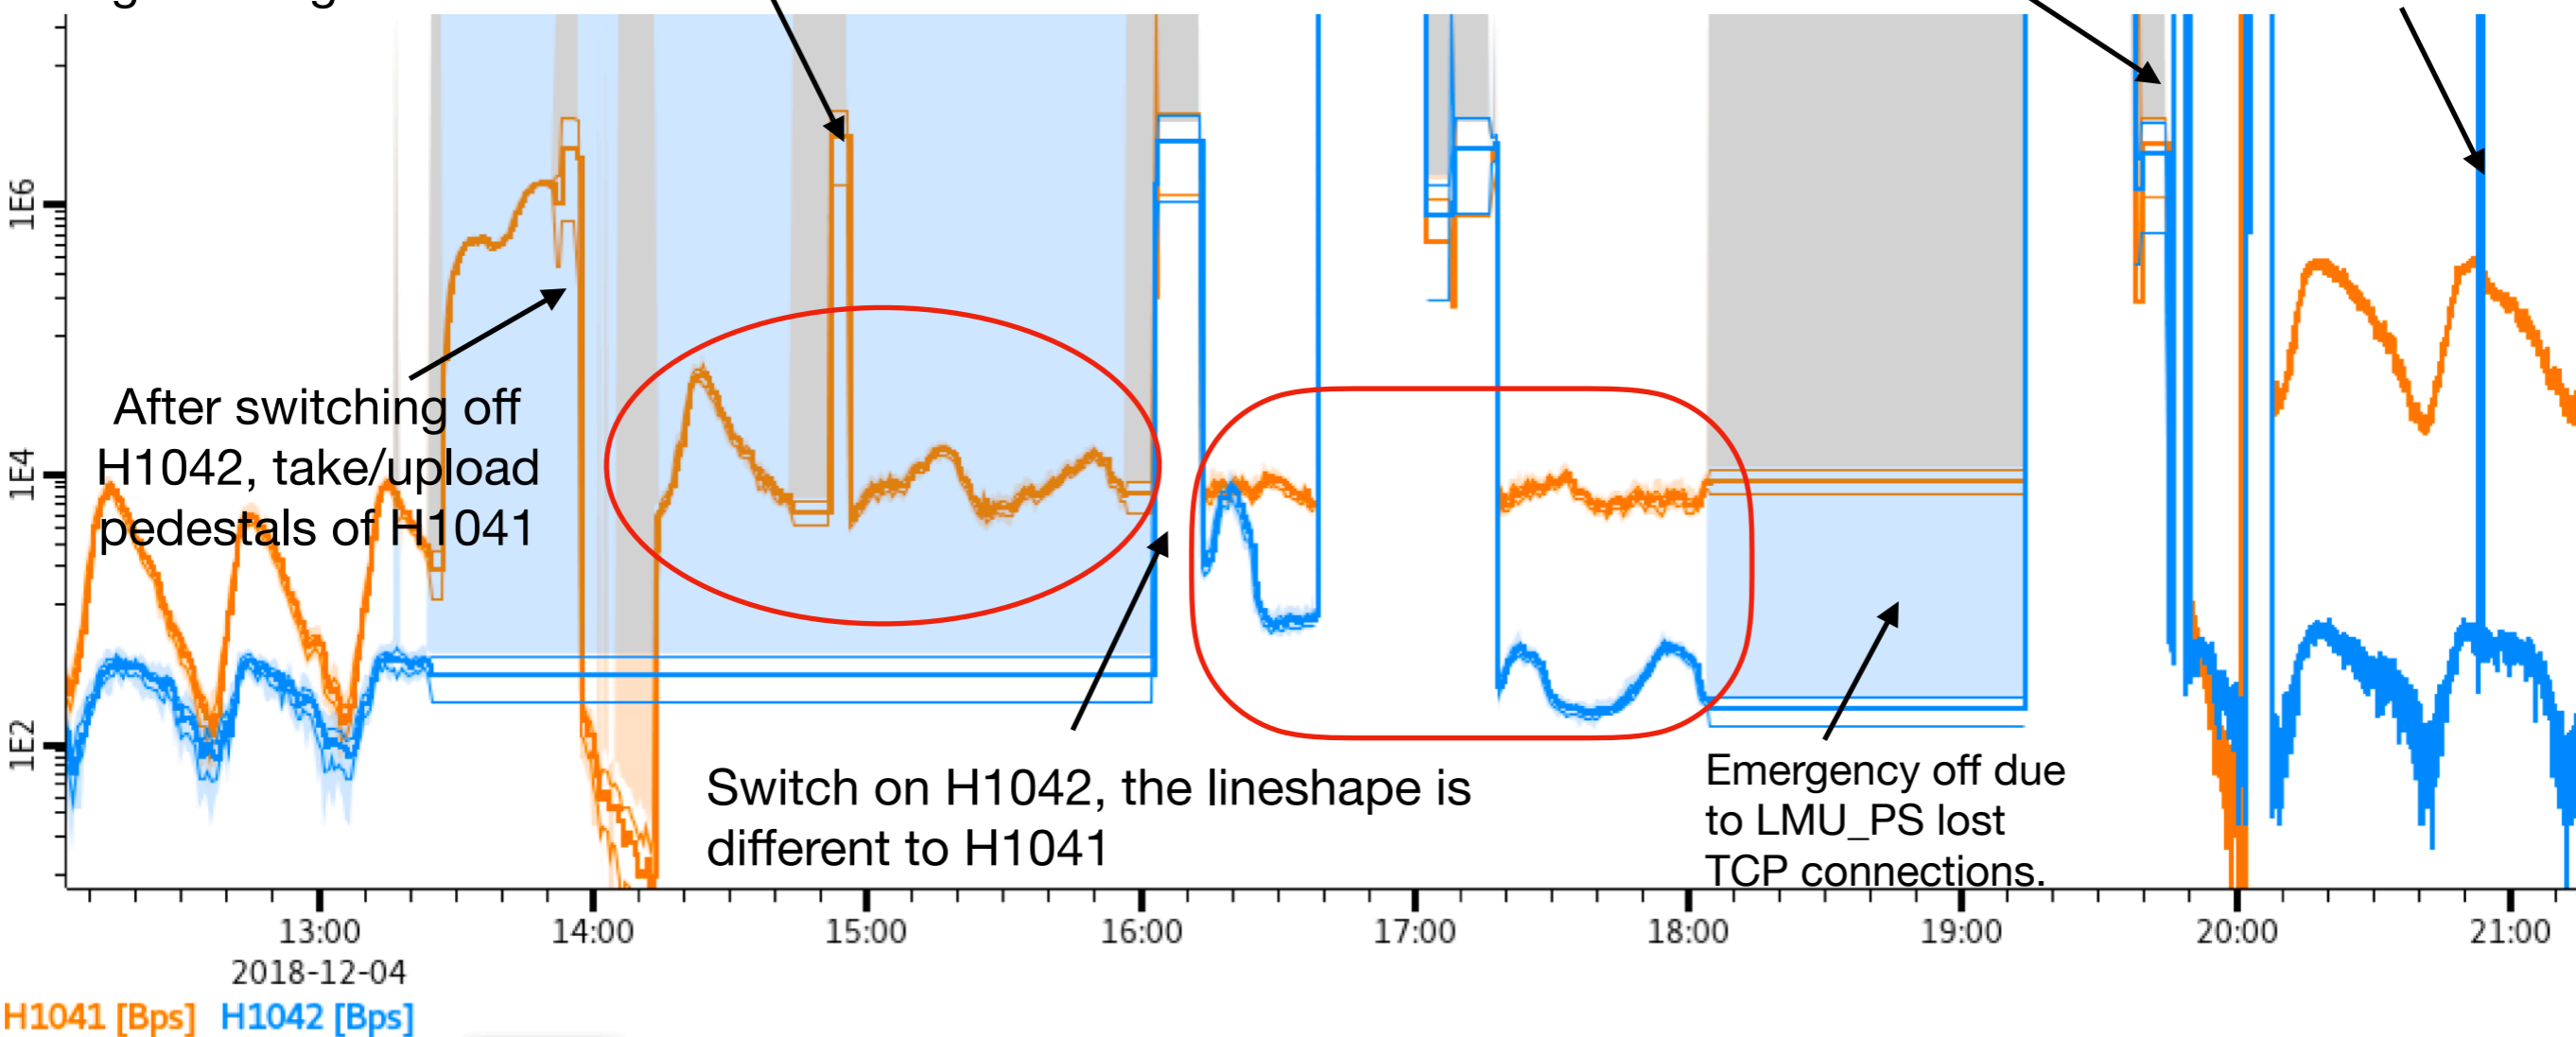
Disconnected DHC 50 from FTSW, and reconnected, DHC50 lost synchronization from FTSW, then the lineshape of oscillation got changed

Swap modules and DHEs, i.e. H1041->DHE54, H1042->DHE53, DHC stay unsynchronized from FTSW, the lineshape looks the same as before

Synchronize DHC to FTSW by programming DHC clock, lineshape did not change

\*After disconnecting DHC from FTSW, the DHE/DHI channels appeared to be disconnected. This was not observed before moving DHH to the top of Belle2.
