# Production tests and commissioning of the Pixel Vertex Detector for Belle II

Philipp Leitl  
phleitl@mpp.mpg.de

Max Planck Institute for Physics

2019-03-25

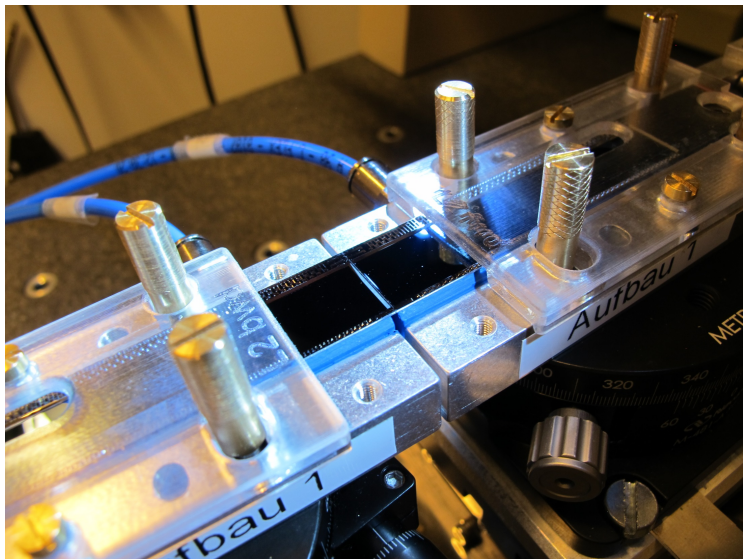
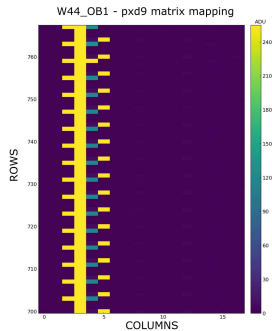
The damaged matrix of W44\_OF1 after gluing of ladder L2\_024 is shown on the left side. The bright spot is the broken BCB passivation layer. The metal lines underneath were damaged as well resulting in short-circuits. The readout of the turned off matrix on the right side shows high current in the affected drains.

- modules are no longer flipped
- the sensitive area is not touched
- ceramic stiffeners are now placed from below

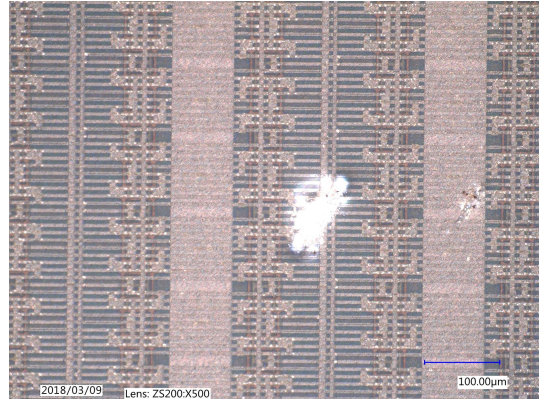
## Impacts in the matrices by hard dust particles (?)

The numbers of failures summed up and it was decided to stop the gluing process in order to not risk the loss of further good modules. Only layer 1 could be completed.

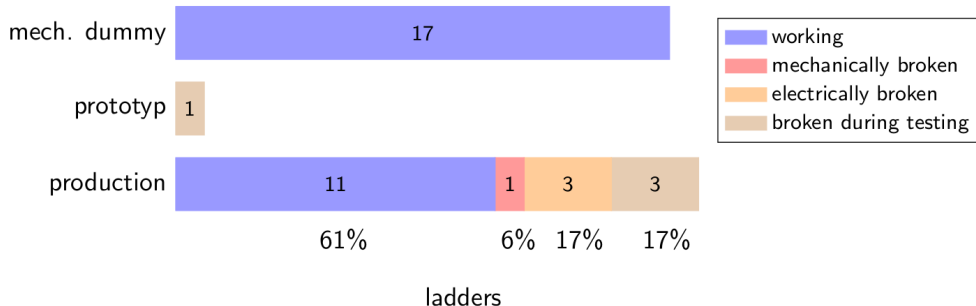
Only the “mechanically” or “electrically broken” categories are directly correlated to the gluing process. Subtracting the modules, which broke during testing, the yield of the production gluing process was at 78%.
