# Production tests and commissioning of the Pixel Vertex Detector for Belle II

Philipp Leitl  
phleitl@mpp.mpg.de

Max Planck Institute for Physics

2019-03-25

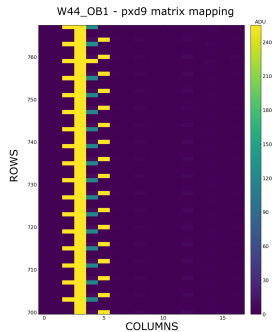
# What could possibly go wrong when you glue?

The damaged matrix of W44\_OF1 after gluing of ladder L2\_024 is shown on the left side. The bright spot is the broken BCB passivation layer. The metal lines underneath were damaged as well resulting in short-circuits. The readout of the turned off matrix on the right side shows high current in the affected drains.

- modules are no longer flipped
- the sensitive area is not touched
- ceramic stiffeners are now placed from below

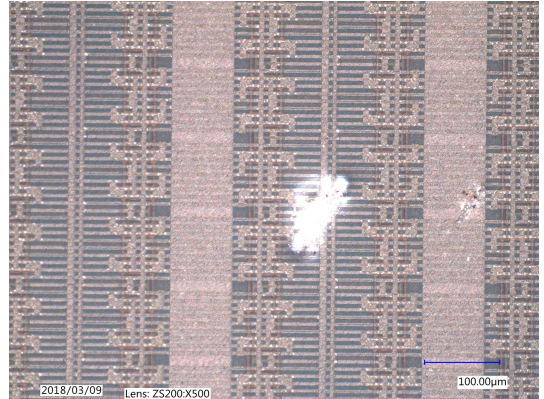
## Impacts in the matrices by hard dust particles (?)

The numbers of failures summed up and it was decided to stop the gluing process in order to not risk the loss of further good modules. Only layer 1 could be completed.

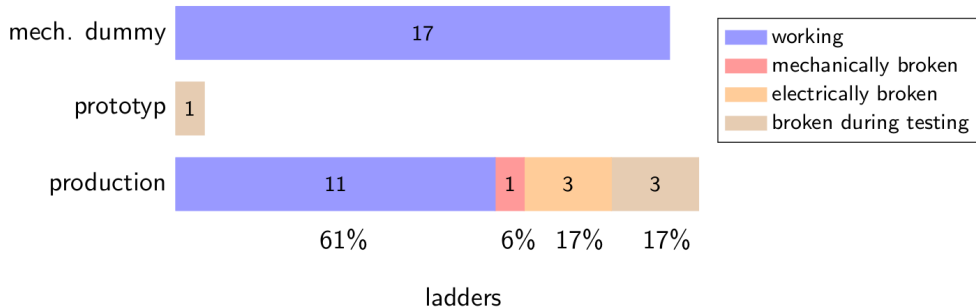
Only the “mechanically” or “electrically broken” categories are directly correlated to the gluing process. Subtracting the modules, which broke during testing, the yield of the production gluing process was at 78%.
