PXD2 Module Assembly/Repair HLL

- status May 2022-

L1_61 history challenge

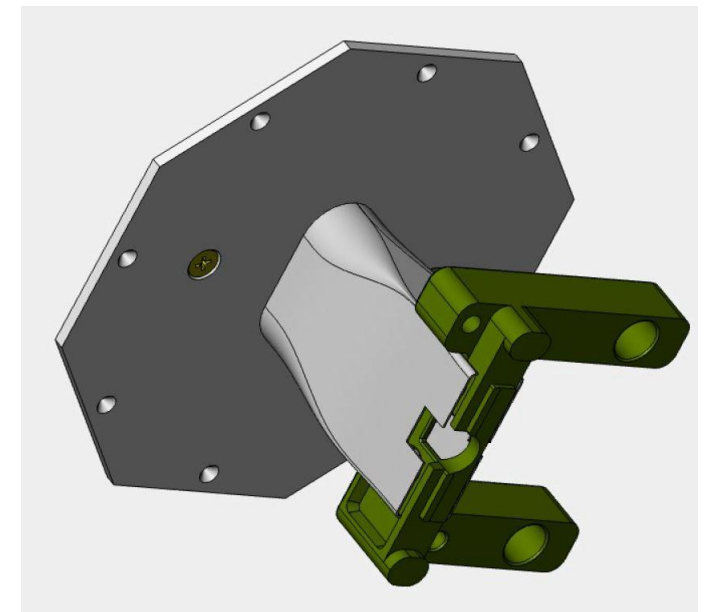
- ▷ Ladder assembled and passed all tests Nov. 2020
- ▷ Mounted on first PXD2 HS July 2021
 - ↳ **14 July 2021:** Tests on HS showed JTAG problem on BWD side (W55_IB),
 - ↳ Dismounted from HS
- ▷ Optical and x-ray inspection revealed displacement of kapton → wire bonds broken
 - ↳ Root cause unknown, possibly overheated during tests, not clear when this happened
 - ↳ On FWD side (W52_IF) no visible damage .. I guess ..
 - ↳ **12 July 2021: last test of FWD side before HS mounting, test after mounting??**

- ▷ Challenge
 - ↳ Replace kapton after ladder assembly → requires new procedure/tooling

- ▷ Procedure
 - ↳ Modify ladder jig to allow alignment of kapton to ladder
 - ↳ Mount ladder on modified jig (tooling available)
 - ↳ Remove old kapton on heat plate/hot air soldering
 - ↳ Modify tooling for kapton fixture to ladder during soldering
 - ↳ Design and produce new tool for rework station
 - ↳ Test and practice with dummy ladder

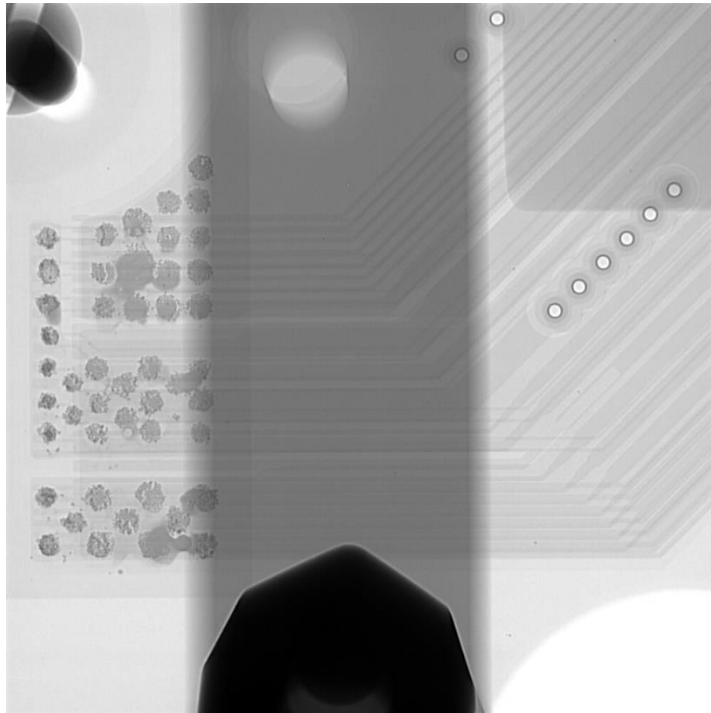
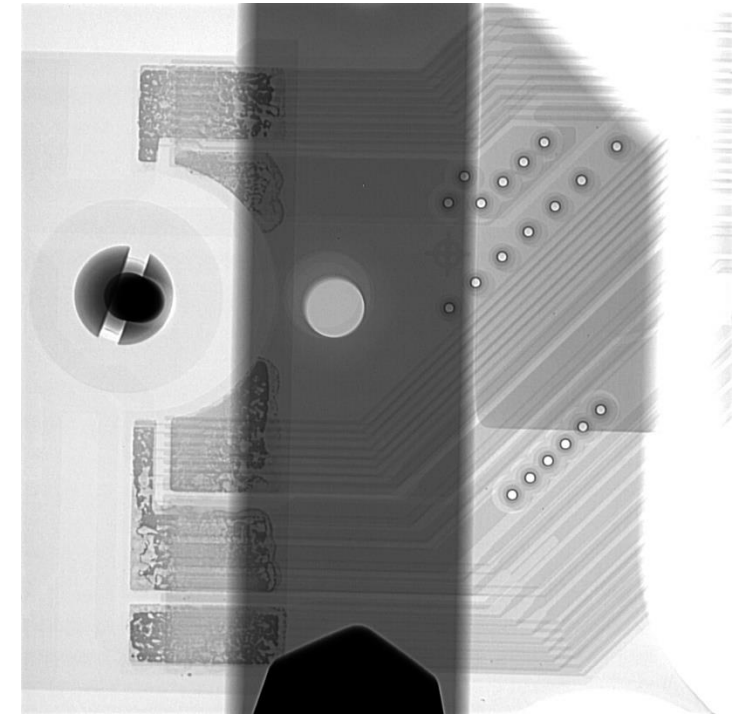
From 1st to 3rd trial

- ▷ Wire bonding without problems at MPP
- ▷ **BWD side fully functional again, but FWD side has now JTAG problems**
- ▷ **Needs follow up ... did not give up yet**
- ▷ **We can also exchange the FWD side if needed ... News from MPP??**

- ▷ Temperature profile was set to have enough heat at one end ($\sim 170^{\circ}\text{C}$), keeping the other as cold as possible ($\sim 70^{\circ}\text{C}$)
- ▷ Three profiles necessary, with intermediate x-ray, to get best result
