PXD Commissioning at DESY Experience P1

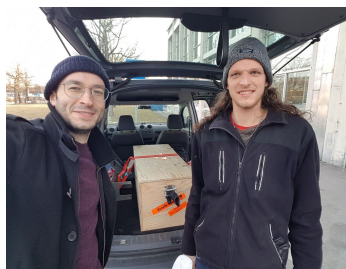
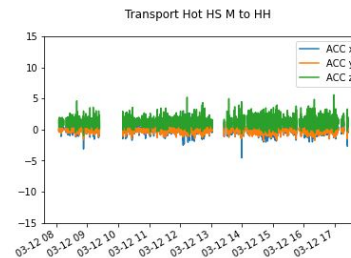
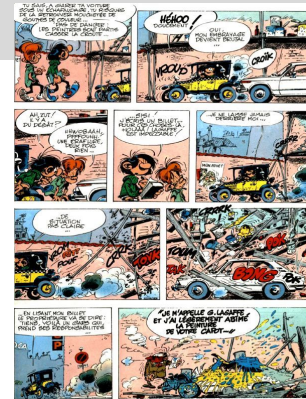
Transport MPP to HH

- A-team by car, kangoo, very slowly
- no (obvious mechanical) damages for dummy HS2
- still uncomfortable road conditions
→ use better rental next round

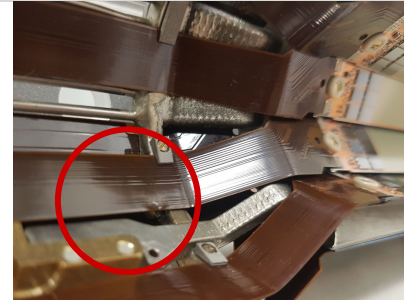
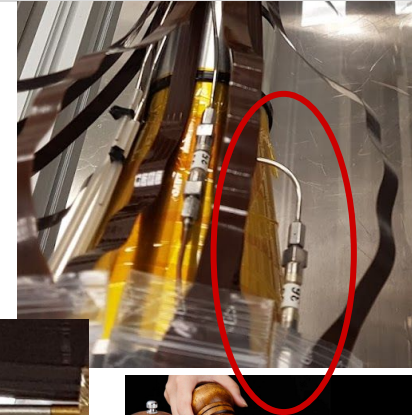
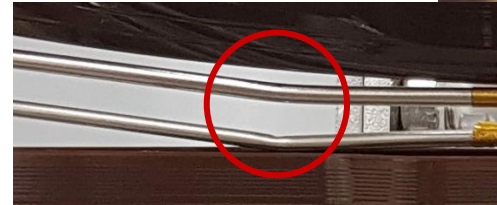
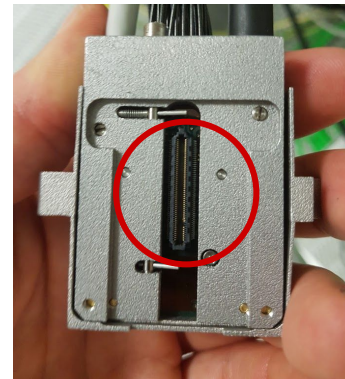
- scratches on L1 Kaptons
 - origin not known, so far no visible impact on module performance
- pipe bending still not perfectly along BP and dents in pipes (interference w/ heavy metal? flow?)
 - to be re-check for second HS
 - re-bending difficult (preserve cross section, ensure no cracks)
- metal specs on matrices
 - could remove some at DESY, though not all
- PP connection damage
 - bent pins during plugging, luckily on female side
 - luckily unproblematic channel, still need to be even more careful

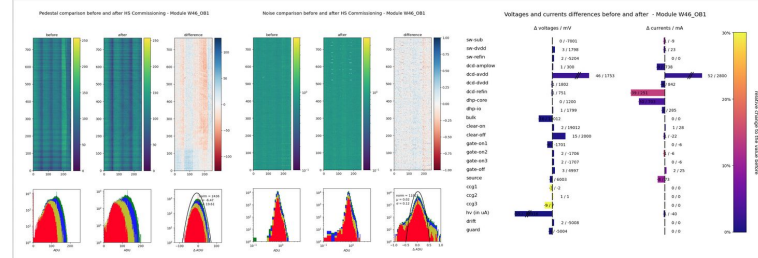
H2042: W46_OB1 (MPP used En60 branch, DESY En90)

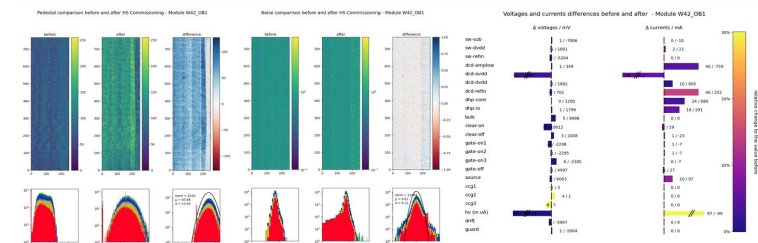
H2052: W42_OB1 (difference not understood, consistent configs! Probably offsets issue?)

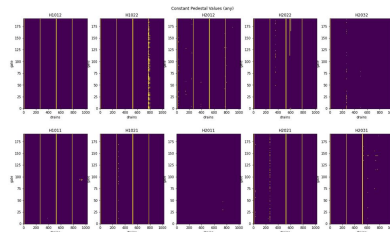
weird constant ADC values

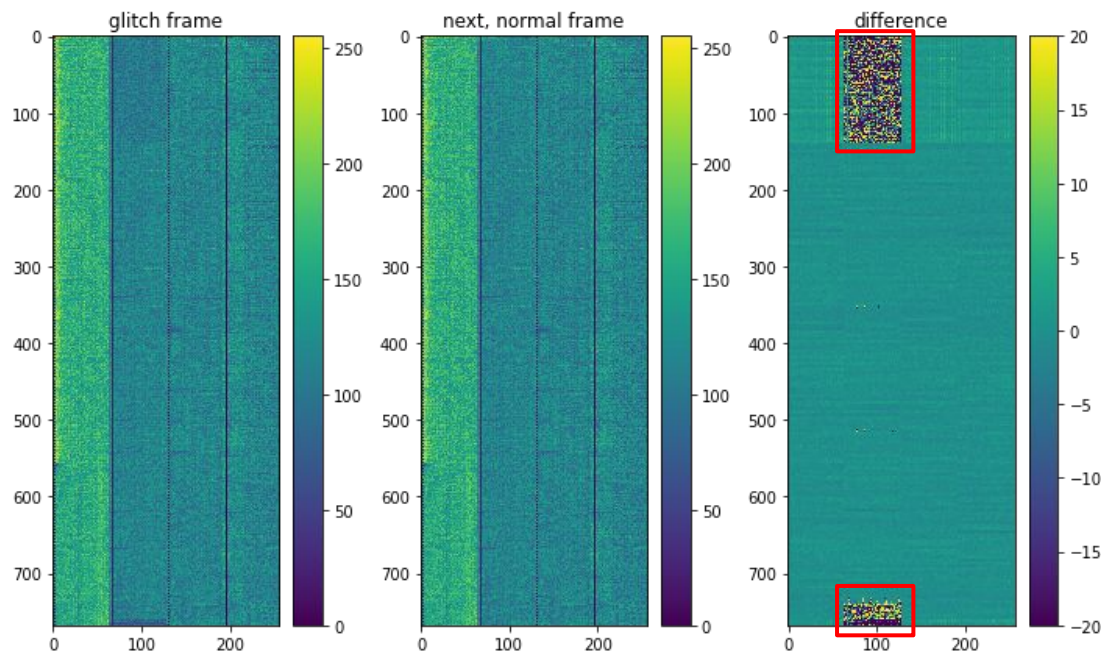
- Shows weird “glitchy” behaviour were pedestals of ASIC-pair 2 shift in some regions for individual gate
- issue not understood, dcd-avdd was particularly low for this module
- issue significantly mitigated by exchange of **DHE/DHI & PSU**
 - module mostly operational, further investigations pending

noise behaviour:
pixel wise and
correlated pedestal
jumps in both dirs
