First Results of PXD6 Prototype Production

R. H. Richter for the HLL technology staff

12/10/2010 5th Int. Workshop on DEPFET Detectors and Applications, Valencia 2010

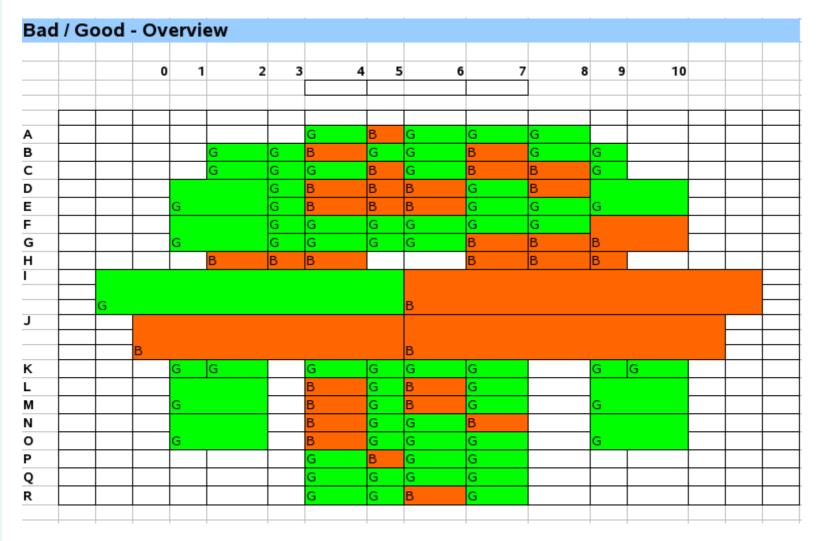
Wafer #2 - all Tests

Yield (big chips): 1 of 16

Yield (small chips): about 80%

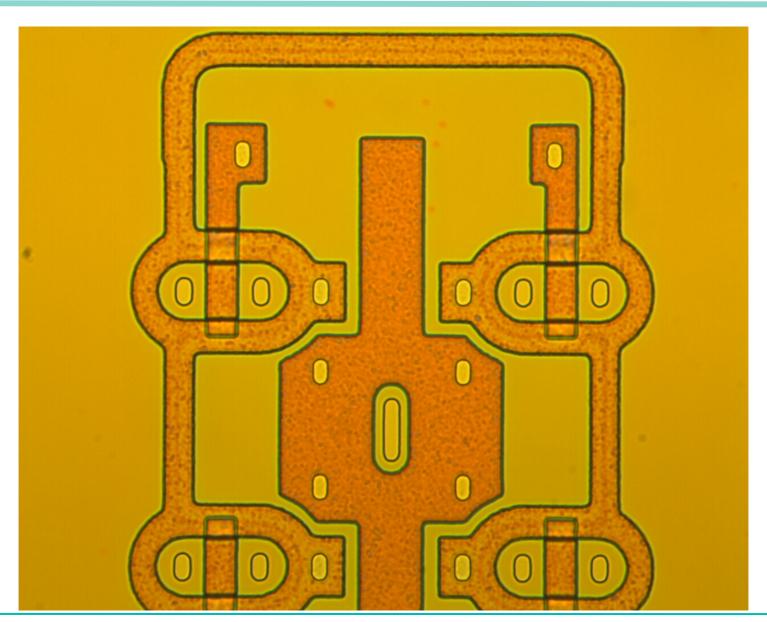
IOO first contact openings

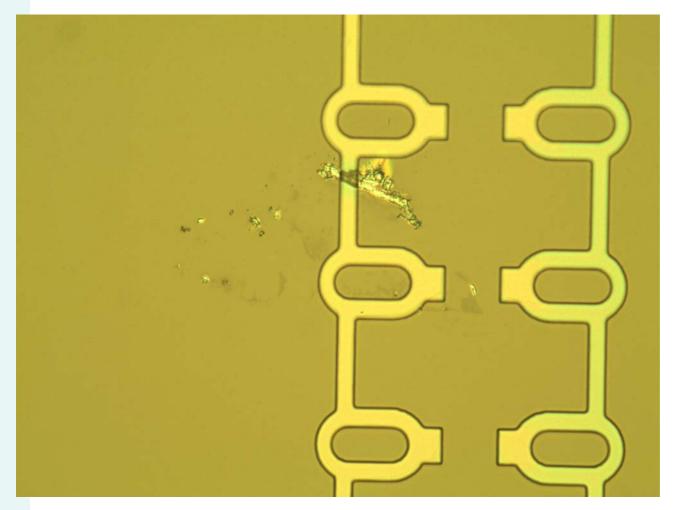
W11 Chip I00

Damage during external implantation

Failed Test 4

CLG vs Si

- all implanations will be done inhouse
- use of automatic inspection microscope
