# PXD Commissioning

22.05.2023

# PXD Services Connection And Testing

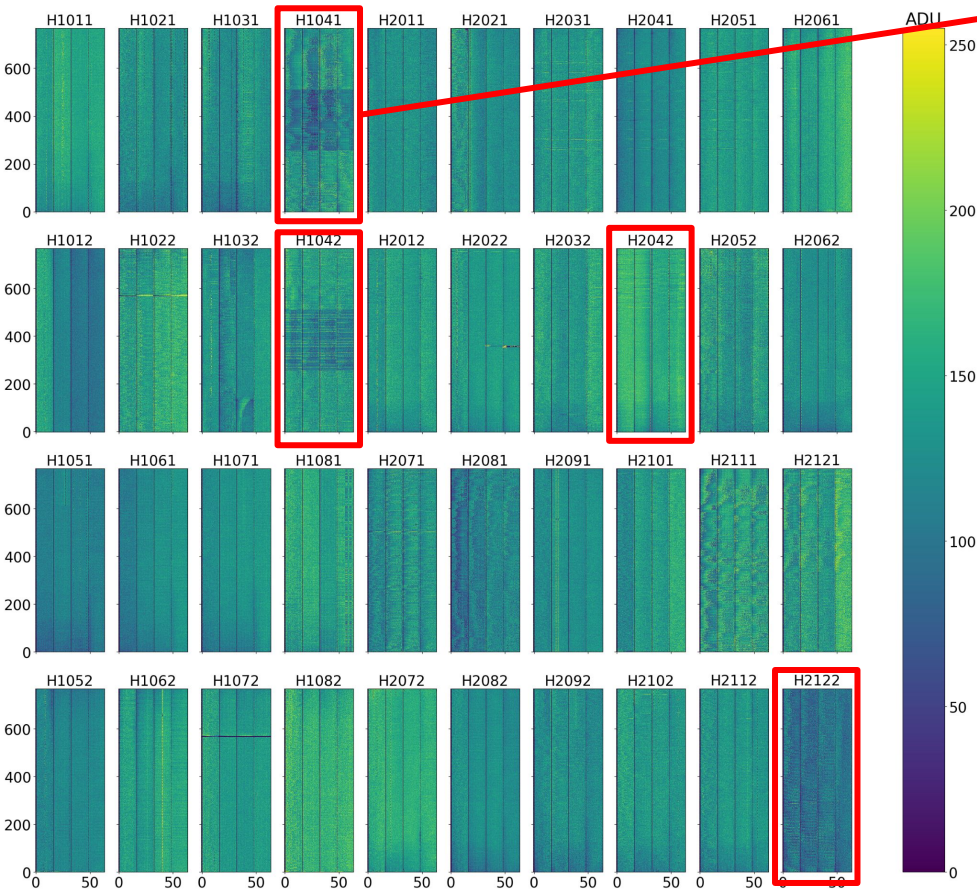
PXD2 - Pedestals (200 frames)

## H1041 & H1042

- occasionally ramp/switch to state with problematic switcher (channel)
- gate\_on2 region w/ much reduced voltage for now to keep source current in limit when this happens
- need some work, ideally only mask problem sw channel

## H2042 & H2122

- have “glitchy” frames where all pedestals jump to very different values
- reason not understood
- observed at DESY already
- impact on data taking not understood

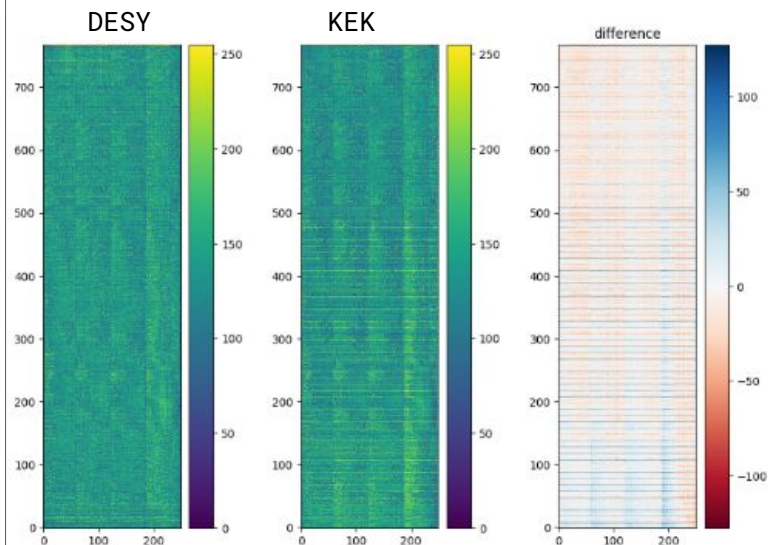
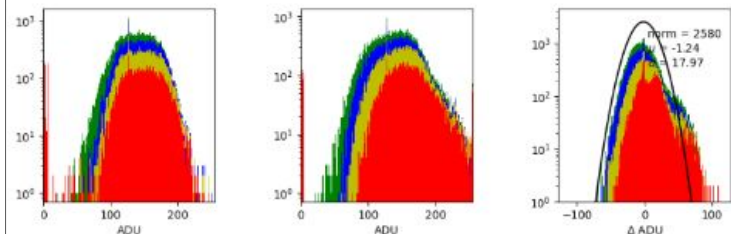
Pedestal comparison before and after HS Commissioning - Module W42\_IB

broken sw 4 or  
possible problem  
gate affecting  
gates downstream  
of the switcher  
sequence /  
rolling shutter  
readout  
full sw 4 but  
overlapping into  
sw 5 region

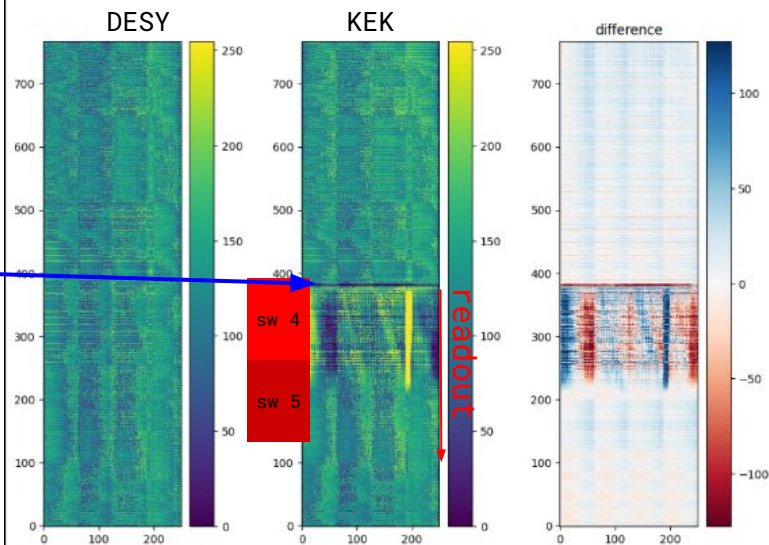
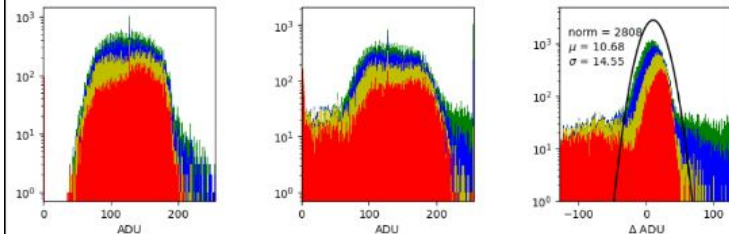
Pedestal comparison before and after HS Commissioning - Module W05\_IF

- Both modules can be powered into “good” and bad state.  
(Stable or switch during operation also?)
- Bad state is qualitatively similar: one dead switcher (channel).
- Introduces pedestal shifts and noise. Doubled source current.
- Temporary mitigation: reduced gate-on voltages. Better if switcher (channel) could be individually masked.
- details [1042](#) and [1041](#)

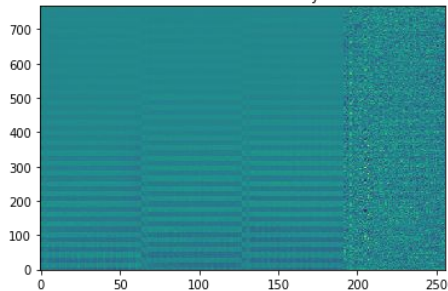
Pedestal Shift From Good To Glitchy Frame H2122

- Already observed at DESY. More details: <https://gitlab.desy.de/belle2/detector/pxd/commissioning/-/issues/221>
- Significant pedestal shifts in individual frames.
  - qualitatively different for different DCDs. Single DCD origin of issue?
- Reason/origin not really known. At DESY services might have had a contribution.
  - not further investigated at KEK
- 2122 exhibits very bad/unstable asic currents that might be related
- Bad delay scan results → could not be improved at DESY

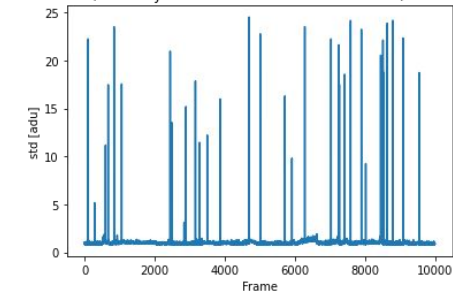
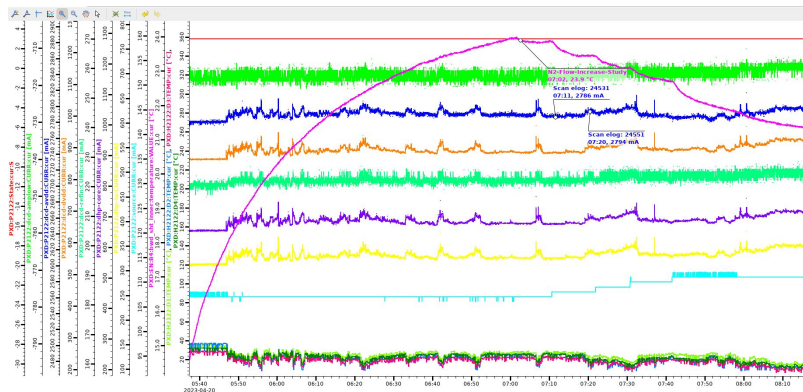
STD(Frame-by-Frame Shift Wrt Median Pedestals) H2122

- 2122 plots
- 2042 qualitatively similar but better currents and lower glitch "rate"

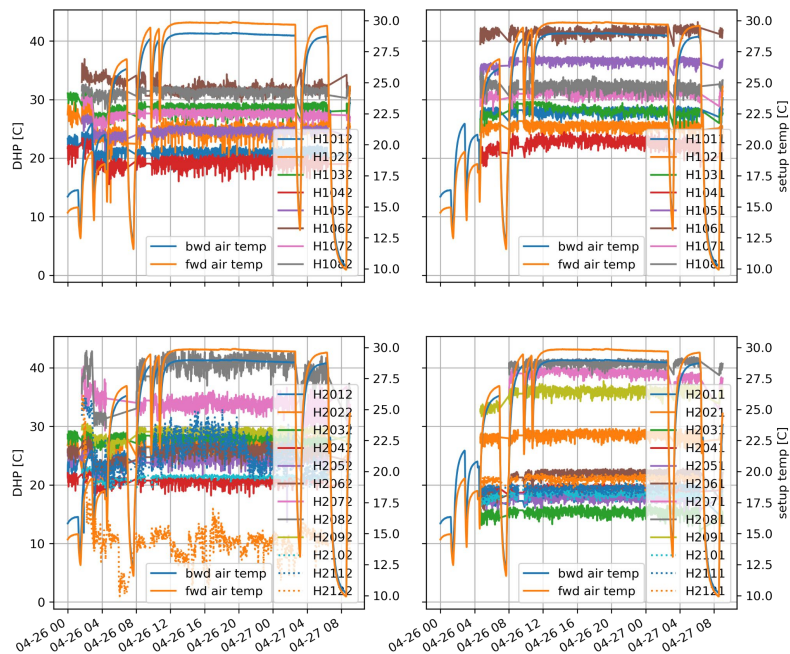
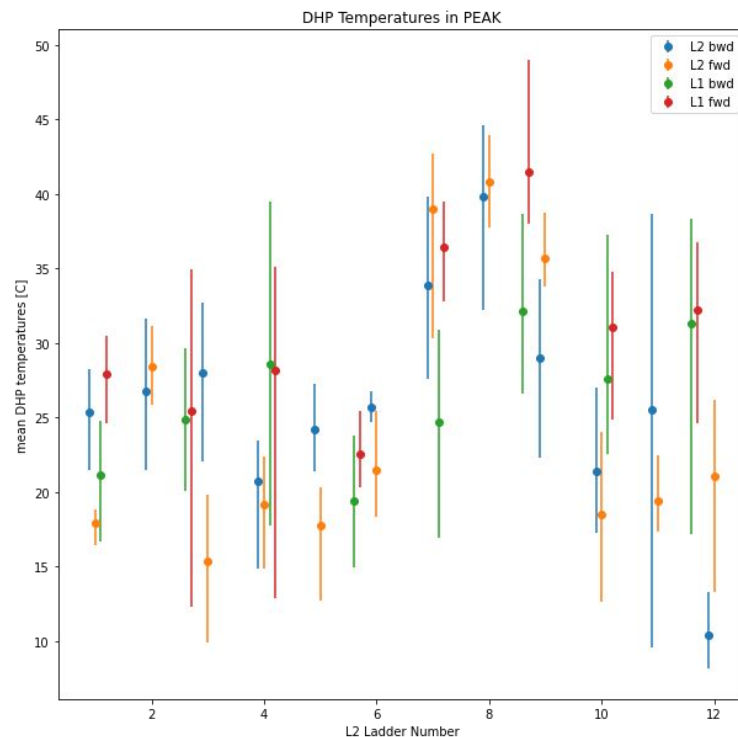
# DHP Temperatures (Full PXD PEAK)

- mostly stable DHP temperatures, large spread between DHPs and mean DHP temperature per modules
- interestingly: strongly bent ladders 207X/208X are also hottest
- HS1 vs H2 difference?
  - origin not known, uneven N2 flow?
  - all N2 lines measured independently at roughly  $\frac{1}{8}$  of flow but varying
  - not an issue in Belle2 anymore with 1 flow meter per channel
- SCB left / right difference?

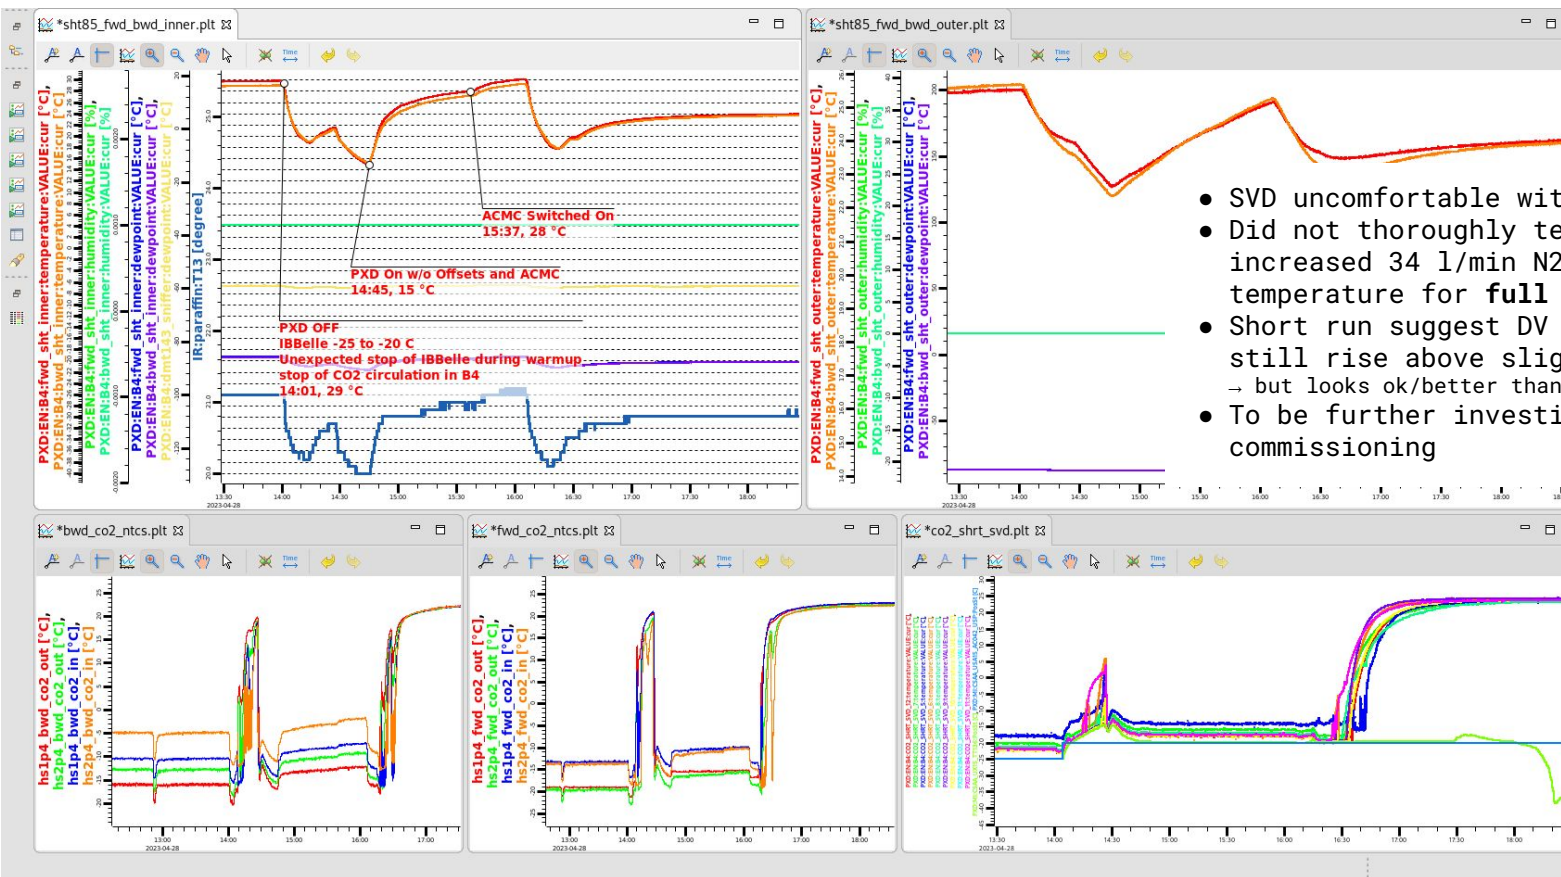
# Terminal Temperature at -20 C CO2 Full PXD

- SVD uncomfortable with -25 C.
- Did not thoroughly test cooling with increased 34 l/min N2 flow at -20 C CO2 temperature for **full** PXD.
- Short run suggest DV air temperatures still rise above slightly 30 C.  
→ but looks ok/better than 24 l/min at -20C
- To be further investigated during VXD commissioning
