Status of PXD 2 ONSSEN System at KEK

PXD Workshop

Mai 22, 2023

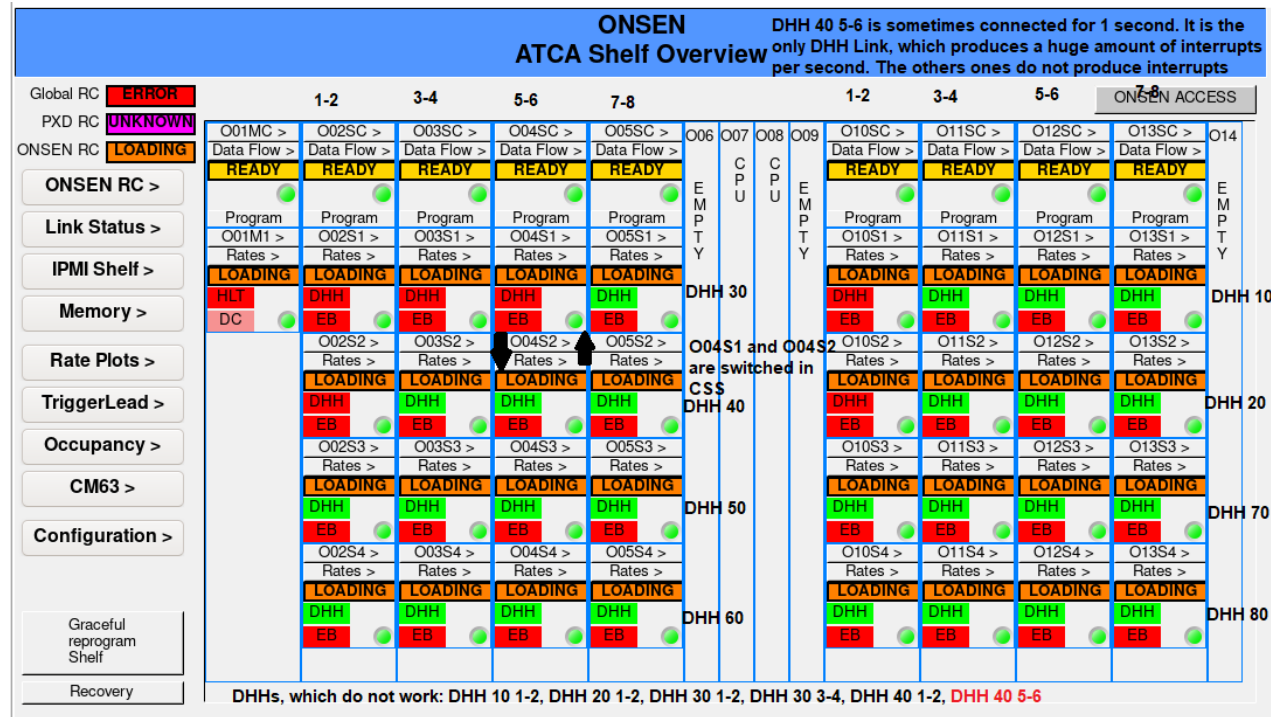
Dockbox cabling (E-Hut) – Link Tests

- ▶ There was an error with the cabling at the DHH
- ▶ Tightening loose screws recovered the two links
- ▶ All DHH to ONSEN links are recovered

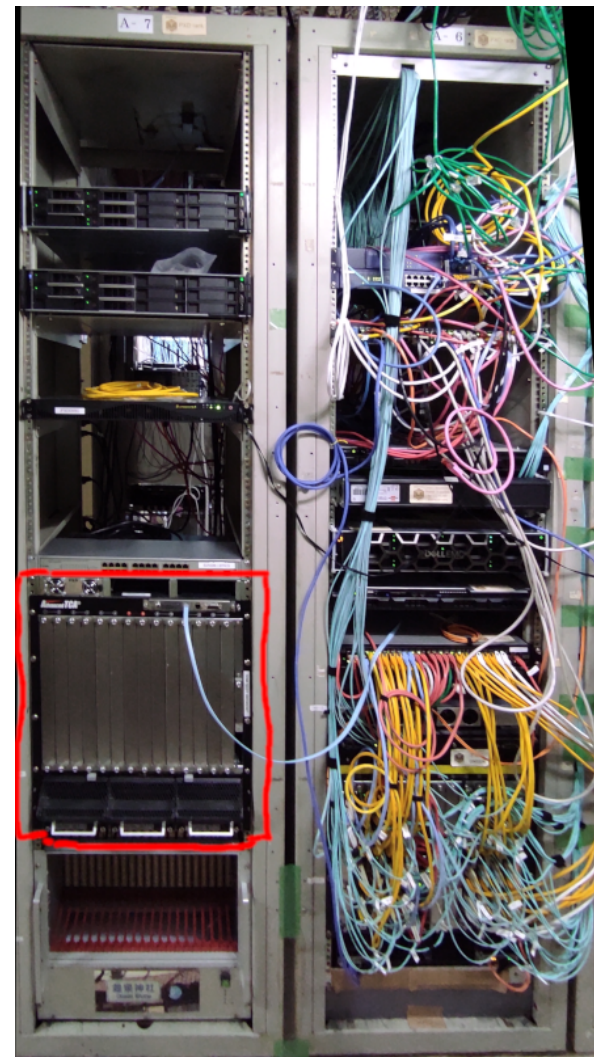
ONSEN Spare Shelves

- ▶ One 2-slot “pizza” ATCA shelf
- ▶ One 14-slot ATCA shelf without full-mesh backplane
- ▶ One 14-slot ATCA shelf with full-mesh backplane, which is bent
- ▶ All shelves were located behind the shifter room in B3
- ▶ The bent shelf was moved to the E-Hut to be usable as spare
