# PXD Grounding Scheme (2018)

# How The Ground Cable was Installed for PXD1

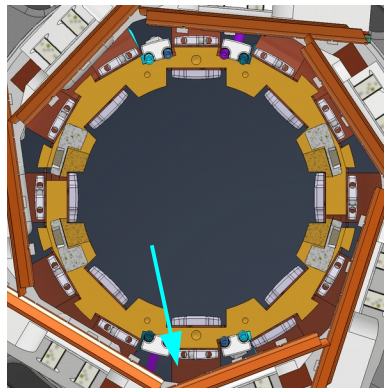
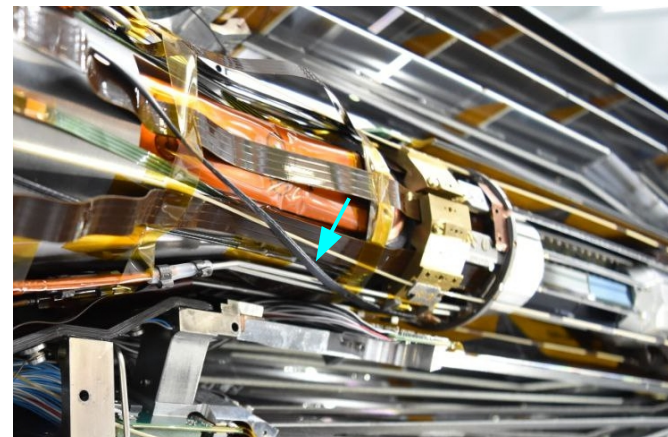
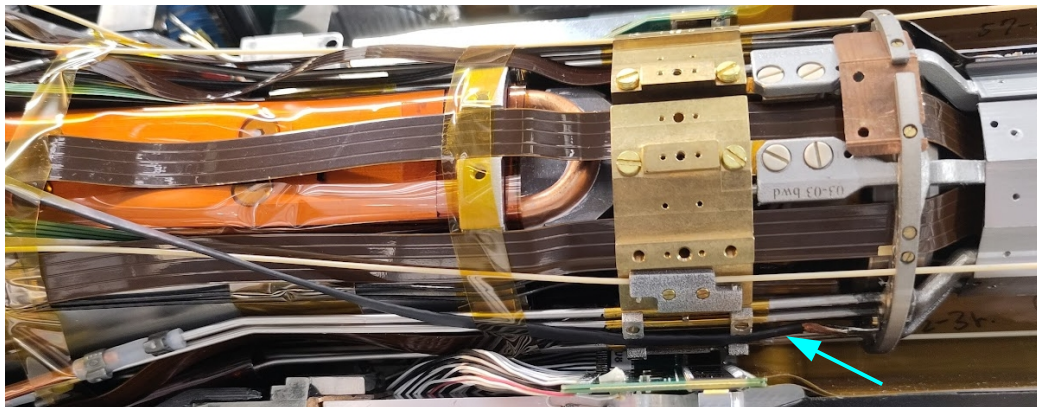
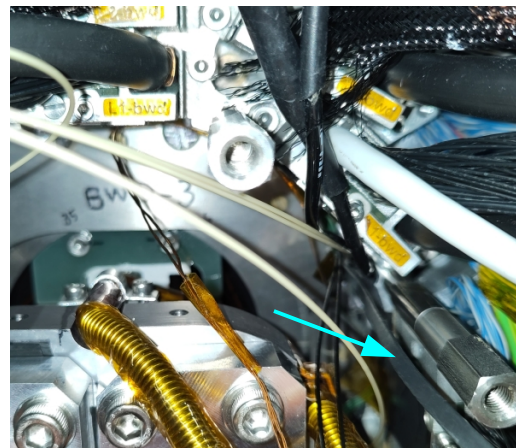
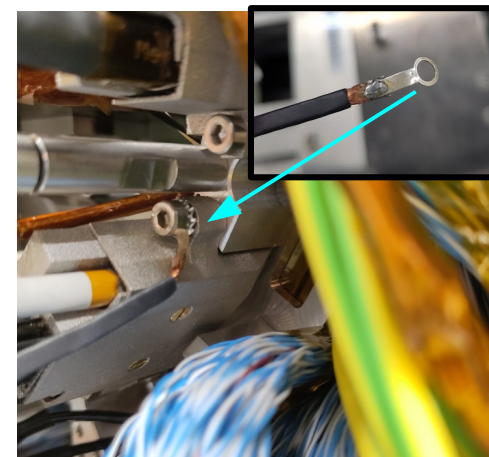
- Flat cable routed over L2 Kapton gap
- Measured cable dimension  $\sim 1 \times 3 \text{ mm}^2$
- Routed through end flange and connected to PP screw

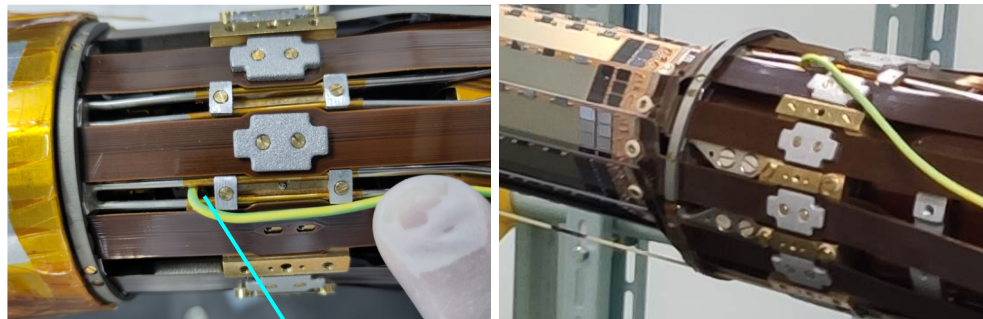
## Ground Cable Collision With SVD Wire Bonds

- SVD wire bonds in the area of our brass piece (1 mm clearance)
- Our ground cable makes a strong bent without any good permanent fixation in that area
- Stripping the cable so close to the Kapton difficult

- Try to route (old) cable behind the Kapton through brass piece gap (carefully remove the Kapton strain relief? **Only when ground ring is installed!**) (**bad**)
- Install a new (thick/flat) cable and solder it to the copper SCB ground connector (cut/remove the old cable) (**good**)
- Route a thin cable through the fiber holder (BUT: Richard says cable should be as thick as possible) (**bad**)
- Route cable somehow though the L1 Kapton gap? (but here is the Kapton strain relief as well) (**bad**)
- Fix cable to the isolator of the carbon tube (**bad**)

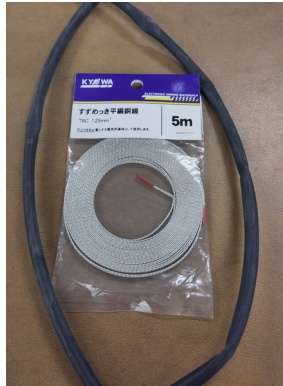
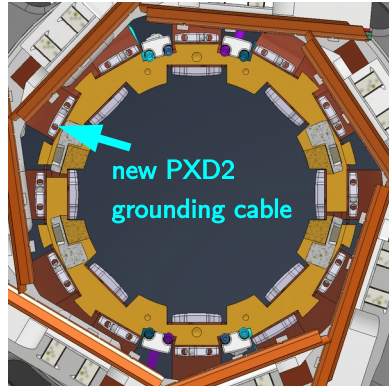
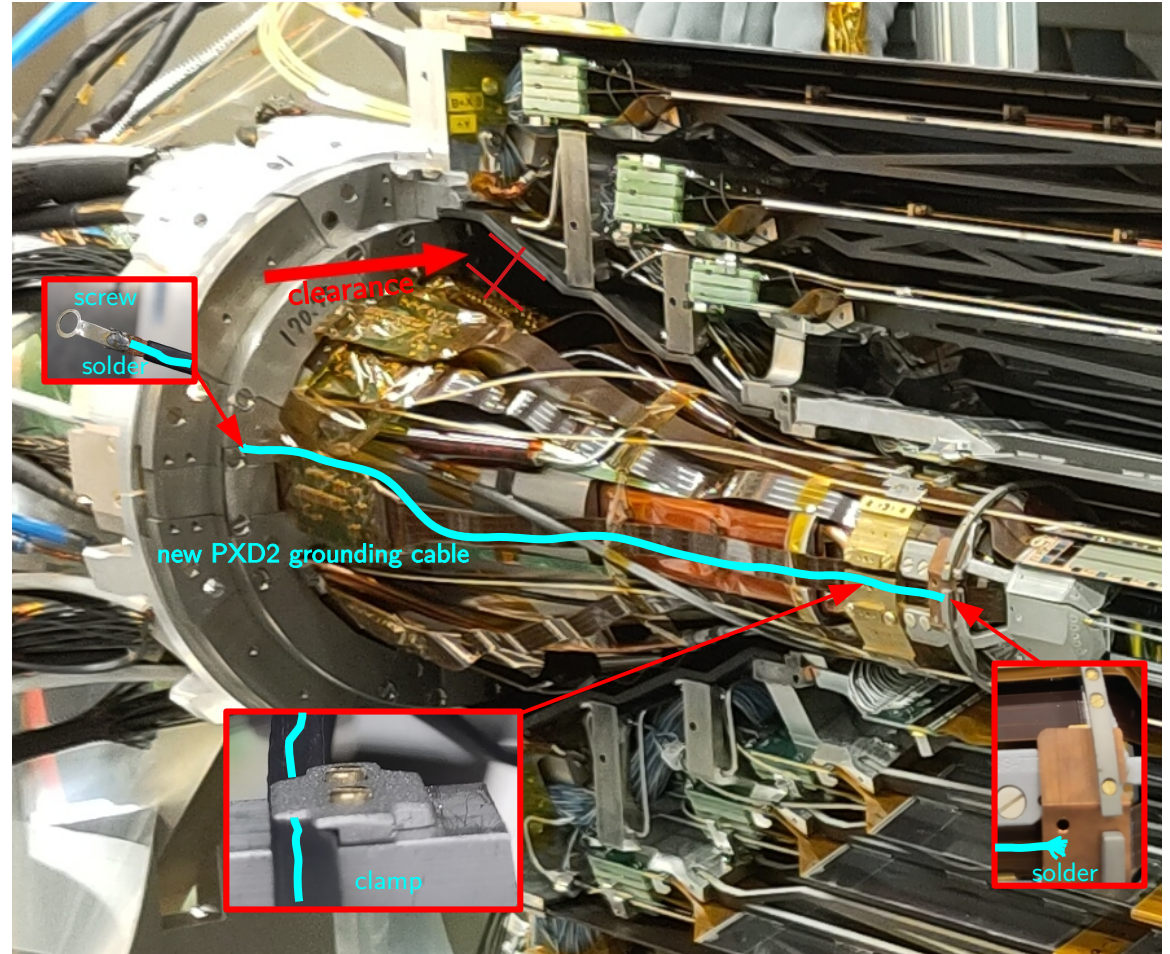
- Impossible to route cable through the end flange
- Enough clearance to the inner side of SVD cone
- Fix the grounding cable (1.25 mm<sup>2</sup>) to the inner side of the end flange (heavy metal piece screw)

- Solder cable to top side of copper plate
- Fix cable with modified strain relief to brass piece
