Status of ATCA/Onsen at IHEP

Jingzhou Zhao/Zhen-An Liu

TriggerLab, IHEP Beijing

Ringberg Germany, June 15 2013

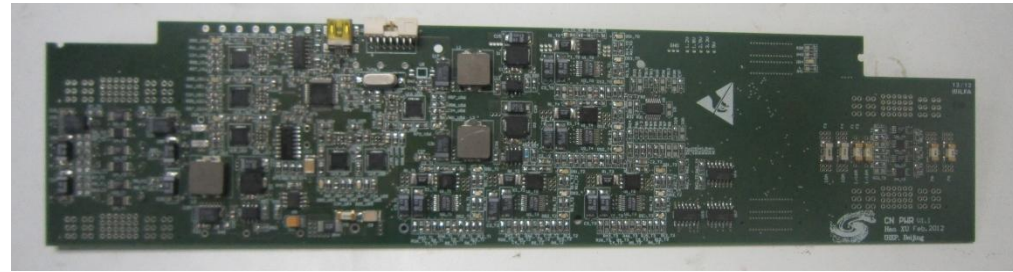
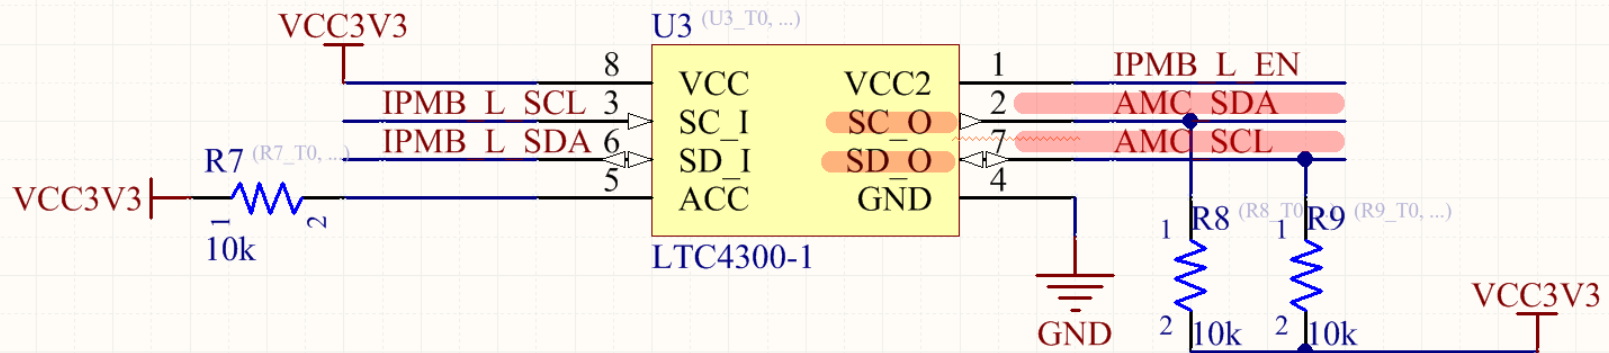
- IPMC/MMC test at Giessen: **X failed**
- Reason found at Giessen in May:
 - Buffer of SCL/SDA wrongly routed(swaped)

Signal	Pin	←--- →	Pin	Signal	Error
SCL	3	<->	2	SCL	SDA
SDA	6	<->	7	SDA	SCL

- Solution to IPMC/MMC error
 - Redesign Carrier Power Board(Ver.3)
 - Errors corrected
 - More resistors for easy testing
 - Ver. 3 has been sent to Factory for PCB
 - To be soldered and tested in July
