# SVD Introduction

Koji Hara (KEK)

**6th Belle II PXD/SVD workshop and 17th  
International Workshop on DEPFET Detectors and  
Applications**

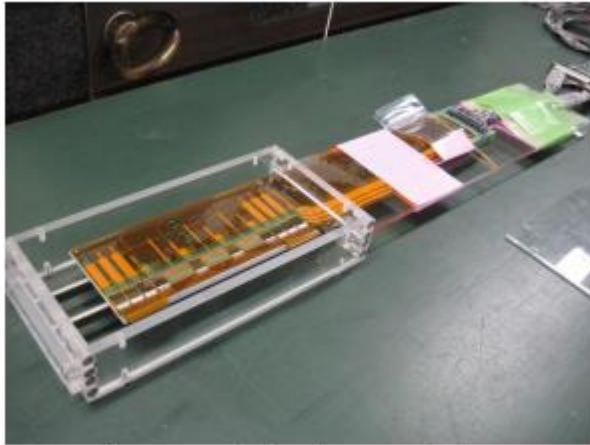
Assembled module

- Origami module assembled with final parts at IPMU
- Found many signal lines on N-side are disconnected

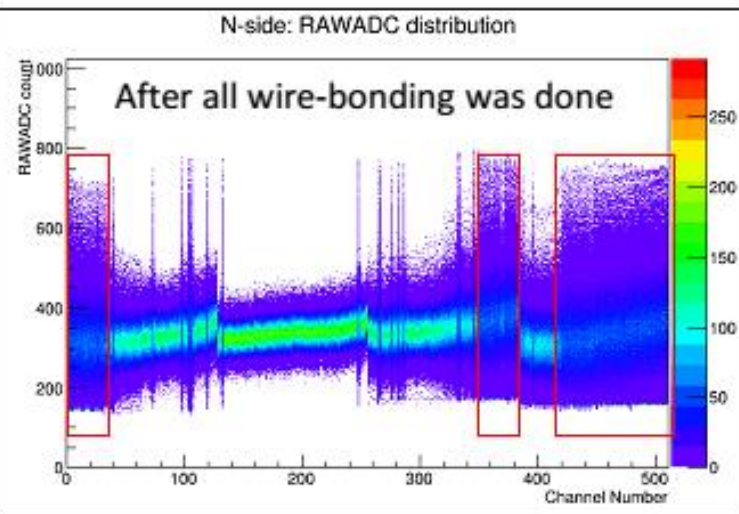
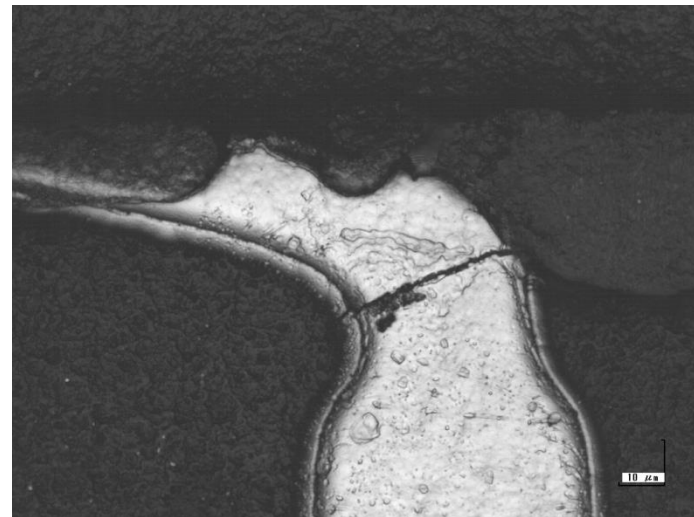
→ Cracks found on PA0

Cracks have been overlooked in Taiyo's check (visual inspection)

- Pre-production before 2013 Oct.
  - No cracks found
- Modification of glue between PA0 layers in 2013 oct.
  - Acrylic glue -> epoxy glue
    - For radiation tolerance and to reduce curvature around PA0
    - Accompanying cover sheet under the glue was also changed
  - Cracks observed
- Final production in late 2013
  - Found cracks in all samples we have checked so far

- Cause of the cracks is identified to be the blanking (cutting) process of PA0 at Taiyo
    - Taiyo verified cracks occurred in the blanking process
    - Using old glue, cracks do not occur
    - Taiyo is trying to improve the process to produce crack-less PA0
  - Two possible (not impossible) ways
    - All Origami have been equipped with APV chips, 70% wire bonded(control lines)
    - a) Gluing new PA0 without cracks on existing Origami PA0
    - b) Full reproduction of Origami
- Need to clarify
- Impact on schedule
  - Total cost , responsibility
  - Solution to go
- Discussion tomorrow

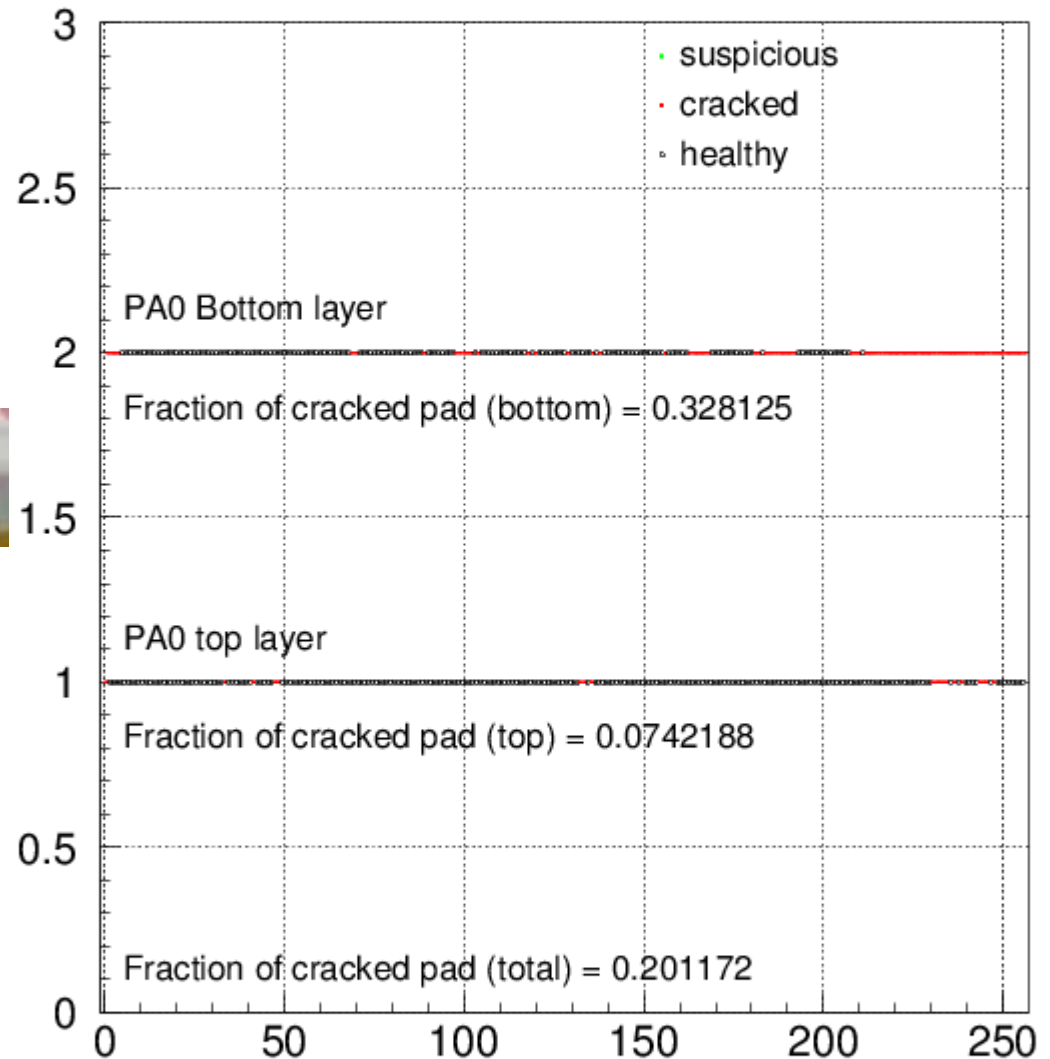
# OrigamiCE-013

Bottom layer  
Top Layer

Many cracks on bottom  
A few cracks on top layer

Cracks also observed **on the bonding pad** (frequent on top layer)
