Modules Overview

- May 2017 -

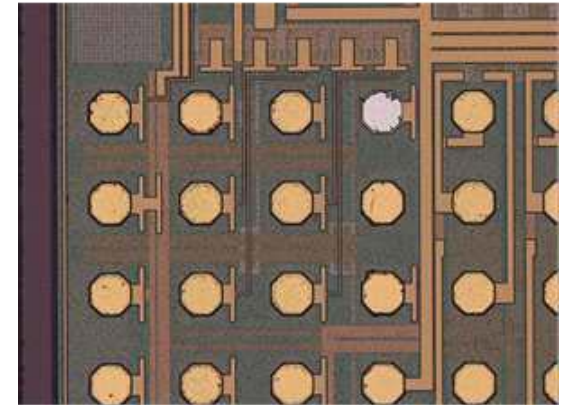
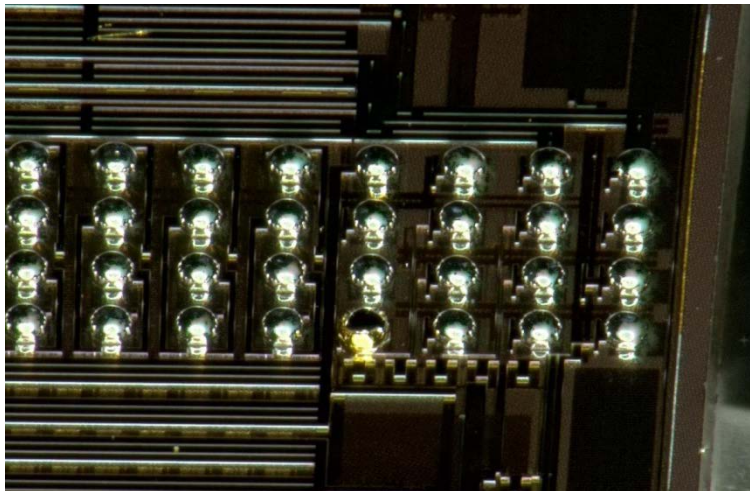
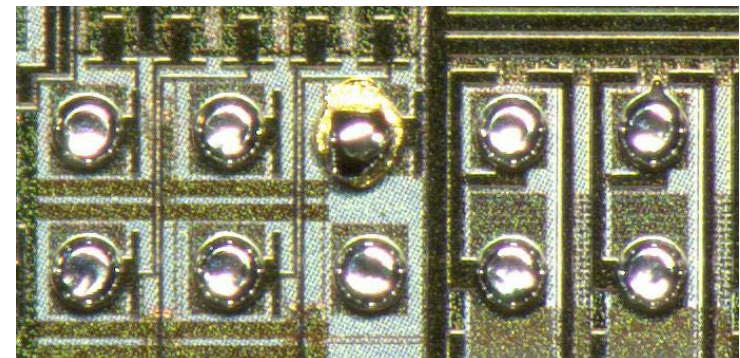
SwitcherBv2.1

- ▷ The Switchers have to be bumped on single die level
- ▷ Bumping (UBM process) causes problems with the new Switcher
- ▷ On one pad – the substrate pad – and only on this pad
 - ↳ Very little or no UBM deposition
- ▷ Main difference to old SwitcherBv2.0
 - ↳ Different passivation ($1\mu\text{m}$ Nitride/Oxide \leftrightarrow PI)
 - ↳ Guard ring of the chip exposed, connected to bulk
- ▷ Work around possible but extremely “ugly”

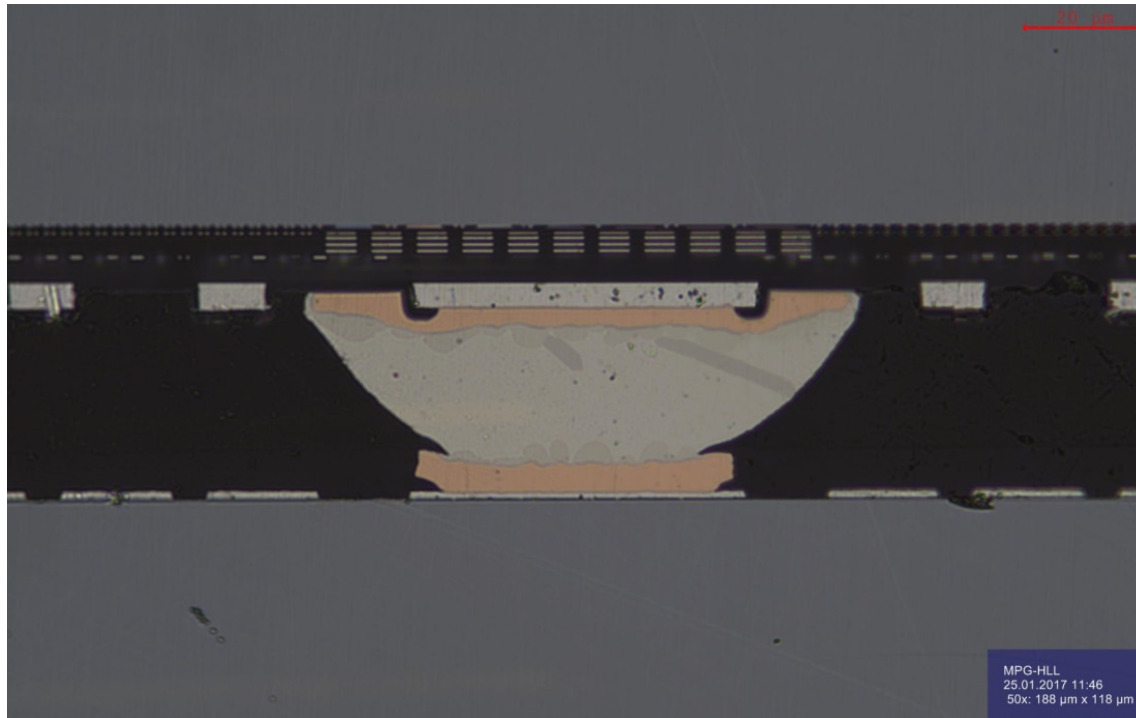
▷ Test assemblies and cross sections

▷ All okay, can't be better ...

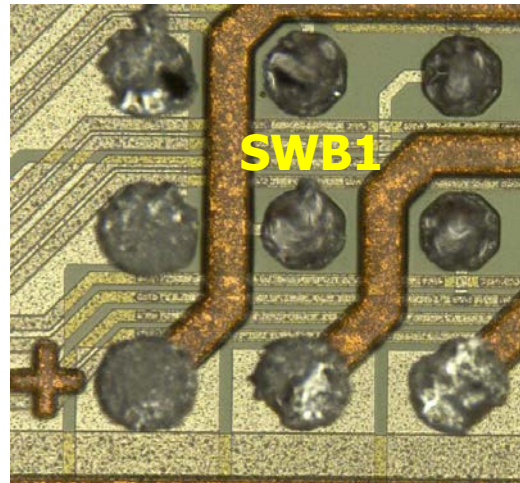
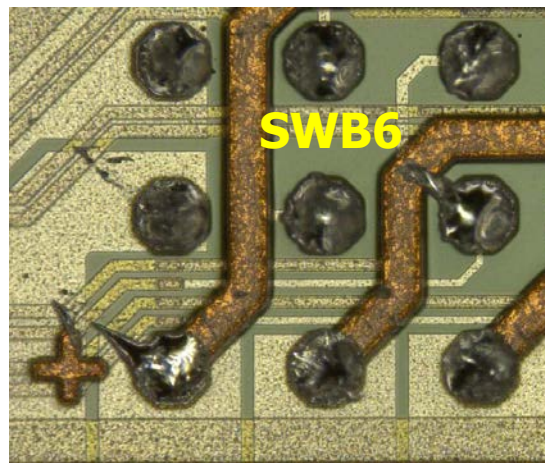
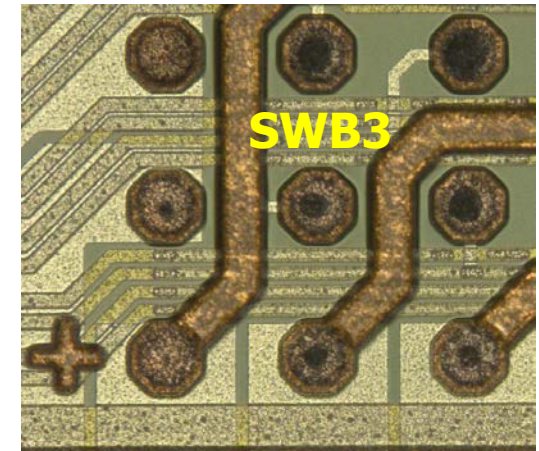
W31-OB2: SWBs removed, check solder joint

Switcher 1-6 →

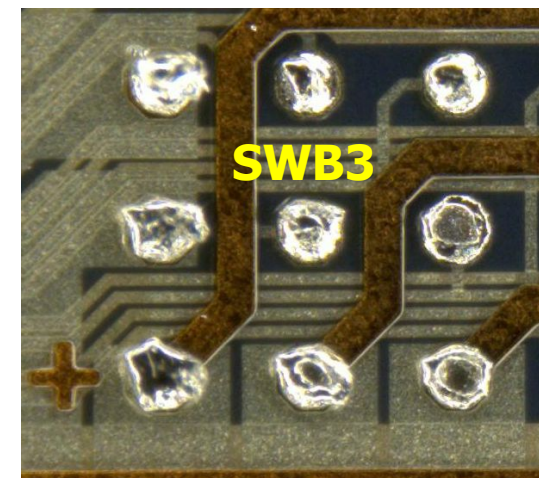
After 2nd FC & removal

- ↳ **Reflow temperature not reached** in the middle of the module due bad contact to the heat plate
 - ↳ Bowing of the module, too little contact area (perforation on balcony..)
 - ↳ In this case a second reflow with HCOOH or flux would help
 - ↳ **W31-IB was actually repaired after a second reflow!**
 - ↳ **→ increase reflow temperature (~10K)**
- ↳ **Possibly CuO residues on pads/insufficient pre-treatment before bump bonding**
 - ↳ **→ Add another cleaning step before bonding**
