# GCK Jitter

Dima Levit

Institute for Hadronic Structure and Fundamental Symmetries E18

August 9, 2017

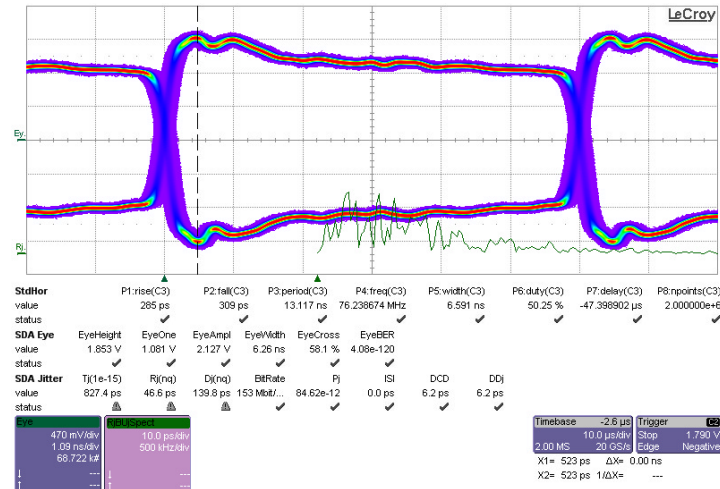
Figure: GCK after 15 m CameraLink cable with clock buffer

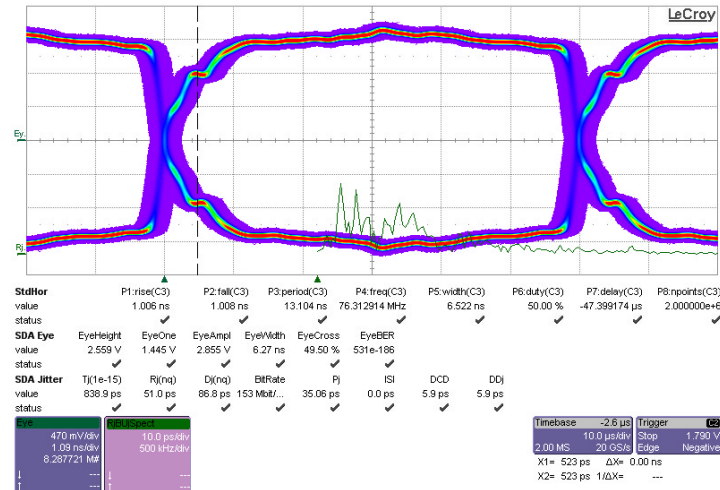
Figure: GCK after 1m infiniband cable

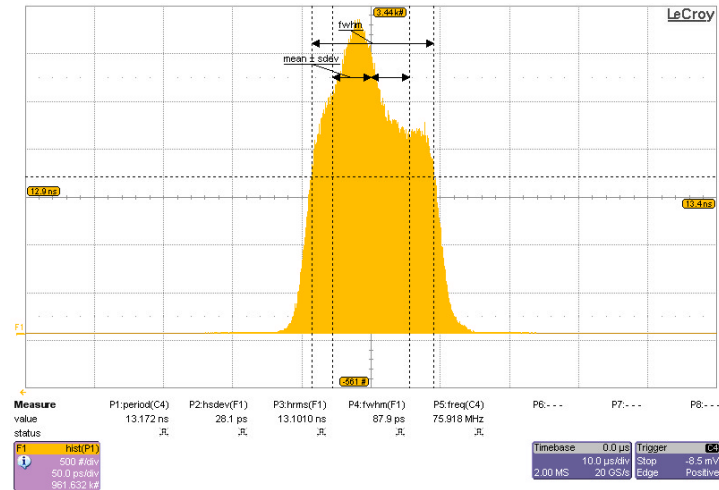
Figure: GCK after synthesis in FPGA (from 2012)

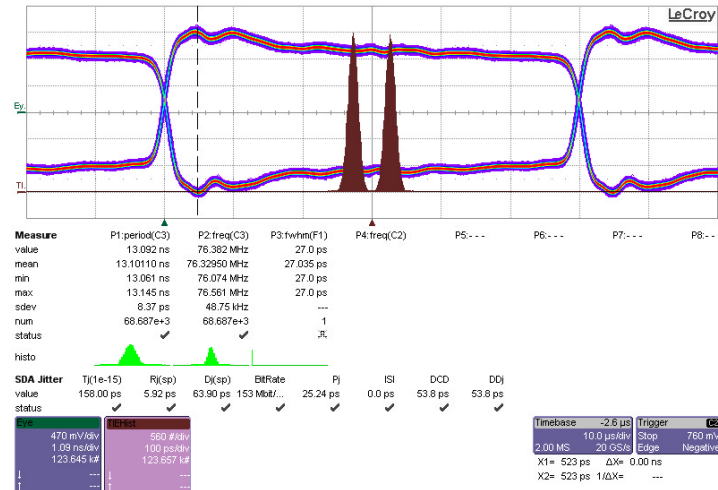
Figure: GCK after 15 m CameraLink cable with the clock buffer

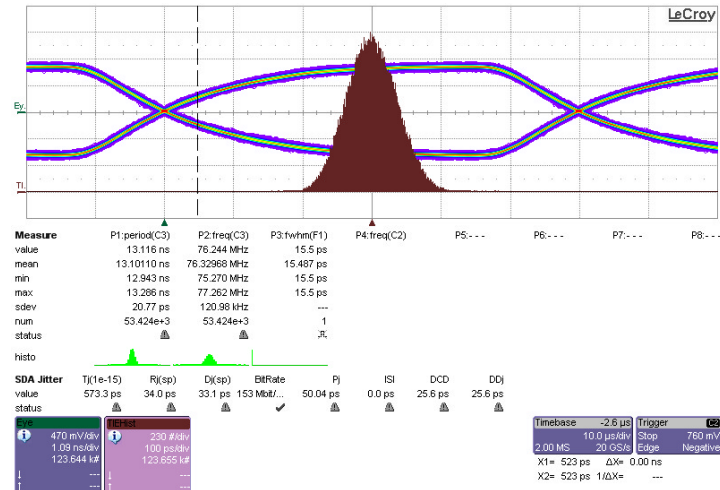
Figure: GCK after 15 m CameraLink cable without the clock buffer

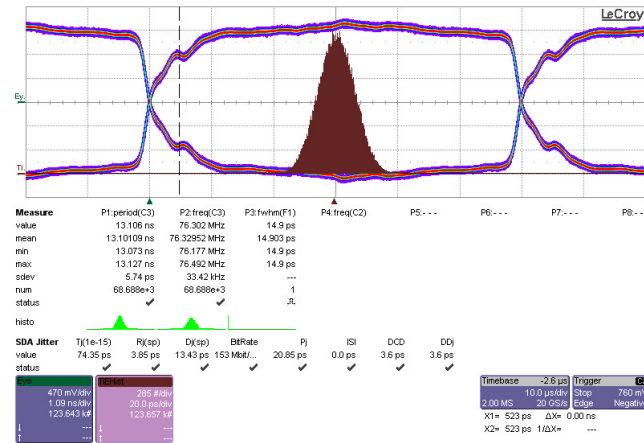
Figure: GCK after 1m infiniband cable

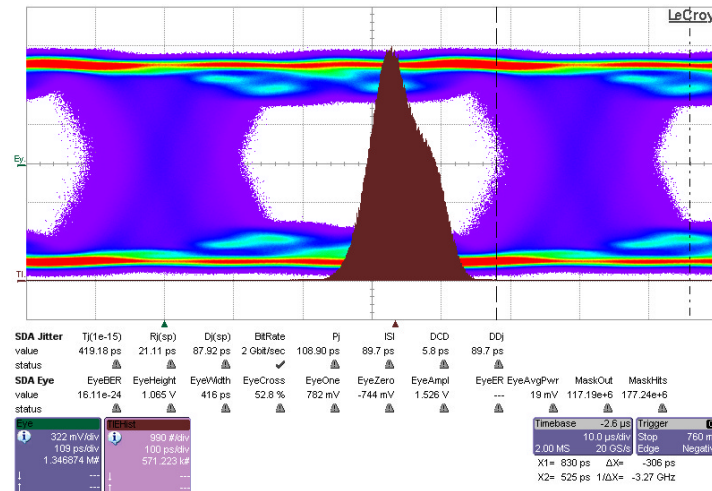
Figure: DHPT0 link with all DHPTs in phase

- GCK phase (to trigger) = 78
- **ref\_clk\_dly = 0**
- pll\_cml\_dly = 2
- idac\_cml\_txbias = 58
- idac\_cml\_txbiasd = 255

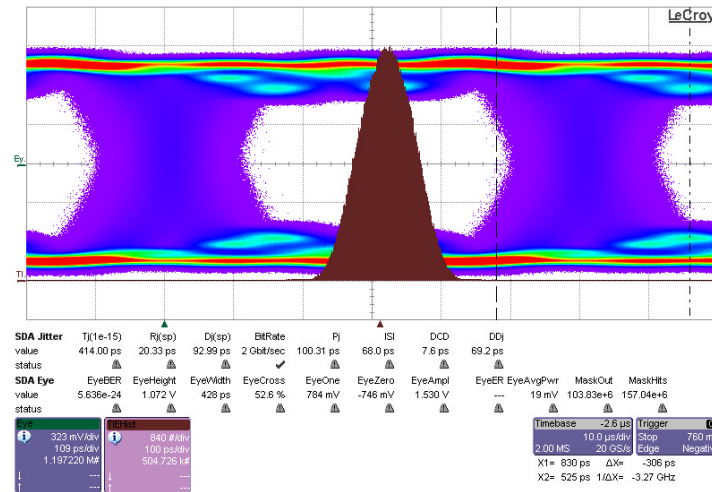
Figure: DHPT0 link with long reset

- GCK phase (to trigger) = 78
- **ref\_clk\_dly = 11**
- pll\_cml\_dly = 2
- idac\_cml\_txbias = 58
- idac\_cml\_txbiasd = 255

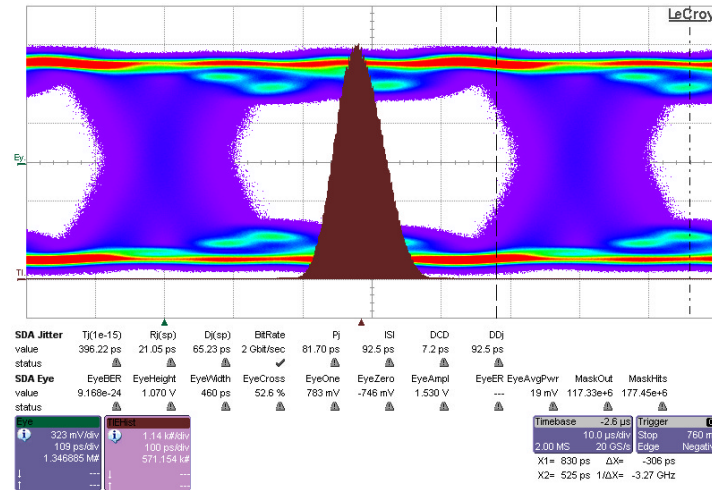
Figure: DHPT0 link without long reset

- GCK phase (to trigger) = 78
- **ref\_clk\_dly = 11**
- pll\_cml\_dly = 2
- idac\_cml\_txbias = 58
- idac\_cml\_txbiasd = 255

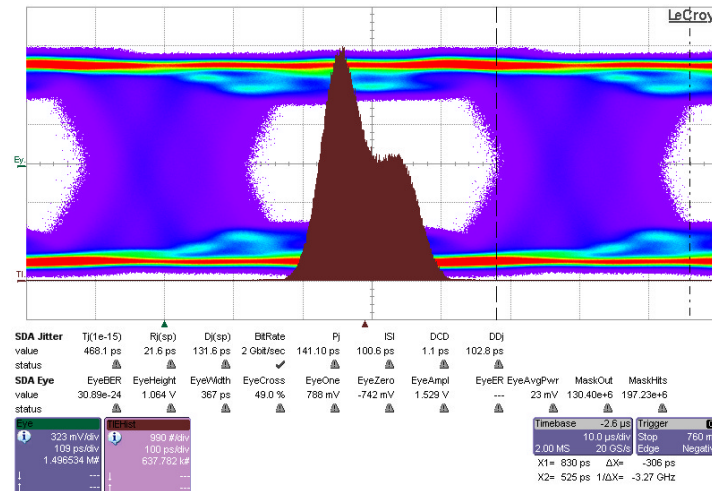
Figure: DHPT0 link without ground connection

- GCK phase (to trigger) = 78
- ref\_clk\_dly = 11
- pll\_cml\_dly = 2
- idac\_cml\_txbias = 58
- idac\_cml\_txbiasd = 255

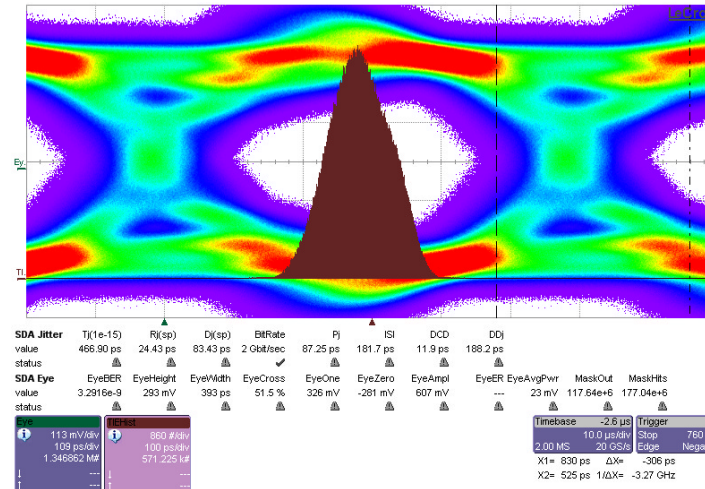
Figure: DHPT0 link after 1m Infiniband

- GCK phase (to trigger) = 78
- ref\_clk\_dly = 0
- pll\_cml\_dly = 2
- idac\_cml\_txbias = 100
- idac\_cml\_txbiasd = 255
