PXD test beam performance

Benjamin Schwenker

II. Physikalisches Institut, Universität Göttingen

BPAC focused review on VXD

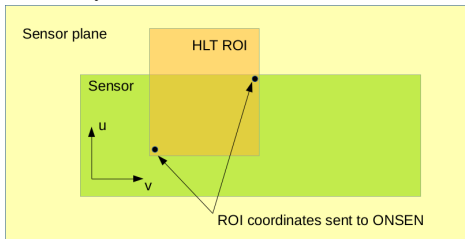
- In u-direction most ROIs lie partially outside the sensor, making the effective ROI smaller.
- For PXD efficiency study no ROIs with intercept outside the sensor area are accepted, limiting how small ROIs can be.
