ONSEN SC, RC, IPMI – Status and Issues

Björn Spruck, Uni Mainz

Ringberg 9.4.2018

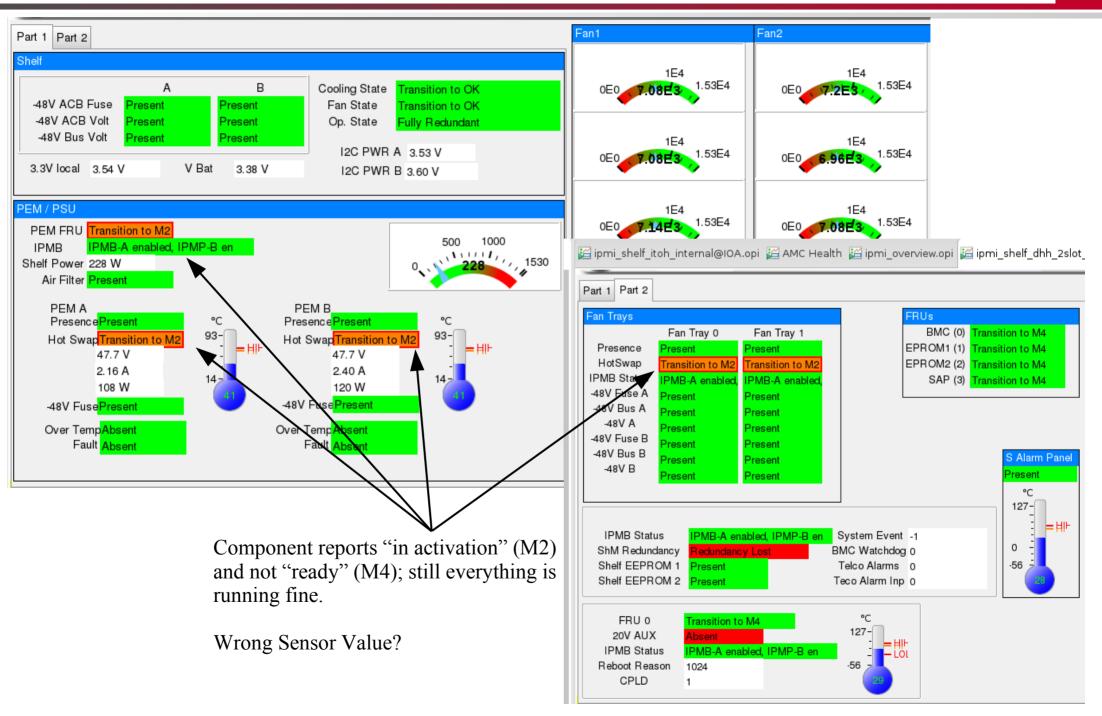
(IPMI) Hardware Issues - DHH Shelf (2Slot)

Sensor reading ("Mask") tells M2, but Shelf Manager reports M4 state. (ShM keeps Track of Messages; but IPMI ioc uses sensor reading)

Clearly a firmware problem (or a questionable implementation) on the FRU ...

But on several at the same time???

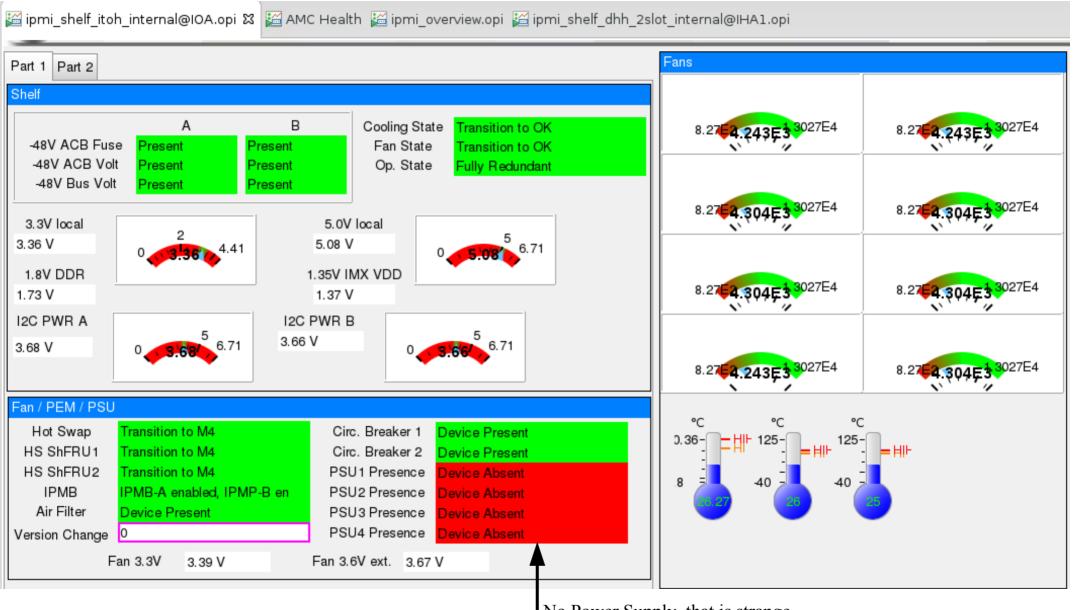
(IPMI) Hardware Issues - ONSEN Shelf

No Power Supply, that is strange.

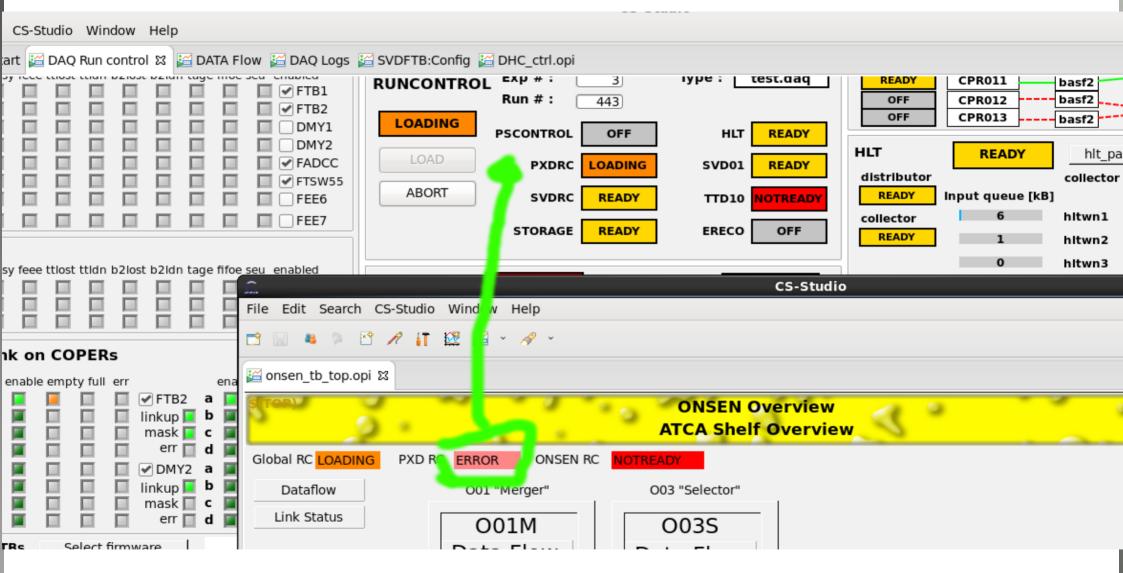
Old picture, but "problem" can be reproduced in current setup. Remark: Its only a (cosmetic) GUI issue.

- Old: ONSEN Firmware required "abort → not ready → loading" sequence before each run.
 - This has been fixed. Cycle "ready→ start → running → stop → ready" is now working as expected by run control.
