More lessons learned from test campaigns

- I. Software/Hardware improvements
- II. Mechanical improvements
- III. Radiation measurements issues November 2021
- IV. May radiation campaign remotely from Munich

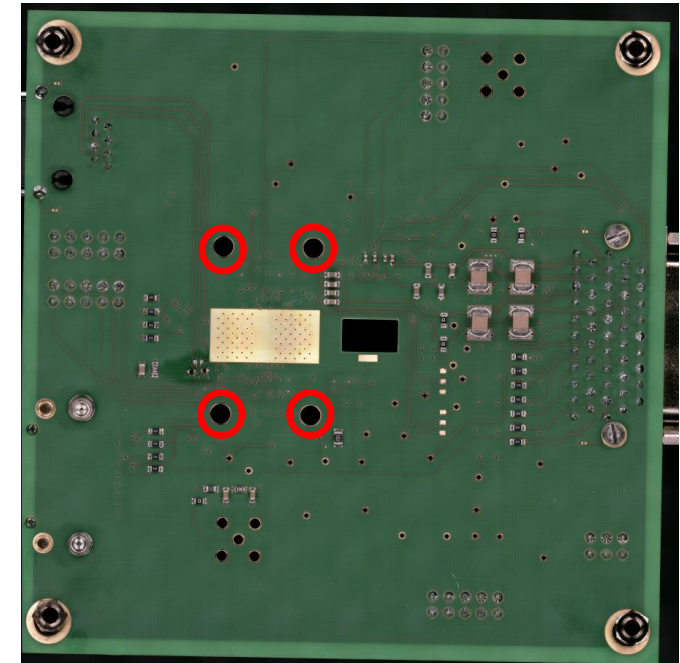
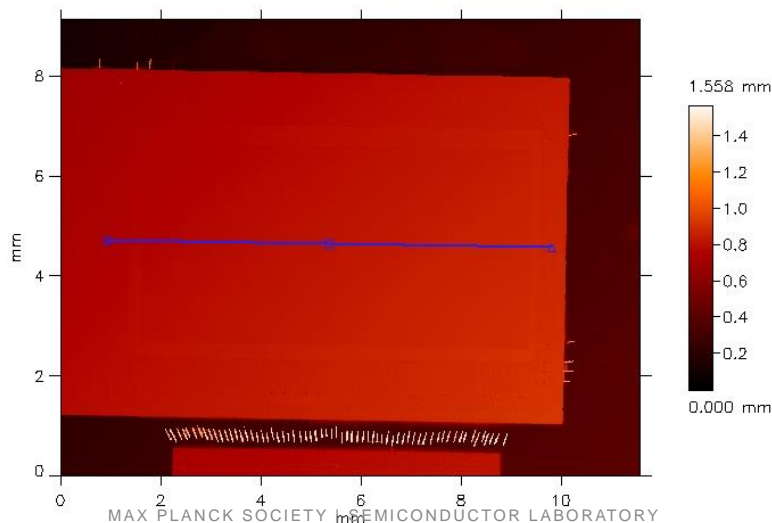
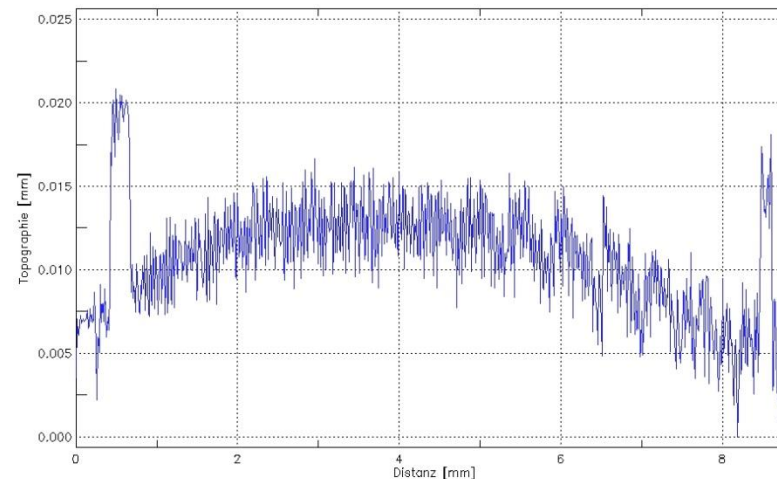
topography of thin matrix before assembly

Headache: Hybrid PCB is thin so it will bend with too tighten screws. This resulted in one broken matrix during the November 2020 campaign.

-> Middle 2021 we made some topography measurements before and after assembly the cooling block adapter with different torques and defined in this way the lowest but necessary torque.

Result: No broken matrix in the 2021 June campaign.

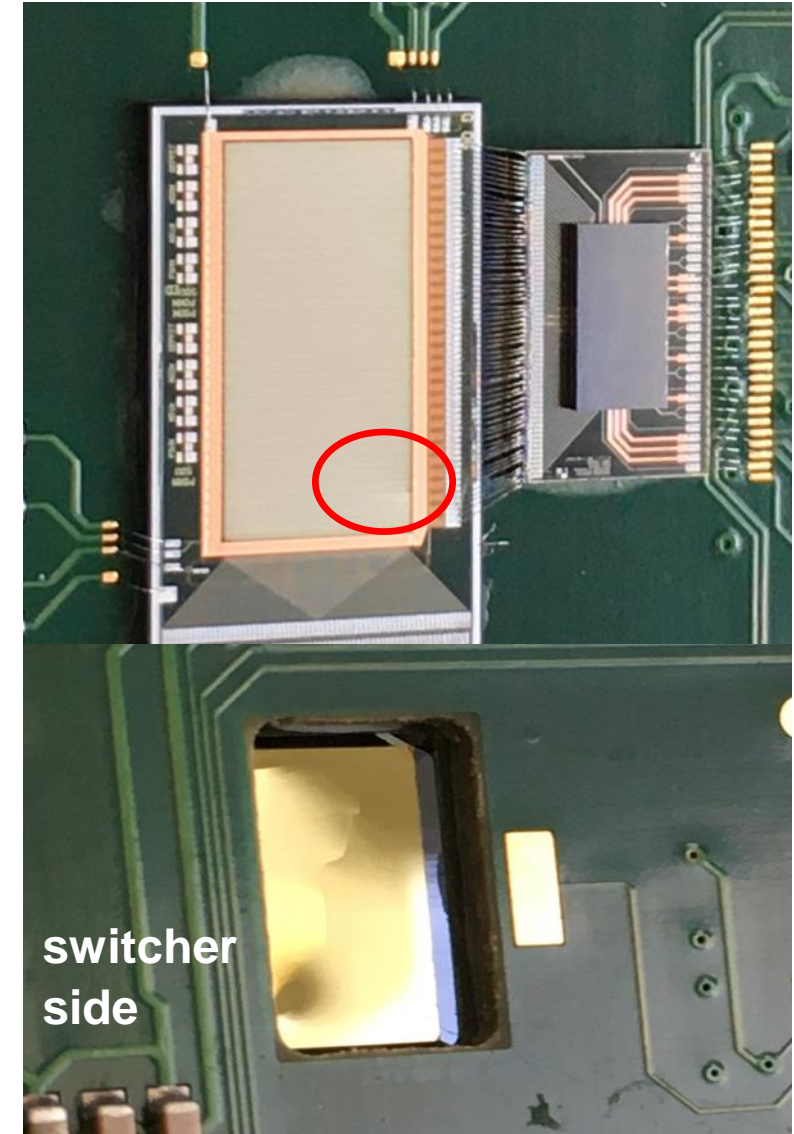
BUT... in the November 2021 campaign again one matrix broke!

This matrix had a second switcher glued on top of the first one perhaps this changed the bending degrees of freedom of the hybrid board in this area?

We decided to use a 100um Indium foil as a spacer. This worked good for the second hybrid board and also the third didn't broke but... the third had a ground short of one ASIC voltage resulting in damaging the switcher.

Solution:

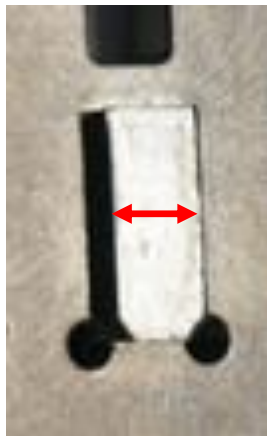
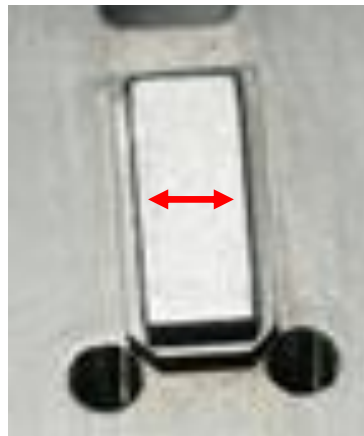
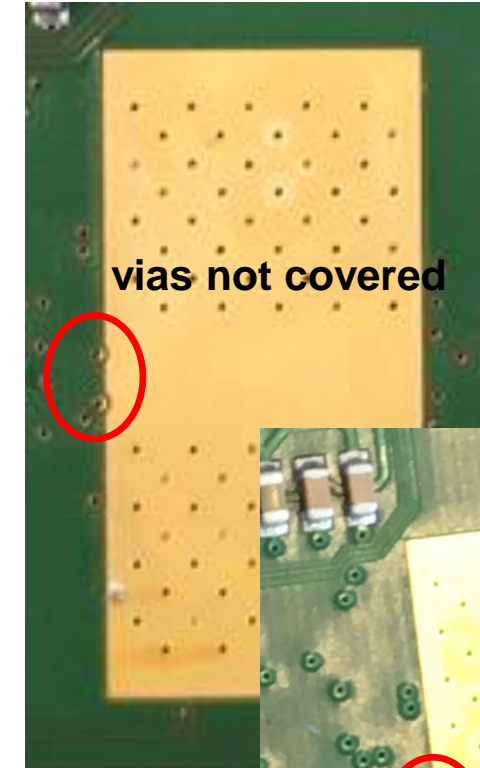
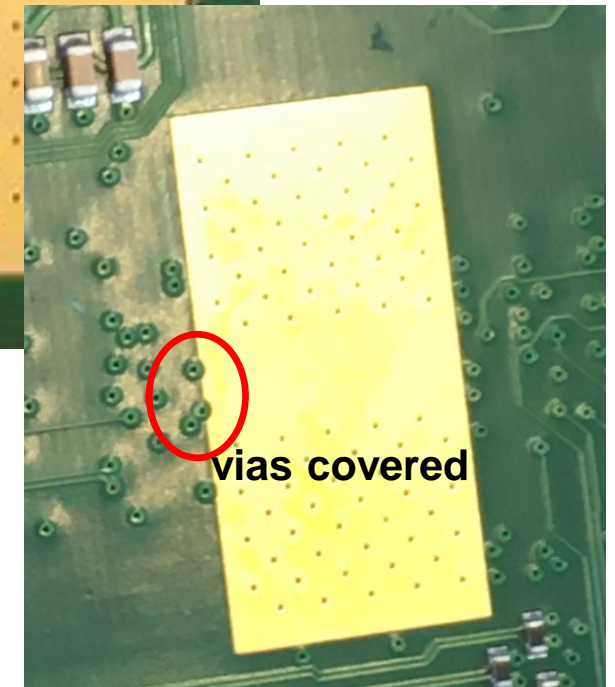
The reason was that some vias are located under the thermal contact surface and not in all hybrid boards the solder resist was perfect covering these vias.

We reduced the size of the cooling block contact area to spare the vias.

With this approach two more hybrid boards could be mounted with the cooling block without any break.

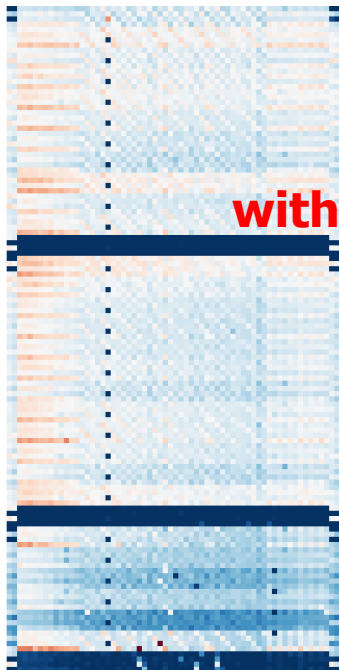
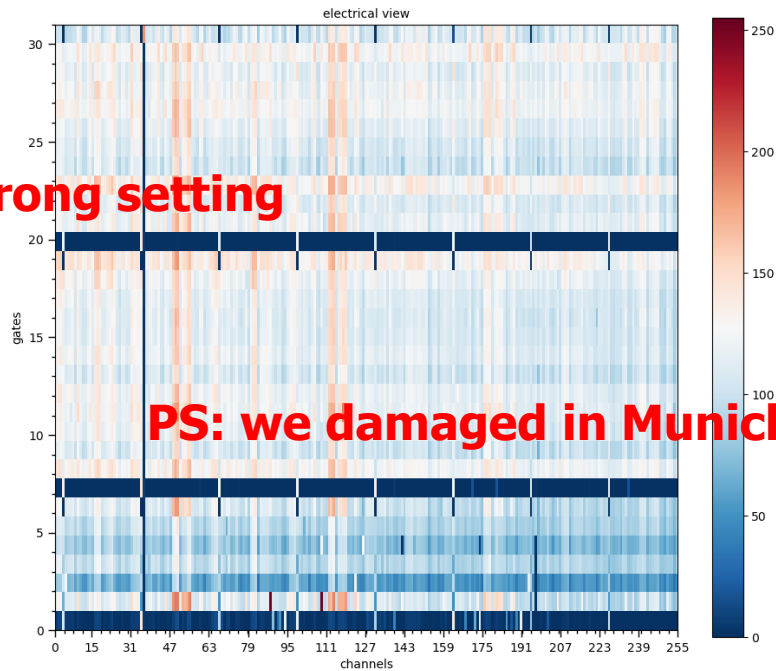
with wrong setting

The two settings to change the SYNC_RESET delay in the DHPT are „ROW2_SYNC_DCD_CLK_DLY“ (7bit) and „DCD_ROW_SYNC_DLY“ (4bit) and these results in the same wrong mapping (left image).

PS: we damaged in Munich three switcher channels...

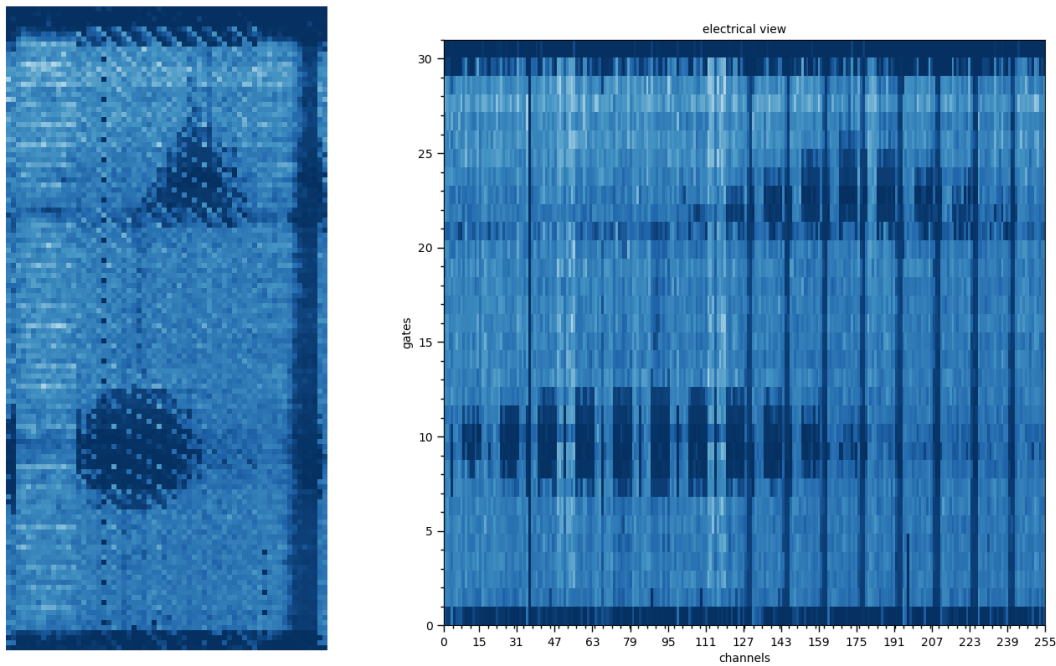
Offset corrected image with wrong mapping

The shift can be adjusted and with this correction the mask after $\sim 10\text{MRad}$ on this 450um matrix looks still nice:

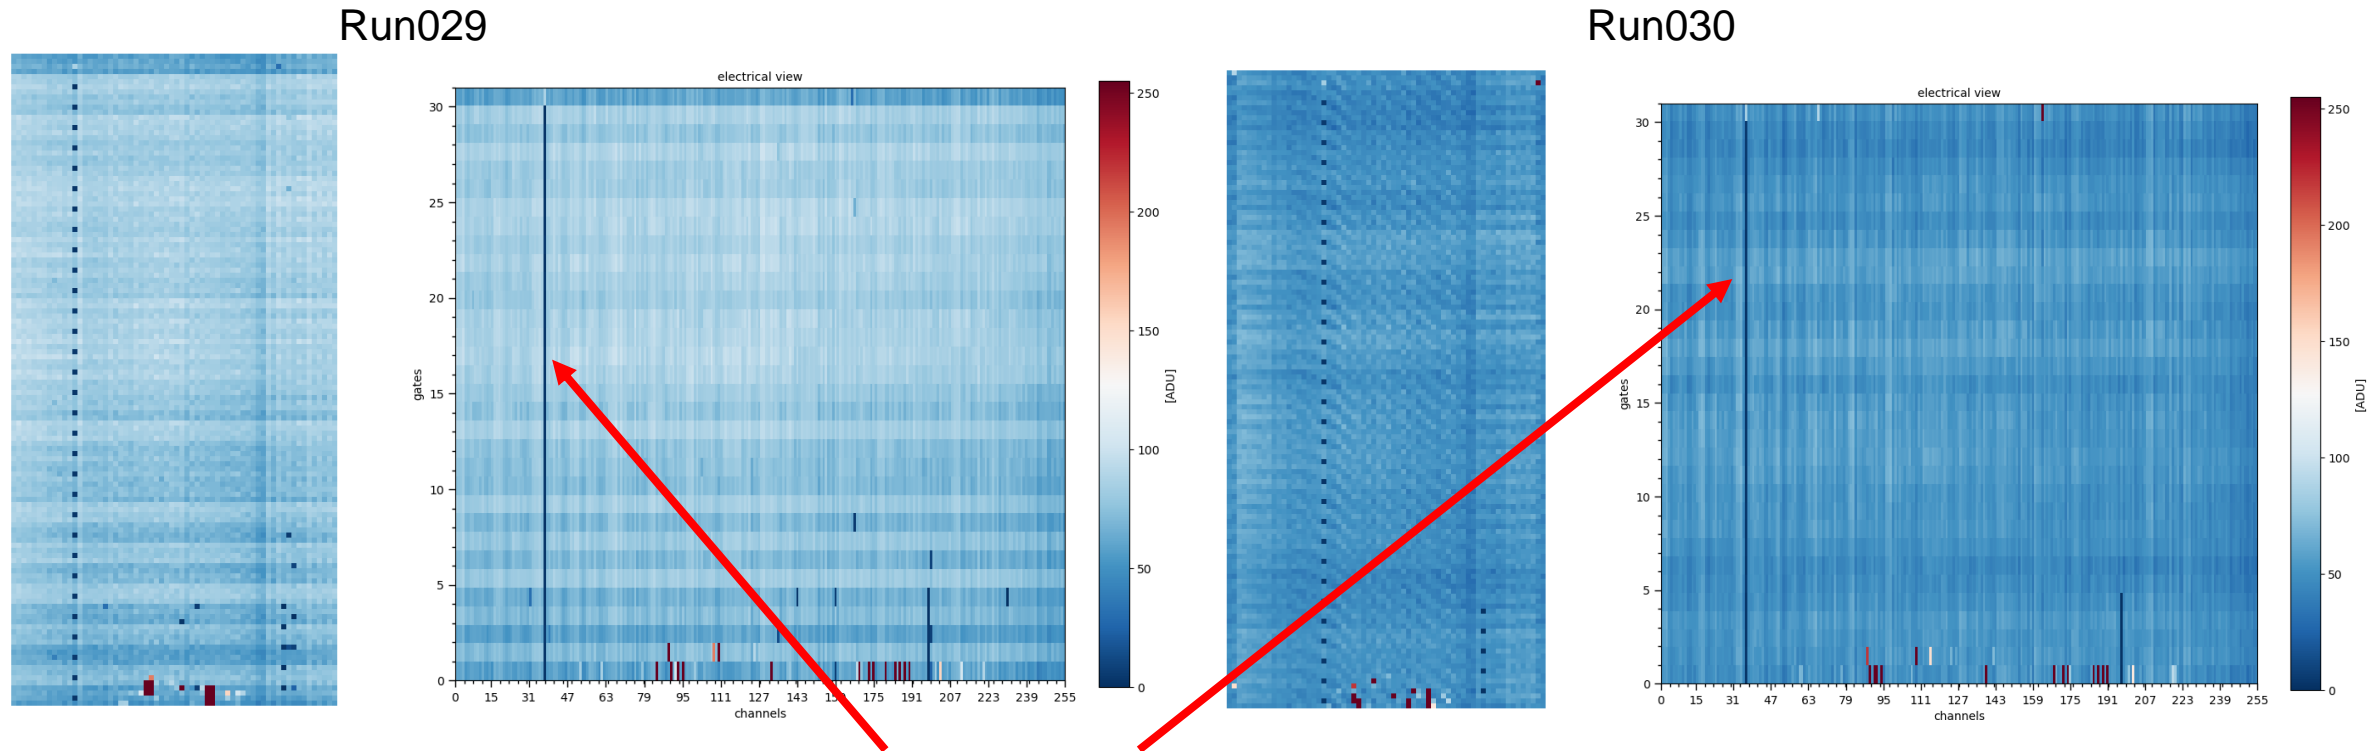
This change happened between run029 to run030 of 128 radiation measurements over 2.5 days. Because of we didn't used any mask or were aware this could happen we just continued with the radiation measurements.

The physical broken drain line shifted one DCD drainline.

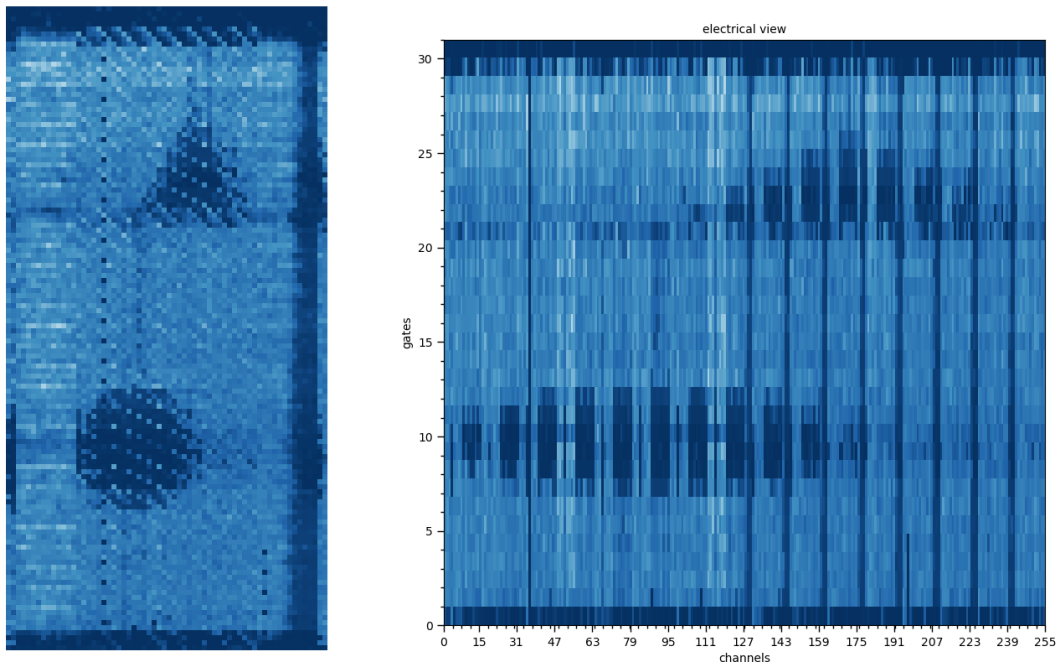
Offset corrected image with wrong mapping

The shift can be adjusted and with this correction the mask after $\sim 10\text{MRad}$ on this 450um matrix looks still nice:

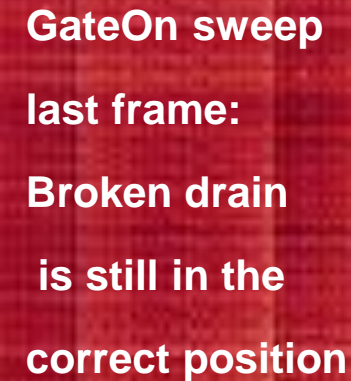
GateOn sweep
last frame:
Broken drain
is still in the
correct position

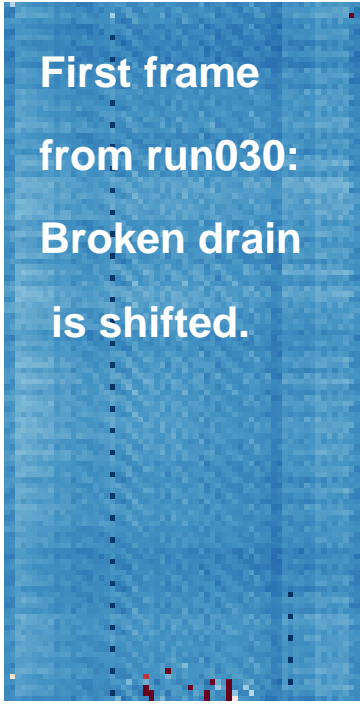
A closer look in the settings and in the corresponding bit values shows that for DCD_ROW_SYNC_DLY only one bit flip would lead to this change.

An assumption would be that somehow this bit flip happended and because of we didn't reconfigured the DHPT during these measurements this setting stayed till the end. Sadly this wrong setting not only leads to this drain line shift but also gives us a little higher offset in the pixels due the wrong sampling time.

The first frame of run030 already showed the shift.

First frame
from run030:
Broken drain
is shifted.

→ For the next campaigns we will more often reconfigure the ASICs
