PXD2 installation at KEK

Fabian Becherer

Deutsches Elektronen Synchrotron, DESY
Belle II Experiment, KEK

May 22, 2023

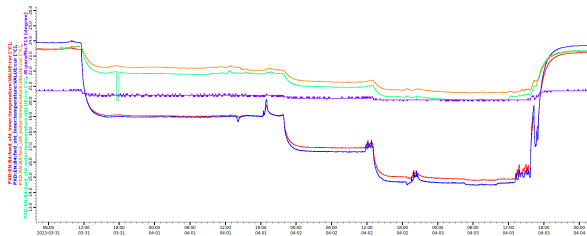
- No (tiny) bending observed during cool-down and warm-up of IBBelle ($< 20\mu\text{m}$)
- Small shift of ladders observed during cool-down/warm-up and when powering for longer time multiple modules ($< 110\mu\text{m}$)
- Shift is against initial bending direction for L1(2)-d ladders
 \rightarrow Strong hints that camera systems moves
- In general small bending during powering
 \rightarrow Most "extreme" case shown in the tables

Status	(μm)		
	L1-a	L2-a	tube
Off	0	0	0
PEAK	33	43	0
Long PEAK	88	109	60
Status	(μm)		
	L1-d	L2-f	tube
Off	0	0	0
PEAK	-1	-26	0
Long PEAK	43	17	45

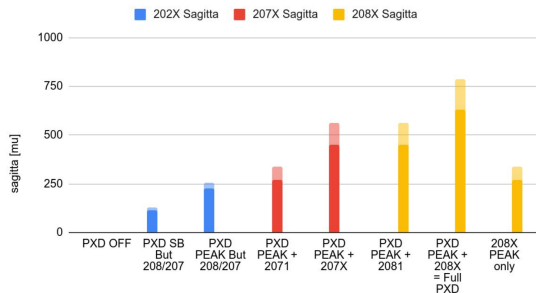
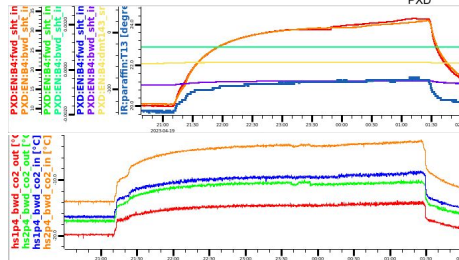
PXD2: Significantly Bent Ladders

- Some problems with service (power supplies)
- Strong bending for 208x and 207x
- Visible bending for 202x
- No significant bending for other ladders
- Temperature of BP rather stable
- Air temperatures strongly increasing

- All temperature stable and reasonable
- 208x and 207x still bending
- Visible bending for 202x
- Torque reduction seem to help slightly

- Both HS successfully installed
- PXD2 is isolated from BP
- During first cooling runs temperature higher than expected
 - ▶ Modification of N2 flow and CO2 temp. stabilized temp.
- Bending for 2-3 ladder (207x, 208x and 202x) larger than wished
 - ▶ Bending up to 700 μm
 - ▶ Ladder at bending studies survived more than 90k cycles with more than 1mm bending
 - ▶ Even if ladder kinks no "breaking" expected
 - ▶ In worst case: Turn off 2-3 L2 ladders
- PXD1 was extracted and SVD removed

Modification of N2 flow

- Two different input tubes per SCB (8x3 l/min)
- Increase of N2 flow reduces temperature
- N2 flow at SCB can be increased without bigger risk
- Carbon tube flow more critical

→ **Increase to 34 l/min (16 + 18 l/min)**

C02 temperature

- Default temperature until now -20 °C
- IBBelle designed for -30 °C

→ **Decrease temperature to -25°C**

Screw torque

- FWD screw torque was reduced from 15 to 10 mNm
- Torque can be further reduced to 7.5 mNm without risk

→ **Reduce torque for 202x, 207x, 208x to 7.5 mNm**

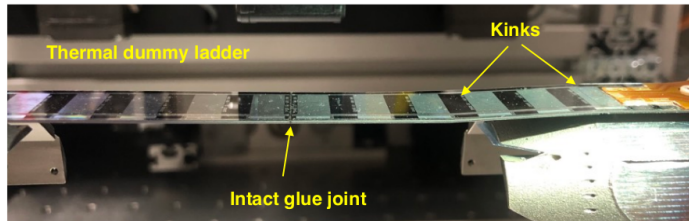
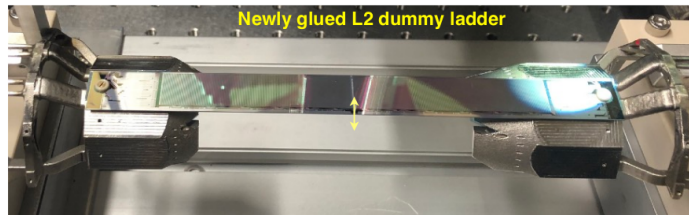
L2 glue joint endurance test

After more than two months with more than 90k cycles with sagitta >1 mm → Ladder still intact
