● The SOI issue

Raw wafer supply → pre-processing → **SOI** → DEPFET process → thinning, dicing, mounting..

- SOI for Belle II PXD

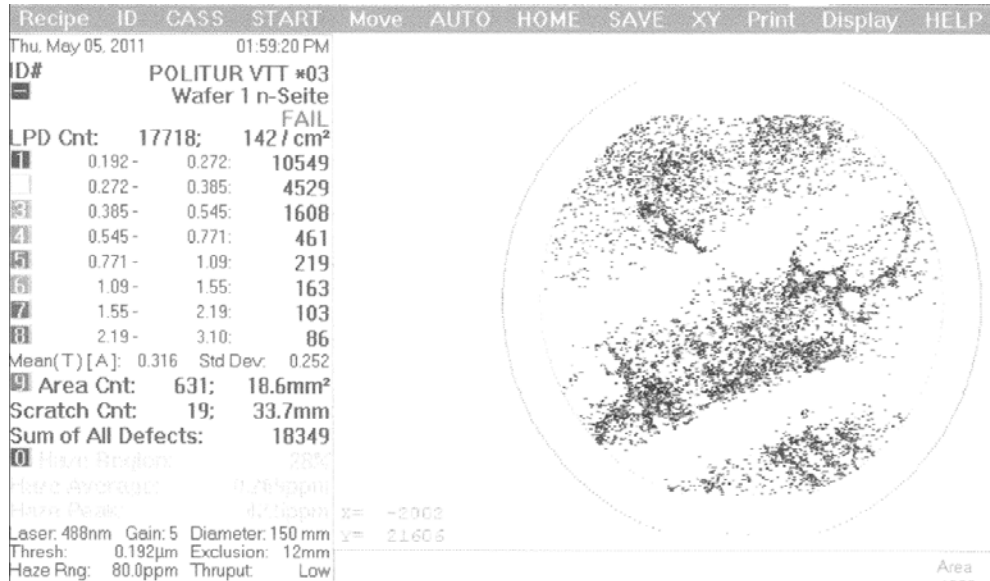
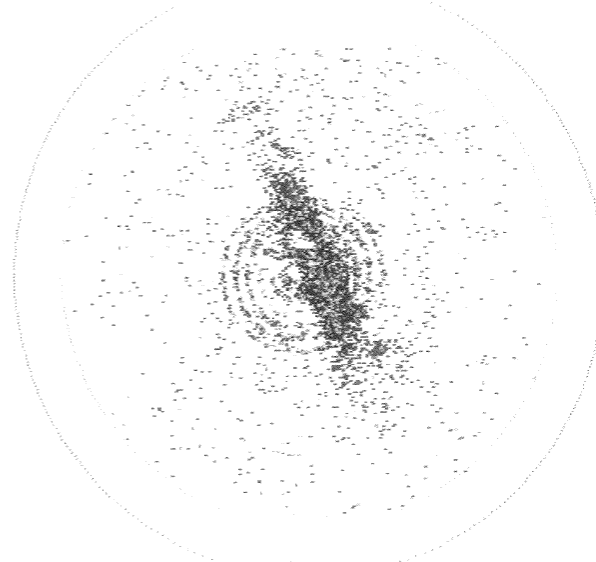
- : 2 DSP wafers were sent to VTT for polishing and cleaning on their line
- : VTT polished one side and sent the wafers back → check quality (particles, defects) at HLL

Defects: 6906

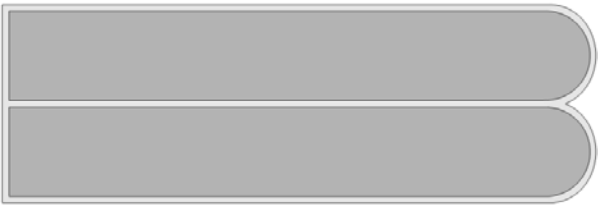
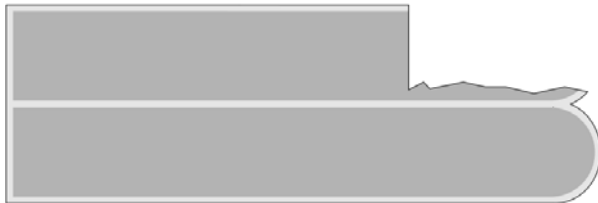
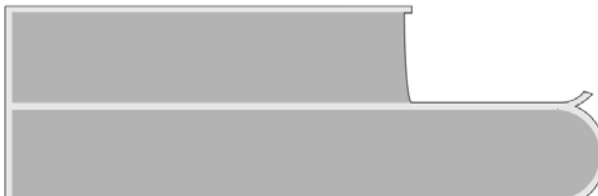
Nice edges, but some yield issues with the edge of the of the handle wafer (chipping due the grinding step). Needs still some improvement ..
