# EMCM testing summary

# Electrical Multi-Chip Module

# Test ZMI 5

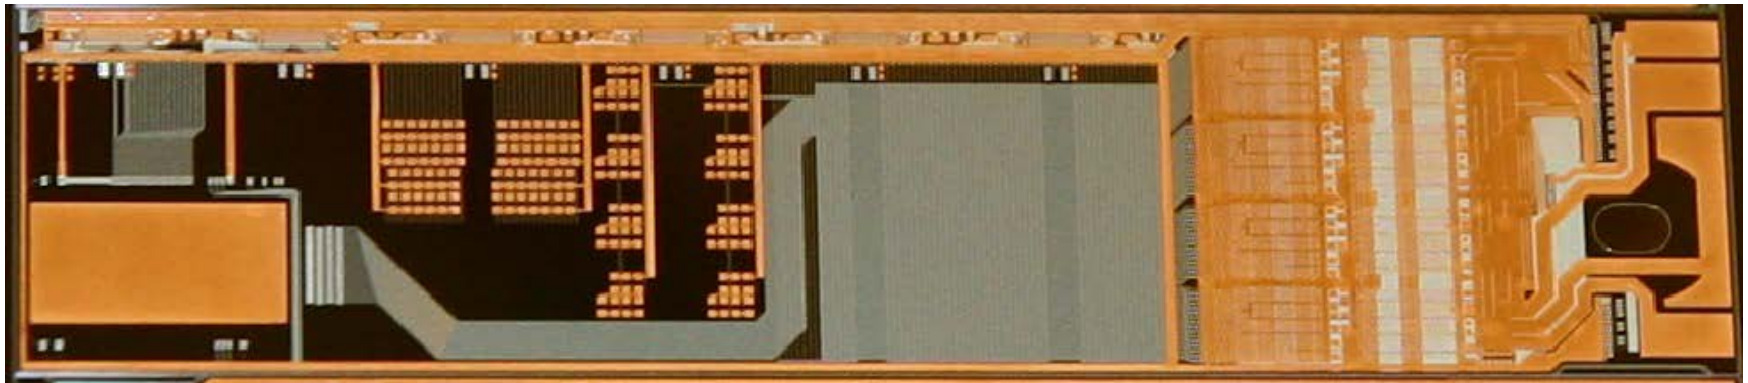
- 3 metal layers on silicon substrate
- 4055 test pads (size down to  $70\mu\text{m} \times 70\mu\text{m}$  and  $50\mu\text{m} \times 100\mu\text{m}$ )
- 2149 different electrical nets
- Open and short test necessary

- Adjacency test contains  $>100\text{k}$  test per EMCM
- With up to  $2\text{k}$  test for individual pads

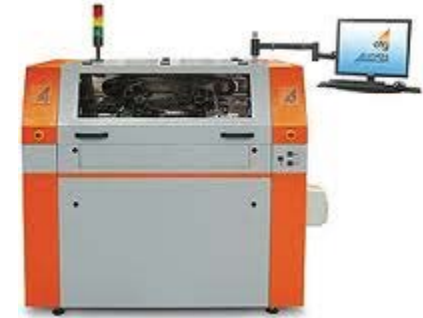
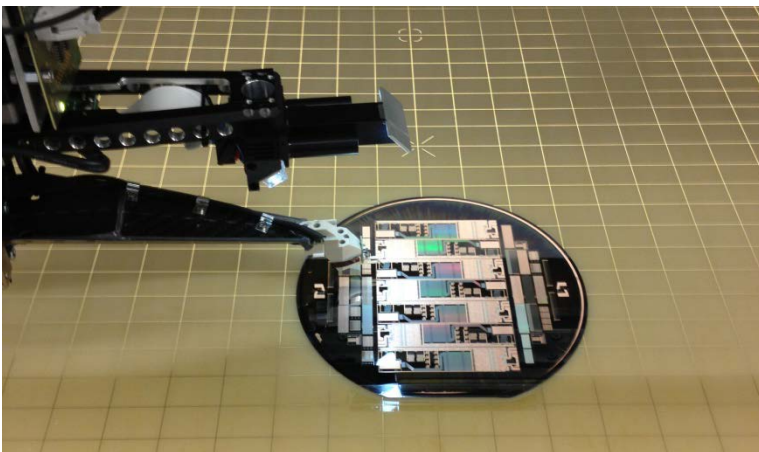
- A7 machine
- 4 flying needles
- Placed in not temperature controlled room and not in the clean room conditions.
- This brought some initial problems with alignment and some “not real” shorts due to the dirt falling on the wafers

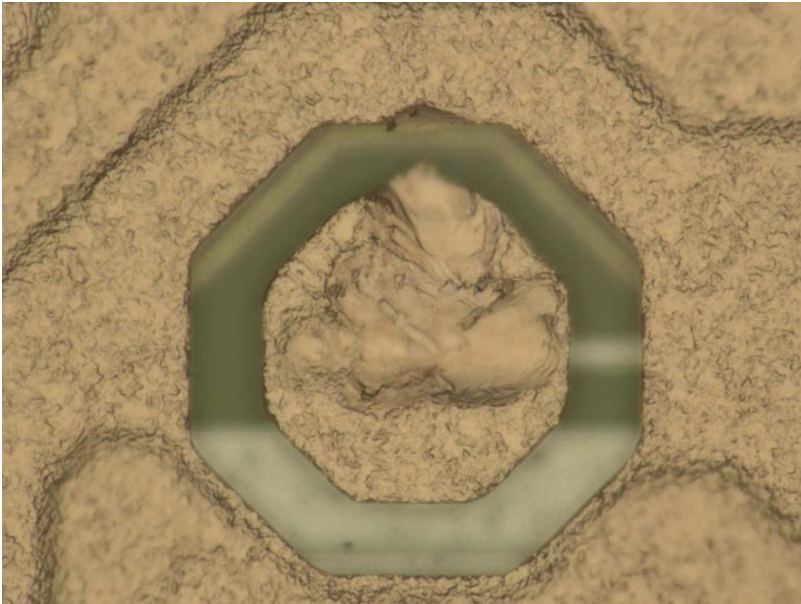
- Problems with alignment accuracy in time (week19)

A7 machine has non optimal accuracy  
Drifts due to the temperature changes

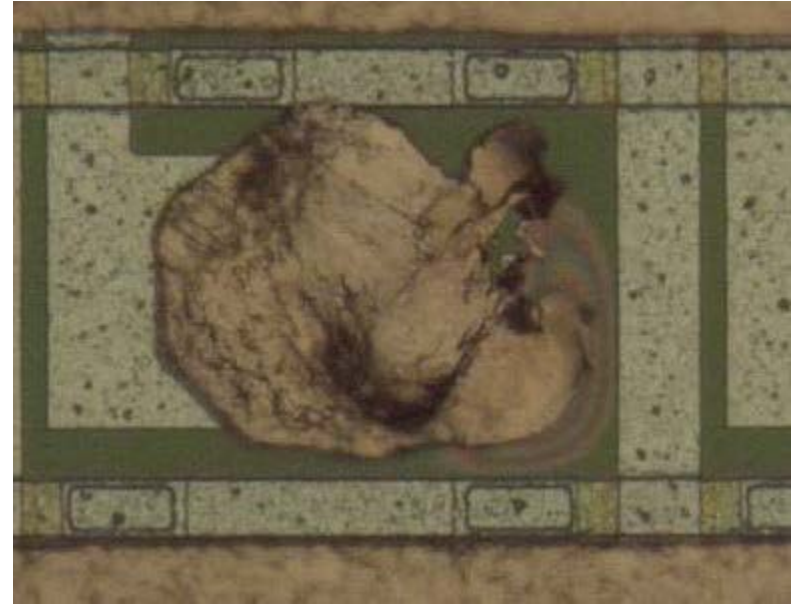
Non optimal stopping speed of the  
probe heads

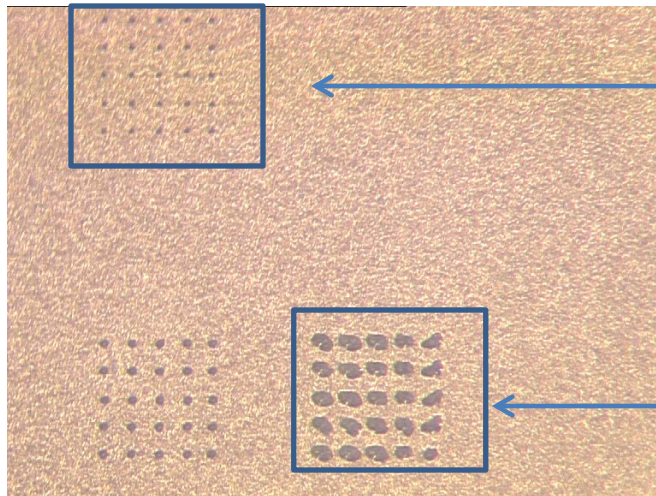
100 x touch down with optimized settings  
(week 20)  
(stroke, pressure and accuracy set to 5)

100 x touch down with non-optimized settings  
from the first week (week19)

- Optimized speed of the probe heads (week20)
- Calibration of the A7 before each run
- Best results in terms of accuracy of the needle position during the night run (wafer P4)

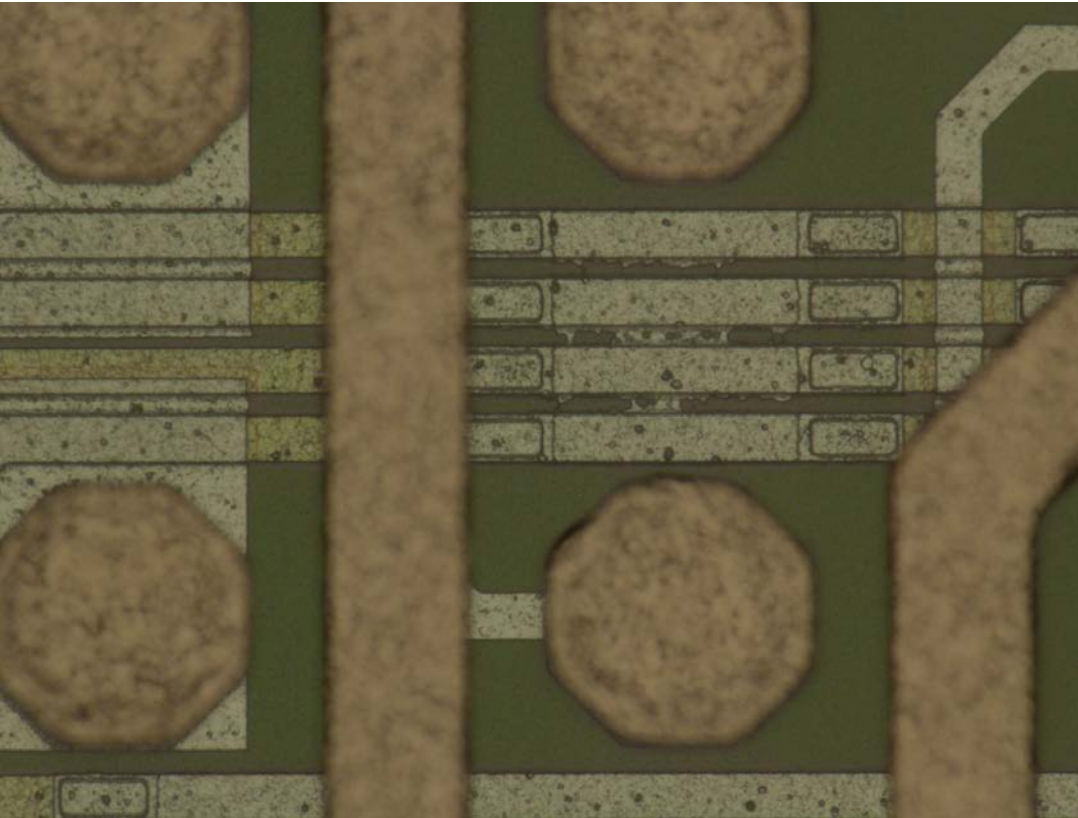
Stack of Al1 +Al2 used to decrease resistance of the control lines of switchers had problems in production  
Differs from wafer to wafer

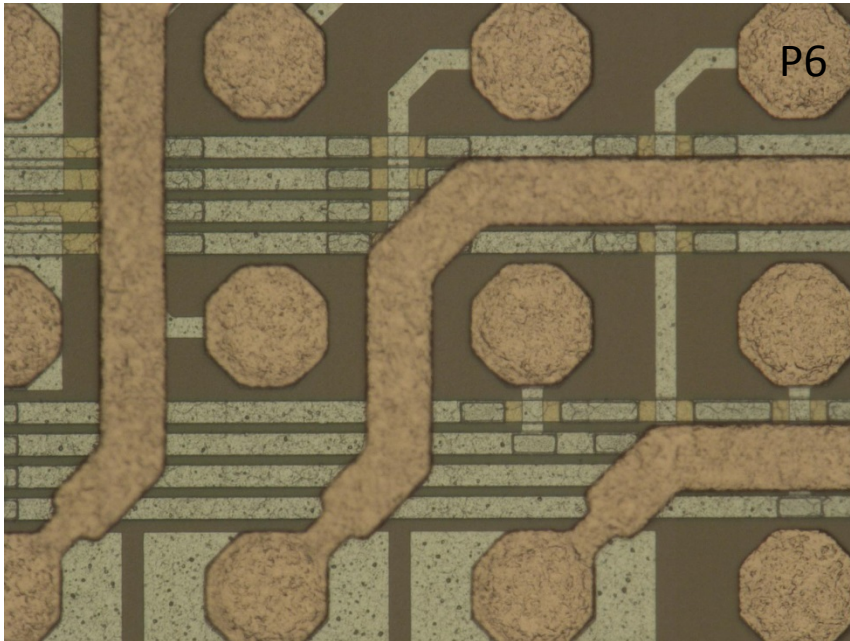
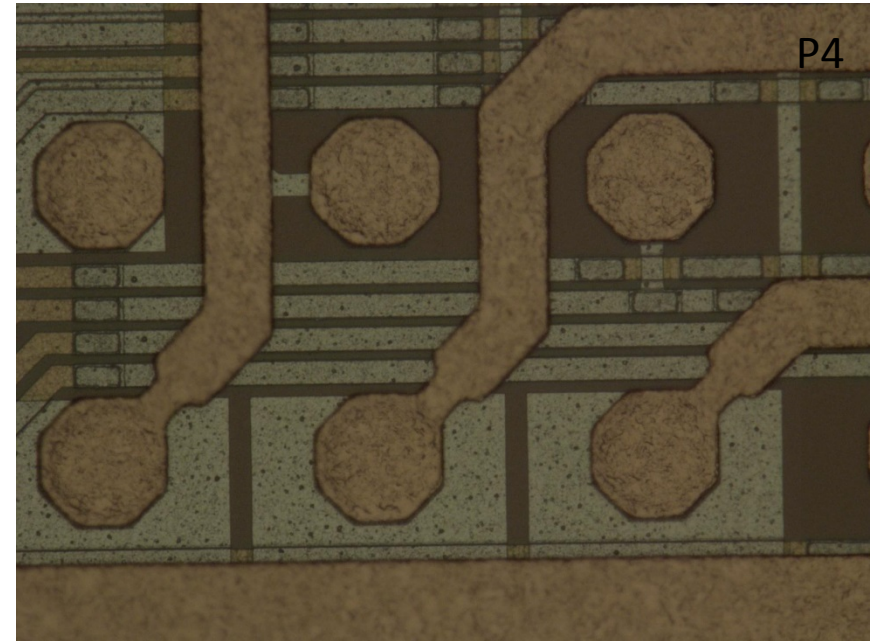
- Optical inspection done on all wafers - this problem could not be identified of wafers P4 and P6 - still significant area under Cu

DUT 1: 1 low ohmic short (??)

DUT 2: no low ohmic shorts

DUT 1 open: 2 x DCD to DHP interconnection in 2<sup>nd</sup> and 4<sup>th</sup>  
pair

DUT 2 open: 1 connection to test switcher pad (2<sup>nd</sup> SW)  
1 drain pad to DCD input

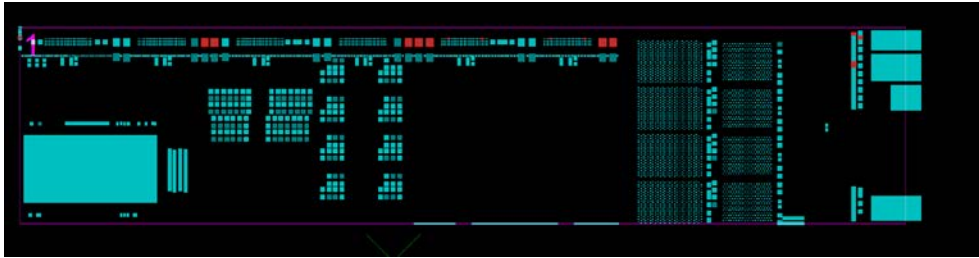
Nets 1721,1749

**DUT1 – short GATE ON –GATE OFF**

Particle or below Cu?

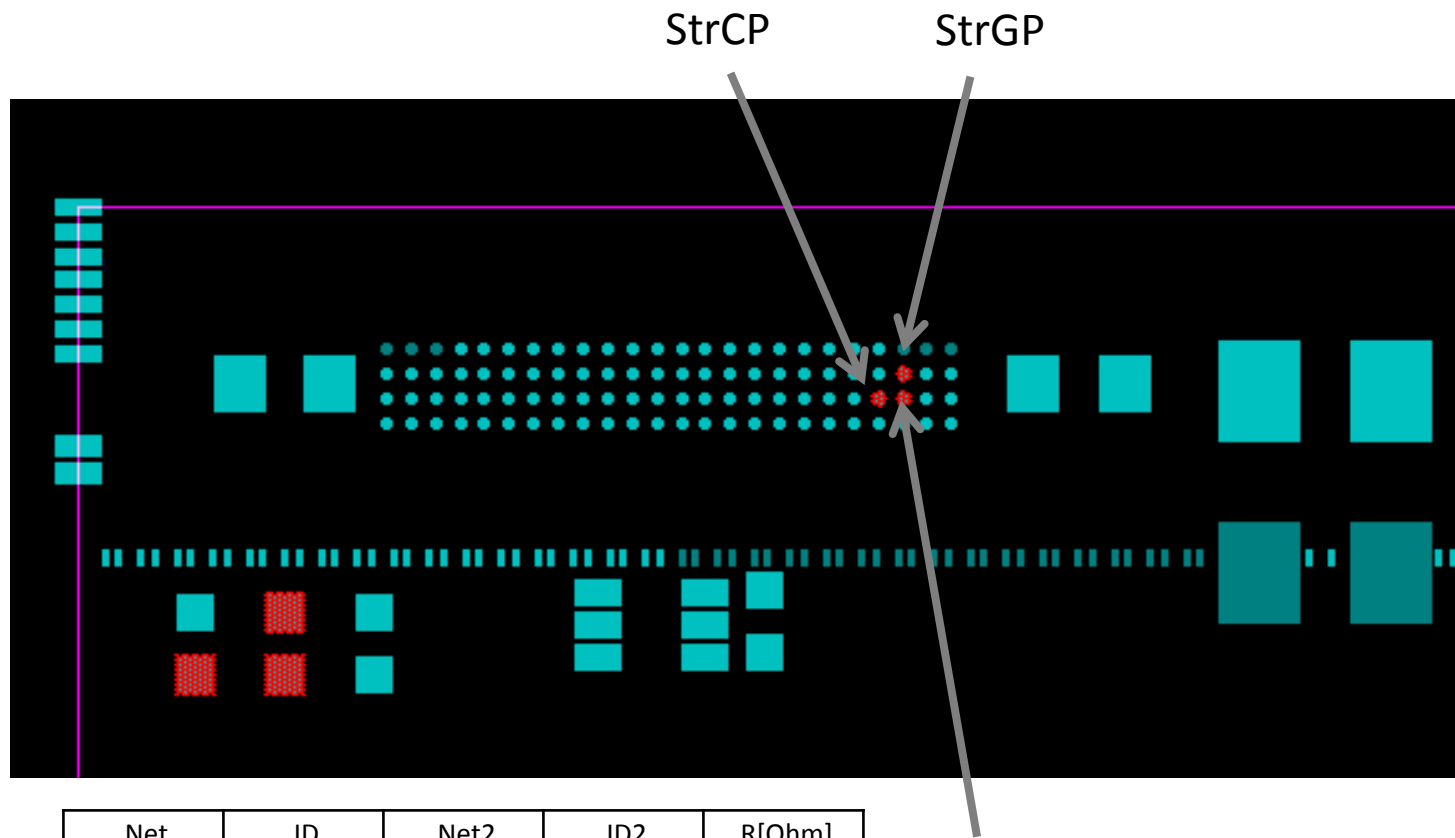
## DUT2 – low ohmic shorts

Net	ID	Net2	ID2	R[Ohm]
1731	3786	1780	3928	31.07
1731	3786	1780	3928	36.18
1732	3793	1780	3928	75.53
1732	3793	1731	3786	80.36
1731	3786	1732	3793	81.49

And in addition several hundred Mohm shorts

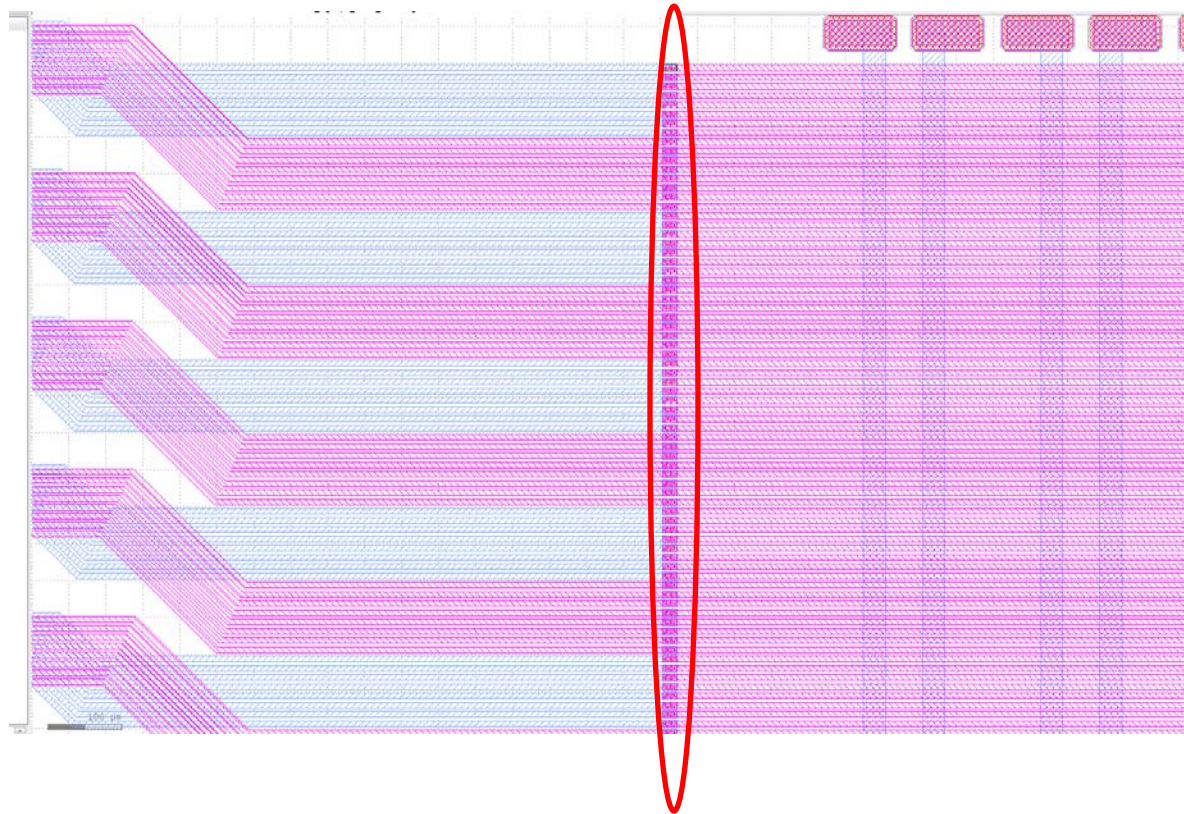
- Present on all tested wafers
- Test ZMI5 project had additional Polysilicon layer and Contact 1 mask to increase topology
- Reason for high ohmic shorts understood.
- During the conversion process to produce mask for photolithography some of the contact 2 openings were transferred into contact1 mask – not really understood how this happened
- Result – all drain lines are connected once to the bulk

Due to the fact that high ohmic material was used one can use those EMCM (in dark dynamic resistance of about  $20\text{G}\Omega$  measured )

- As soon as we got the results we have initiated new fast production run
- Wafers with 7 EMCs/wafers are being processed
- All problems realized up to know fixed
- Structuring of the first Al layers is being done at the moment
- Time estimate 6 more weeks till new EMCs are processed
- ATG is preparing better S machine for the next round of testing - will be ready within the next 3-4 weeks

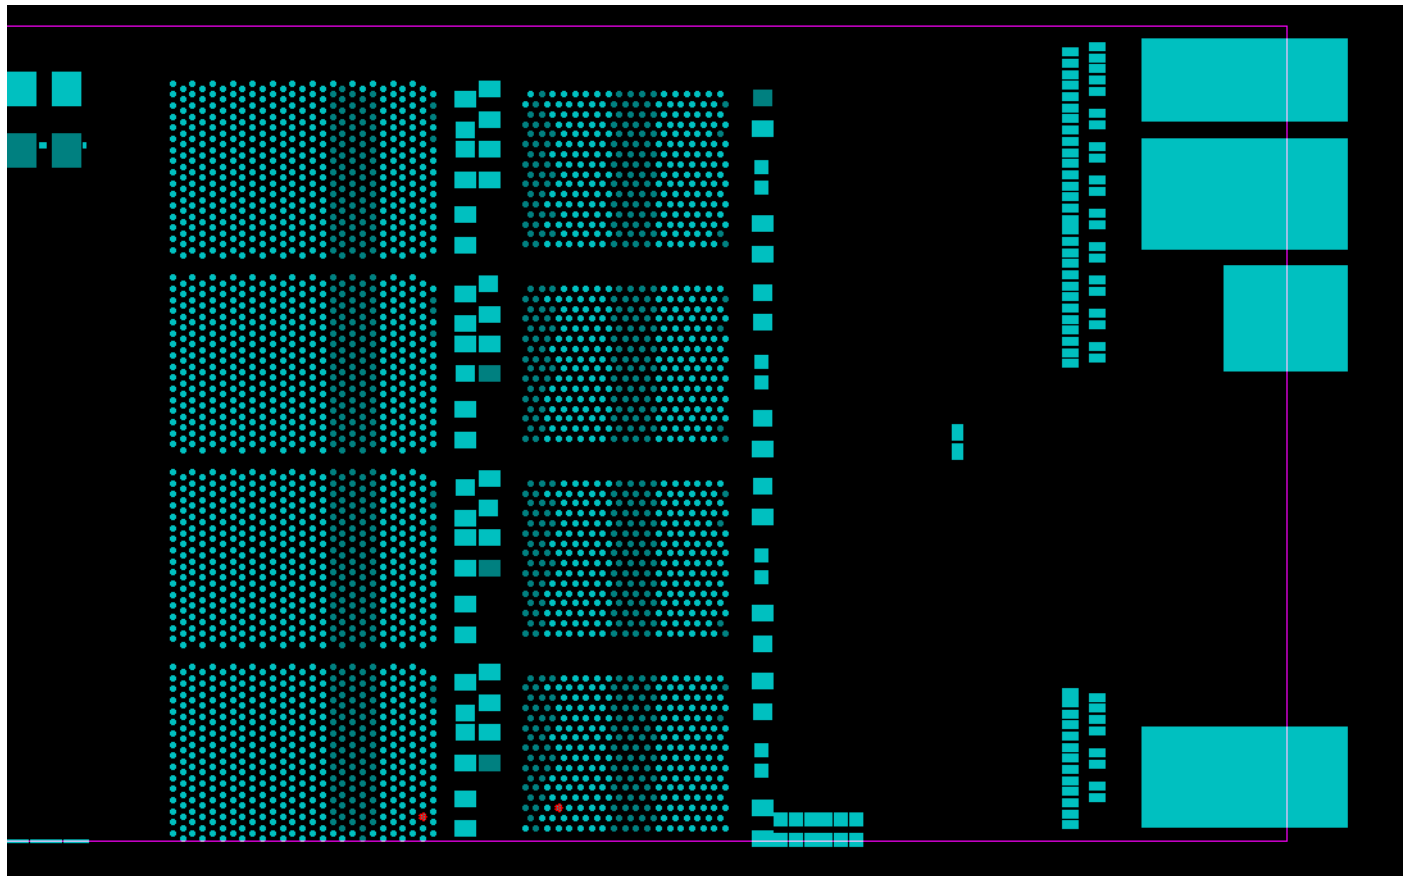
Pad 1290 - 1289

**DUT2 – open**

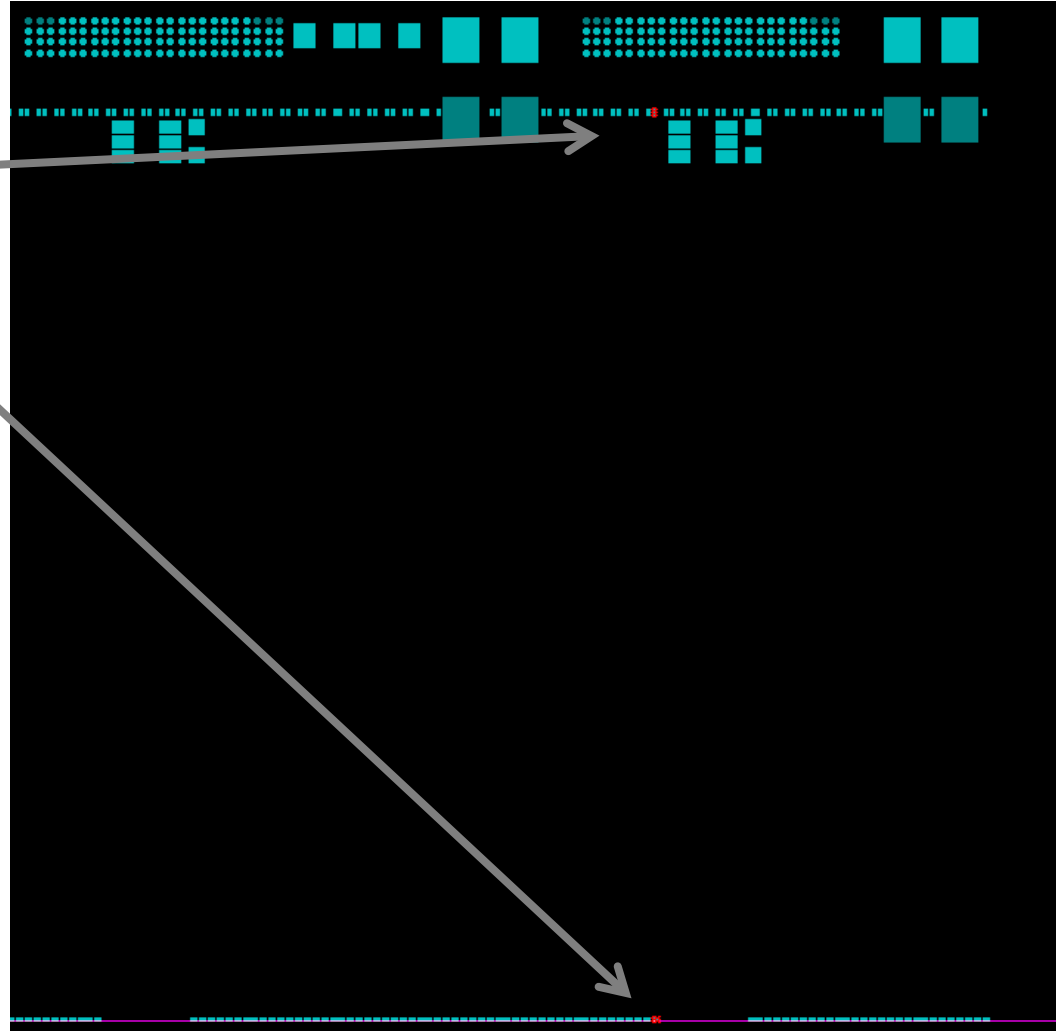
SwitcherB Output

DUT2 – open
