SVD session summary

Koji Hara (KEK)

Jan. 23, 2015

7th Belle II VXD Workshop and 18th International
Workshop on DEPFET Detectors and Applications

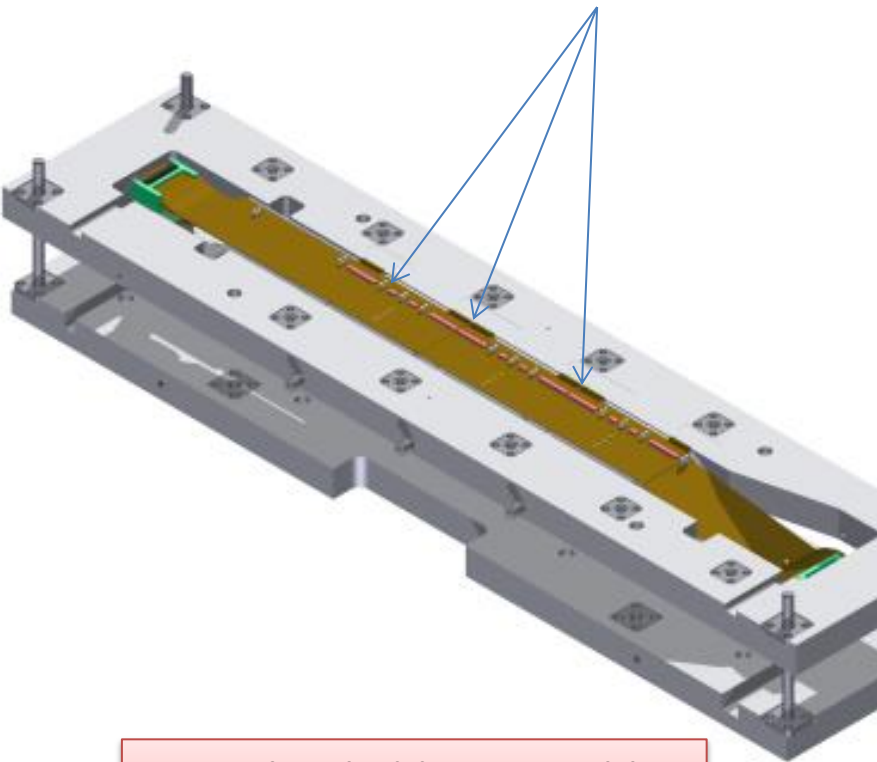
Keratherm on APV on APV
How to put them: open issue

- How to attach Keratherm is one of the most serious missing pieces to be solved asap.
 - Higher priority than the how to attach CO2 cooling pipe.
 - We'll start ladder production. Where it should be in procedure and what implementation method.
 - Closest distance between bonding pad is 0.548mm.
 - Cut precision is unknown since very soft and sticky.
- So far, it is believed there are 2 timings to attach Keratherm.
 - During ladder assembly as same as attaching CO2 clips.
 - After ladder mount.

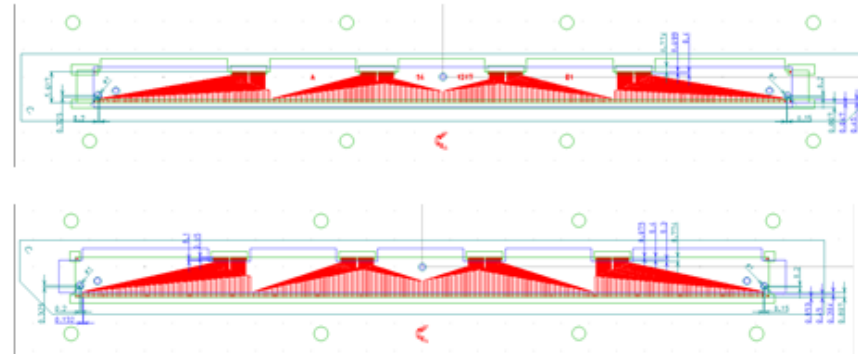
PA0 latest Design by Taiyo

- Released for review by SVD group on Jan. 19
 - Followed our request on the pad lengths and bias hole positions
- dxf files on PATaskForce twiki page

Test production and
evaluation in Feb.
Discussing mass
reproduction plan

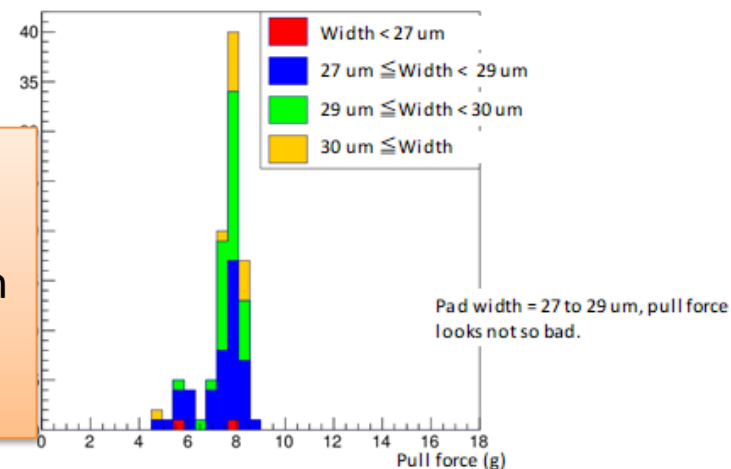
Pad width V.S. pull force of PA2

PA-Flex bonding pad minimum width settled to be 30 μm

- 4 PF/PB from 2nd preproduction, with regions with small pads, bonded to CMS half moon
- Bonding efficiency 100% but in regions with pads < 30 μm some bonds had to be redone a 2nd time
- Poor alignment can make bonding very difficult also with pad = 30 μm !
- See full set of pictures in
 - https://drive.google.com/folderview?id=0BzYaX1UJ403HZWWhNQTAWTUduVXc&usp=drive_web
- NO pull force done (done in other sites with good results)
- Previous bonding experience on PA from 1st preproduction confirmed from this tests.
- **Our conclusion: bonding on pads $\geq 30 \mu\text{m}$, can be painful but ok.**

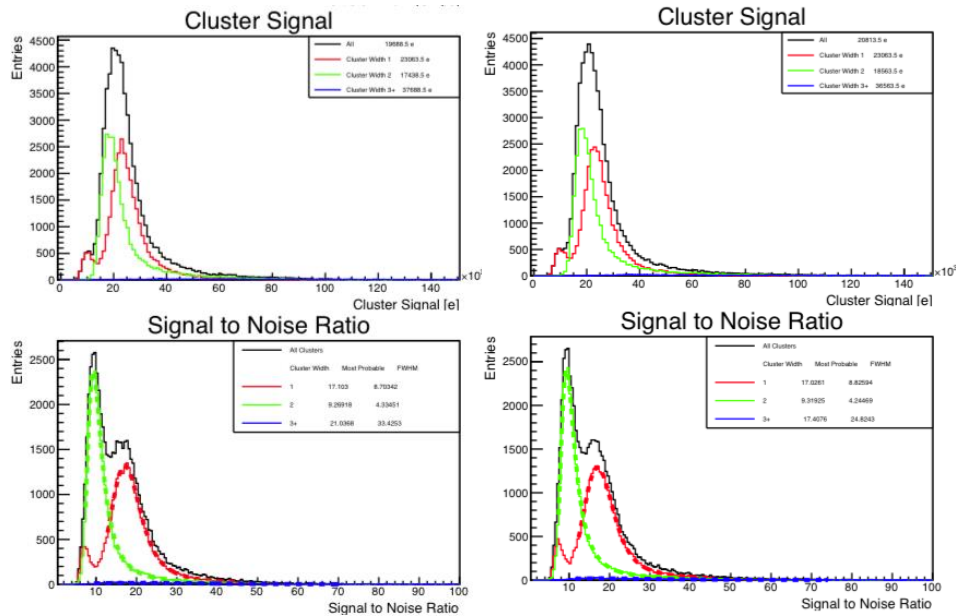
Old Wedge results

No significant differences between runs in spite of shifting the beam spot

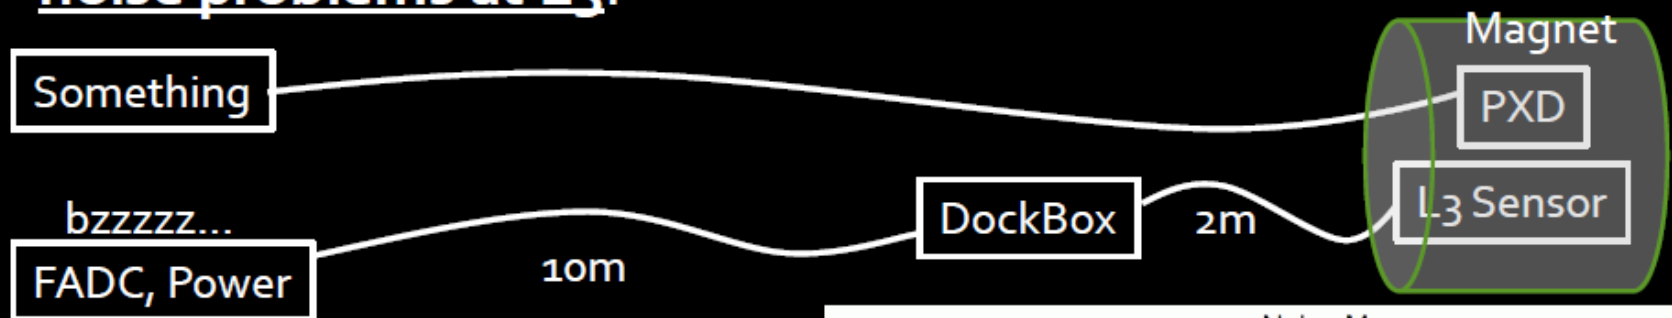
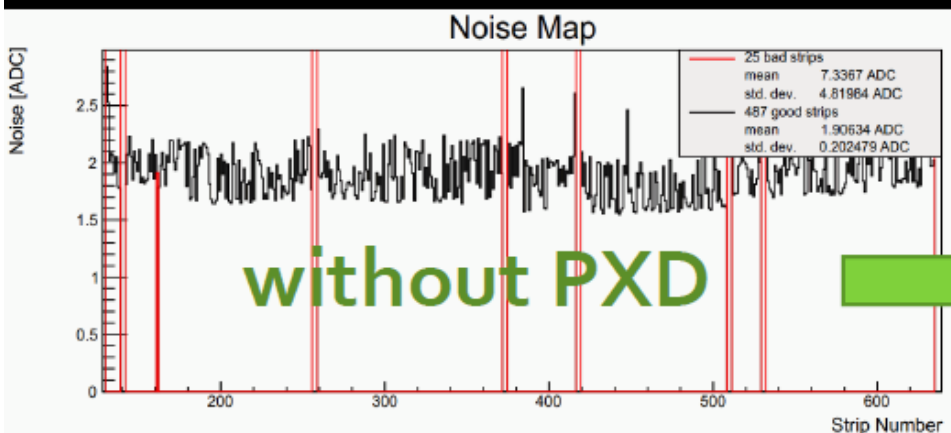
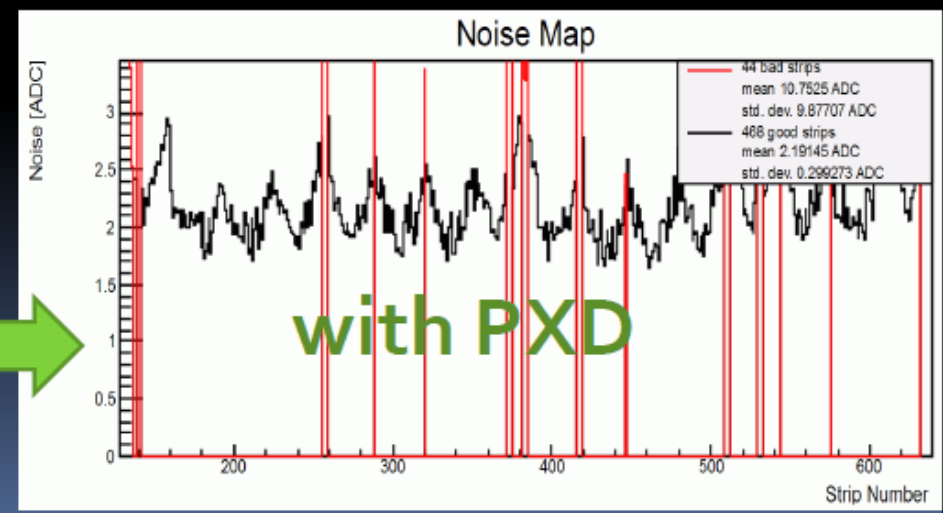
DESY Noise Problems – Symptoms

- The PXD was installed then and connected to its power supplies etc => since then the SVD software showed severe noise problems at L3.

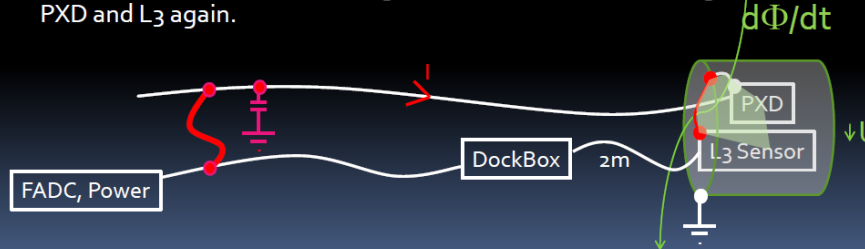
DESY Noise Problems – Educated Guess

- So... if we would have grounded the L3 directly inside the magnet housing without including the 2m wires outside the magnet housing to the Dock box into our current loop, the problem **should have virtually disappeared**.

Groundings or connections on any other **additional point(s)** now are **bad** because then we have a low impedance voltage divider of the voltage generated in the big loop between the impedance of the grounding lines and those of the external cabling. This causes to rise the voltage between PXD and L3 again.

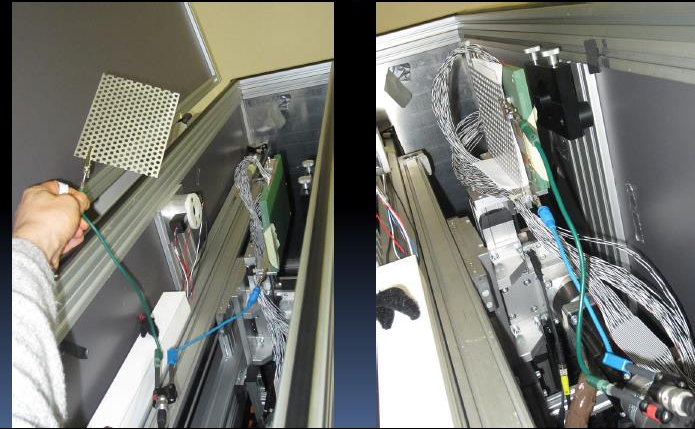
DESY Noise Problems – Investigation

- The very first attempt was: A simple **metal sheet**, insulated by a sheet of paper, connected to a **frequency generator**, and placed near the L3. Frequency: 1.5 MHz, amplitude 20 Volts.

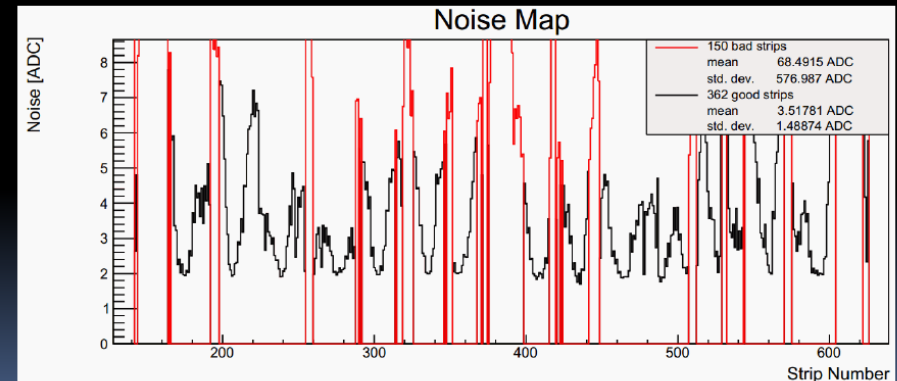
DESY Noise Problems – Investigation

- Result: Noise behavior similar to DESY, but much worse.
- So we just lowered the amplitude to 5 volts – and we had **very similar noise** compared to the DESY beam test situation!

- Based on these educated guess, so if such a **loop really was the cause of the noise**, it should be possible to **reproduce** the DESY-noise by applying some material close to the L3-sensor which has alternating voltage respect to the sensor.
- If such a loop with a voltage between the PXD and SVD was **not the cause**, it should be **unlikely** that such an **investigation brings comparable results**.

The plan was to **inject some noise** (different shapes, amplitudes, ...) in different ways (capacitive, inductive, combinations of them) with different injectors into the L3, until the software shows similar noise behavior as at the DESY beam test, to conclude what can have caused the problems.
