# FW/BW Subassembly Report

(an update since June B2GM)

S. Bettarini on behalf of the Pisa SVD Group

VXD Workshop, SVD session - Trieste, Sept. 10, 2015

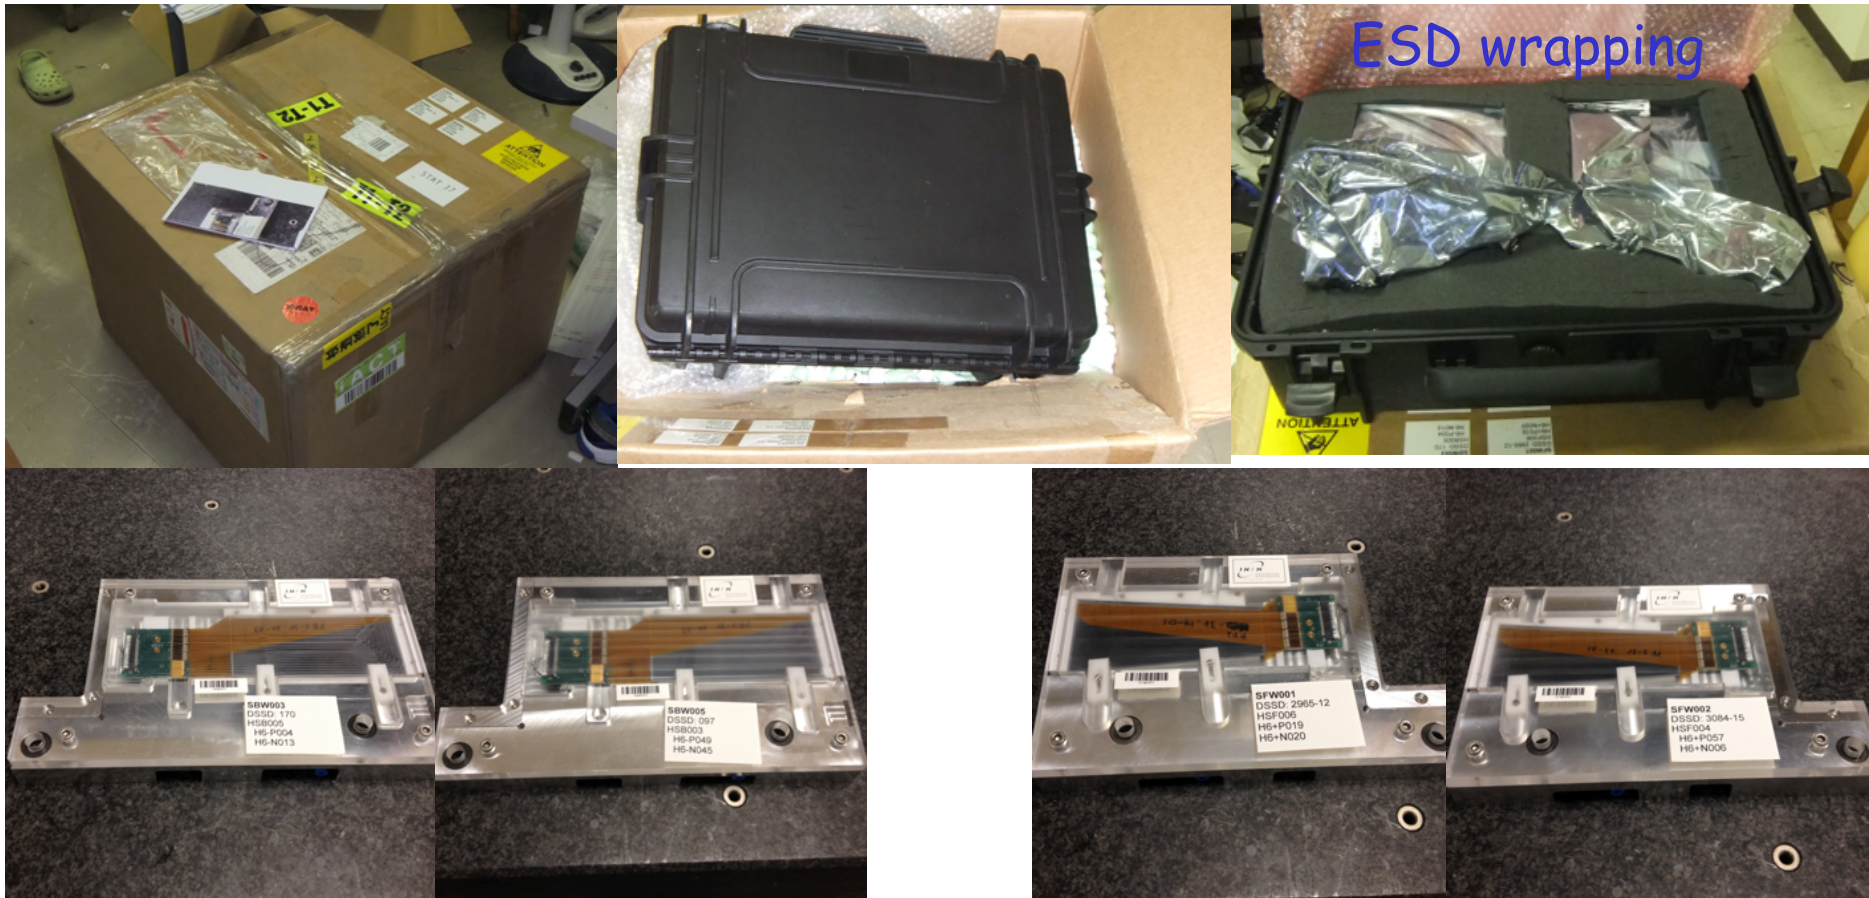
- Before the summer holidays:
  - 2 class B+ SFWs (001,002) + 2 SBWs (003, 005) all built with parts under IPR sent to KEK using the final custom "procedures"

- Cost optimization mandatory: in future, shipments will be optimized, by sending 9 SA at the same time (using new bigger boxes).

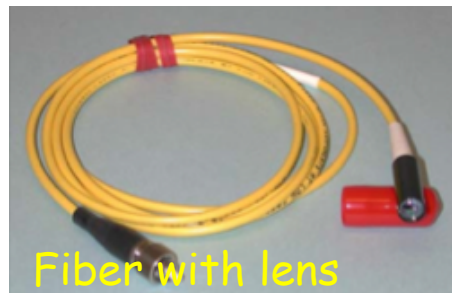
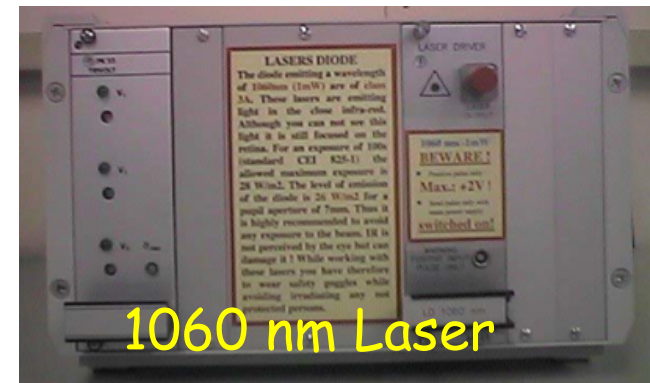
# Sub-assembly electrical characterization and laser-scan

- After the unique bonding phase (N&P side w/o any intermediate test) a complete electrical test is foreseen with the sub-assembly Z-up on the MP chuck, to eventually spot new defects (and verify the known ones!).
- The final qualification of the sub-assembly is the functional characterization by a laser scan.

- Giulia reported that on Sept. 3<sup>rd</sup> between the calibration tests and the laser scan the test-stand experienced a "failure":
  - ADC Delay Scan returns delays with differs up to 4 ns;
  - with Internal Calibration Run on the reference hybrids, several warnings (one each event) arose.
- Standard working condition found on Sept. 8<sup>th</sup> by Eugenio without any modification/actions!

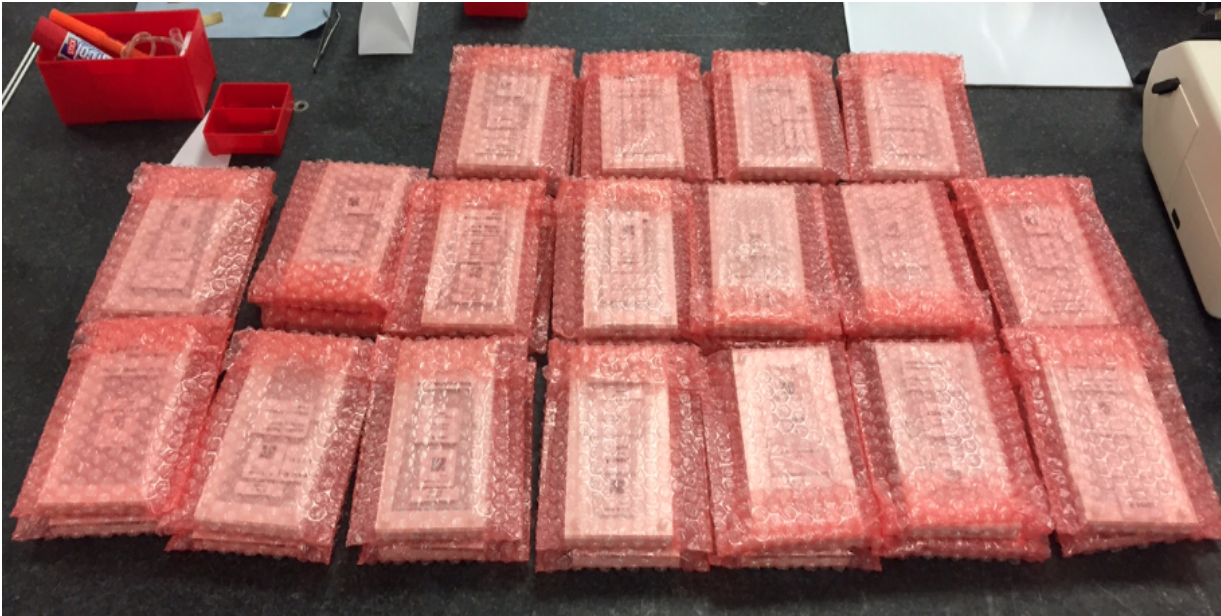
# Micron det's ESD packaging (left Pisa on June 24)

+ HPK # 83 to be tested  
(after wrongly  
using that to tune chucks)

These detector will be returned to Pisa (not shipped but safely carried by hand) on Fri. 11st September, with some mechanical piece (cooling pipe, MPCs) received from Vienna.

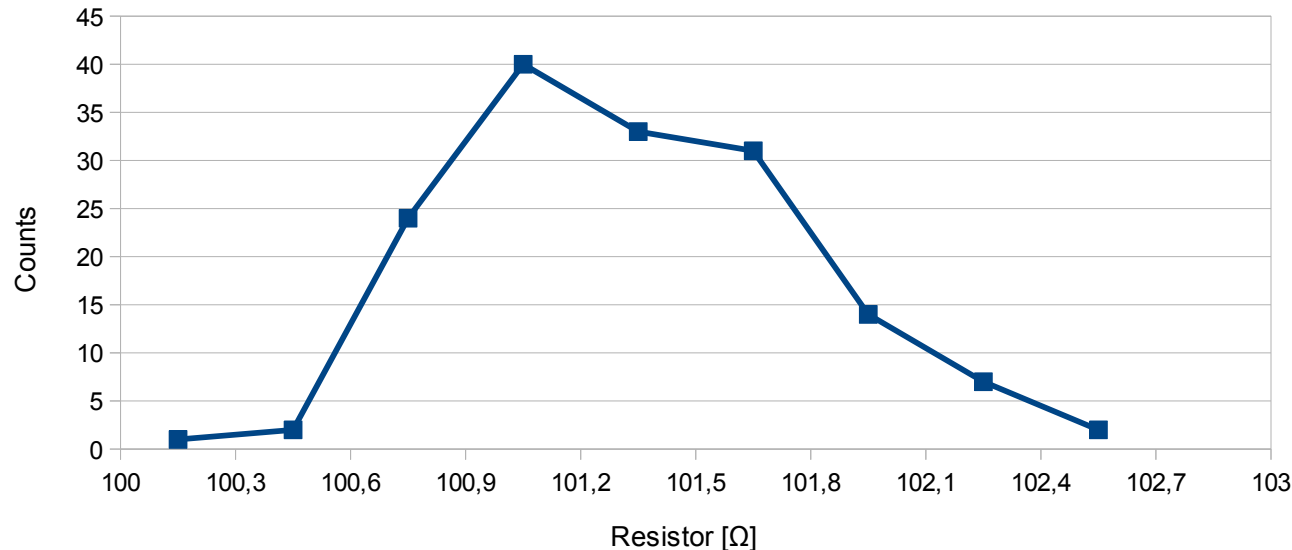
Distribution of all measured resistors

average =  $\mu = 101.3 \Omega$   
st. deviation =  $\sigma = 0.5 \Omega$

The single distributions (e.g.  
forward p-side trigger, etc.) have  
a similar trend

The lead resistance (cables, connectors, etc.) has  
been evaluated with the  
4-wires probes method (by Keithley 2001)  $1.2 \Omega$

$$R = 100.1 \pm 0.5 \Omega$$

Only one measured resistor (not shown in the plot above!) is  
far more  $3\sigma$  from the average value (see next slide)
