LMU München - Excellence Cluster Universe

## PS & Services

**20<sup>th</sup> International Workshop on DEPFET  
Detectors and Applications  
11.05.16-14.01.16  
Seeon**

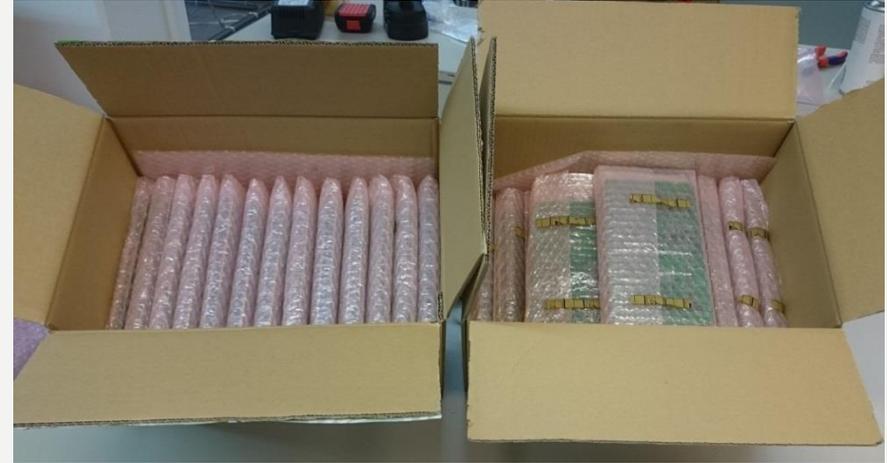
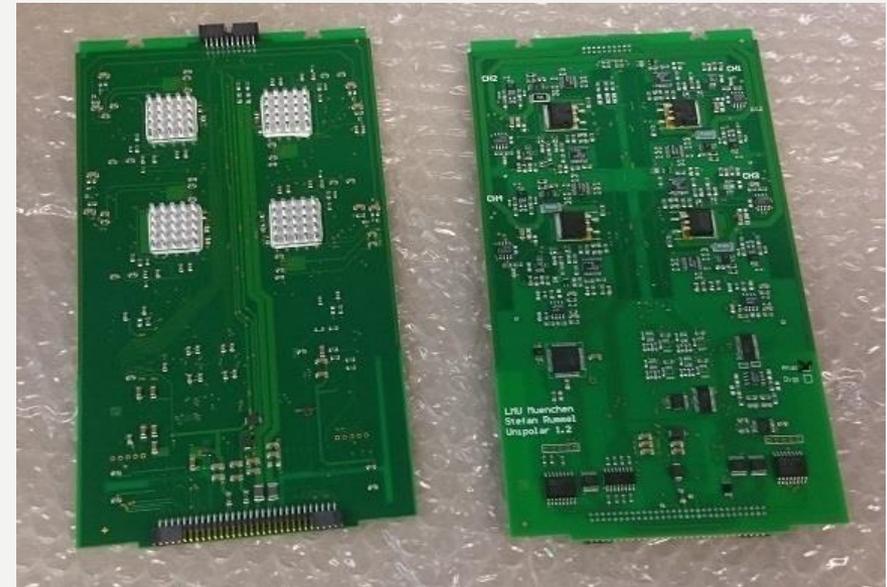
## Unipolar – Cards:

- PCB design has been finalized
- Relaxed via diameters
- Ratings of all components has been crosschecked
- Passives: High quality, thin film resistors, automotive qualified capacitors
- Base material High Tg FR 4

→ Full set, 140 boards available

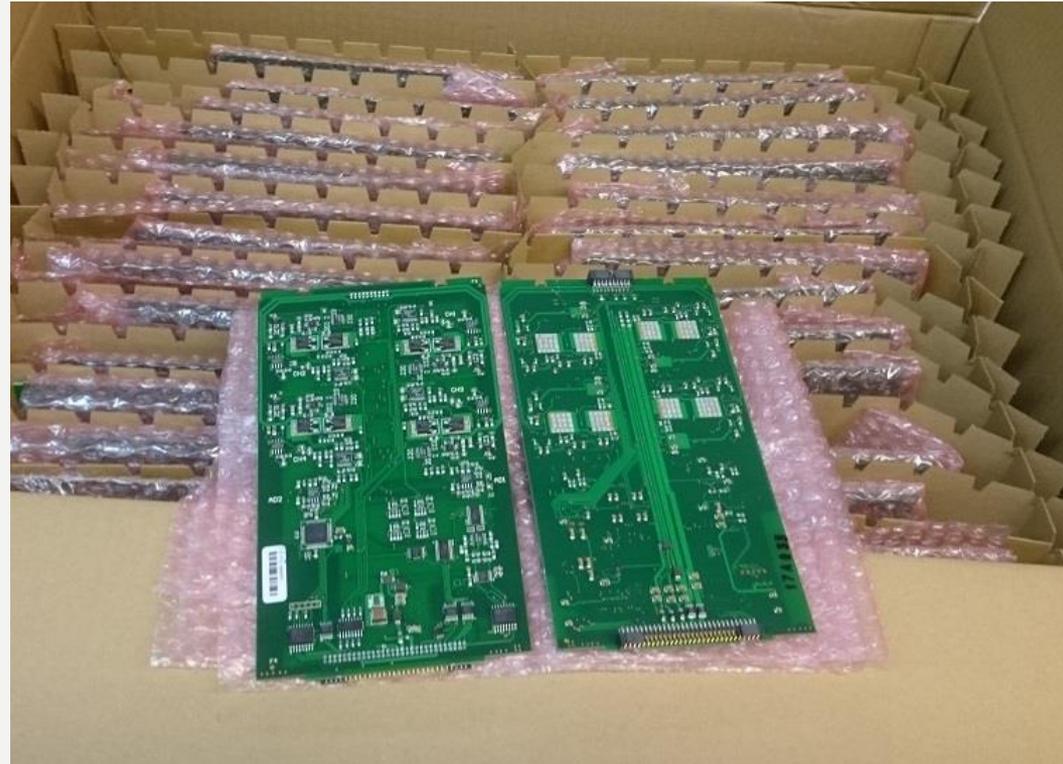
## Bipolar – Cards:

- PCB design has been finalized
  - Relaxed via diameters
  - Ratings of all components has been crosschecked
  - Passives: High quality, thin film resistors, automotive qualified capacitors
  - Order is placed
- 80% delivered end of April  
→ First boards tested, flawless behavior

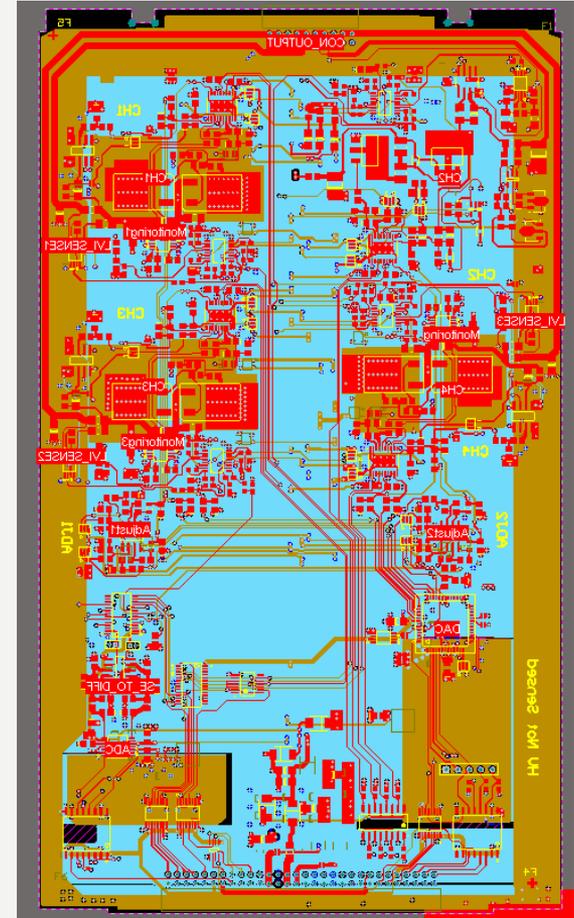
## HV – Card's & CCG Channels:

- Received new feature request just before Christmas
- Monitoring with 20nA resolution for various channels (CCG's, Bulk, HV, Drift)
- New circuitry for measurement necessary
- Design finished
- First orders placed

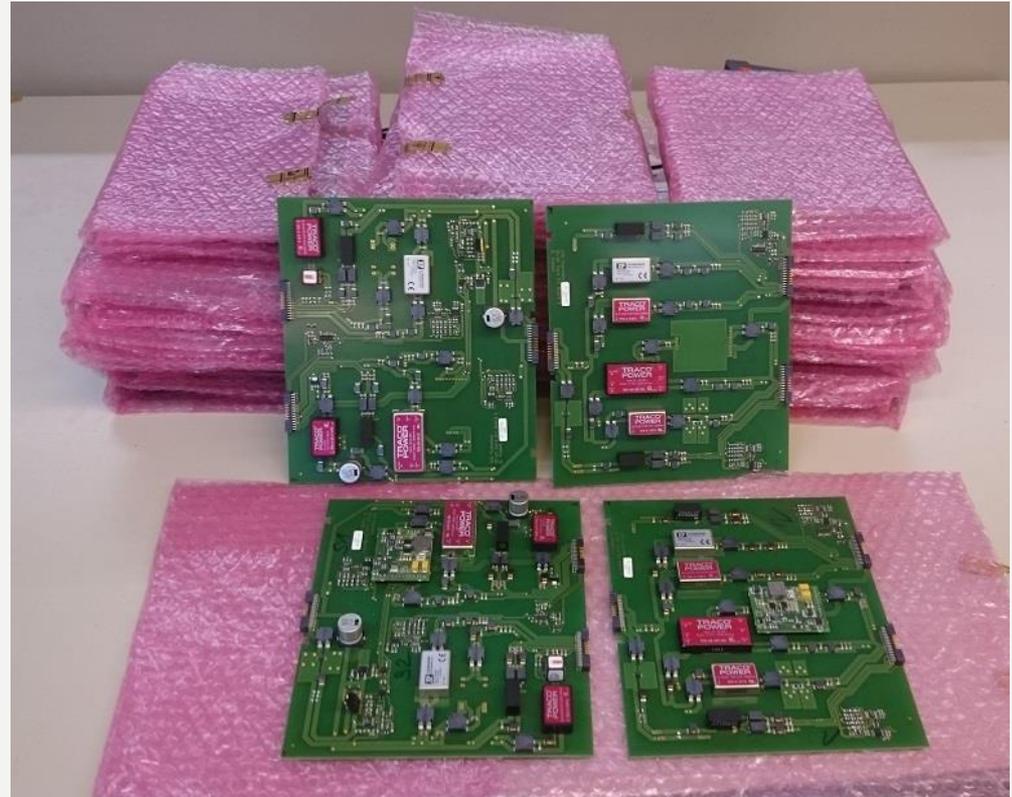
# Main production – DC/DC converter cards

- PCB design has been finalized
- Additional feature:
  - Voltage supervisor as additional safety measure
  - Failure at DC/DC converter level can be mitigated before it has impact on output voltages
- First batch available
- First set successfully operated

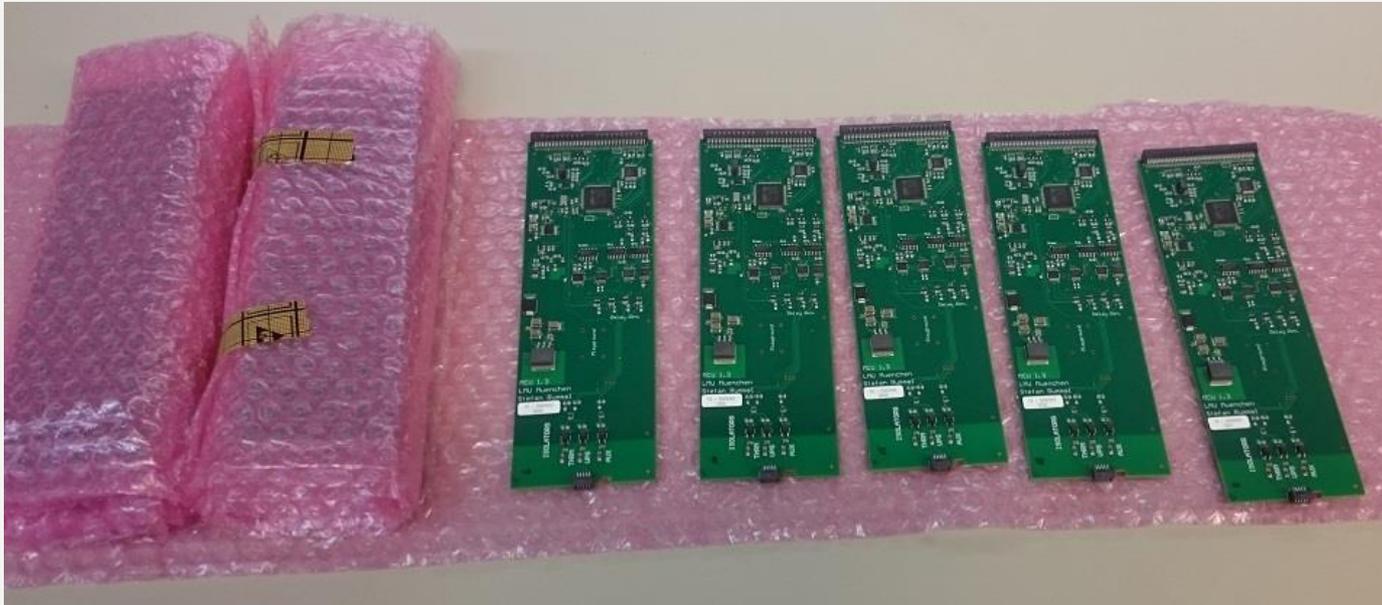
- Bugs from previous designs fixed
  - MCU watchdog
  - Various smaller issues which were fixed with wires
- Design finished, PCB's available
- First batch of 20 ready

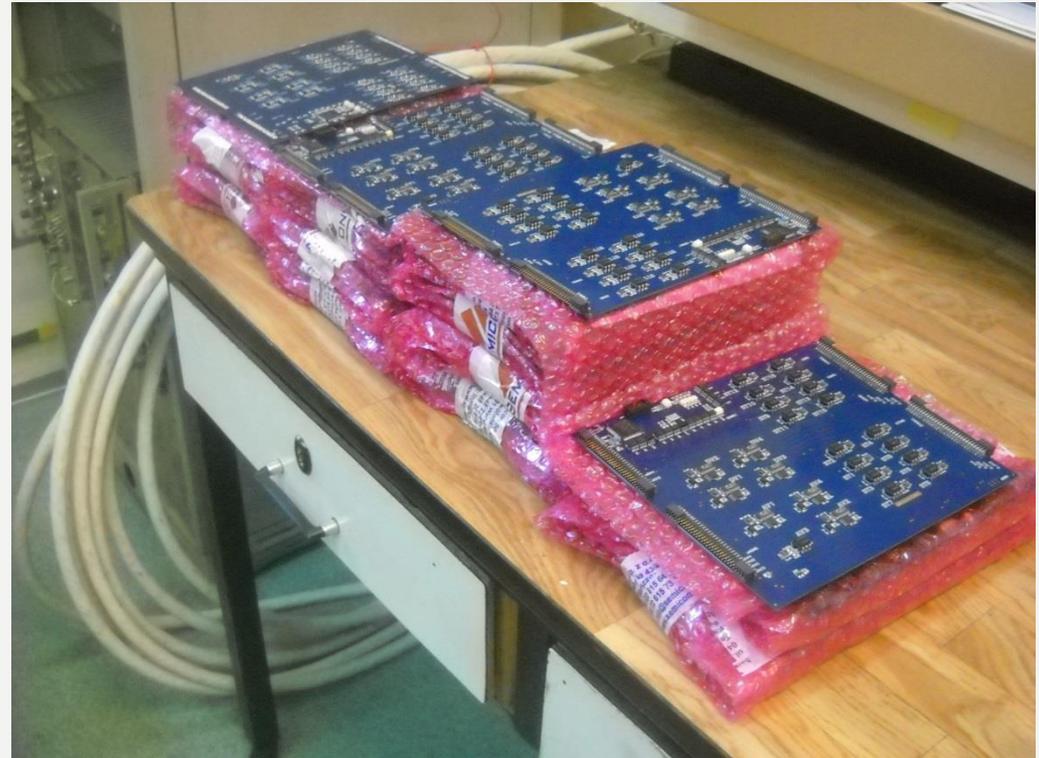
- 50 boards available
  - Rework of boards successfully
- Boards will be available soon

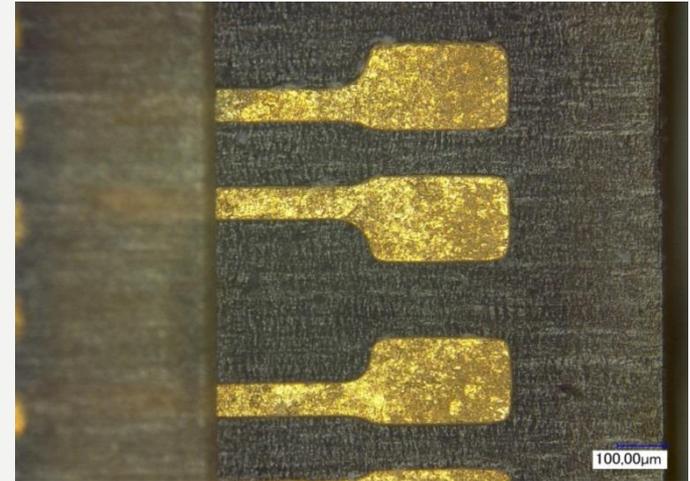
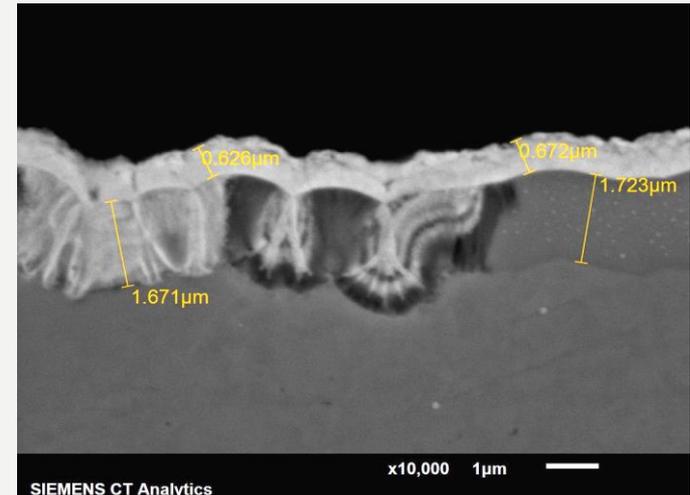
- Taiyo Kaptons showed some issue with surface quality
  - New layer specifications slightly better
- Bond strength acceptable
  - Underlying issue rigidity of layer stackup
- Cost of productions exploded for the last production
- Looking for second vendor

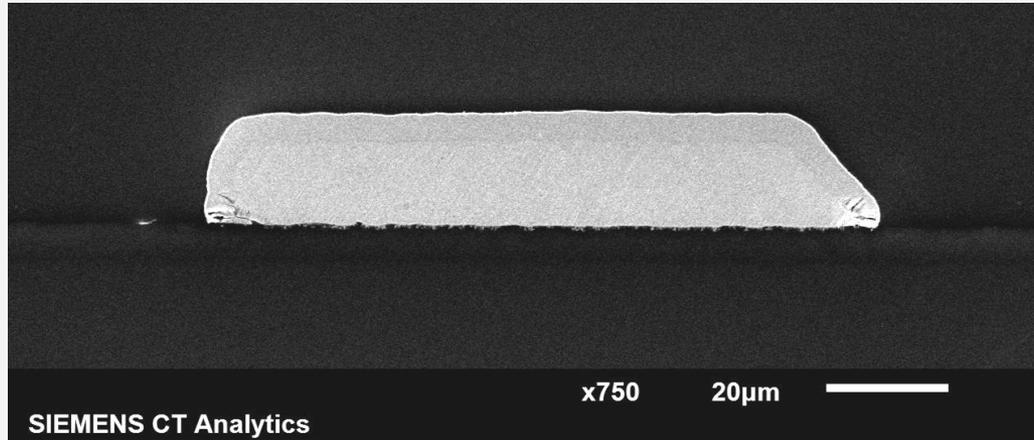
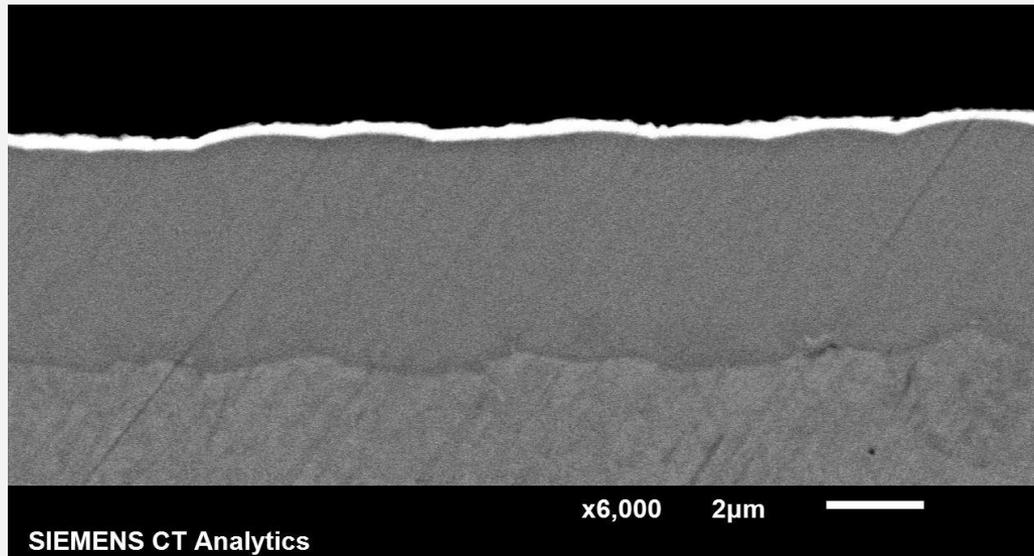
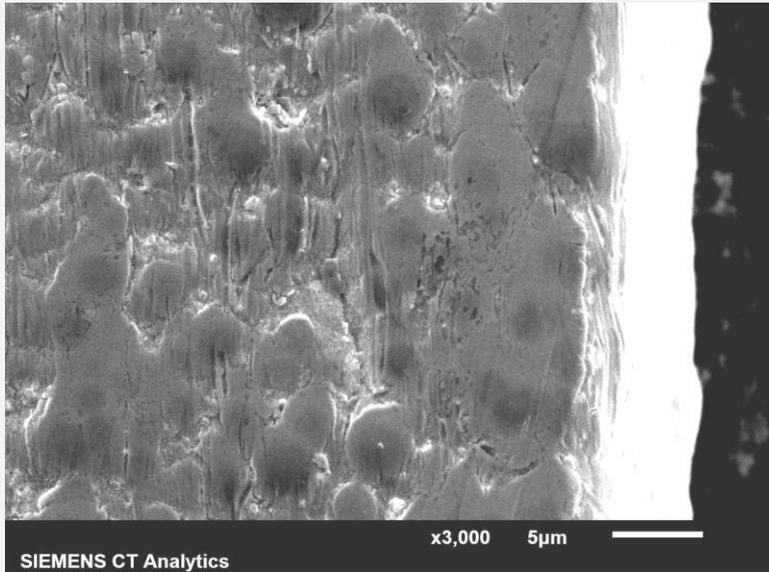
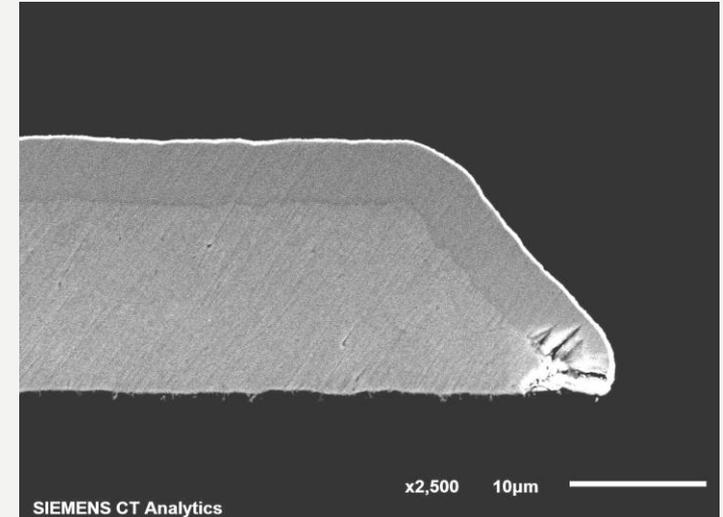
# Kapton – Kaupke prototypes

- Kaupke a service provider was able to establish a new contact to “MOS Electronic”
  - Located south Germany
  - First face to face meeting mid April
- First Prototype L1Bwd available
  - Surface quality significantly improved
  - Bond strength noticeably improved
  - Some minor issue with underetching on the edges of the pads
  - Bending successfully tested
  - TDR under way

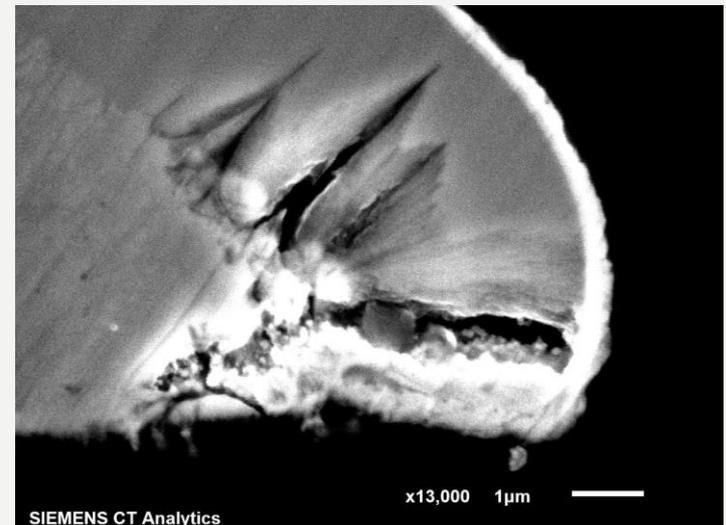
## Results: [Siemens CT]

Die Pads haben unten an der Seite Bruchzonen, deren Ursache wohl eine starke (ca. 10 µm) Unterschneidung des Kupfers ist. Das NiP weist in dieser Unterschneidung Hohlräume auf und ist lokal oxydiert. **Davon abgesehen wurden keine Fehler gefunden**, die Goldschicht ist 150 – 200 nm stark.

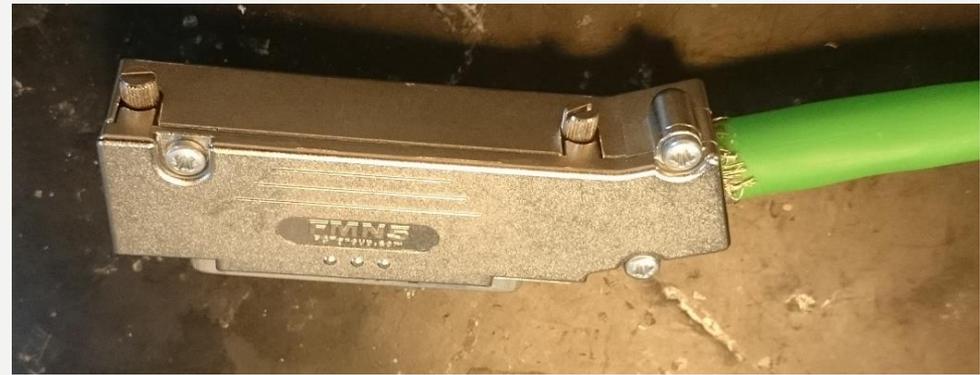
- *Prototype is successfully used in most test setups using the LMU-PS*
- Investigation within the grounding project showed promising results
- Prototype with final connectors has been produced

→ *Ready to start procurement of power cables*

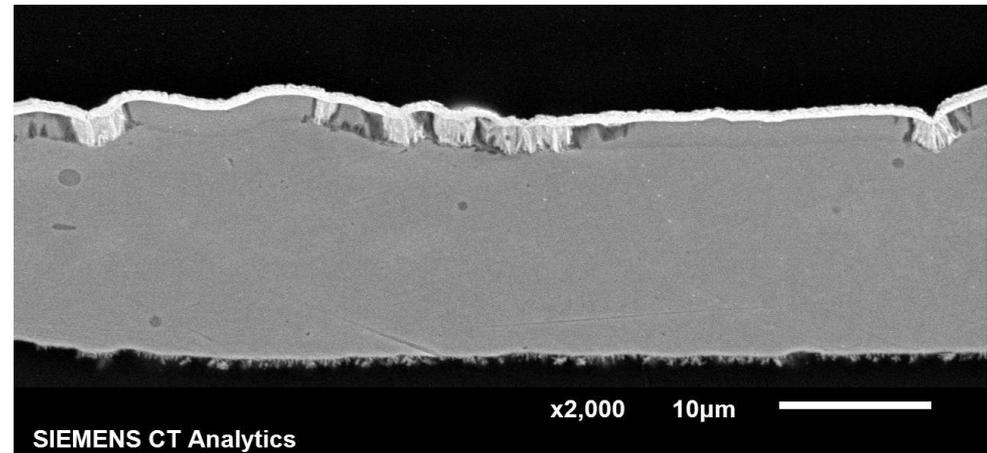
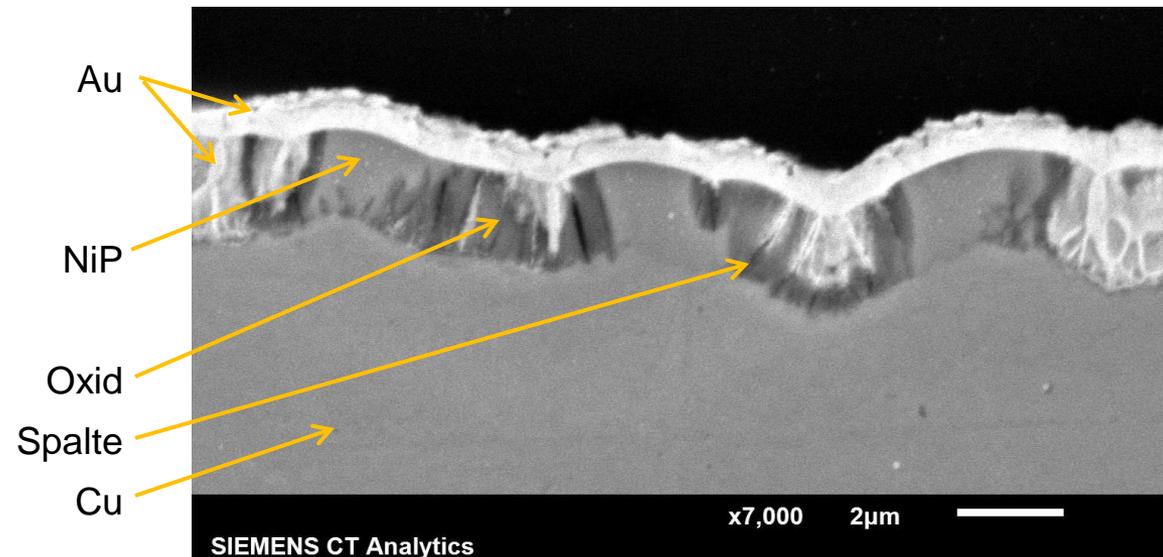
## Taiyo, Querschnitt

Die NiP-Schicht weist sehr viele Fehlstellen auf mit Spalten und Oxid. Bei der Abscheidung von Gold ist Au dort eingedrungen (helle Strahlen). Das Oxid hat sich stellenweise ins Kupfer hineingefressen.

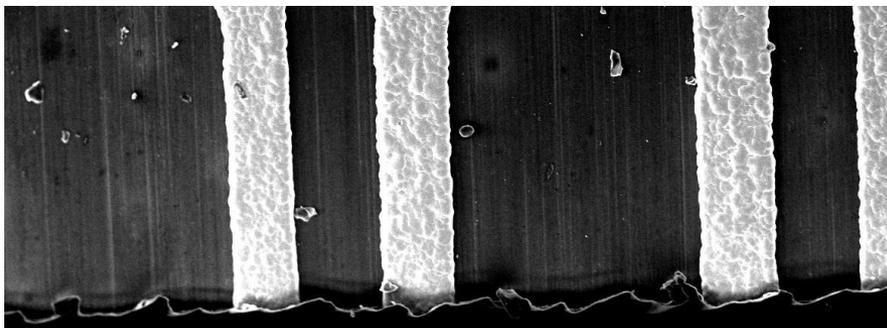
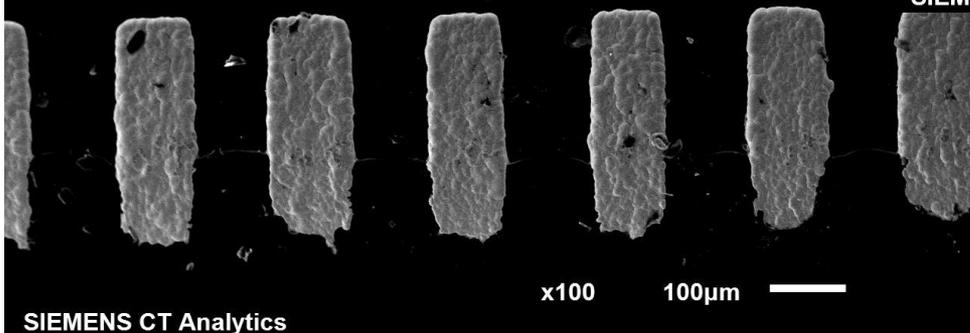
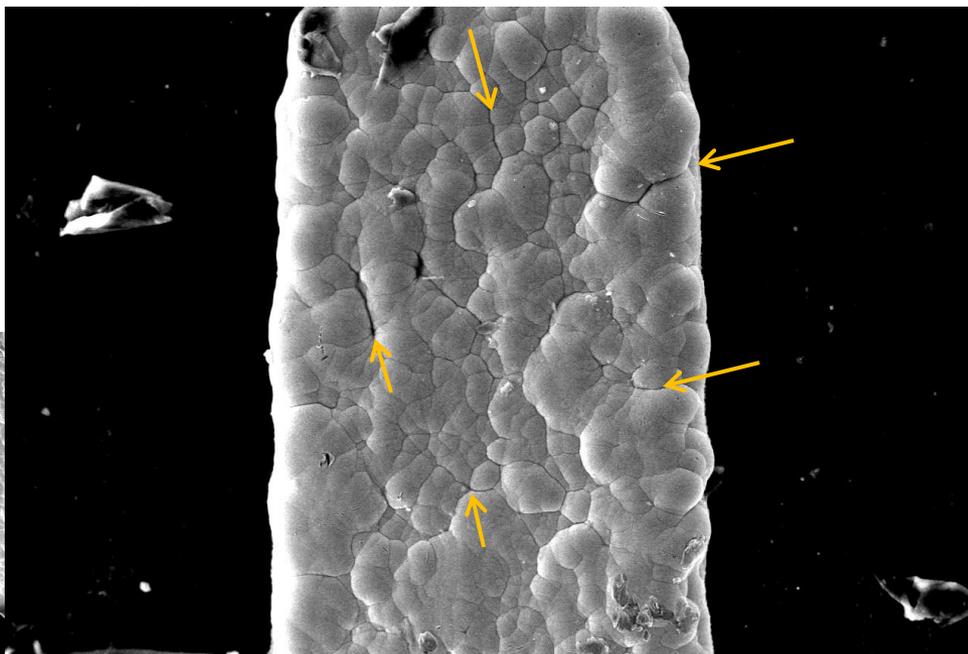
# Taiyo, Oberfläche

Die Goldoberfläche zeigt Spalte (Pfeile).

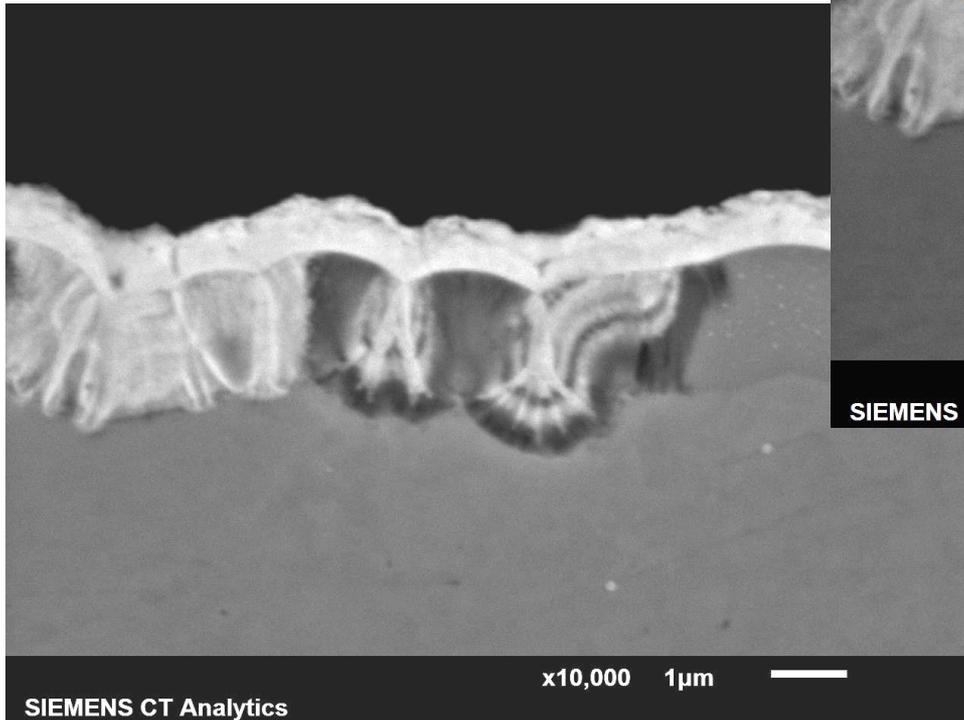
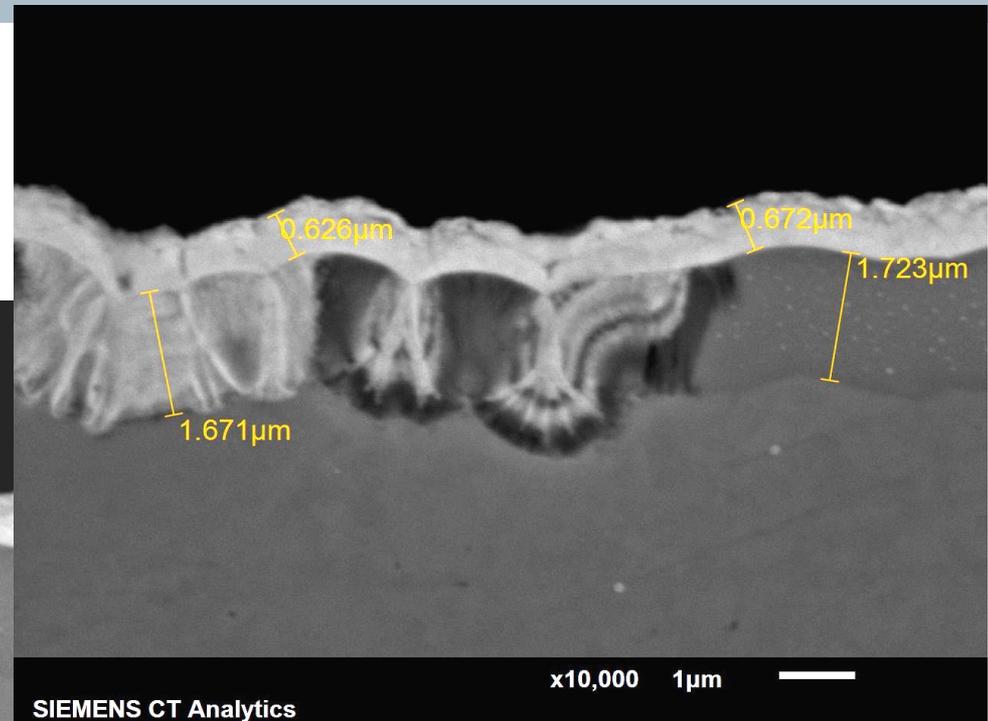
## Taiyo, Querschnitt

Die Goldschicht ist gut 600 nm stark, die NiP-Barriere 1.67 bis 1.73  $\mu\text{m}$ , die Dicke schwankt auffallend.

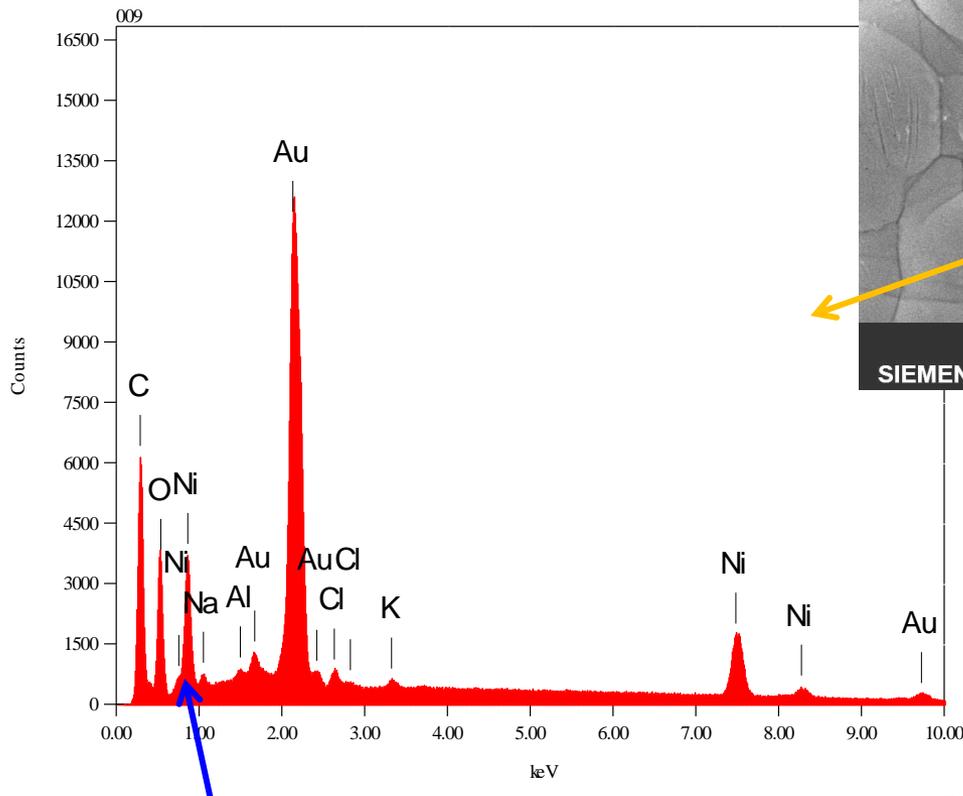
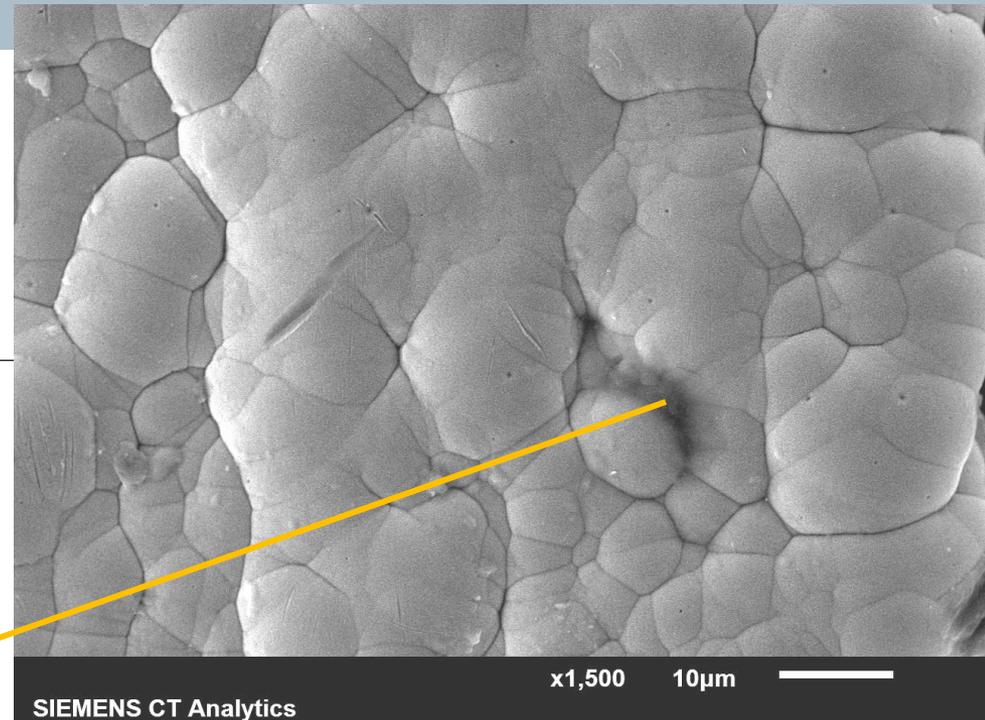
## Taiyo, Oberfläche, EDX

EDX-Analyse von einem Fleck auf der Oberfläche. Der Fleck liegt in einer Mulde, ist also nicht aufgeschmiert, das Material ist wohl aus einem Spalt ausgetreten.

Auffallend ist die hohe Konzentration an C, der Fleck besteht im Wesentlichen aus organischem Material. Ni liegt ebenfalls an der Oberfläche, das weiche Ni-L Signal (blauer Pfeil) wäre sonst nicht zu beobachten gewesen. Die Elemente Na, Cl und K stammen von Fingerabdrücken.

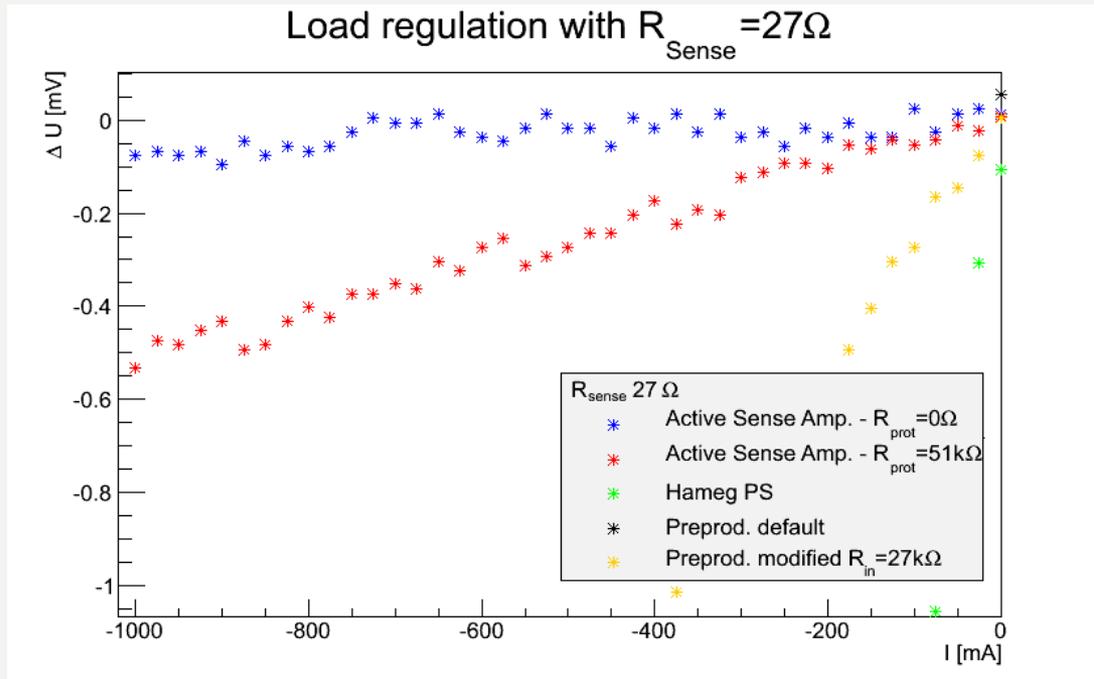
- Preproduction in modified configuration significantly improves output DC impedance to 2.5mW significantly better than commercial unit
- Baseline for main production: Active sense amplifier with 51k protection resistor
