22nd INTERNATIONAL WORKSHOP ON DEPFET DETECTORS AND APPLICATIONS

STATUS UPDATE: PXD9 MODULE TESTING AT BONN

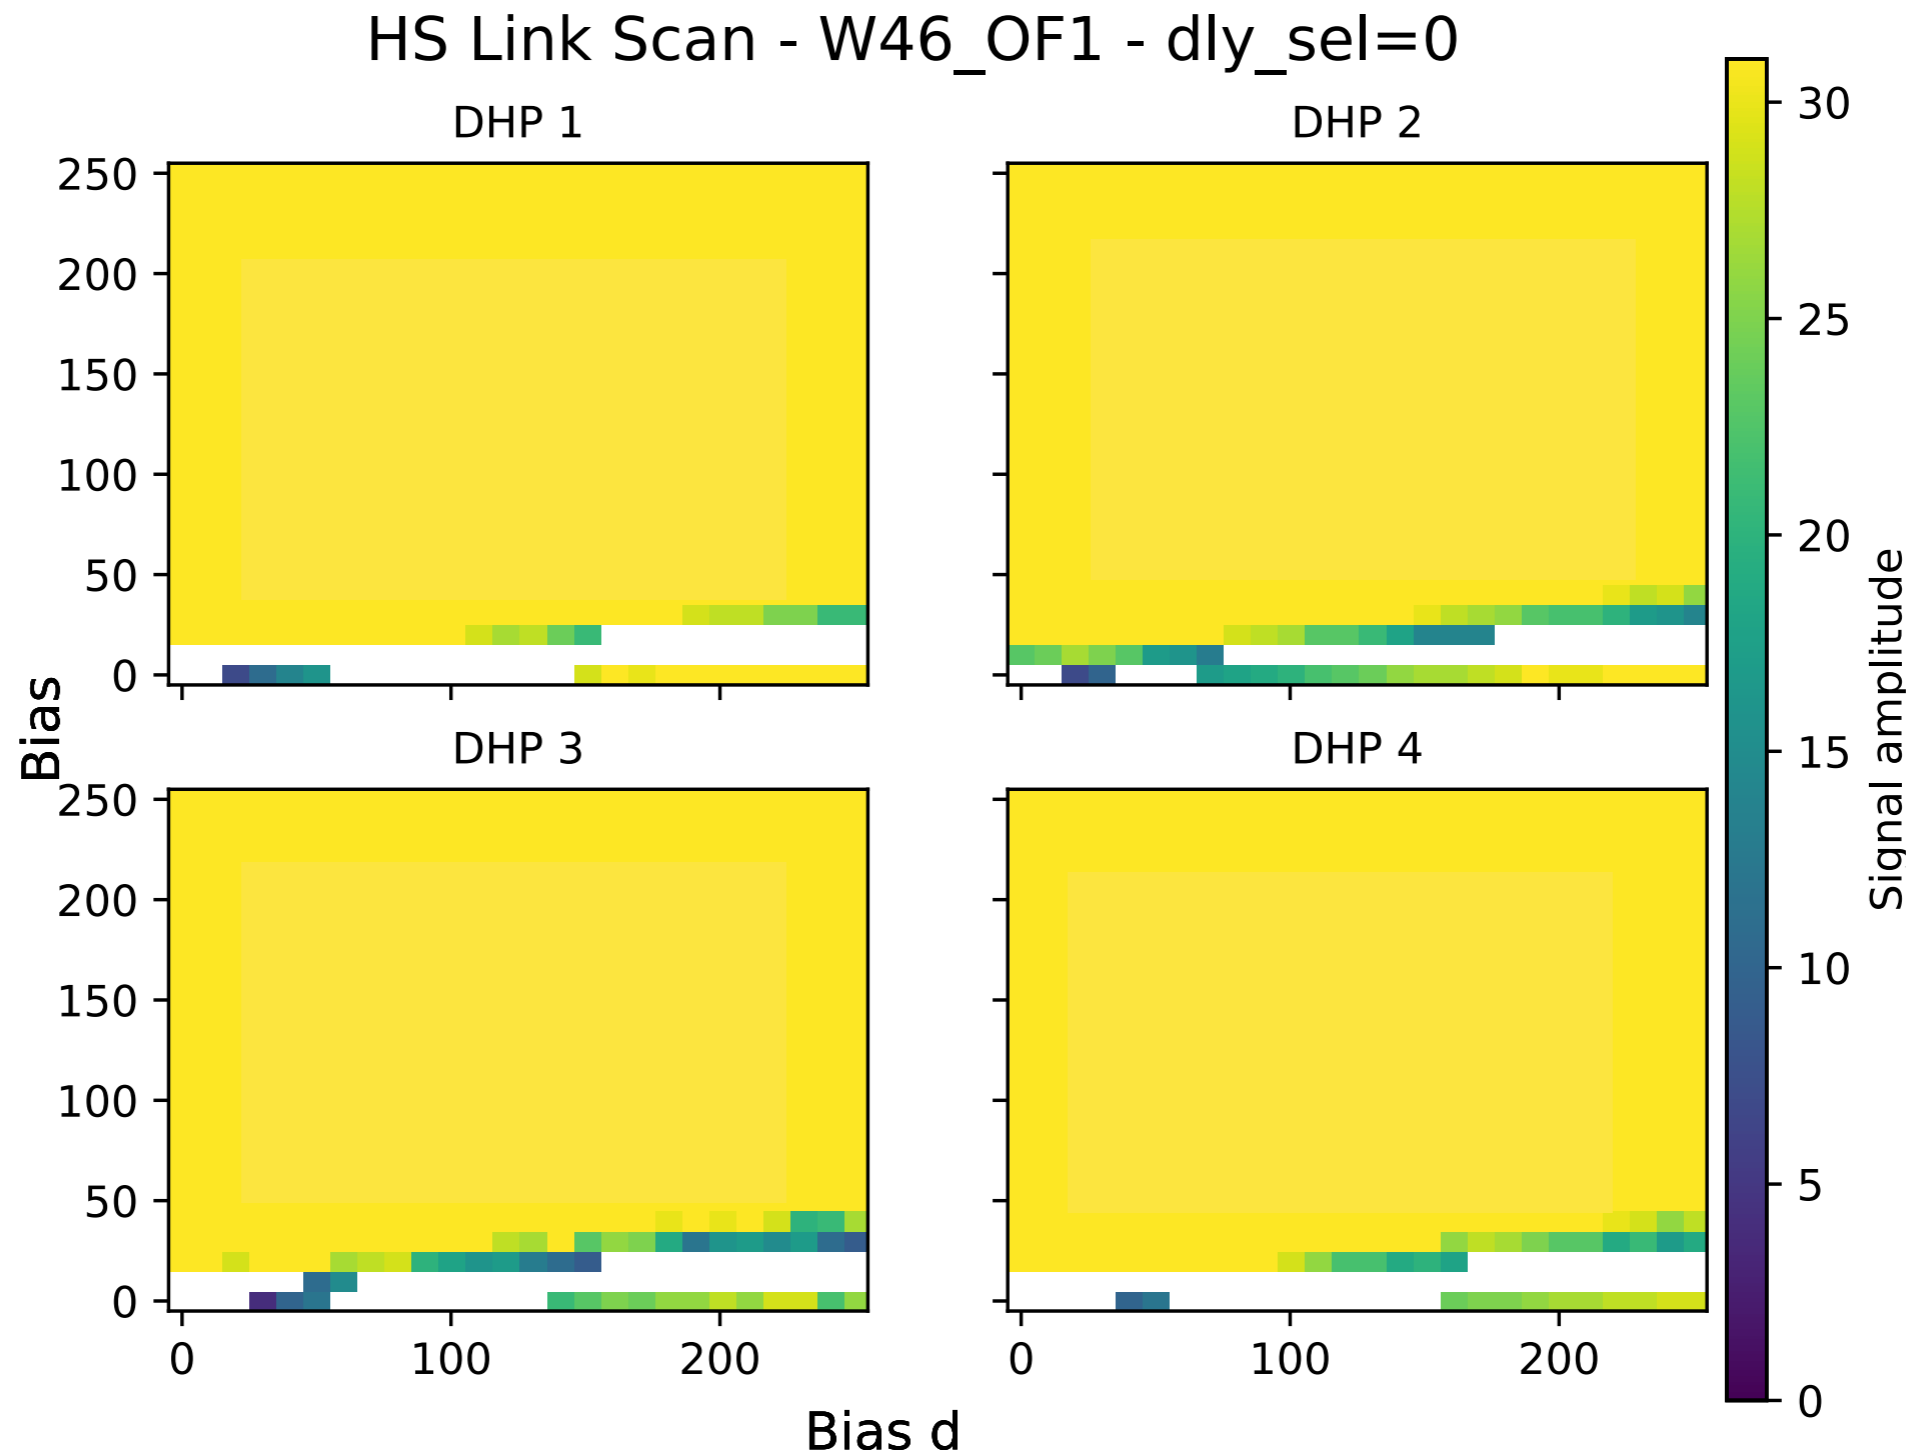
Standard bias=225, biasd=125, dly_sel=0 values were used. HSL were up and running stable over all our measurements. A delay optimisation was successfully performed.

- ▶ Measurements:
 - ▶ HSL: we used the standard values, which worked fine. Links were stable overnight.
 - ▶ Delay scan: typical anti diagonal results with a band of error-free communication. DCD-DHPT communication worked fine. See backup for details.

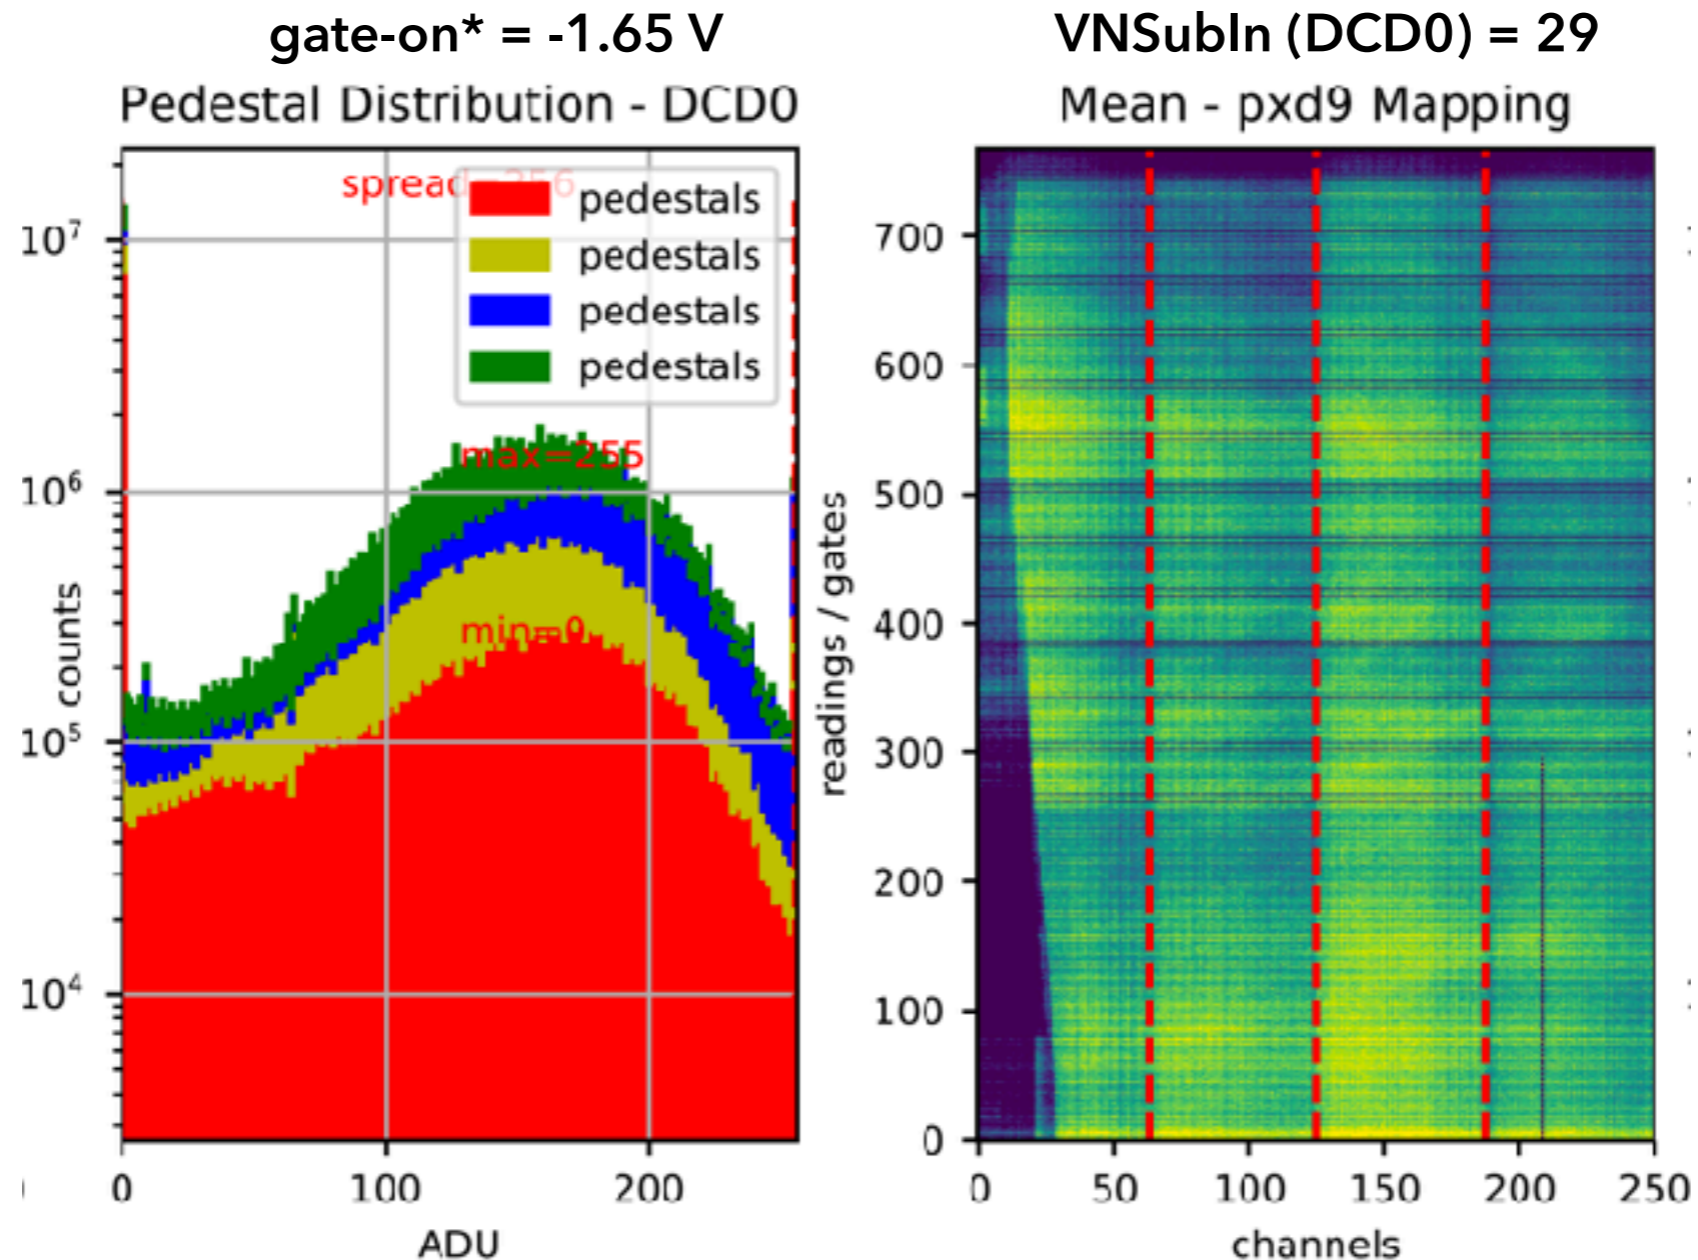
This module shows 3 interesting effects:

- ▶ radiation damage near the EOS and the balcony,
- ▶ 3 broken drains in DCD4,
- ▶ double gate structure with lower ADU values (4 and 34 healthy gates in between the weaker gates respectively).

- ▶ Raw pedestals: some radiation damage is appreciated near the EOS and the balcony, the "double-gate" structures are present, and 3 drain lines are half-broken.

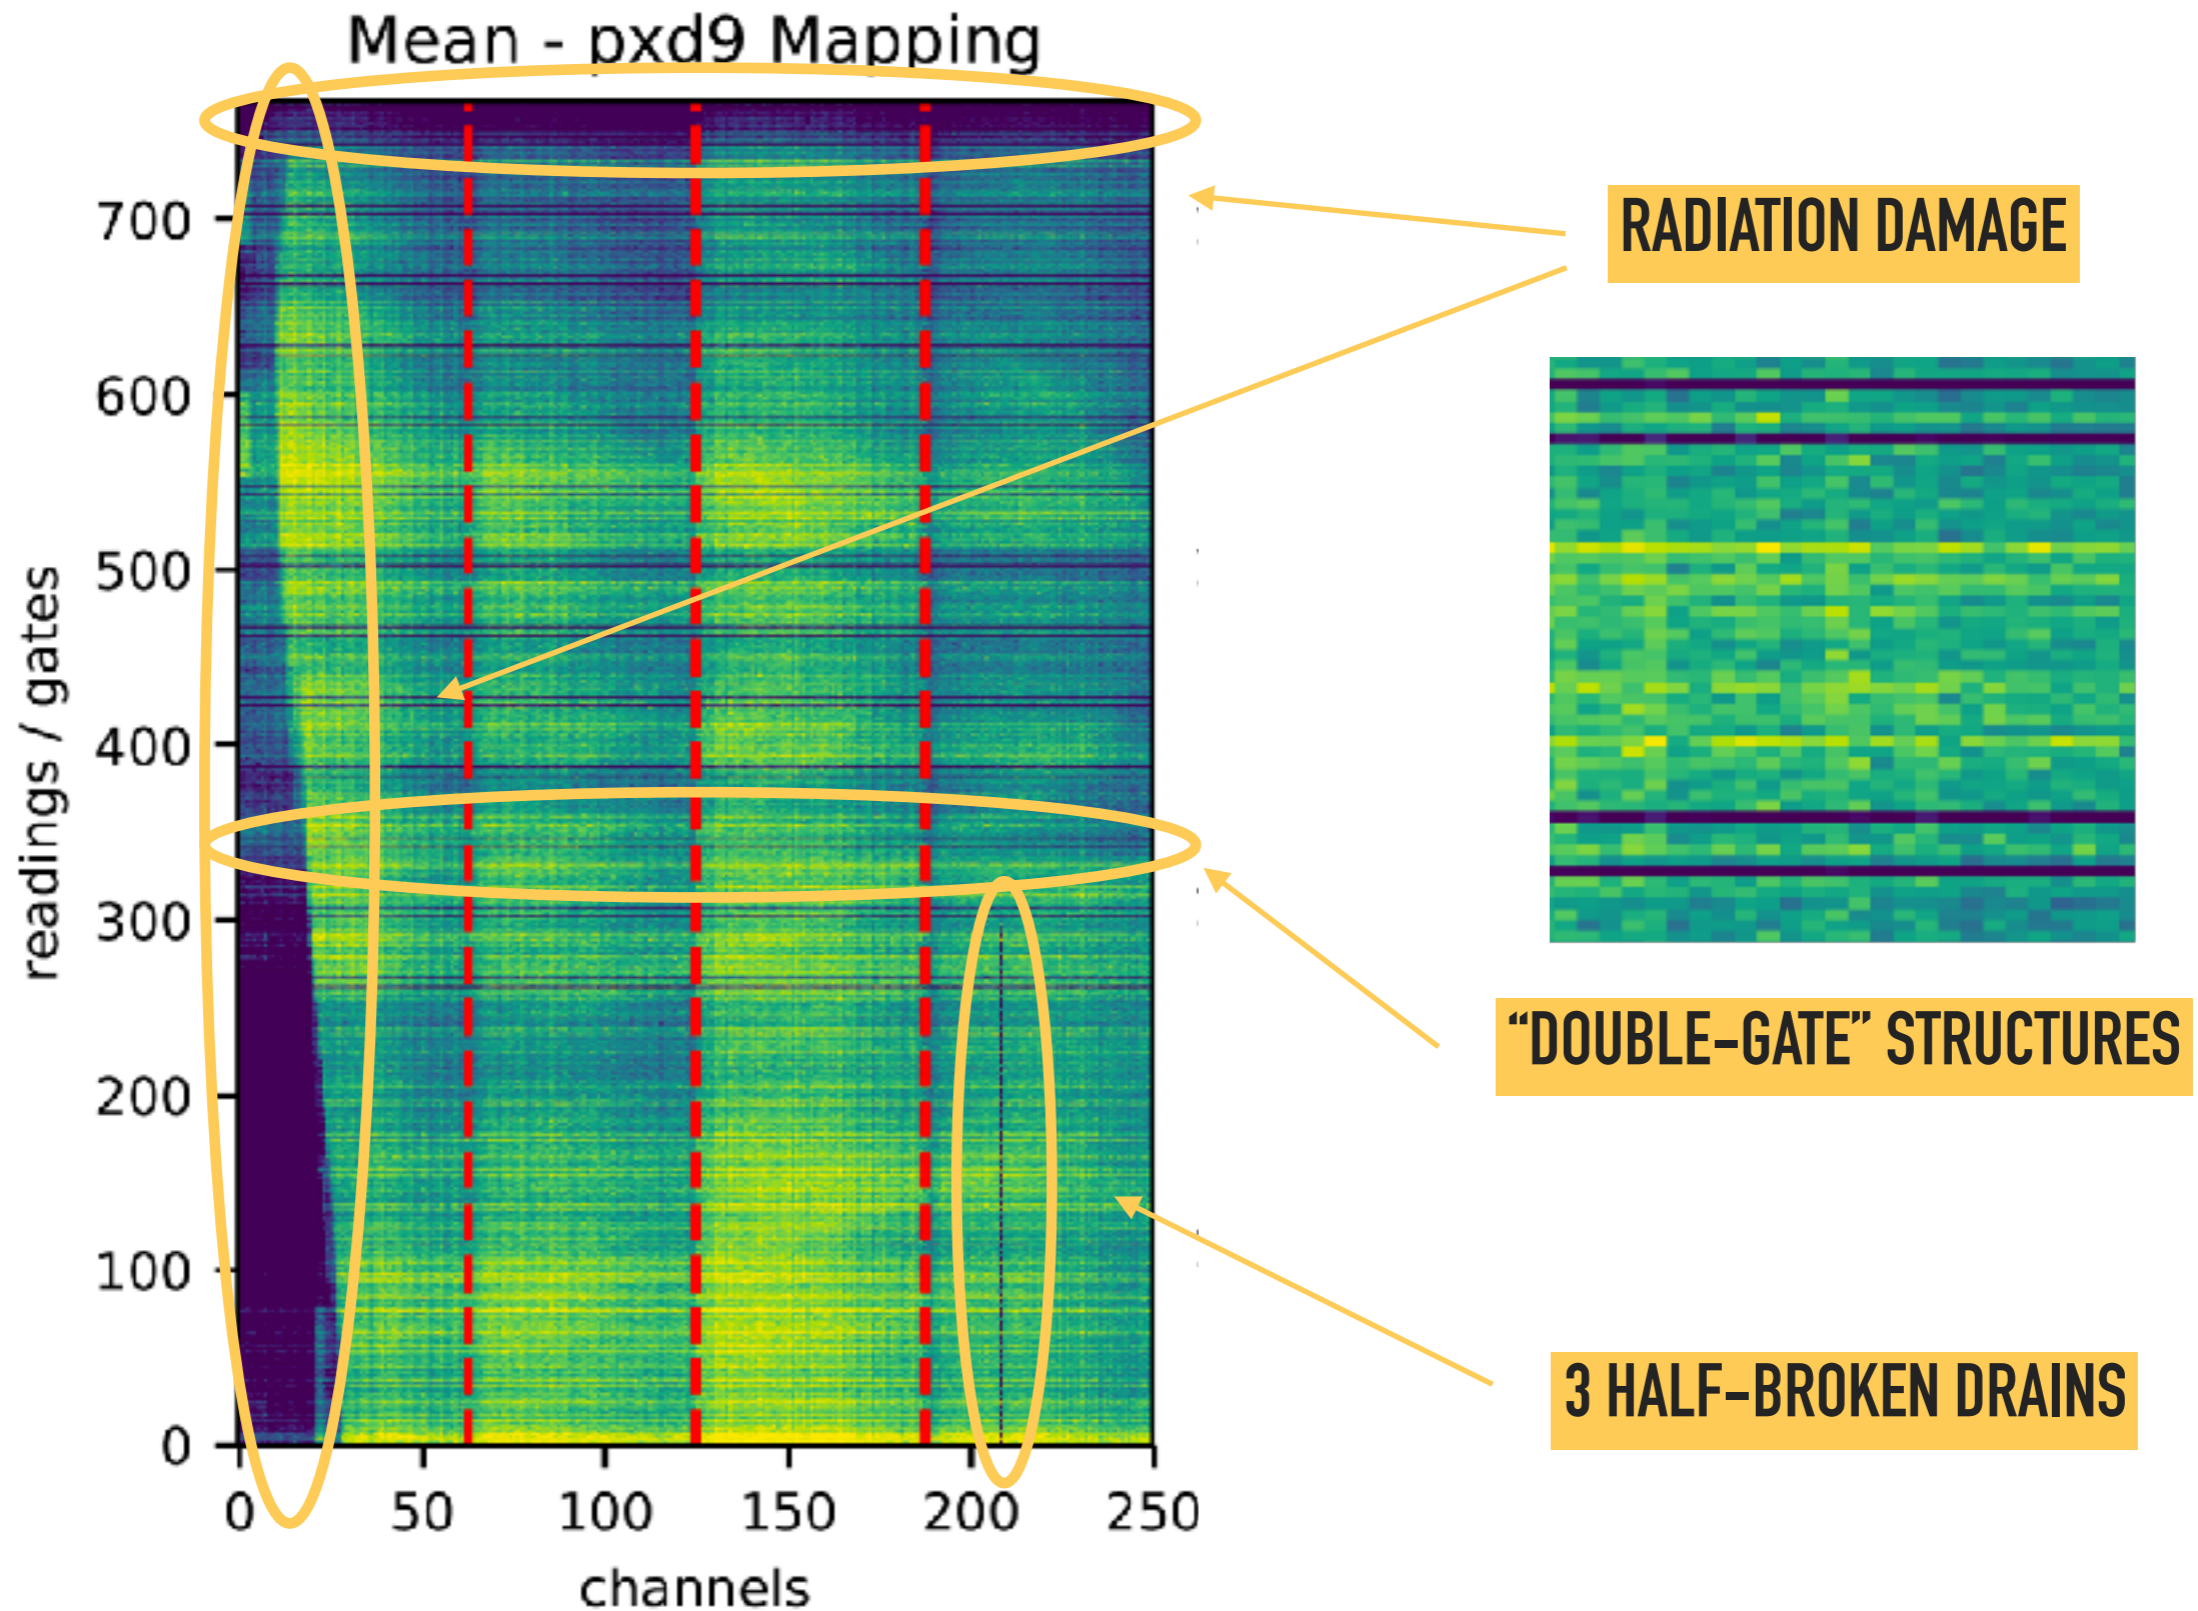
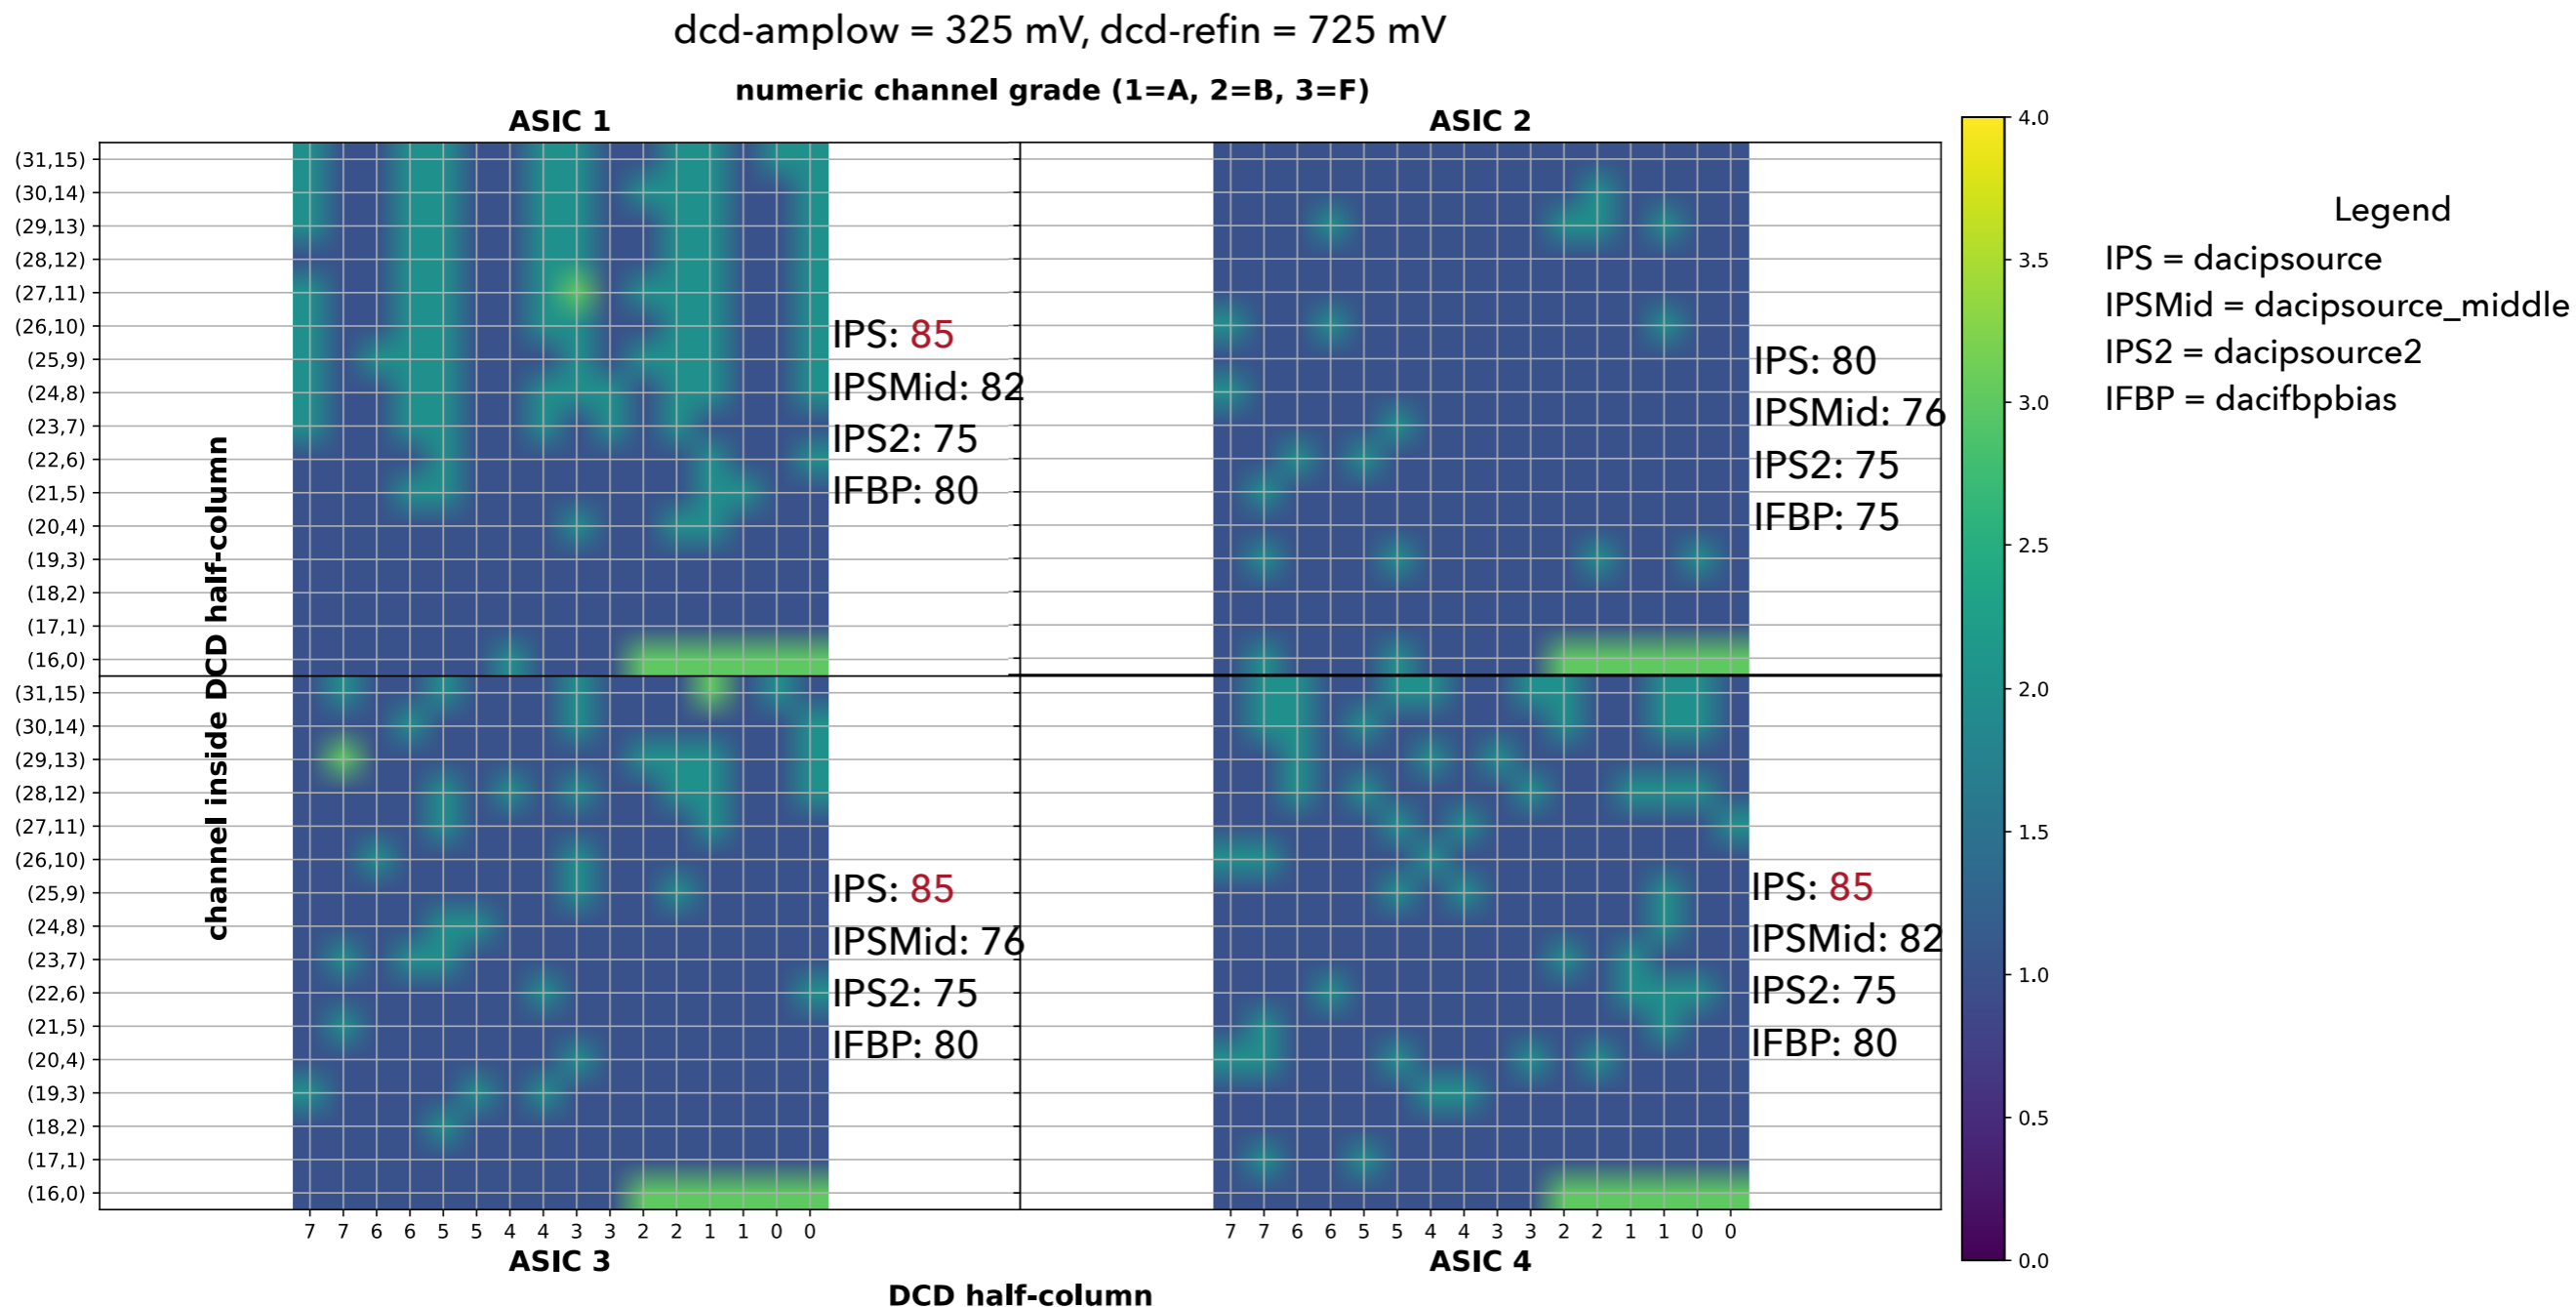
- ▶ We went for the ADC scan with the values proposed in the handbook.
- ▶ 2 ADC channels are graded as broken, all the other channels work fine.
- ▶ Some of the optimal values found were in the upper limit of the scan (in red).

- ▶ ADC sweep: 3 channels were marked as failing, all the other channels worked fine after the optimisation.
 - ▶ Offsets: with the 2-bit DAC and ACMC all the matrix could be fitted in the dynamical range (except the 3 half-dead drain lines). Noise of 0.69 ADUs was recorded.

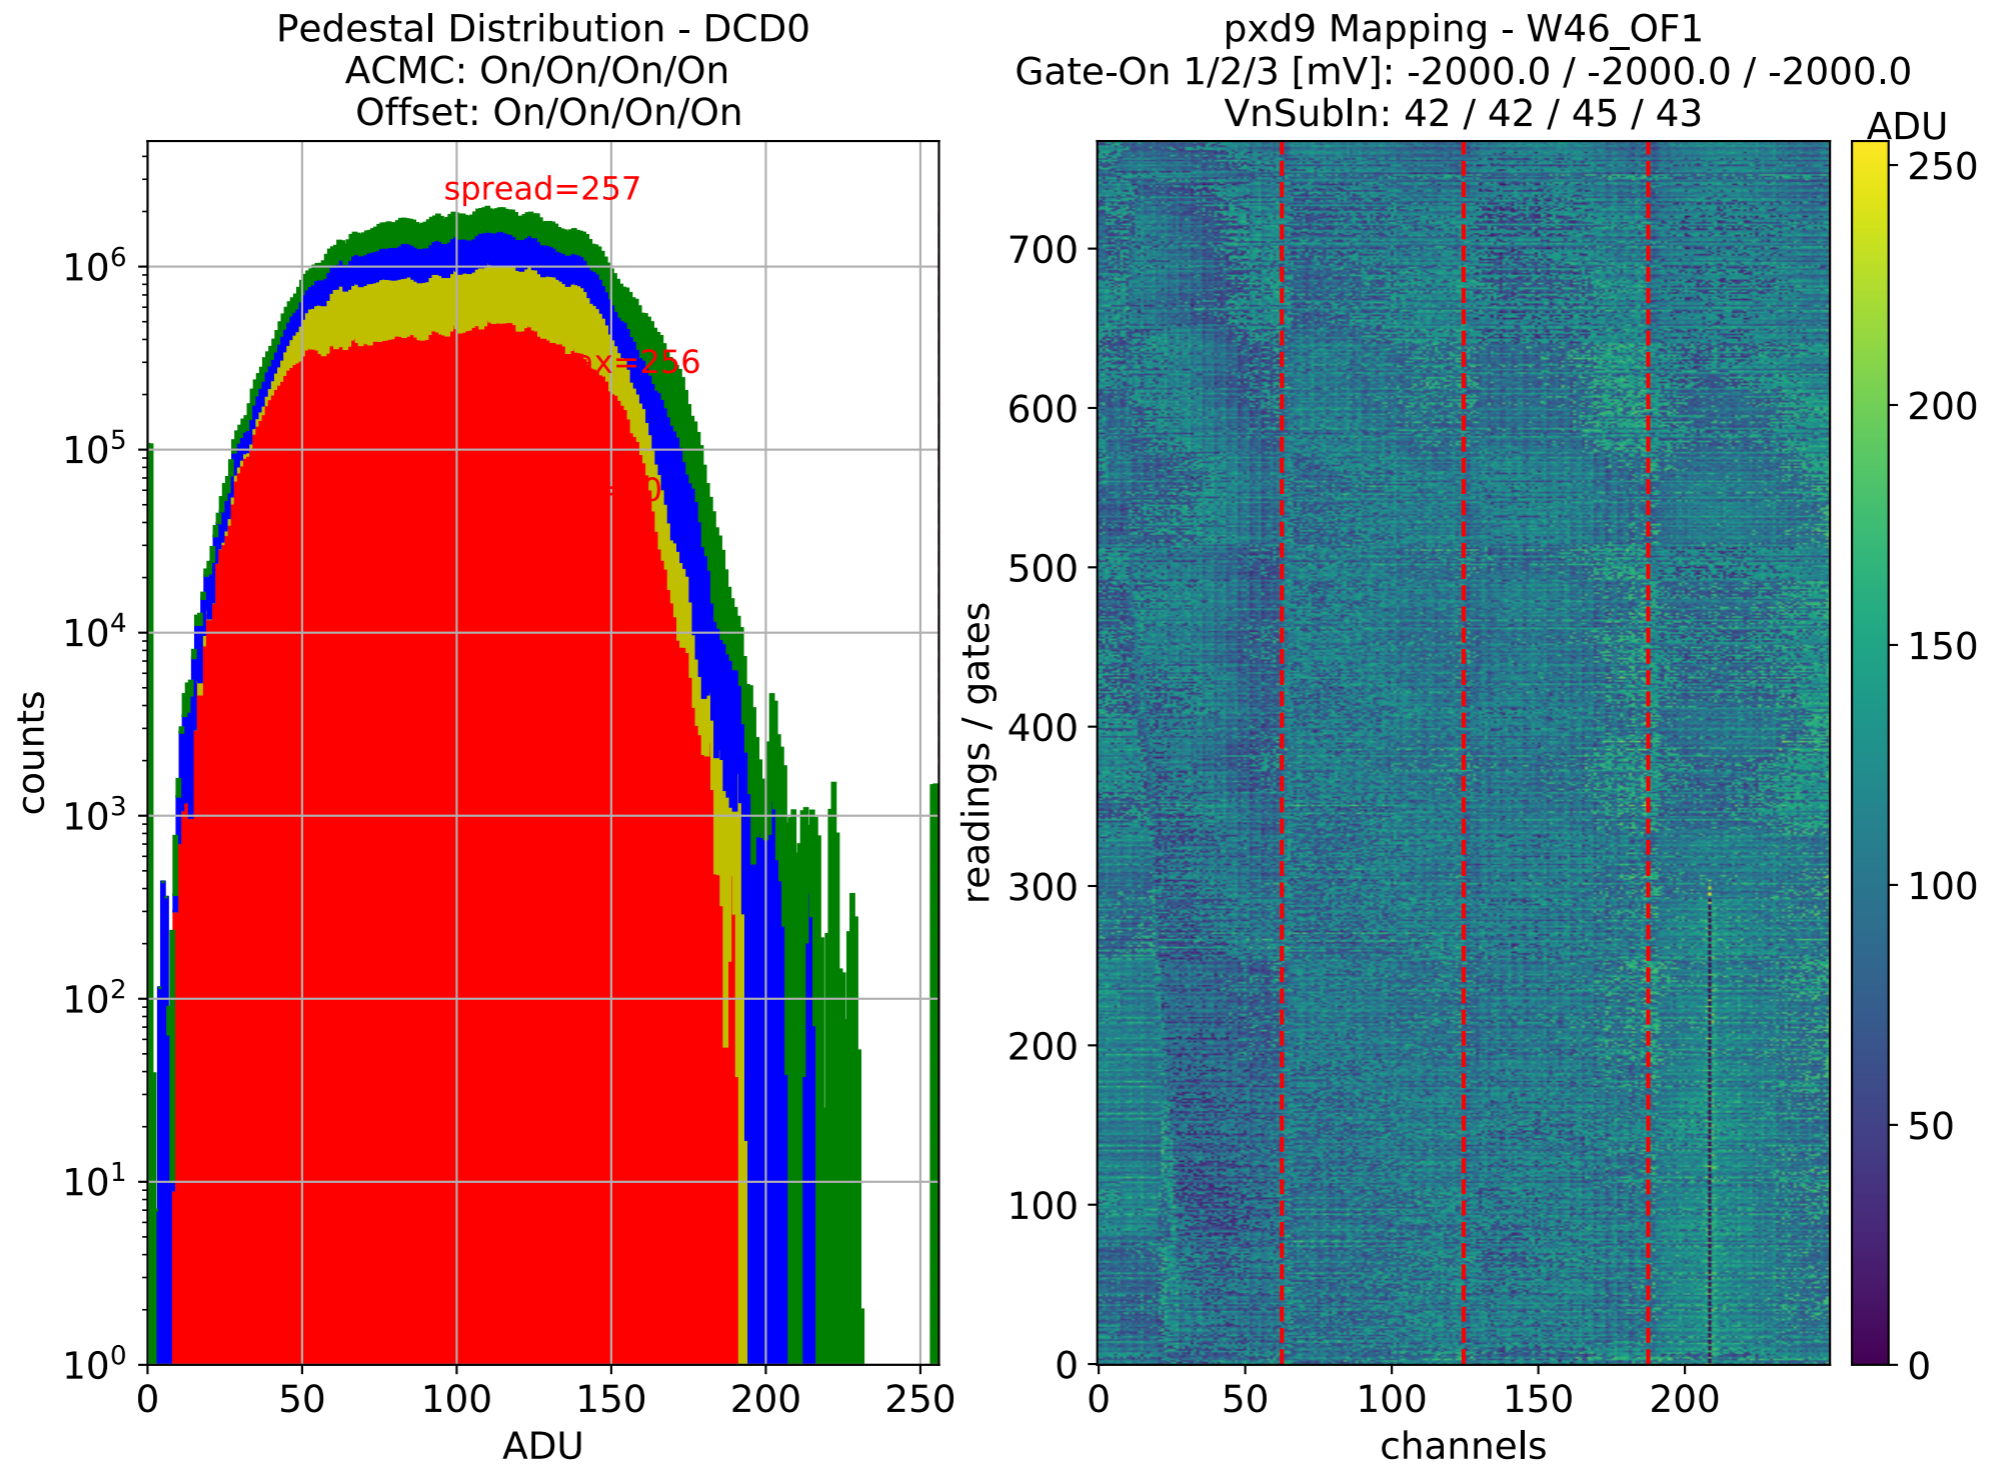
The 2-bit DAC is used mostly to recover the weaker regions: those affected by the radiation, and the double gate structure.

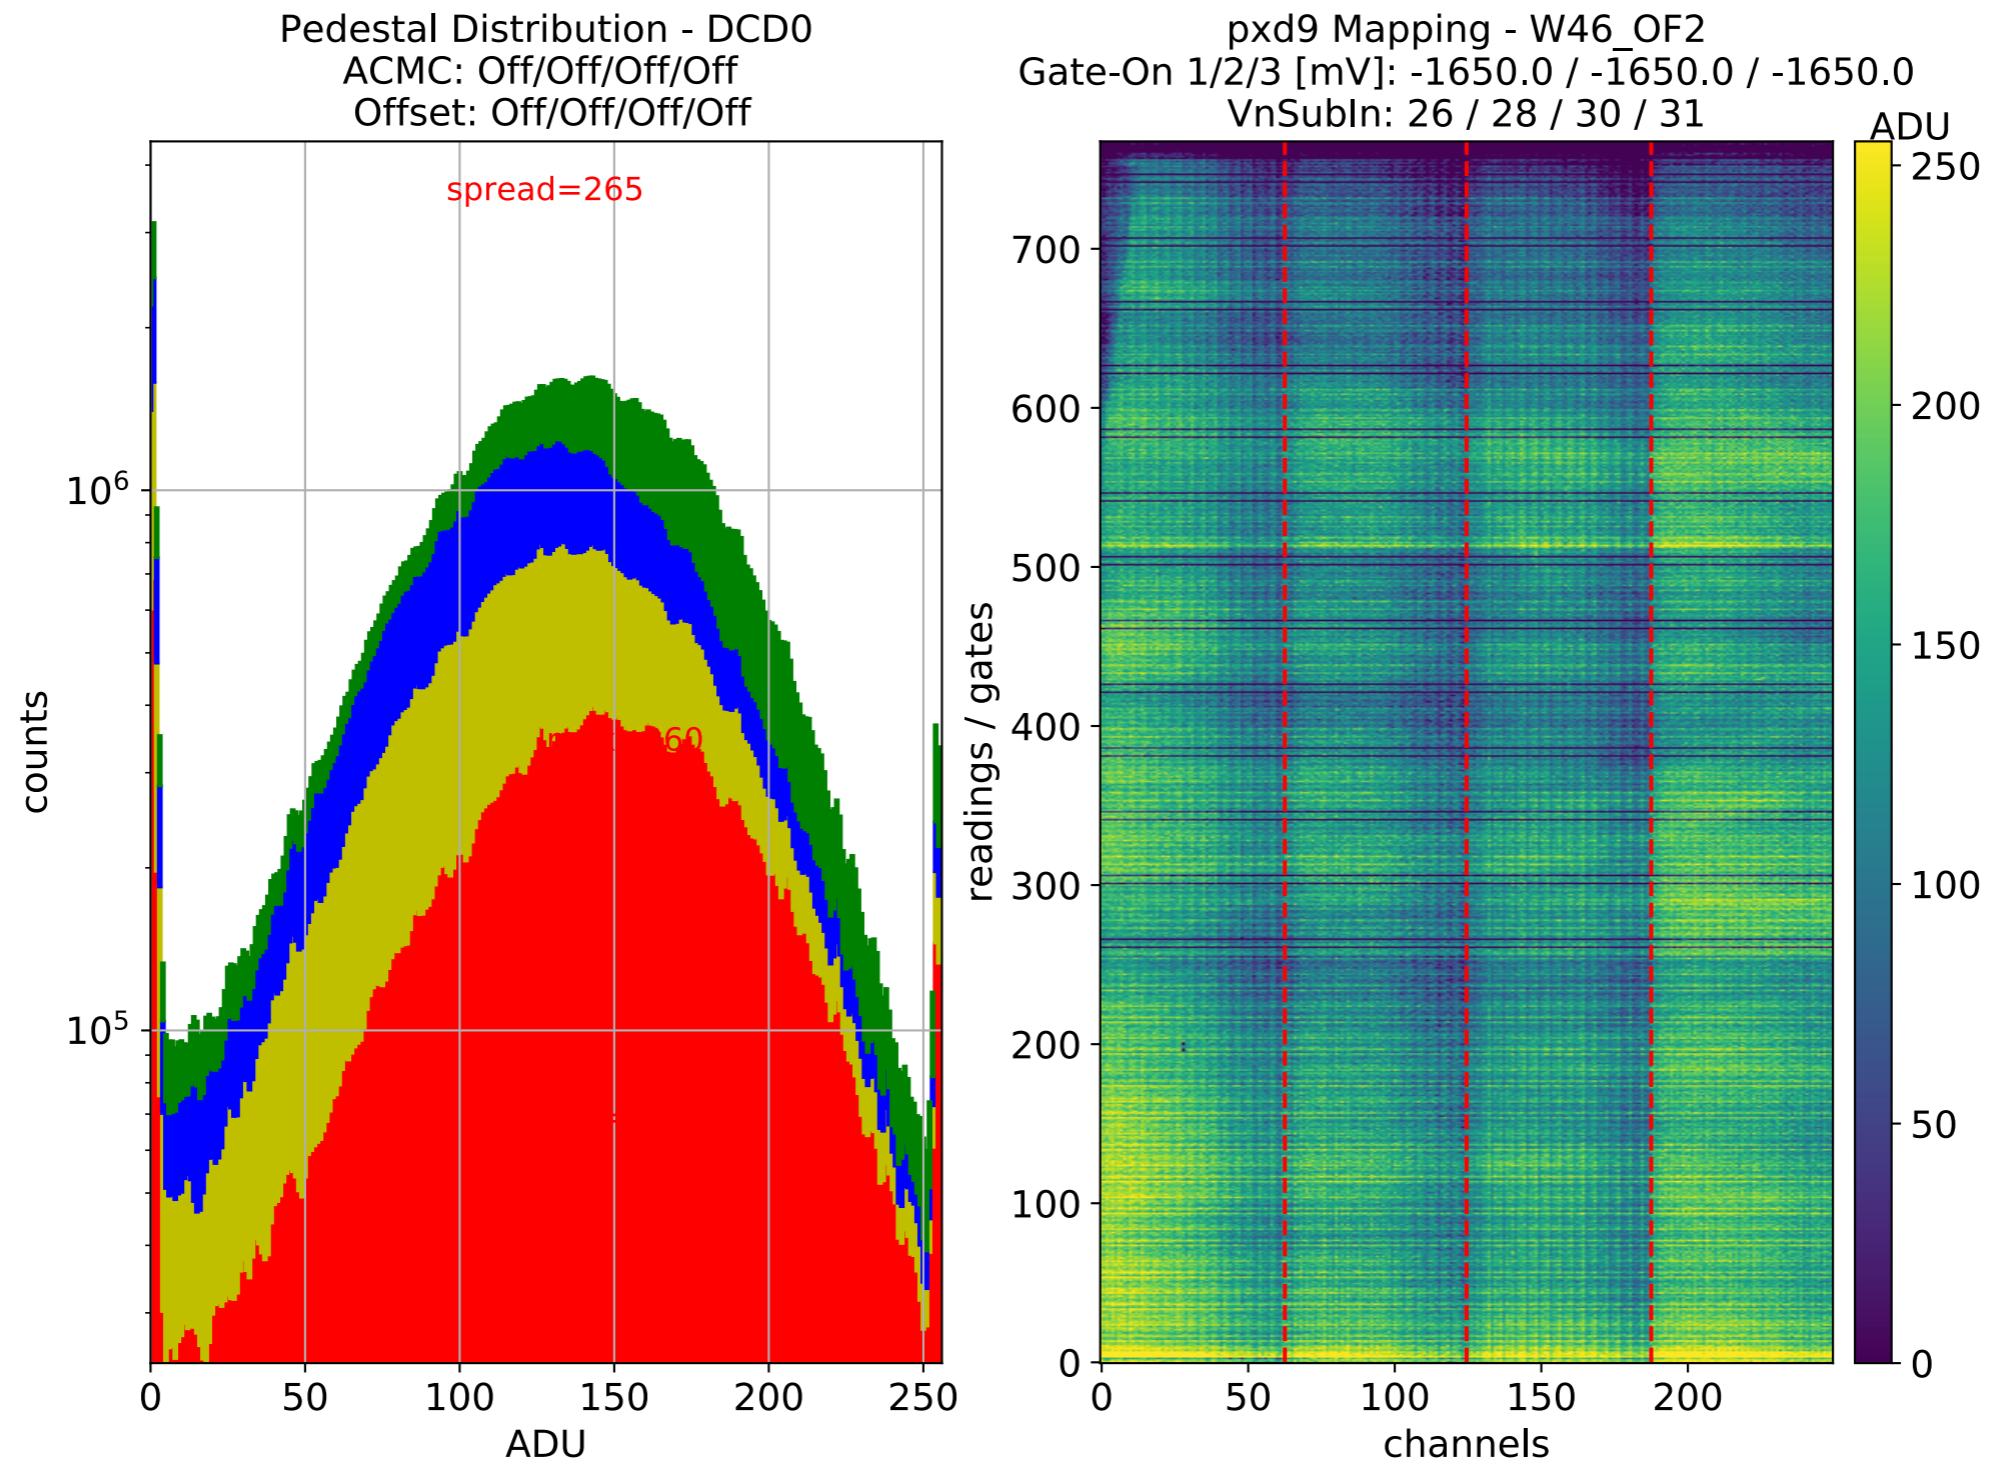
The radiation damage is mostly contained in the EOS. The same double gate structure observed in W46_OF1 is present. Also, 4 individual pixels are broken in DCD1.

- ▶ Raw pedestals: some radiation damage is appreciated near the EOS, the “double-gate” structures are present, and 4 individual pixels are dead.
 - ▶ ADC sweep: all the DCD channels were working fine after the optimisation.
