22nd INTERNATIONAL WORKSHOP ON DEPFET DETECTORS AND APPLICATIONS

STATUS UPDATE: PXD9 MODULE TESTING AT BONN

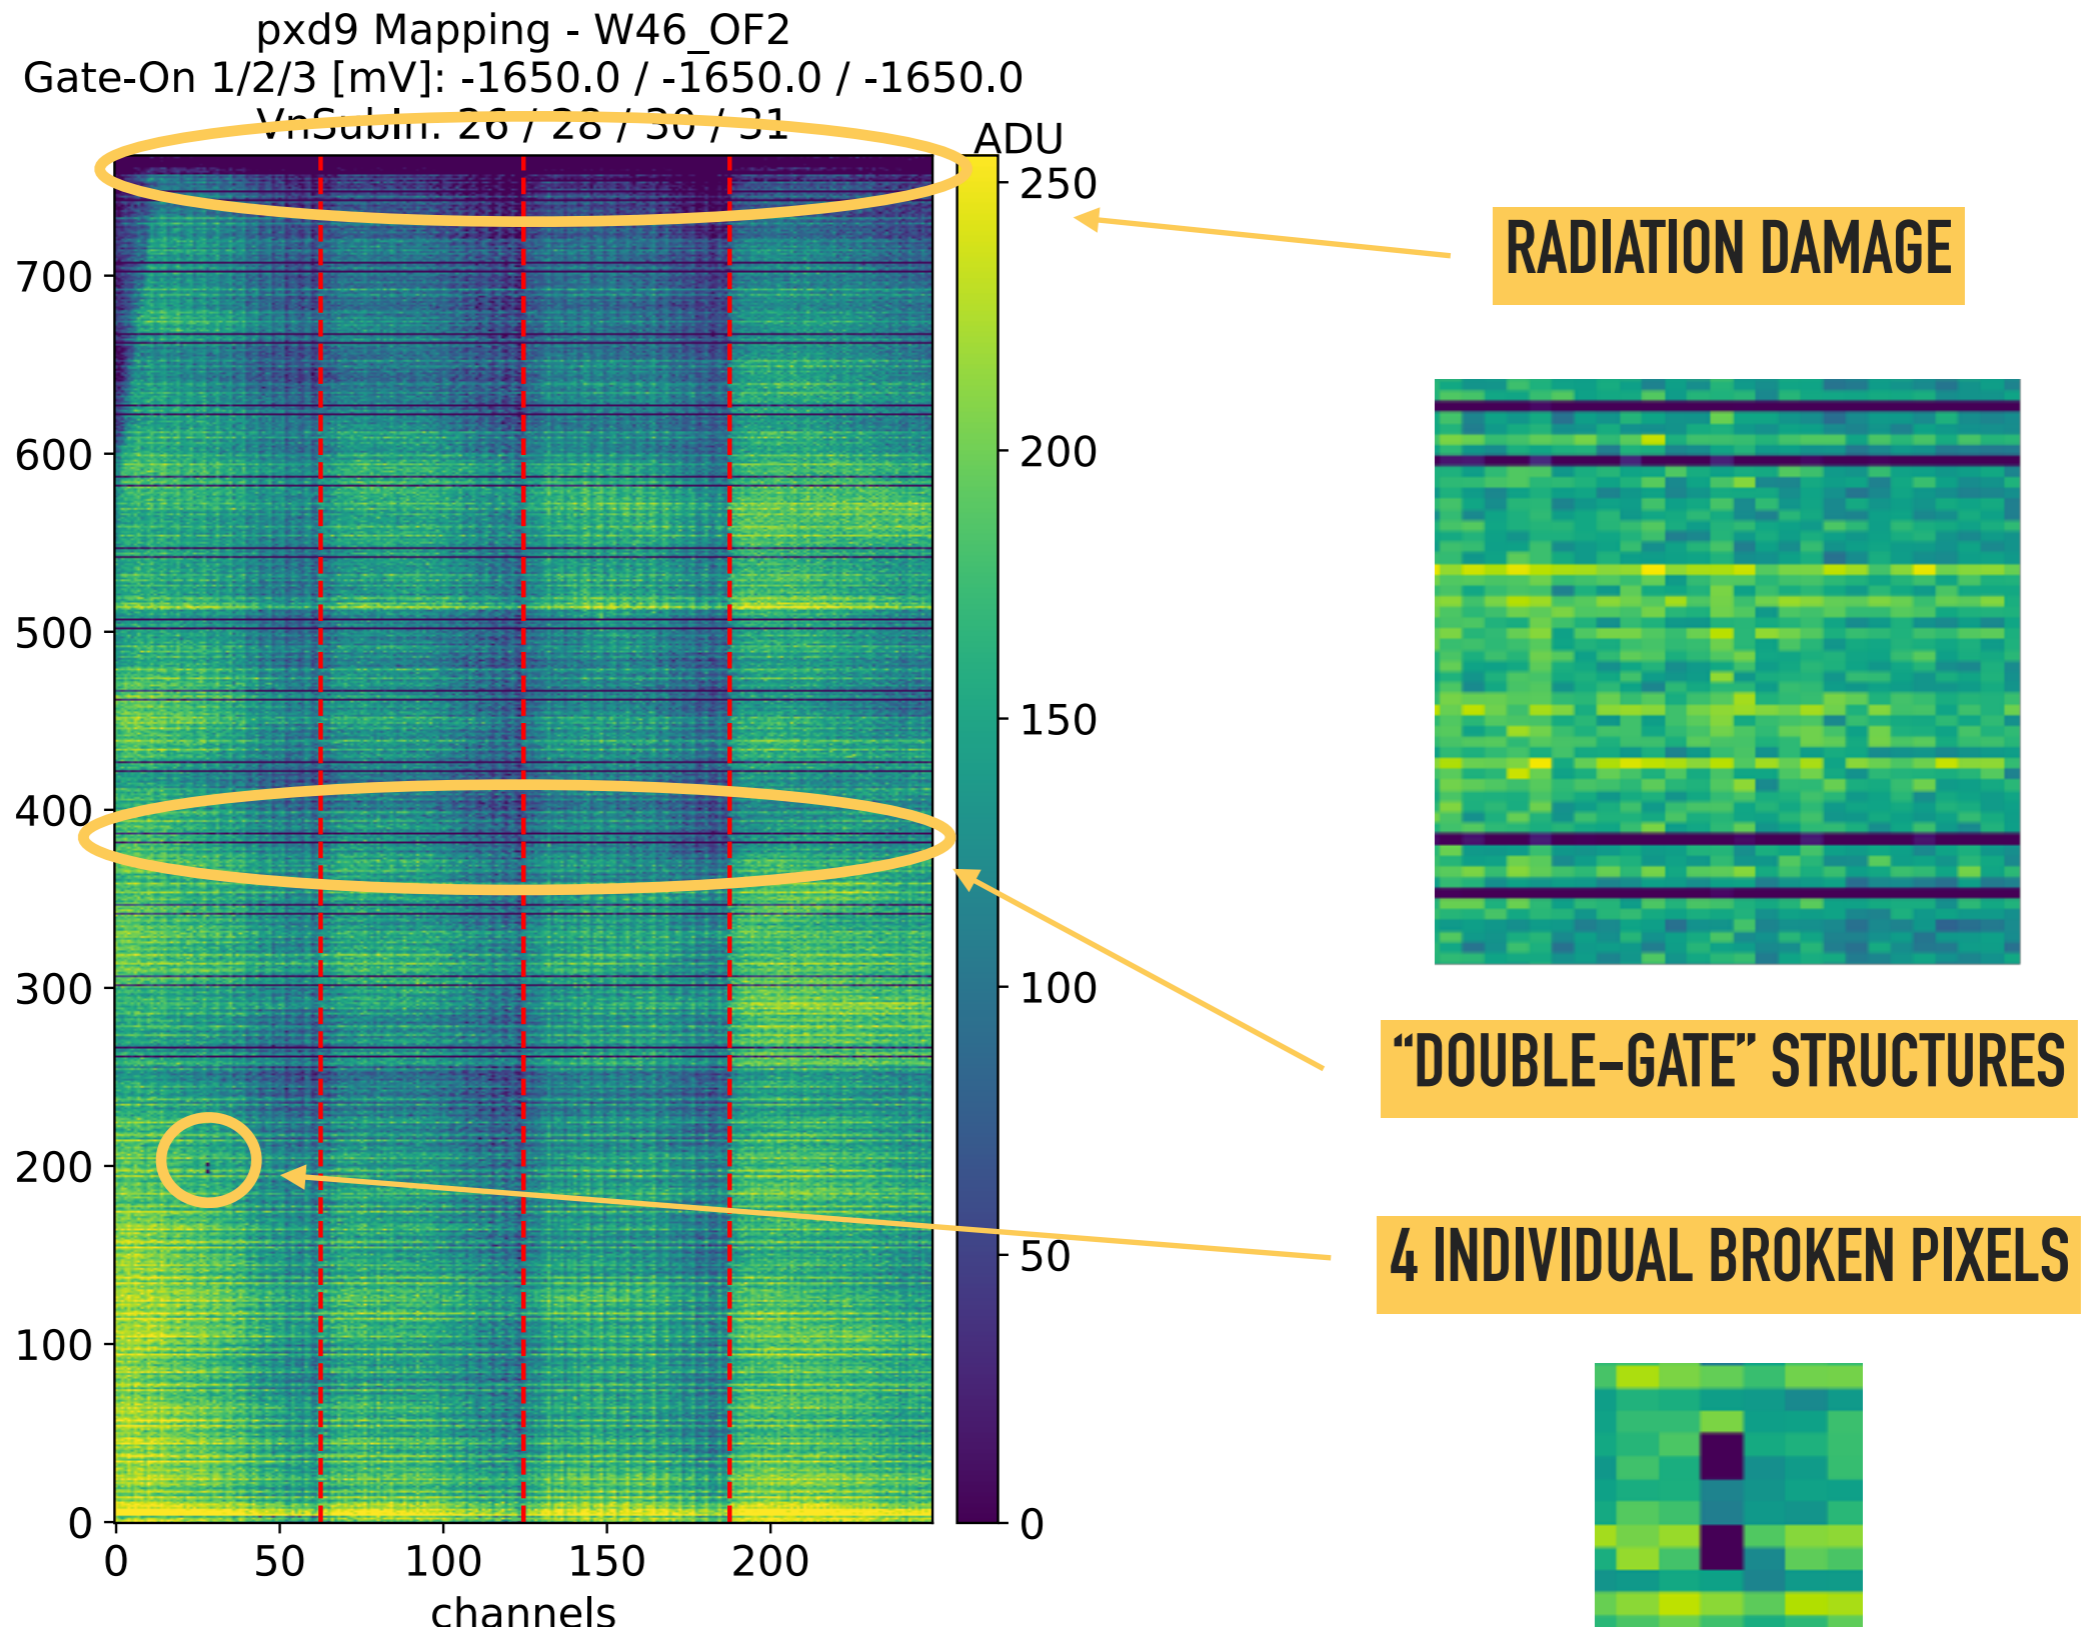
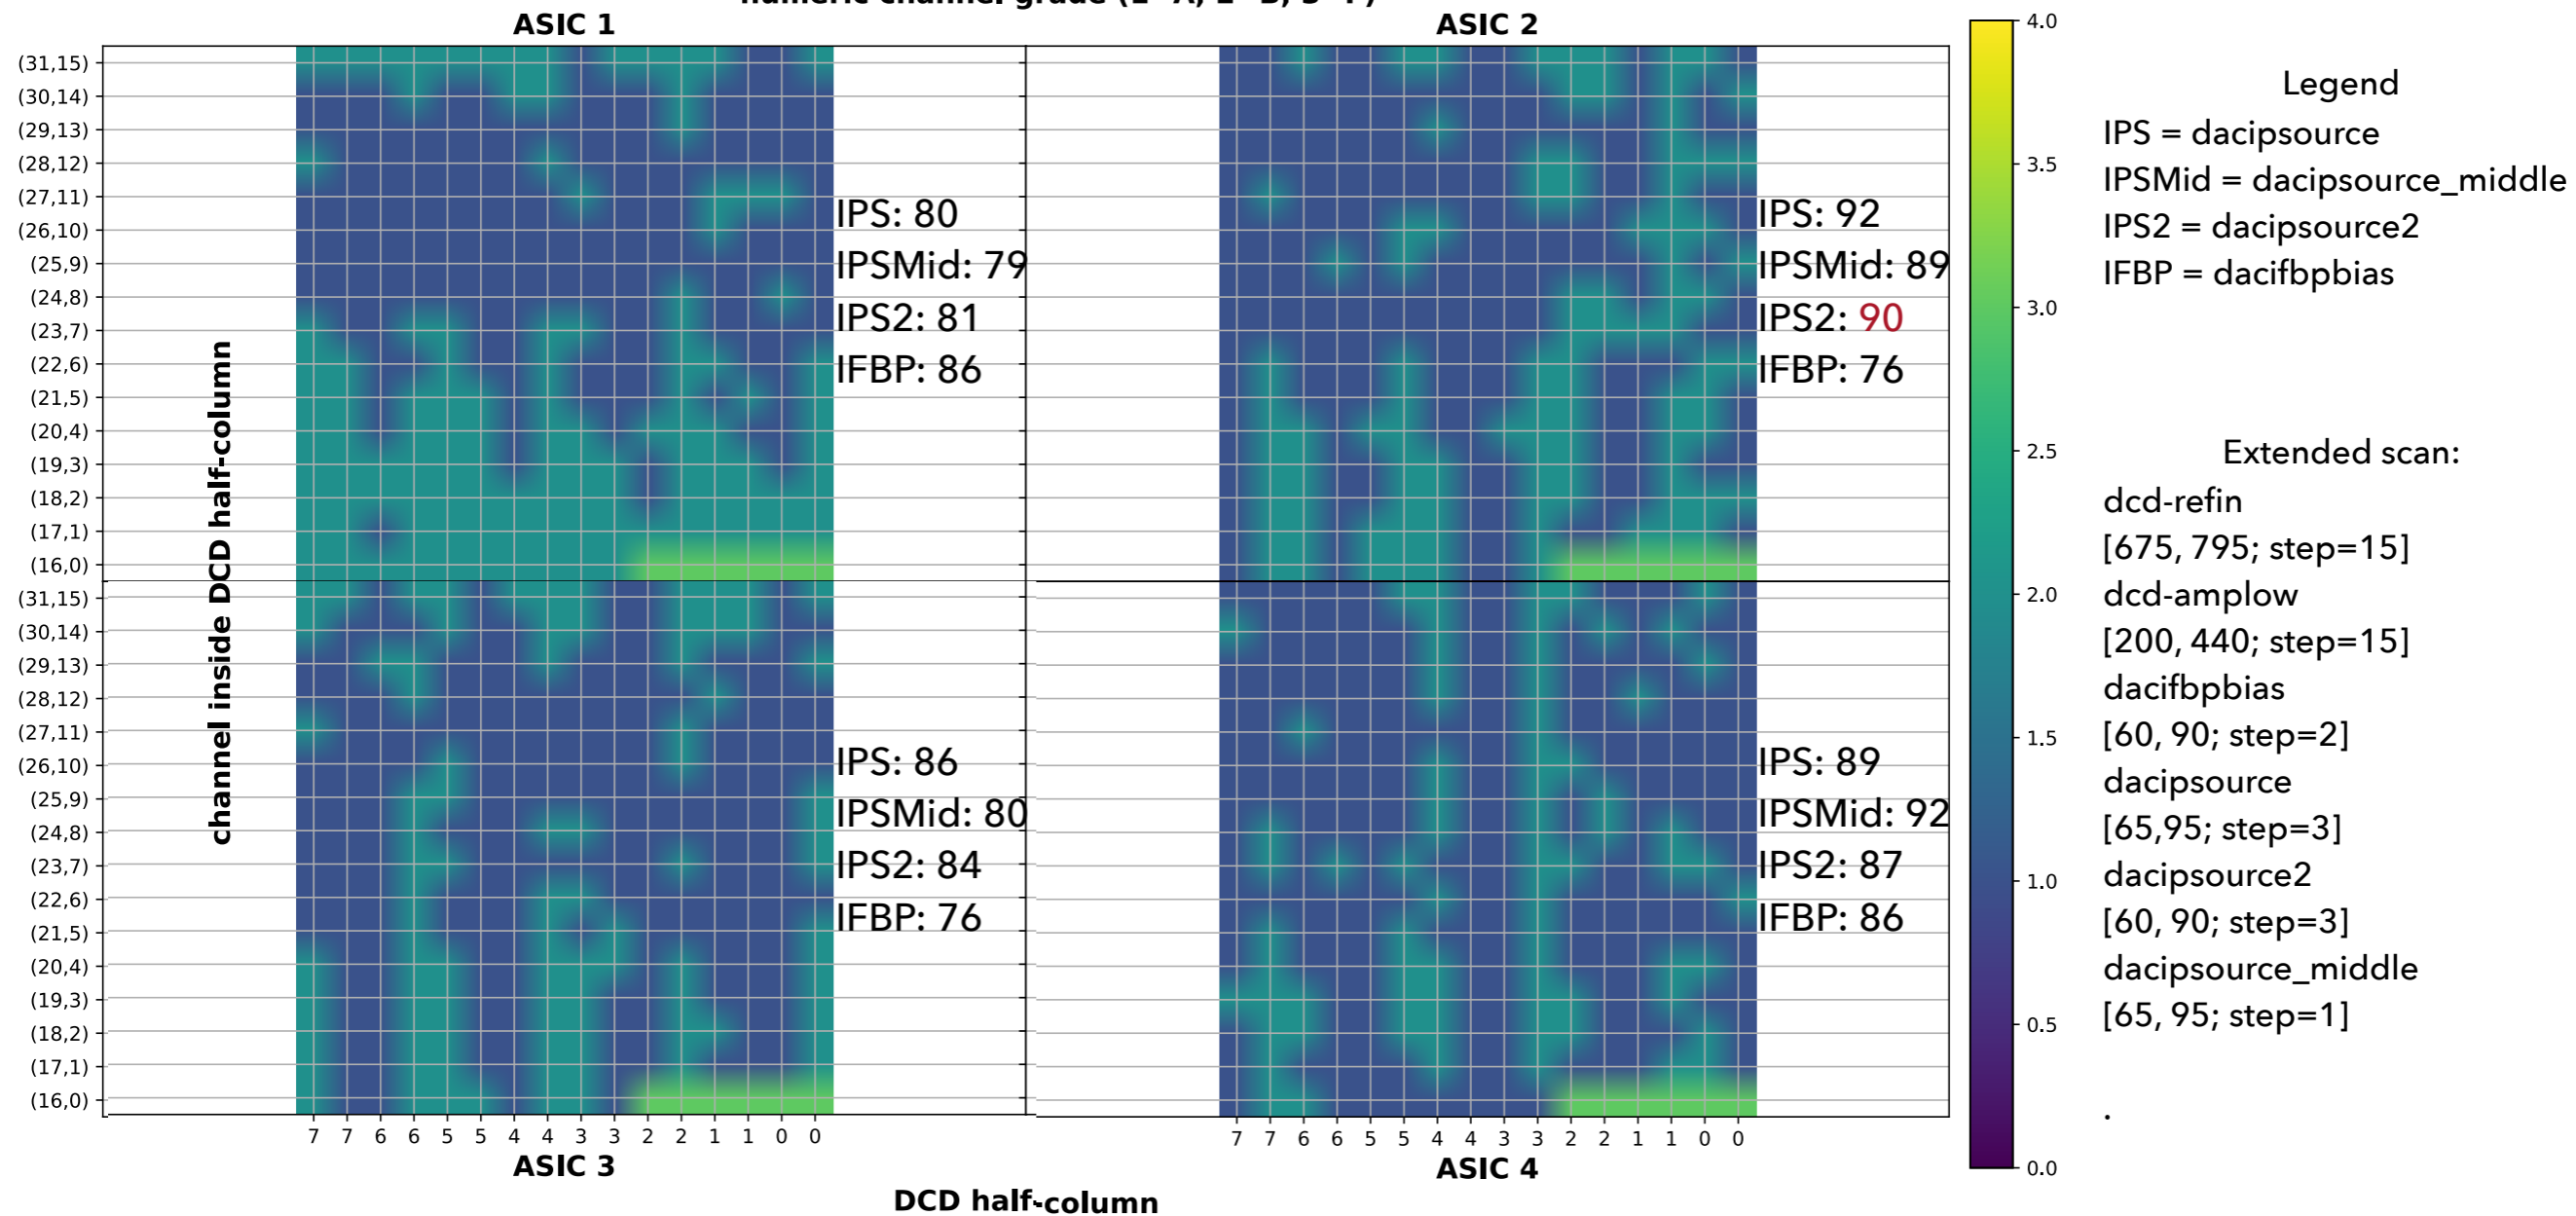
dcd-amplow = 200 mV, dcd-refin = 720 mV

numeric channel grade (1=A, 2=B, 3=F)

- ▶ We went for an extended ADC scan, as with W46_OF1 we were hitting some limits.
- ▶ All the channels are working fine. No broken channels found in the analysis.
- ▶ We found an unusually low dcd-amplow voltage to be the optimal point.

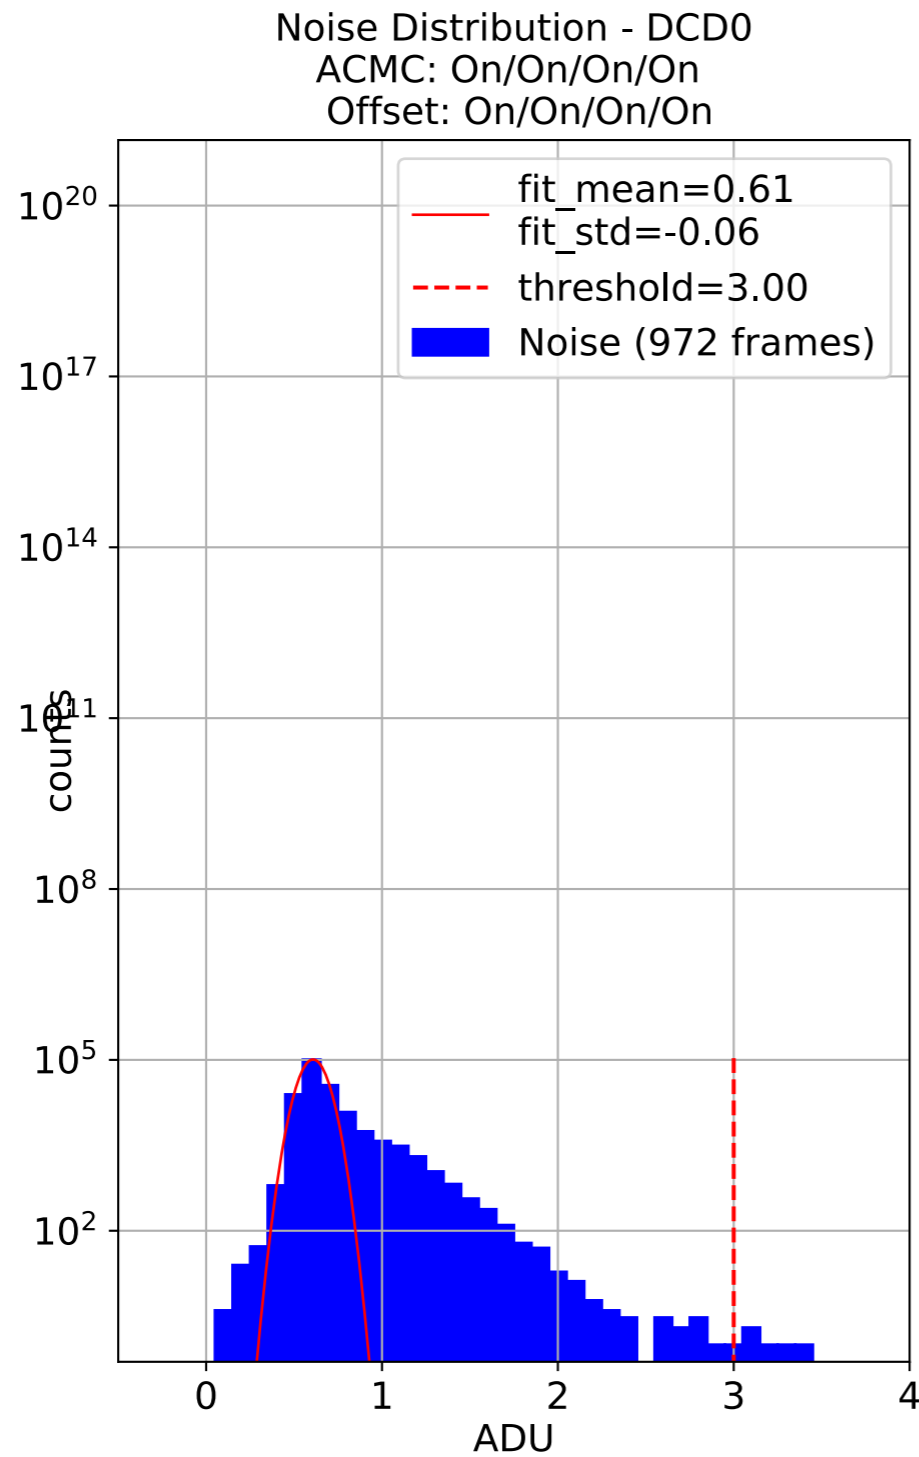
Optimal
(higher peak,
both sources,
~ringless)

HV -58V

Drift -5V

Clear-off 2 V

Gate-on -2V

The optimal parameters for this gain are compatible with the ones found for the higher gain.

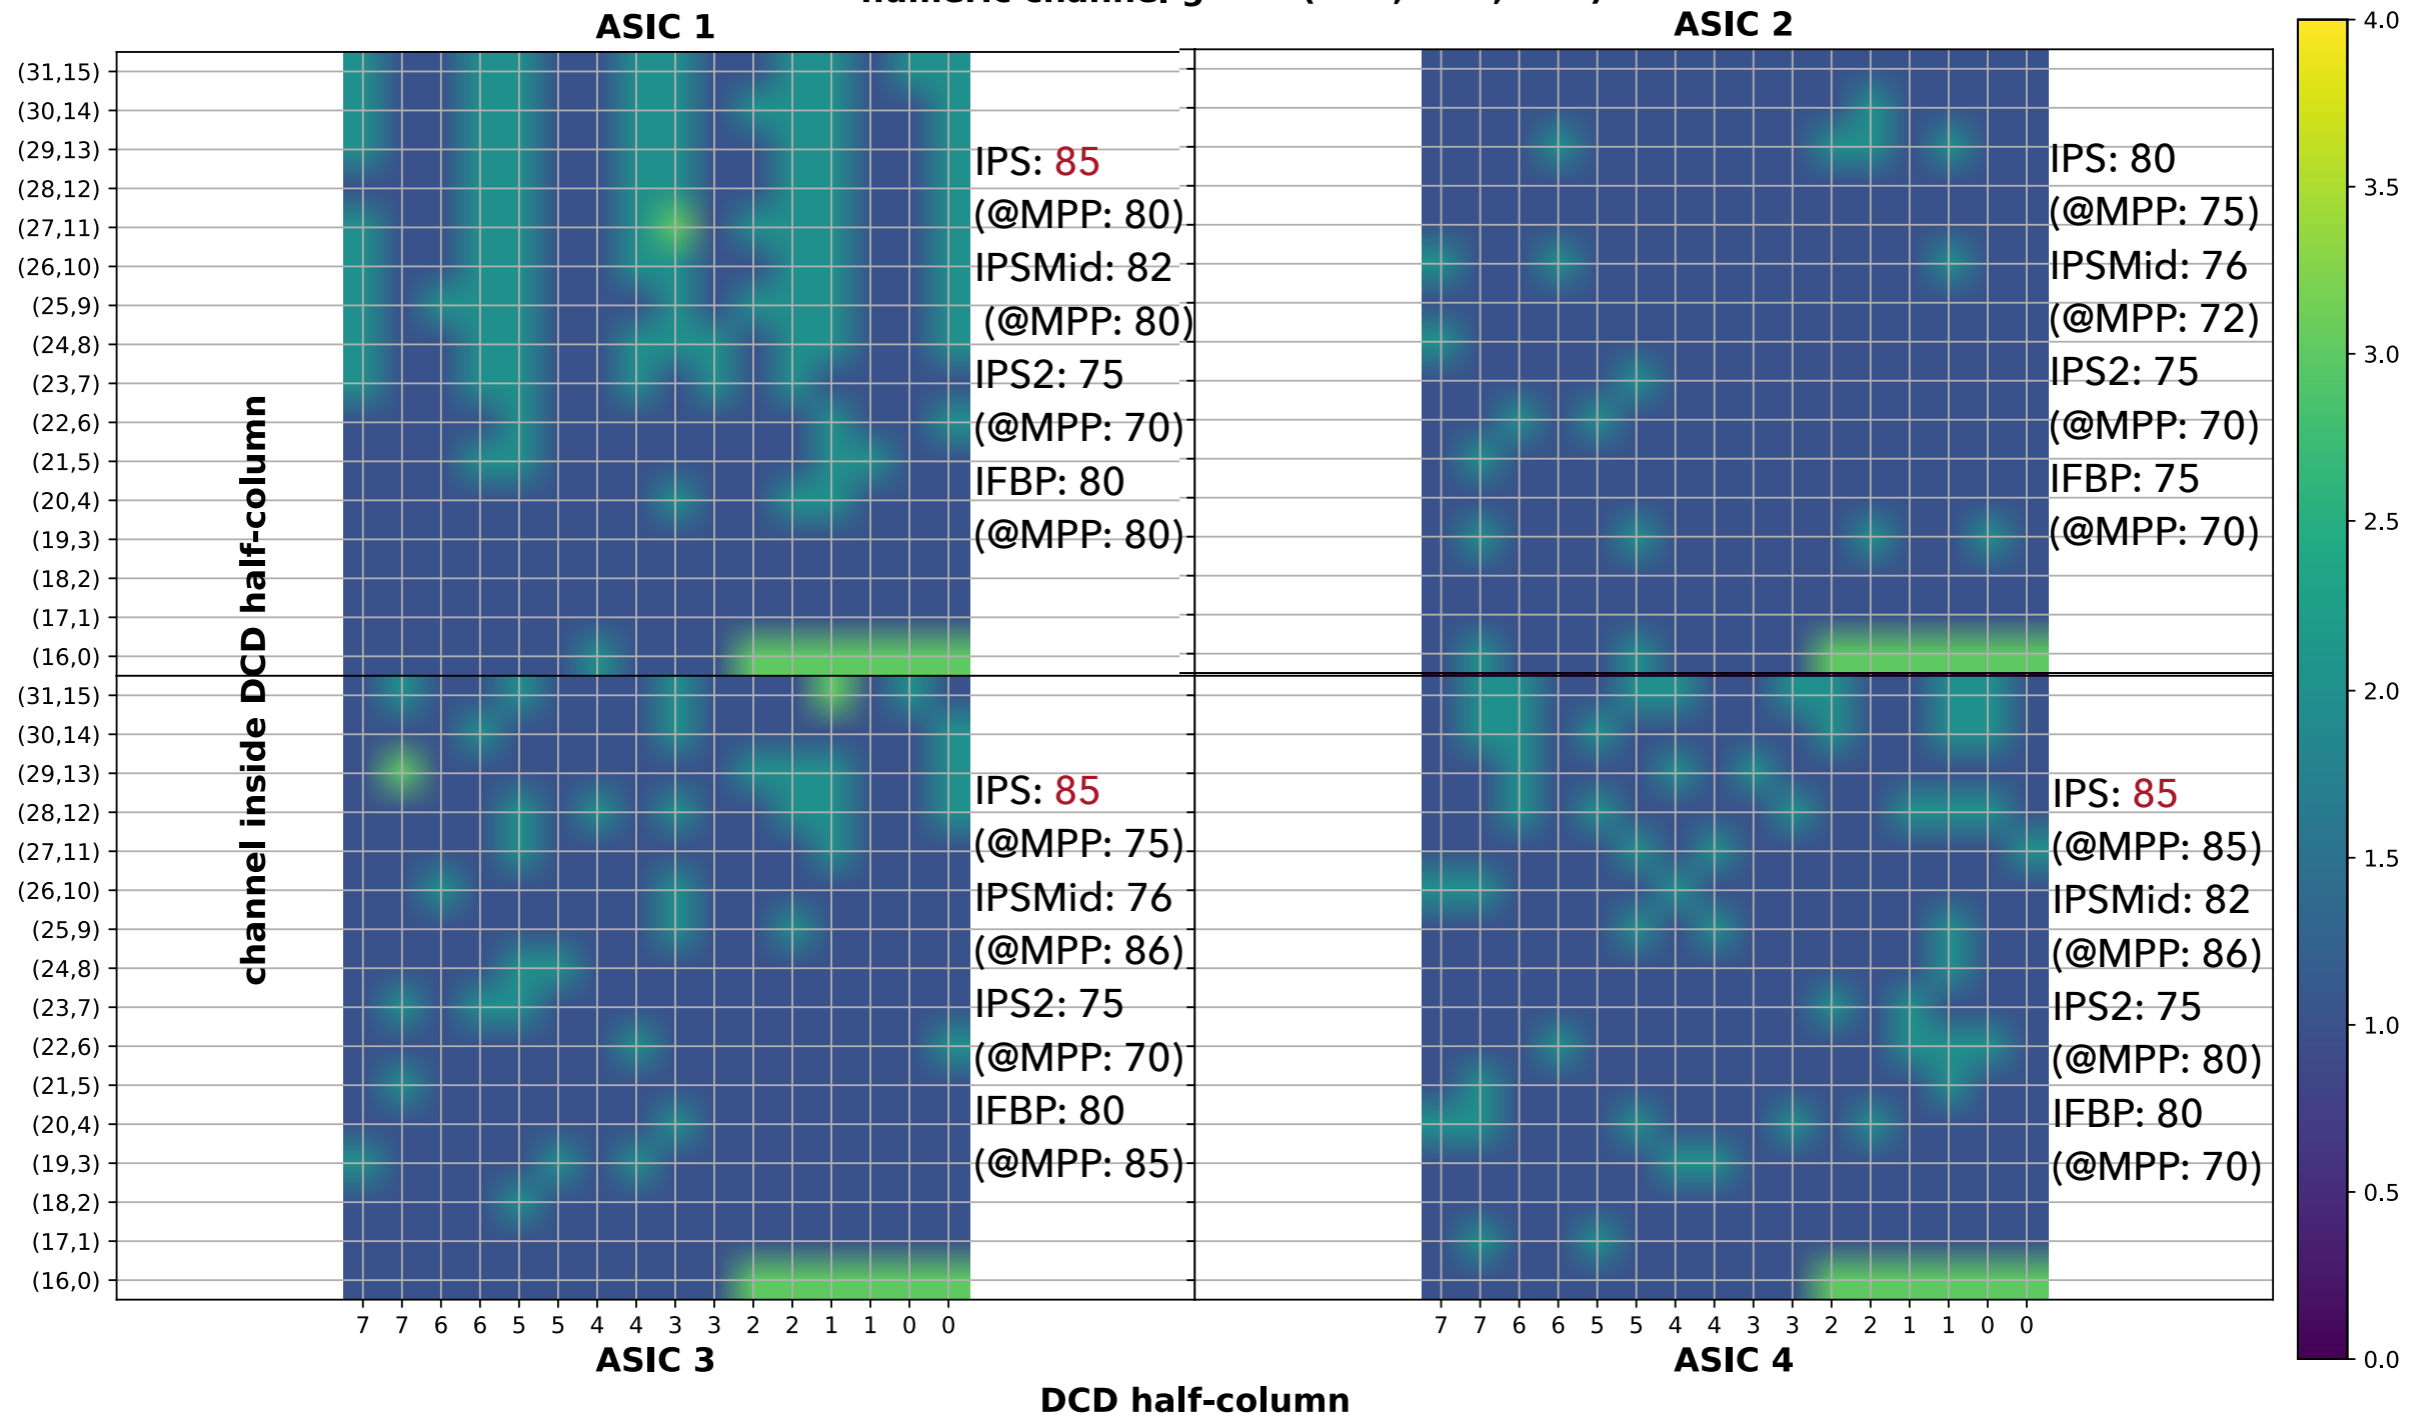
W46_OF1 ADC SCAN COMPARISON WITH MPP

dcd-amplow = 325 mV (@MPP: 300 mV), dcd-refin = 725 mV (@MPP: 750 mV)

numeric channel grade (1=A, 2=B, 3=F)
