# PXD10 WAFER PRODUCTION SUMMARY

**Semiconductor Laboratory of the  
Max Planck Society**

# PXD10 PRODUCTION OVERVIEW

# PXD10-3 WAFER LEVEL TEST AFTER ALU2

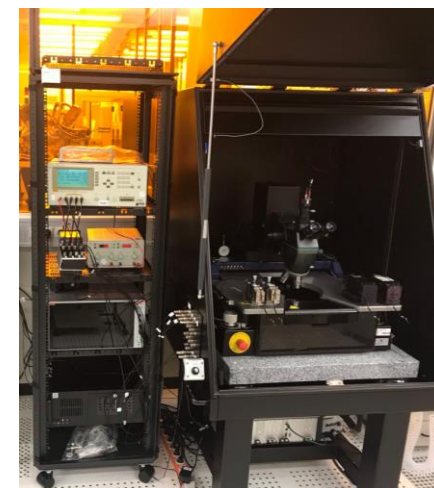
## Probe Card + 1 automated needle measurements (IV curves)

- **AllClear vs. Source:** integrity of all pn-junctions, Clear voltage sweep [0V:15V], current compliance 10  $\mu$ A
- **AllClearGate vs. Source:** integrity of the poly gates (ClearGate and Gate), does not show Gate to Clear shorts but Gate to ClearGate shorts; AllClearGate voltage sweep [-10V:+10V], current compliance 1 mA
- **AllGate vs. Source:** AllGate voltage sweep [-10V:+10V], current compliance 1mA
- **AllGate vs. AllClearGate:** AllClearGate voltage sweep [-10V:+10V], current compliance 1 mA

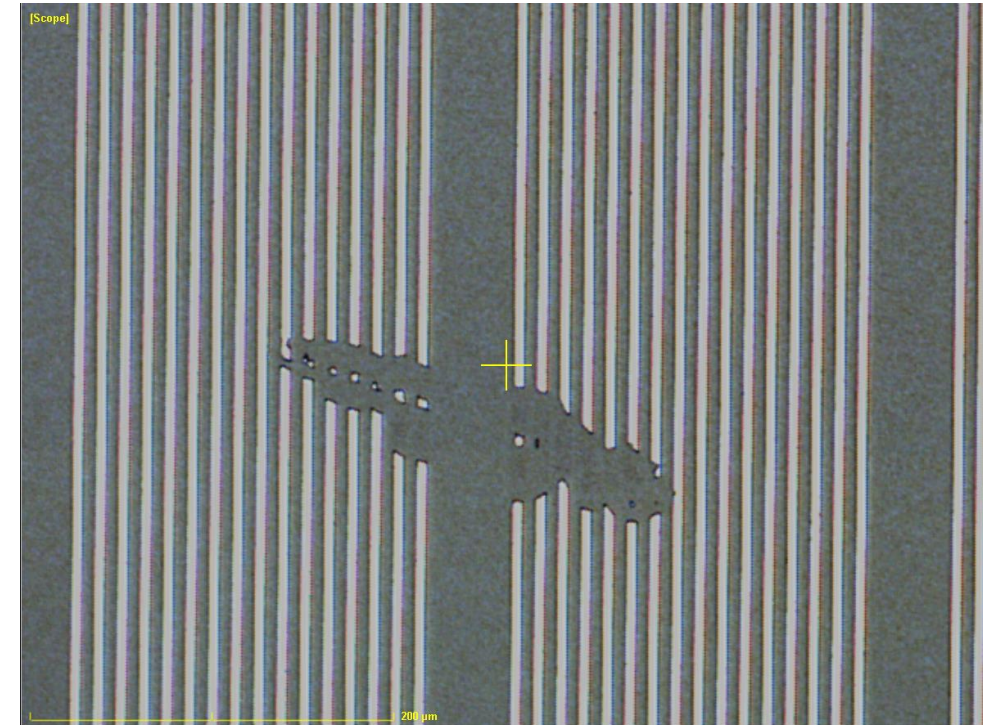
## PXD10-3 W01 D00

| Wafer | DUT | Global Test | IV Test | Comment | Repair |
|---|---|---|---|---|---|
| 1 | D00 | PASS | FAIL | 49 OPEN mainly between matrix and test pads | none |

- 49 open drain lines
- 14 due to disconnected test pads
- No shorts
