VXD Commissioning Outlook

22.05.2023

VXD Reinstallation Schedule

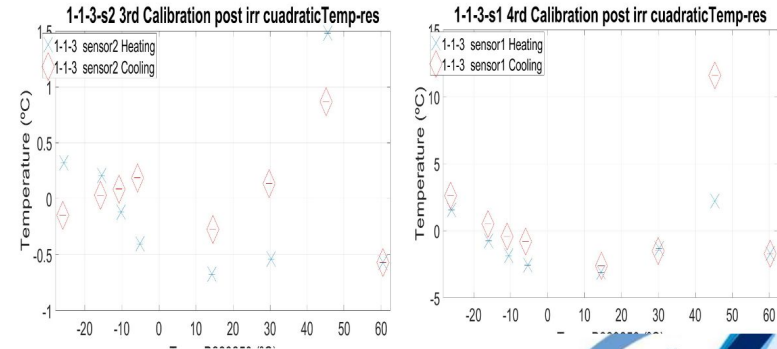
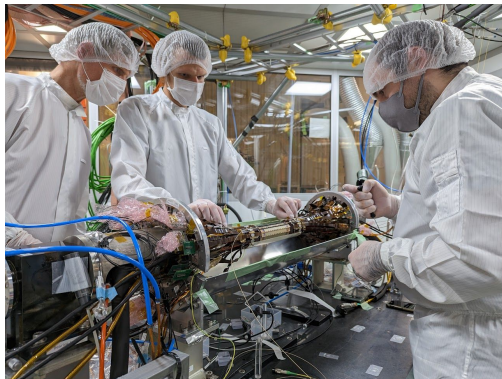
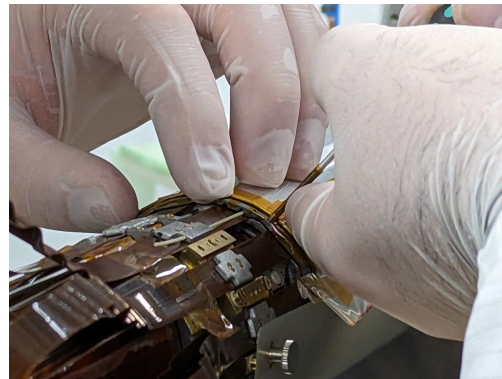
- 5 new FOS fibers have been prepared by IFCA for PXD2
 - for (only) temperature measurements at 3x4 in z x rphi positions (4 fibers)
 - not installed on PXD half shells for transport but brought to KEK separately
 - exhibit some non-understood calibration instabilities
 - exhibit some not fully understood dependence on relative air humidity
- Fiber choice and installation
 - needed to install fibers on bottom HS_1p4 before BP rotation
 - chose (good) 5th PXD1 backup fiber and "best" of the new fibers
 - for to HS_2p4 plan to reuse PXD1 fibers (after discussion with ICFA experts and SVD)
 - already take off from PXD1
 - opportunity to install next week

Fibers calibration: Bad calibration curves

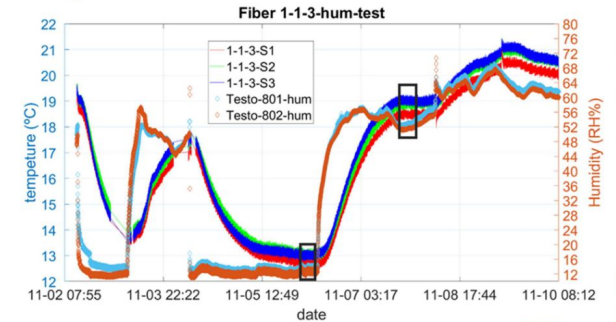
Humidity sensitivity after temperature compensation

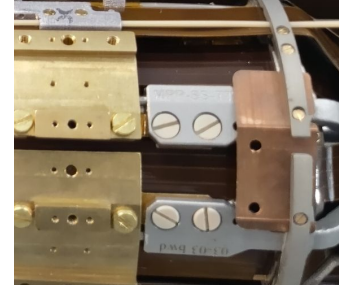
PXD2 Proposal

- solder to copper clamp
- flat cable fit through Kapton fixation
- fix on inside of heavy metal

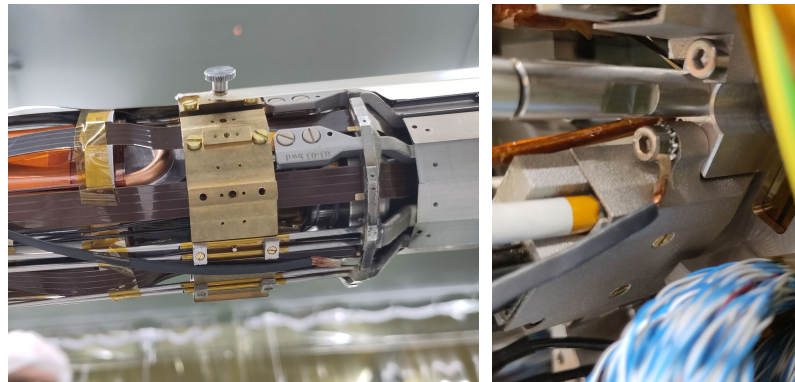
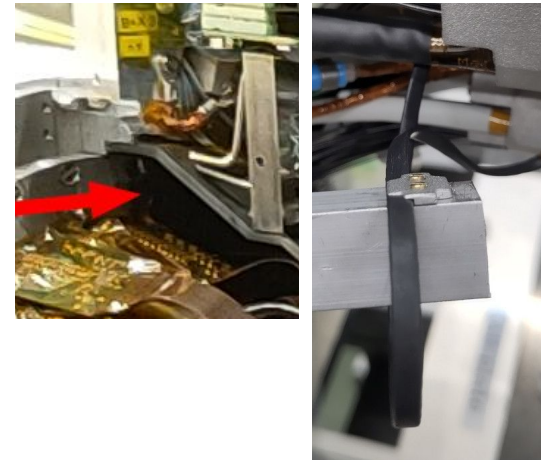
- PXD2 grounding cable connected to SCBs at grounding ring
 - sandwiched between L1 and L2 Kaptons
 - last minute ad-hoc "solution"
 - no cable routing past brass mount block foreseen
- tightest space to SVD wirebonds

PXD1 Setup

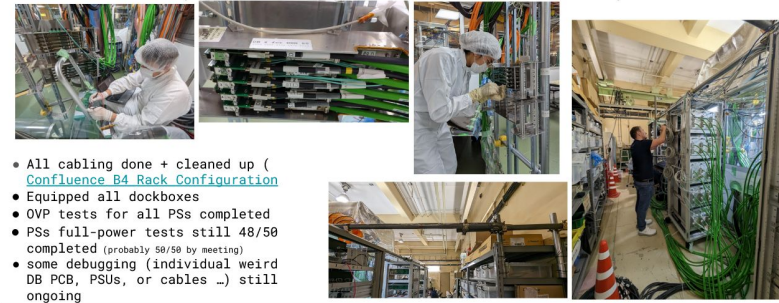
PXD Services Preparations: Power Supply System

- last week: pushed service teams (power supply, DHH, env monitoring, ...) to get things working minimally for mechanical HS_2p4 tests
→ approach safe and fast but incomplete
- this week: make everything perfect and prepare and test full PXD services system

- All cabling done + cleaned up ([Confluence B4 Rack Configuration](#))
- Equipped all dockboxes
- OVP tests for all PSs completed
- PSs full-power tests still 48/50 completed (probably 50/50 by meeting)
- some debugging (individual weird DB PCB, PSUs, or cables ...) still ongoing

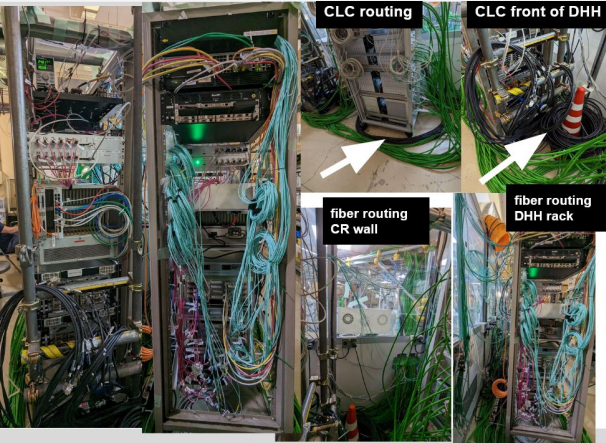
DHH Rack

- 40 CLC routed to DHH rack
- All dockbox fibers routed to DHH rack
- Cleaned up all DHH rack Connections
- Fiber to optical switch tests completed
- optical switch to DHH tests pending (need modules)
- Debugging ongoing (config, single cards not fully behaving yet)
