- Charge collection of PXD9 Depfets

Charge loss mechanisms  
Ring pattern  
Operation windows  
Recommendations

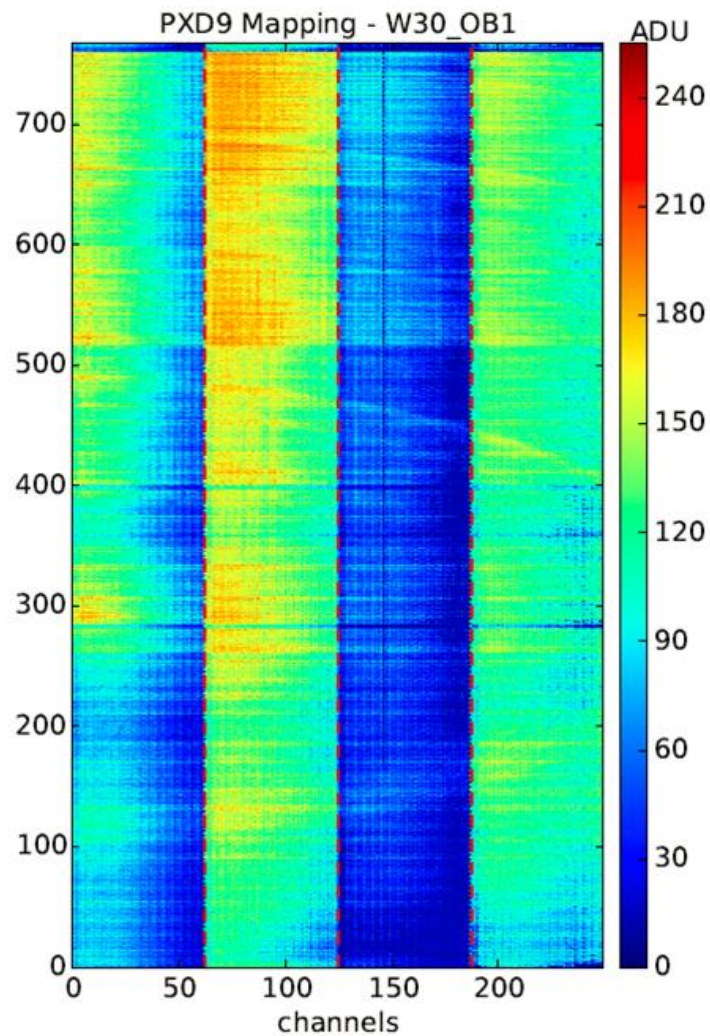
- Pedestal Map

● But we see strips in the charge collection

Strips change their behavior.

Dead strips at low HV show  
best charge collection  
on very high HV  
and vice versa

Strips are inclined:  
cannot be assigned, neither to  
columns nor to rows

Must be a sensor property

measured by Christian and Felix

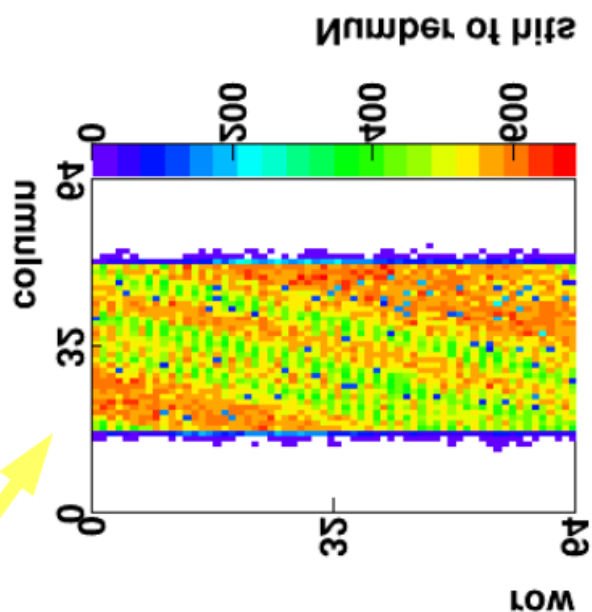
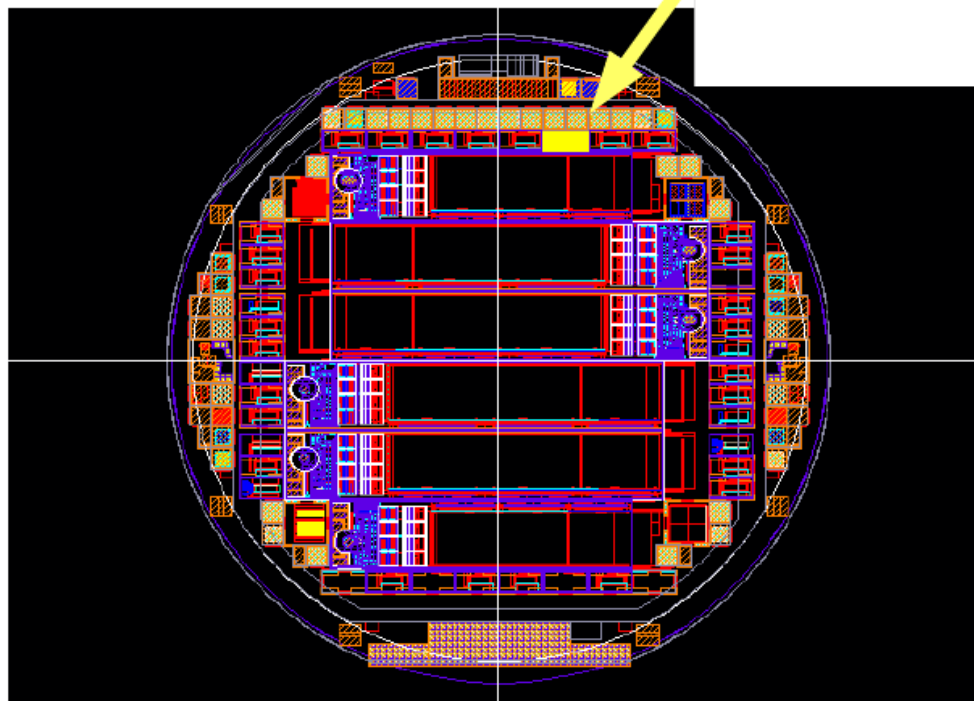
Chip number: PXD9-6 W30 A05

**variations in the bulk doping**

Must be strong and on a short lateral scale

- Idea: variation of bulk doping in concentric rings around wafer center

- yellow area on wafer: tb sensor

- hit occupancy mirrored to match orientation of chip on wafer.

- Already observed on DEPFETs produced for the Bepi Colombo mission

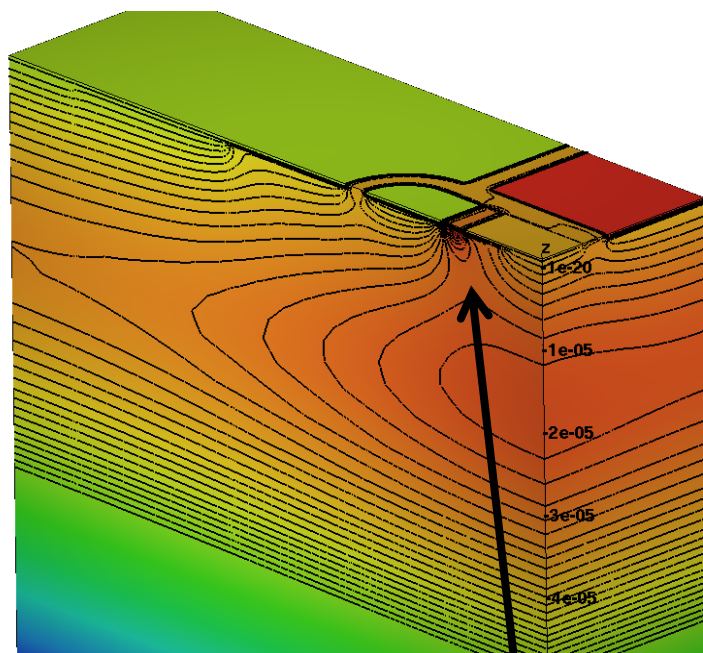
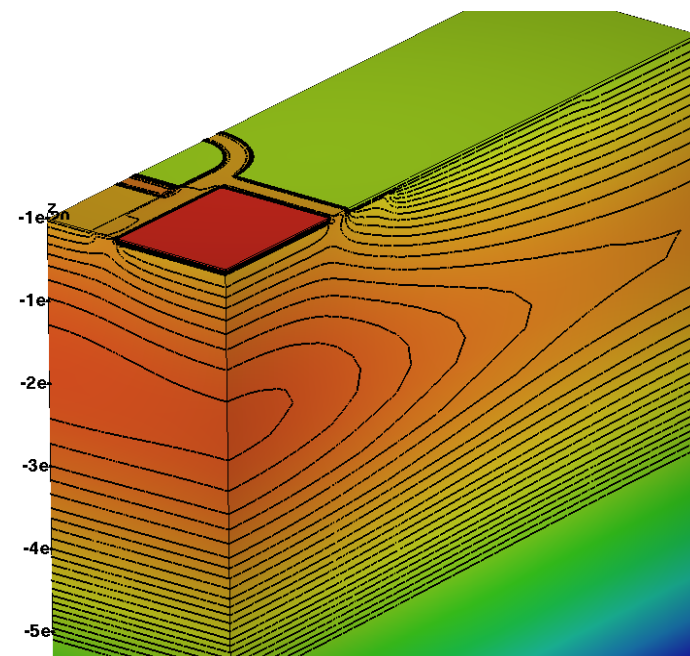
- If we increase the bulk doping by 50% -  $1.5 \times 10^{13} \text{cm}^{-3}$

Saddle point pinches off the Internal Gate

- No charge collection possible

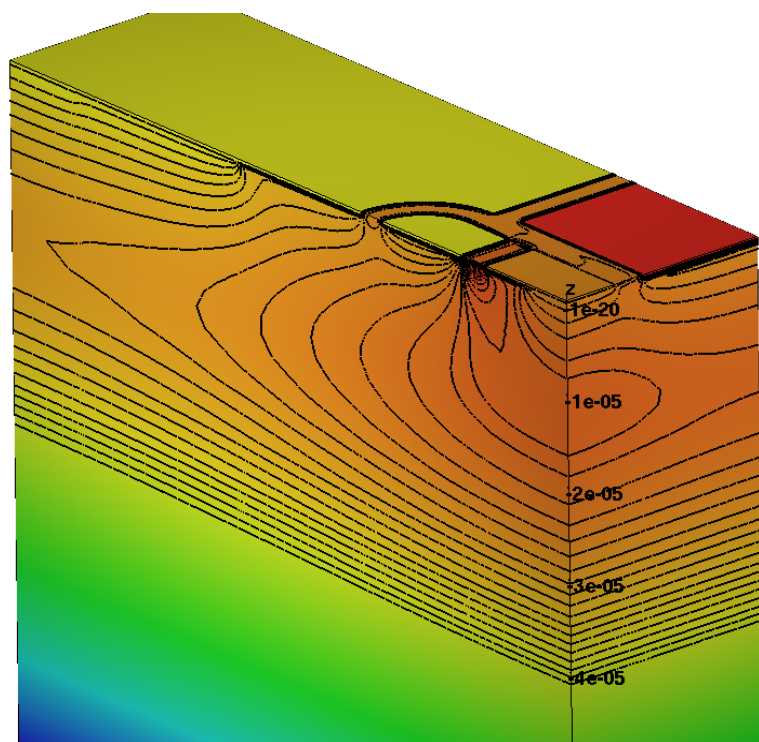
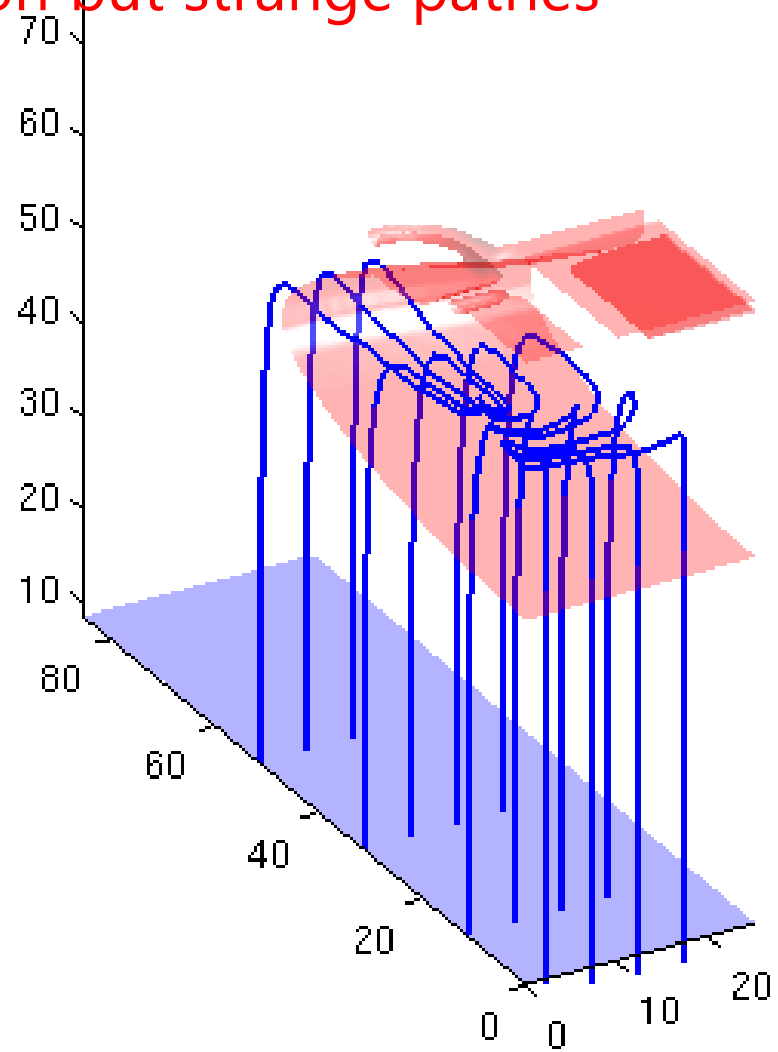
- Nbulk  $1.5 \times 10^{13} \text{cm}^{-3}$ : Can the charge lost be repaired?

Decrease  $V_{\text{back}}$  down to  $-39\text{V}$   
 -> good charge collection but strange pathes

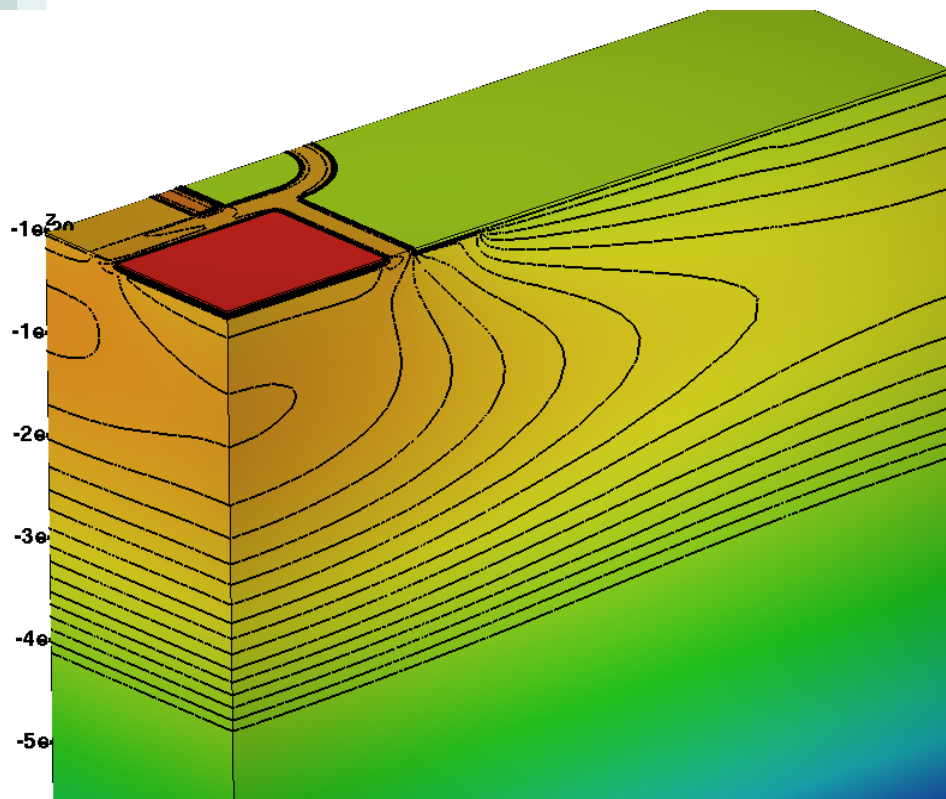
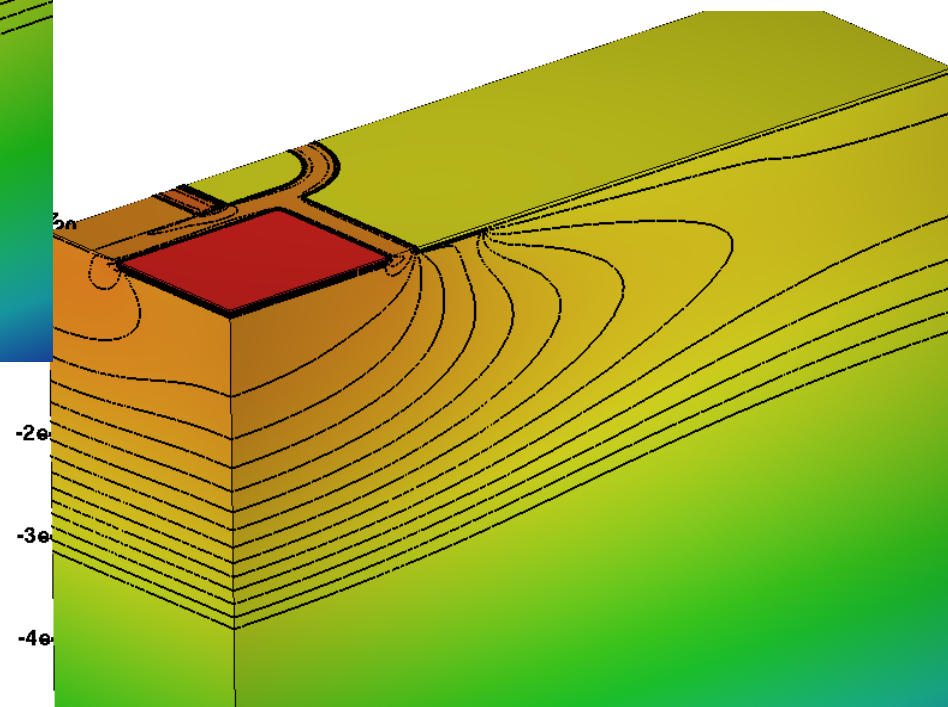
- But what happens to the normal doped pixels

$V_{back} = -30V$

$V_{back} = -39V$

● Normal bulk doping at  $V_{nack} = -39V$

A local bulk doping increase of 50% cannot be compensated by a more neg. bias voltage

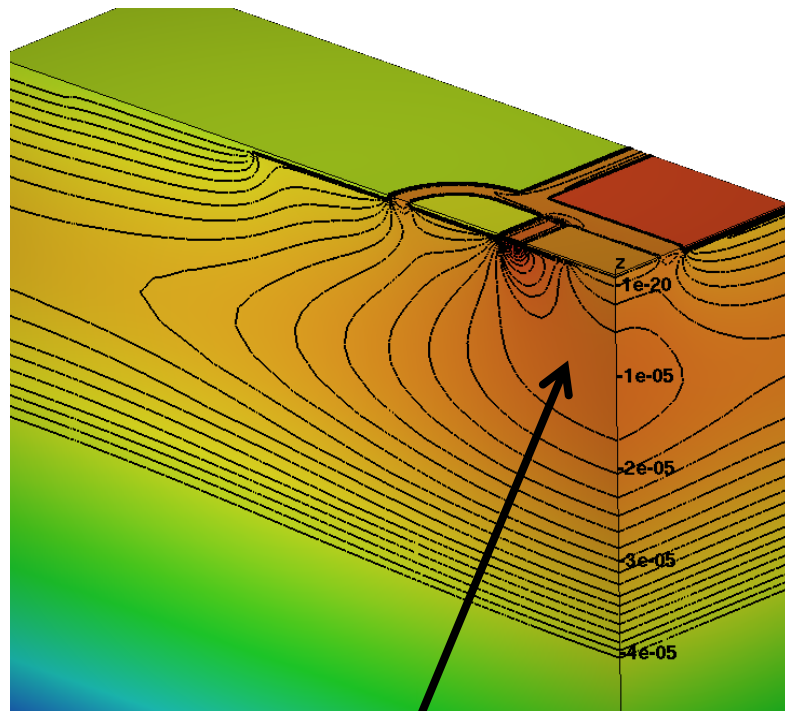
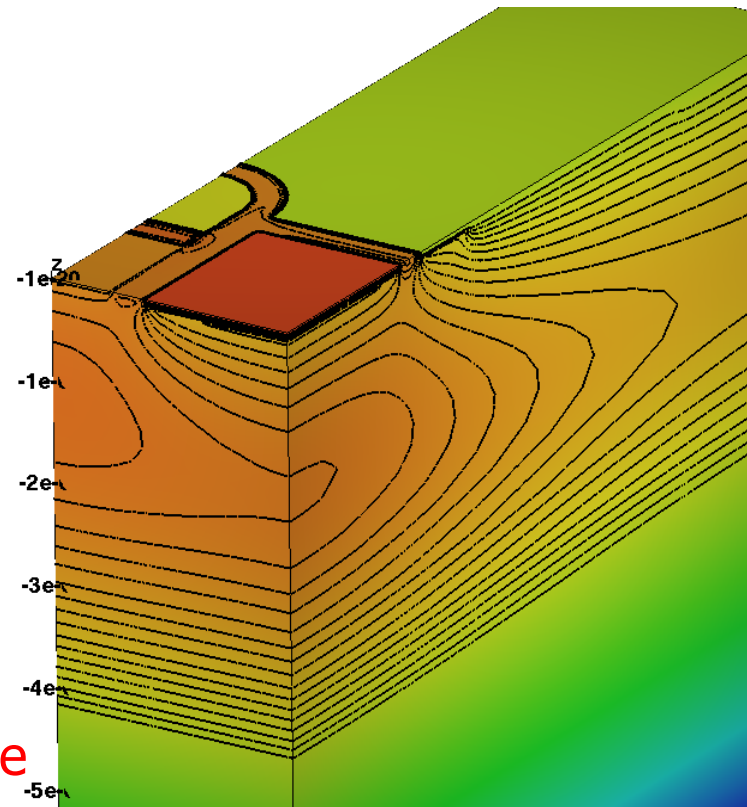
- $V_{\text{clear-low}} = 3\text{V}$  ,  $V_{\text{drift}} = -7\text{V}$  ,  $V_{\text{back}} = -38\text{V}$  ,  $N_b = 1.5 \times 10^{13} \text{cm}^{-3}$

Low field region beneath the Source  
But no pinch off

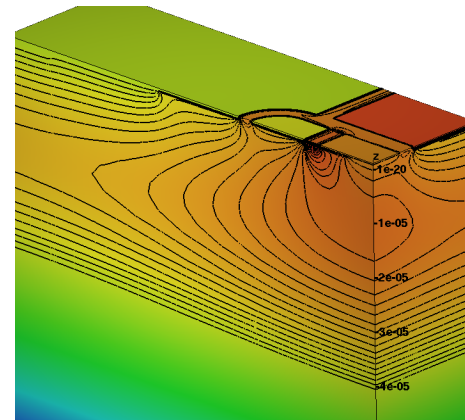
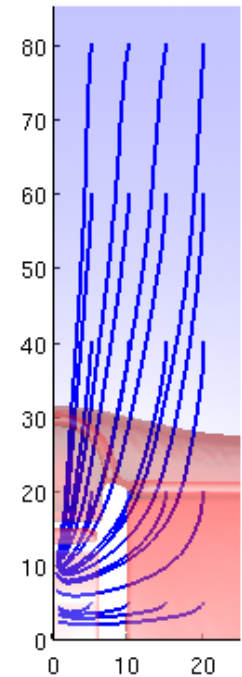
Charge is pressed to pixel center  
But does not reach the southern pixel boundary!

$V_{\text{clear-low}} = 3\text{V}$  ,  $V_{\text{drift}} = -7\text{V}$  ,  $V_{\text{back}} = -38\text{V}$  ,  $N_b = 1e13\text{cm}^{-3}$

Normally doped regions have to run with more neg. backside

Drift path is pushed toward the topside

Electrons could be trapped by ClearGate regions

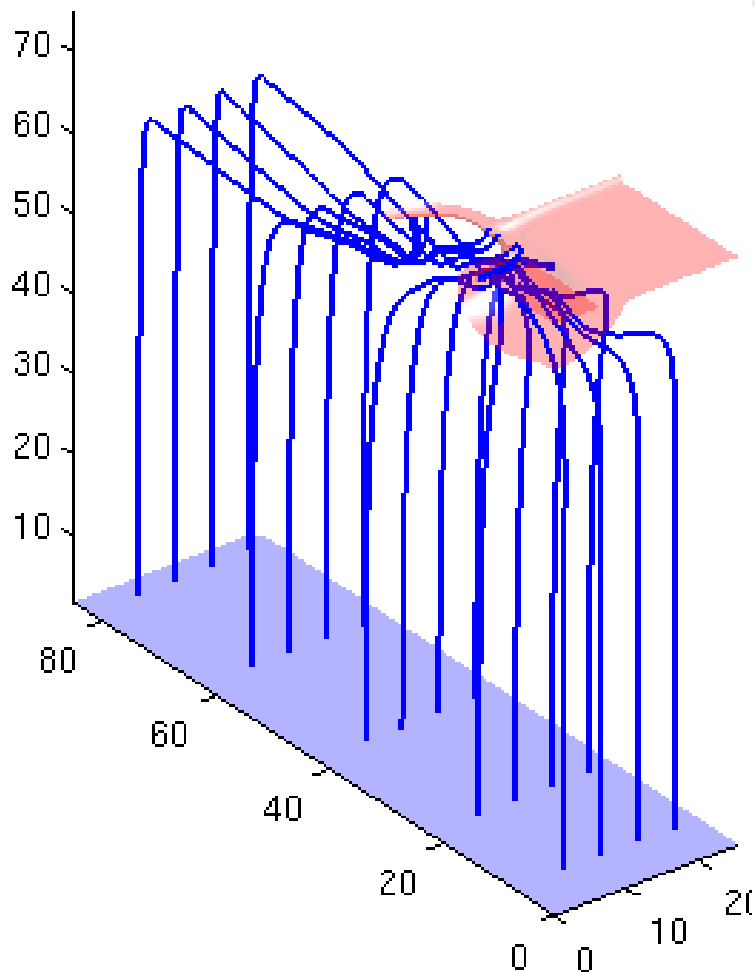
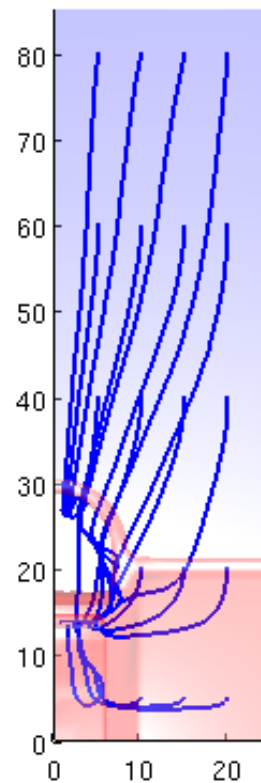
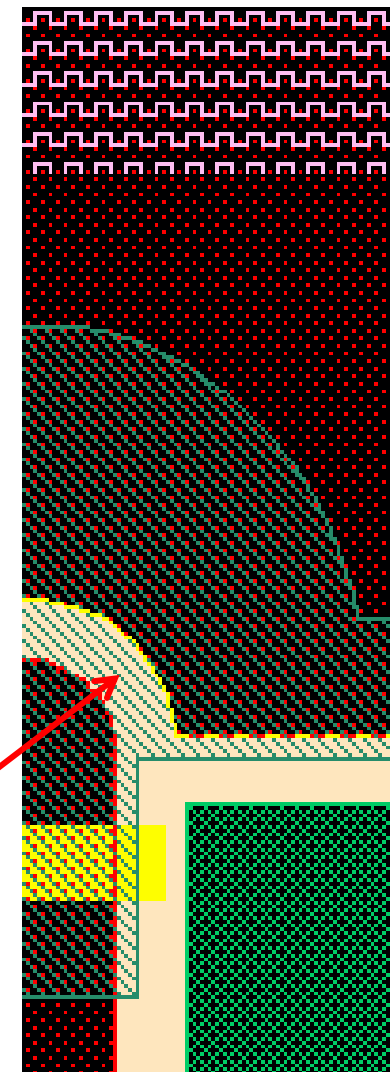
Shaped ClearGate

Charge should drift slowly to the Internal Gate  
 if  $V_{clear}$  (3V) is not too positive -> no significant loss  
 to be tested

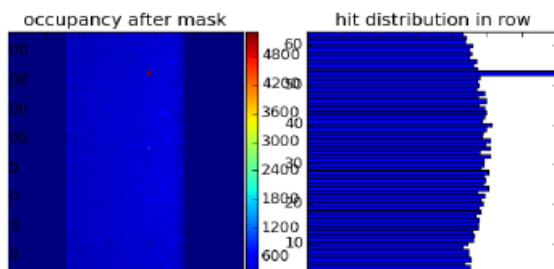
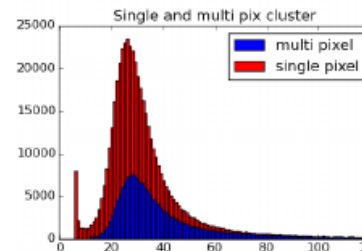
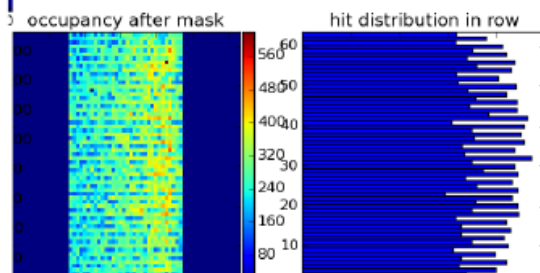
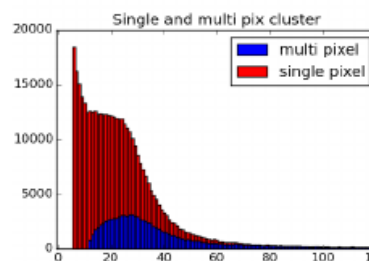
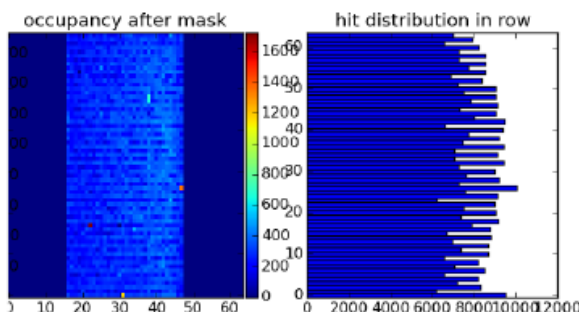
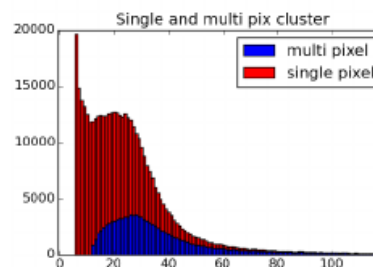
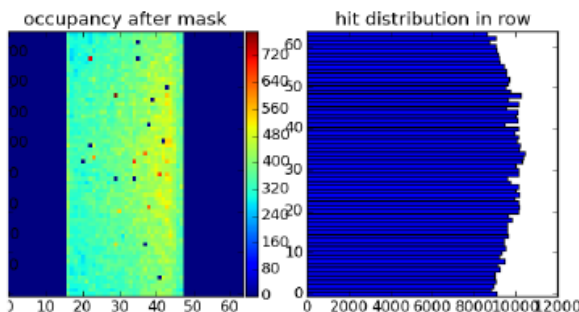
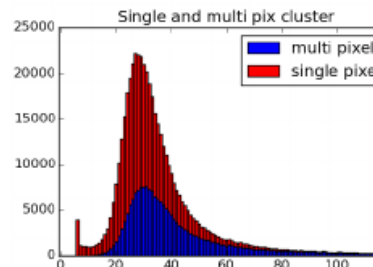
# ● Laser measurements – B. Paschen (Bonn)

Good response  
over a wide  
HV range
