# Switcher Bumping Status

# The new SwitcherB18v2.1

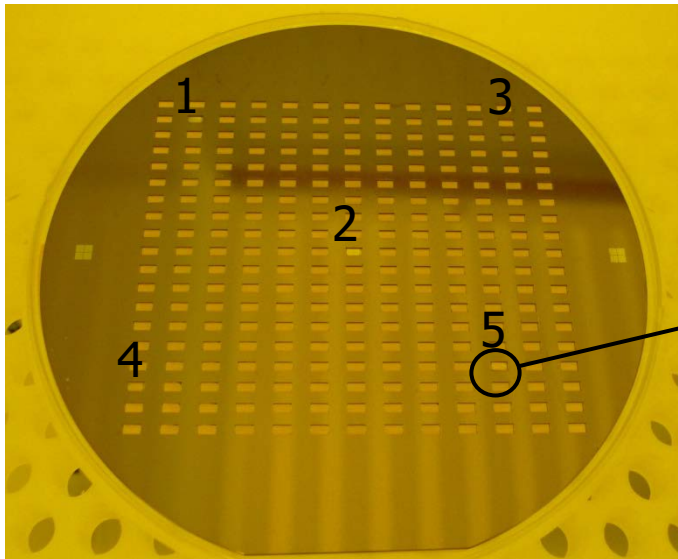
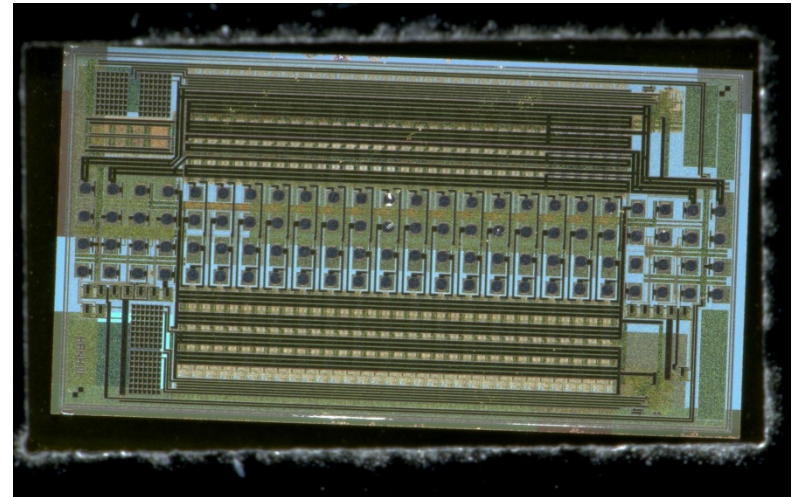
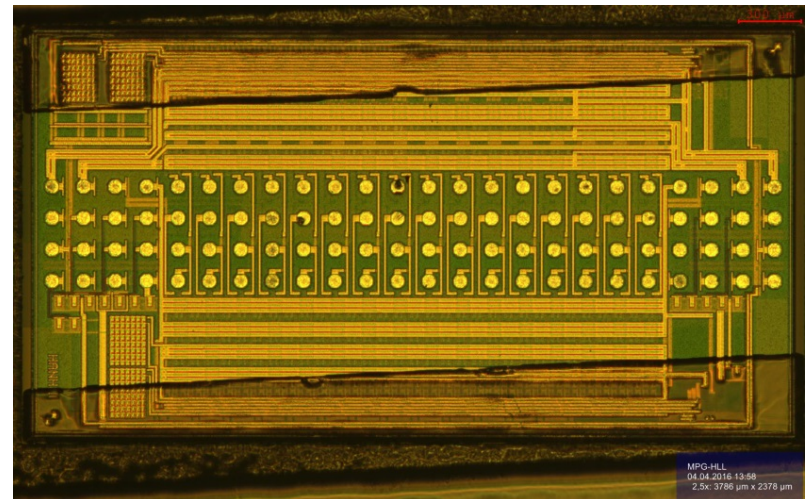
- ▷ After successful single chip coating by hand with miserable yield, trial to make it a batch process
- ▷ Re-assembly of a "wafer"

- ▷ Test successful
  - ↳ UBM successful on test wafer with five SWB
  - ↳ Balling was okay
  - ↳ Shear tests passed

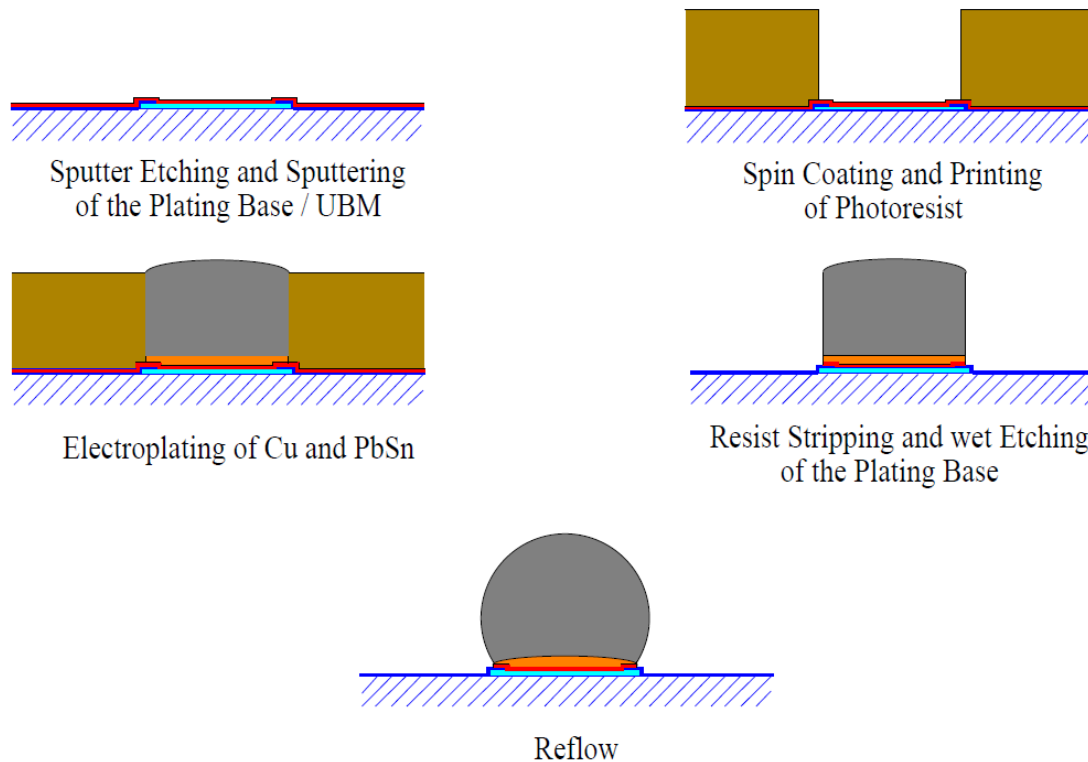
- ▷ Assemble a "wafer" by pick-and-place of Switchers to support with alignment marks
  - ↳ Accuracy ~few microns, subsequent wafer level lithography possible
  - ↳ Possibility to apply standard technology bumping by electro-plating

- ▷ Tests at IZM are ongoing ... litho processes to be done this week
