● SOI Wafers ordered at Tracit/Soitec

● The Issue...

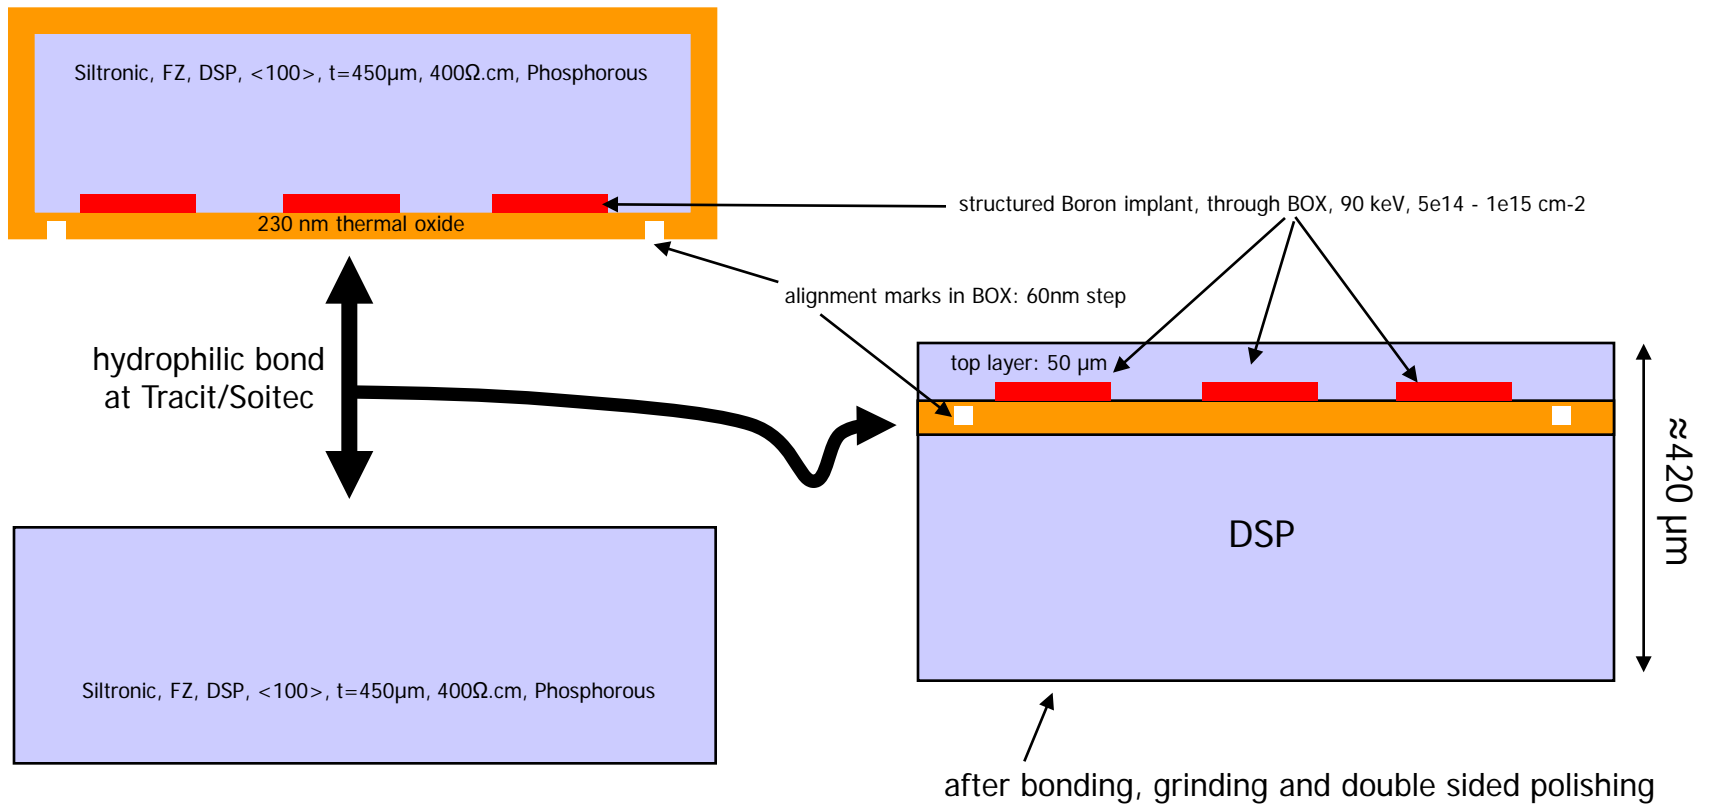
-: top and handle wafer delivered by MPI
 -: pre-processing of top wafer at MPI

-: 25 engineered BSOI wafers prepared at Tracit/Soitec
 -: DSP, $\approx 420 \mu\text{m}$ overall thickness, $50 \mu\text{m}$ top layer
