More lessons learned from test campaigns

- I. Software/Hardware improvements
- II. Mechanical improvements
- III. Radiation measurements issues November 2021
- IV. May radiation campaign remotely from Munich

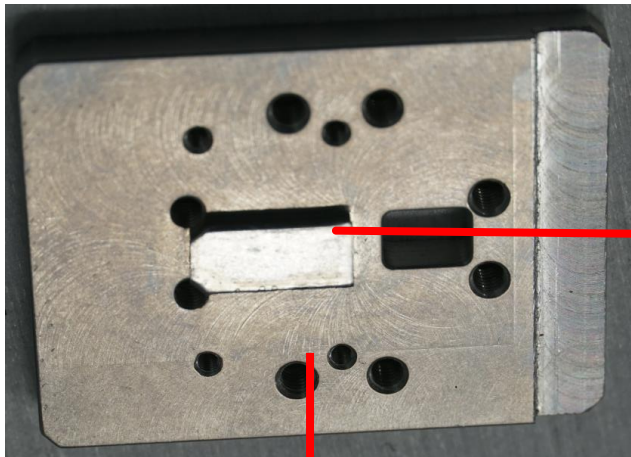
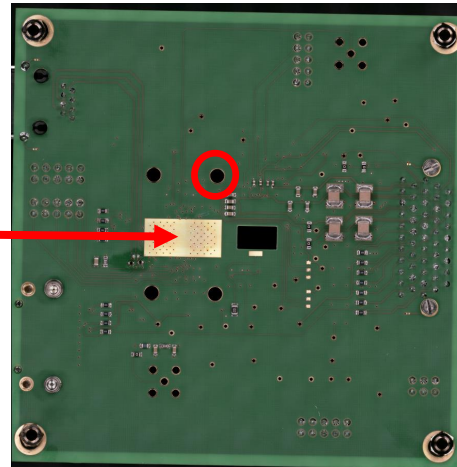
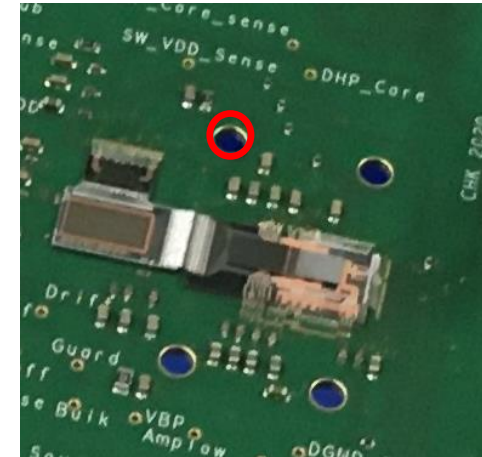
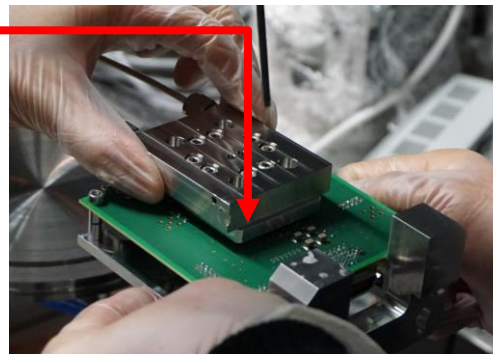
Assembly of cooling block an hybrid board and than to the main cooling block in the vacuum tank.

BUT... in the November 2021 campaign again one matrix broke!

Solution:

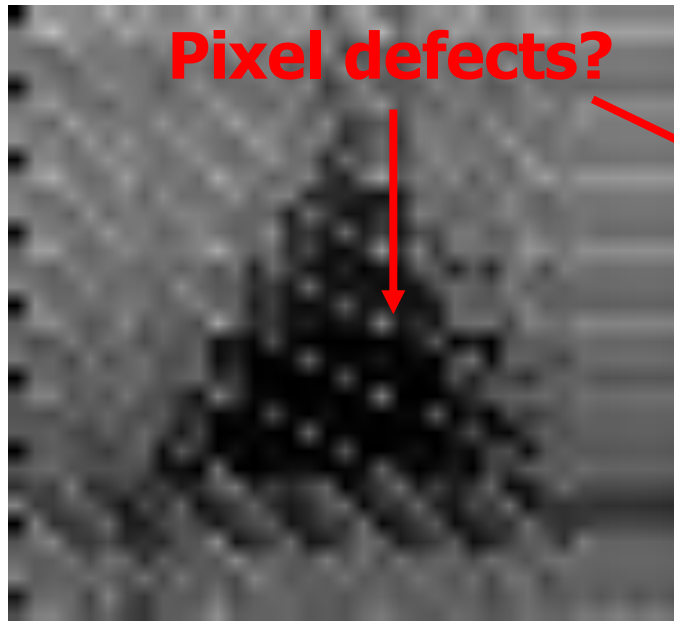
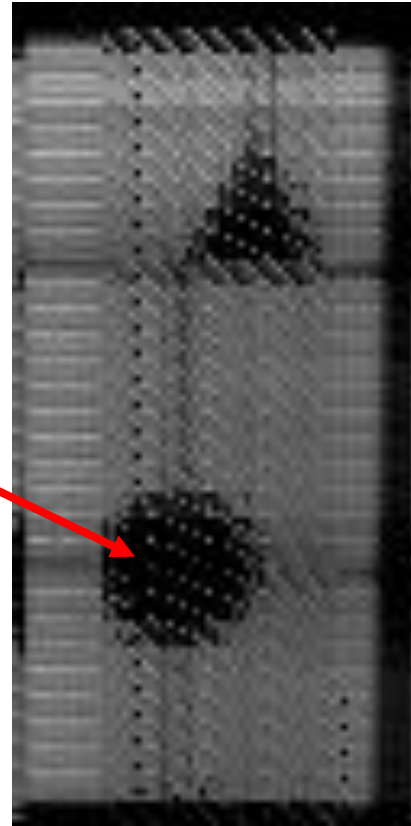
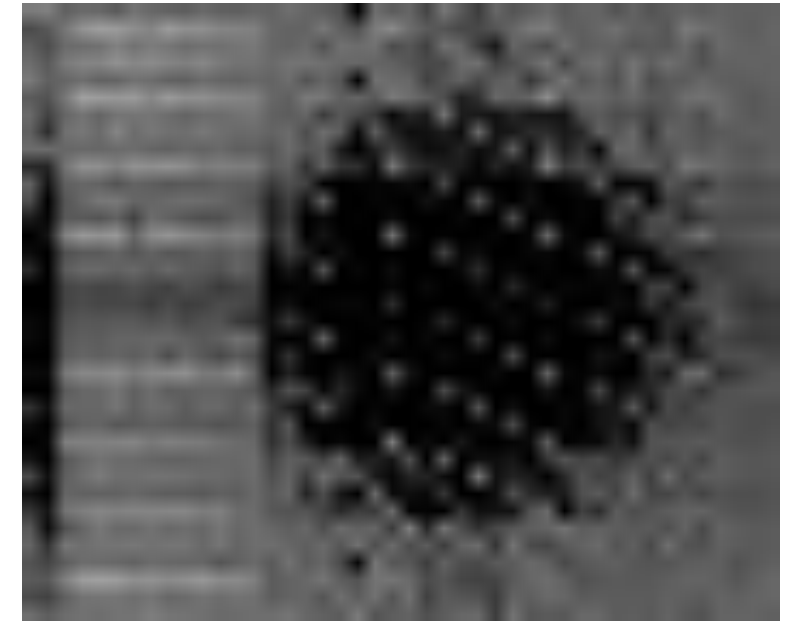
(HYBRID BOARD #9 450UM W11_C06 PXD10-1 L05)

Mask used on hybrid board #9 after ~ 10Mrad radiation

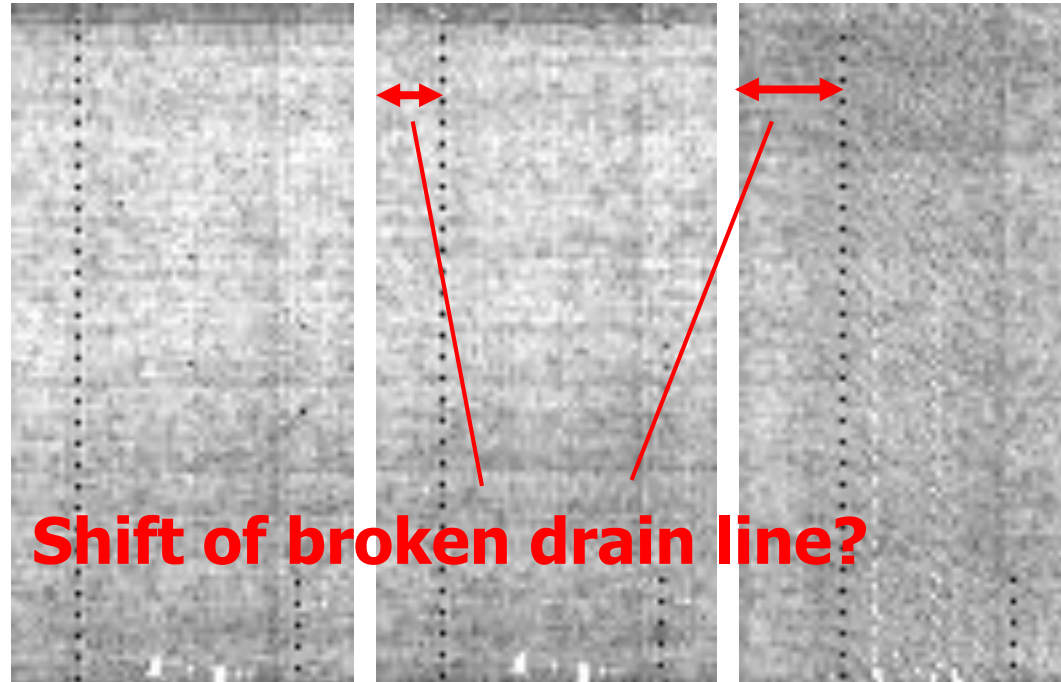
Raw images after irradiation (Vmax@150ADU always the same):

~ 2Krad

~ 20Krad

Of course not the physical location of the broken drain lines changed but rather there was a shift in the recording of the data.

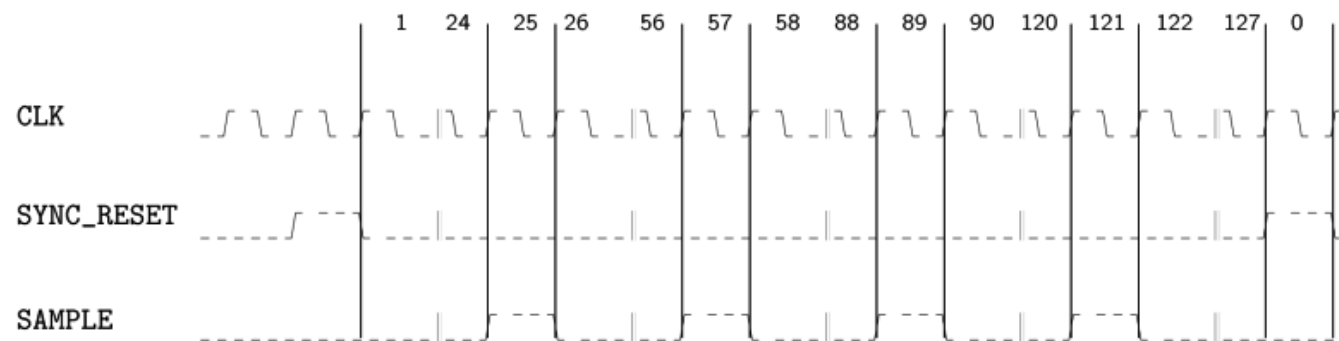
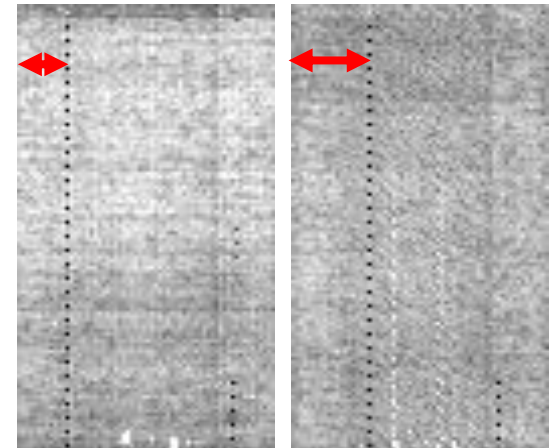
For the read out the switcher, DCD and DHPT have to work synchronic. A master clock comes from the XU1 board to the DHPT and the DHPT is controlling the DCD and switcher.

After complete configuration of the DCD the data processing is controlled by only two signals: CLK and SYNC_RESET. At first the clock (CLK) must be activated while holding SYNC_RESET high. Then, the DCD starts data processing as soon as SYNC_RESET is released.

The SYNC_RESET delay can be changed via two settings in the DHPT.

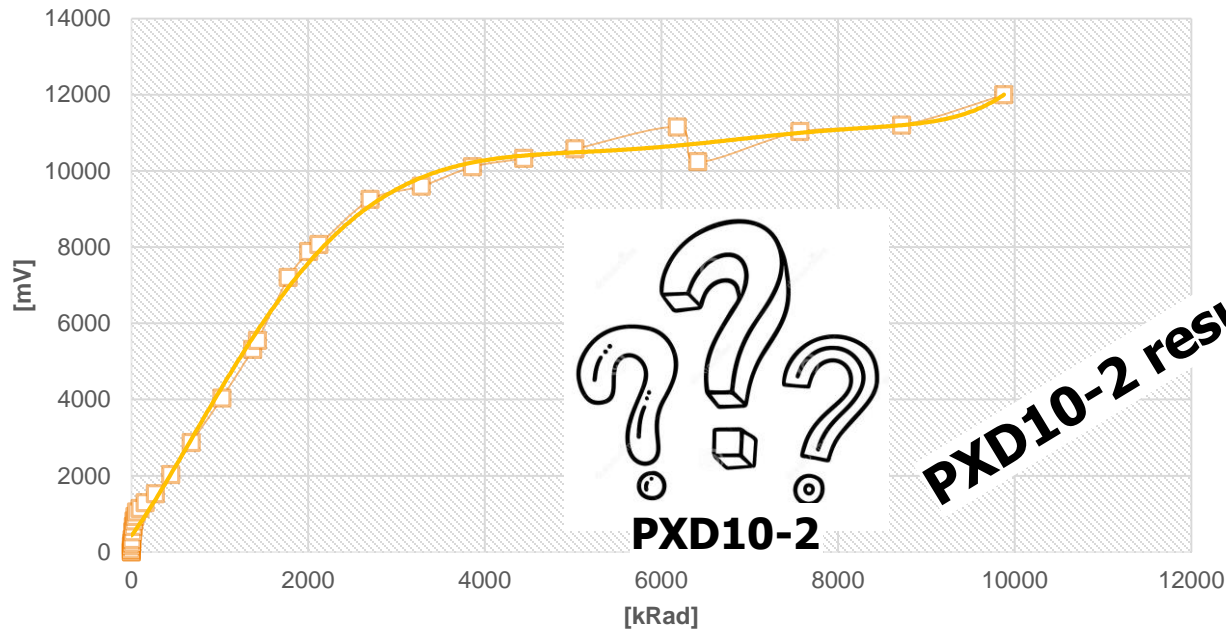
GateOnShift vs Dosis [kRad]

GateOnShift ~ -12 V

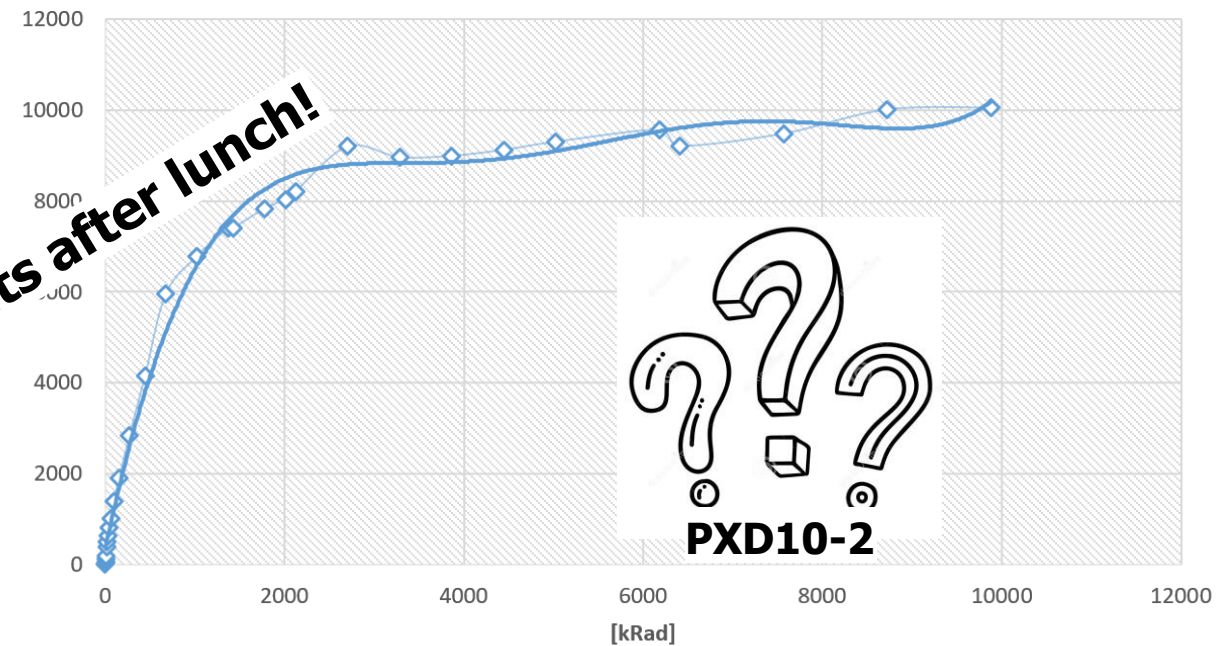
ClearGateShift vs dosis [kRad]

ClearGateShift ~ -10 V
