Status of PXD 2 ONSSEN System at KEK

PXD Workshop

Mai 22, 2023

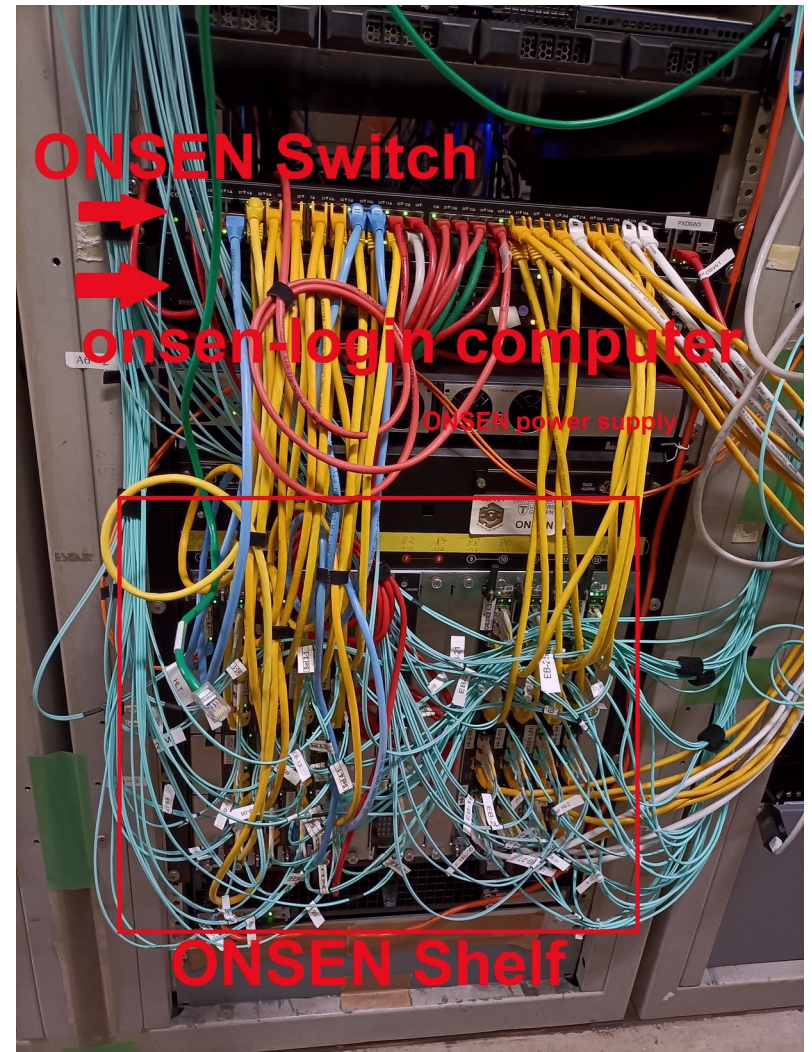
Starting ONSEN

- ▶ Not all boards started properly up
- ▶ Slot 03 Carrier and AMCs shut down after several hours of running
 - This was not observed again
- ▶ The file `/tmp/envPaths` is created automatically during start up, is missing sometimes
 - Fixed by reprogramming the board
 - This can happen to every board
- ▶ All boards are running and functional

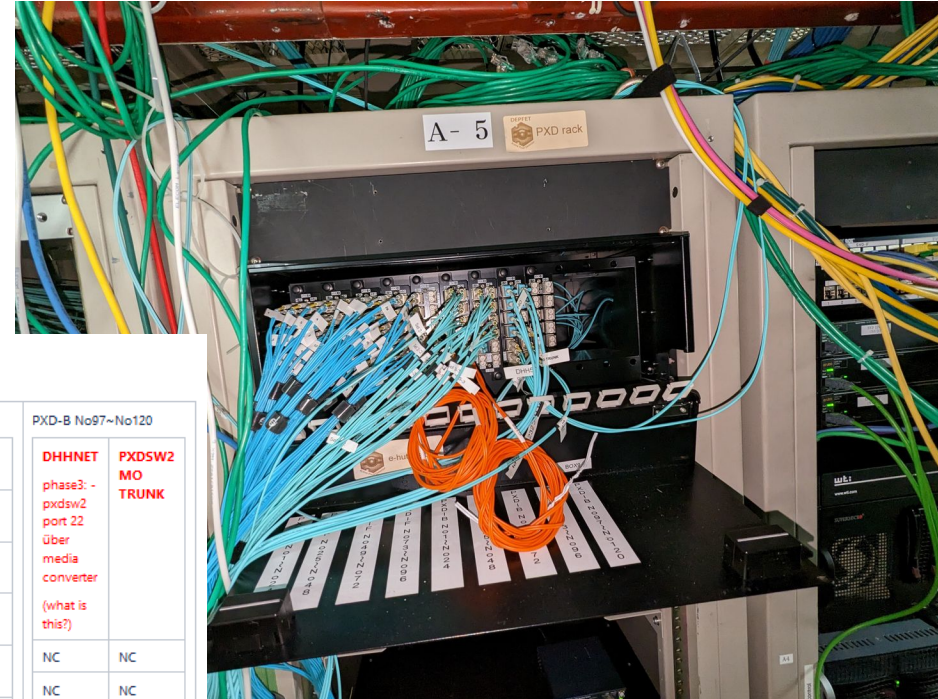
Dockbox cabling (E-Hut)

- ▶ The full ONSEN system will be used, for the first time (factor 2 more hardware compared to phase phase 3)
- ▶ The remaining ONSEN board had to be connected to the dockbox

Configuration:
bold red = new/changed connections from B4 side w.r.t phase3
 Where ONSEN connection not yet set DHH link names are given
