# PXD Grounding Scheme (2018)

# How The Ground Cable was Installed for PXD1

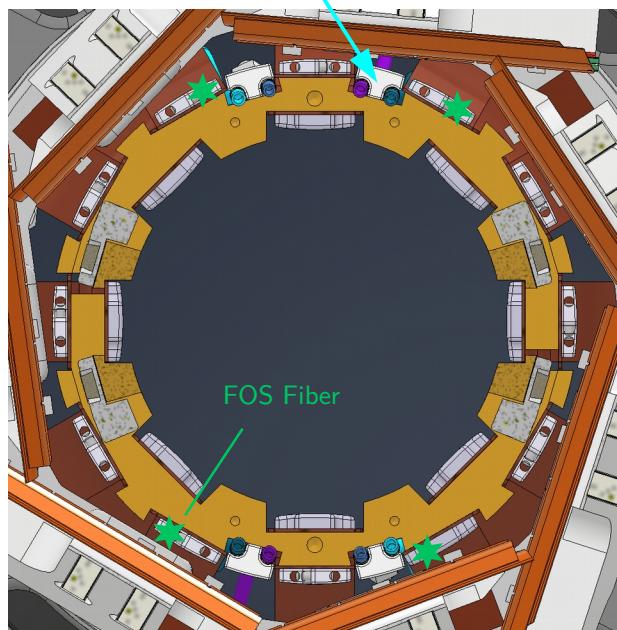
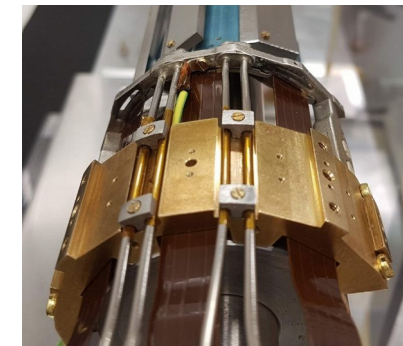
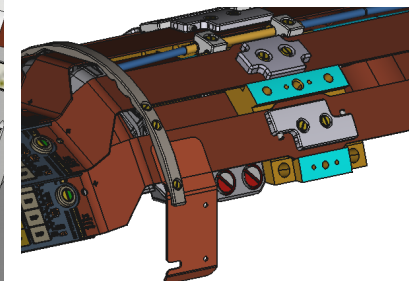
## Ground Cable Collision With SVD Wire Bonds

- SVD wire bonds in the area of our brass piece (1 mm clearance)
- Our ground cable makes a strong bent without any good permanent fixation in that area
- Stripping the cable so close to the Kapton difficult

- Try to route (old) cable behind the Kapton through brass piece gap (carefully remove the Kapton strain relief? **Only when ground ring is installed!**) (**bad**)
- Install a new (thick/flat) cable and solder it to the copper SCB ground connector (cut/remove the old cable) (**good**)
- Route a thin cable through the fiber holder (BUT: Richard says cable should be as thick as possible) (**bad**)
- Route cable somehow though the L1 Kapton gap? (but here is the Kapton strain relief as well) (**bad**)
- Fix cable to the isolator of the carbon tube (**bad**)
