Hybrid 6 Testing

Florian Lütticke
University of Bonn

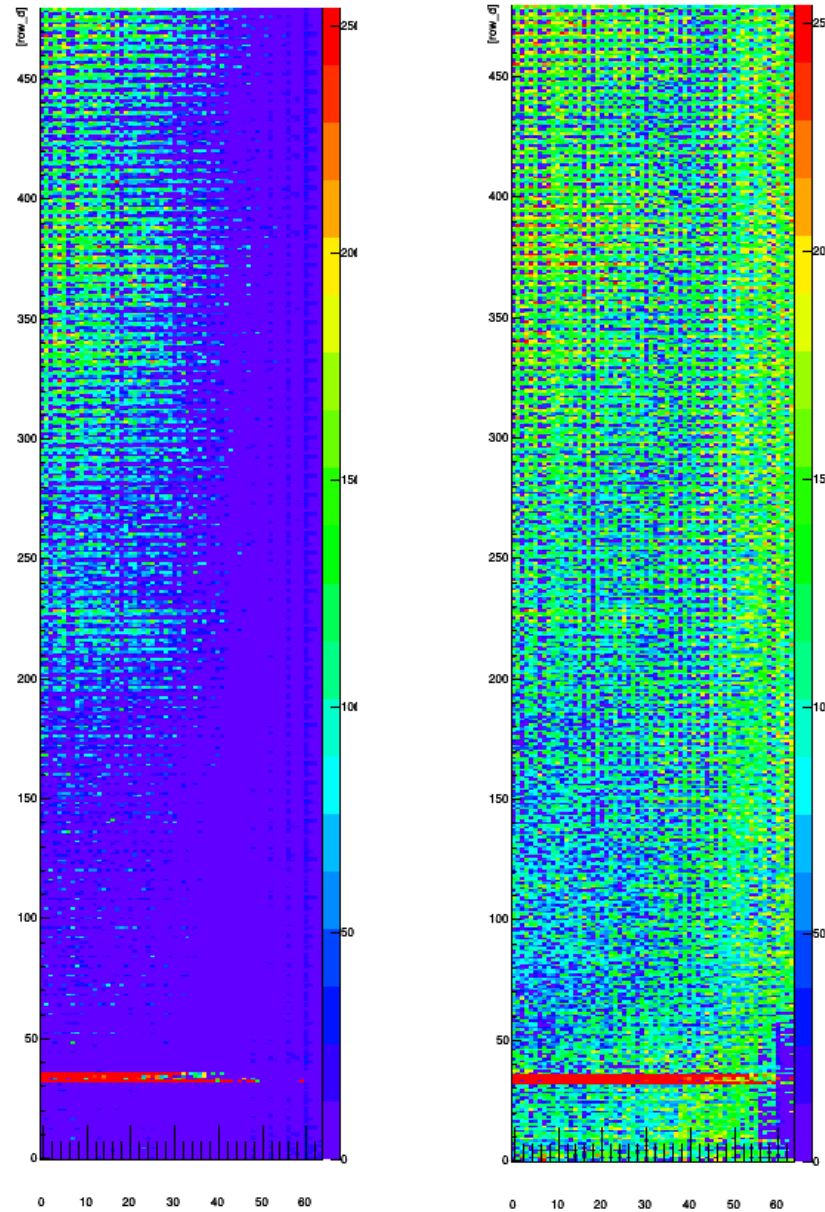
Large PXD6 on
test beam

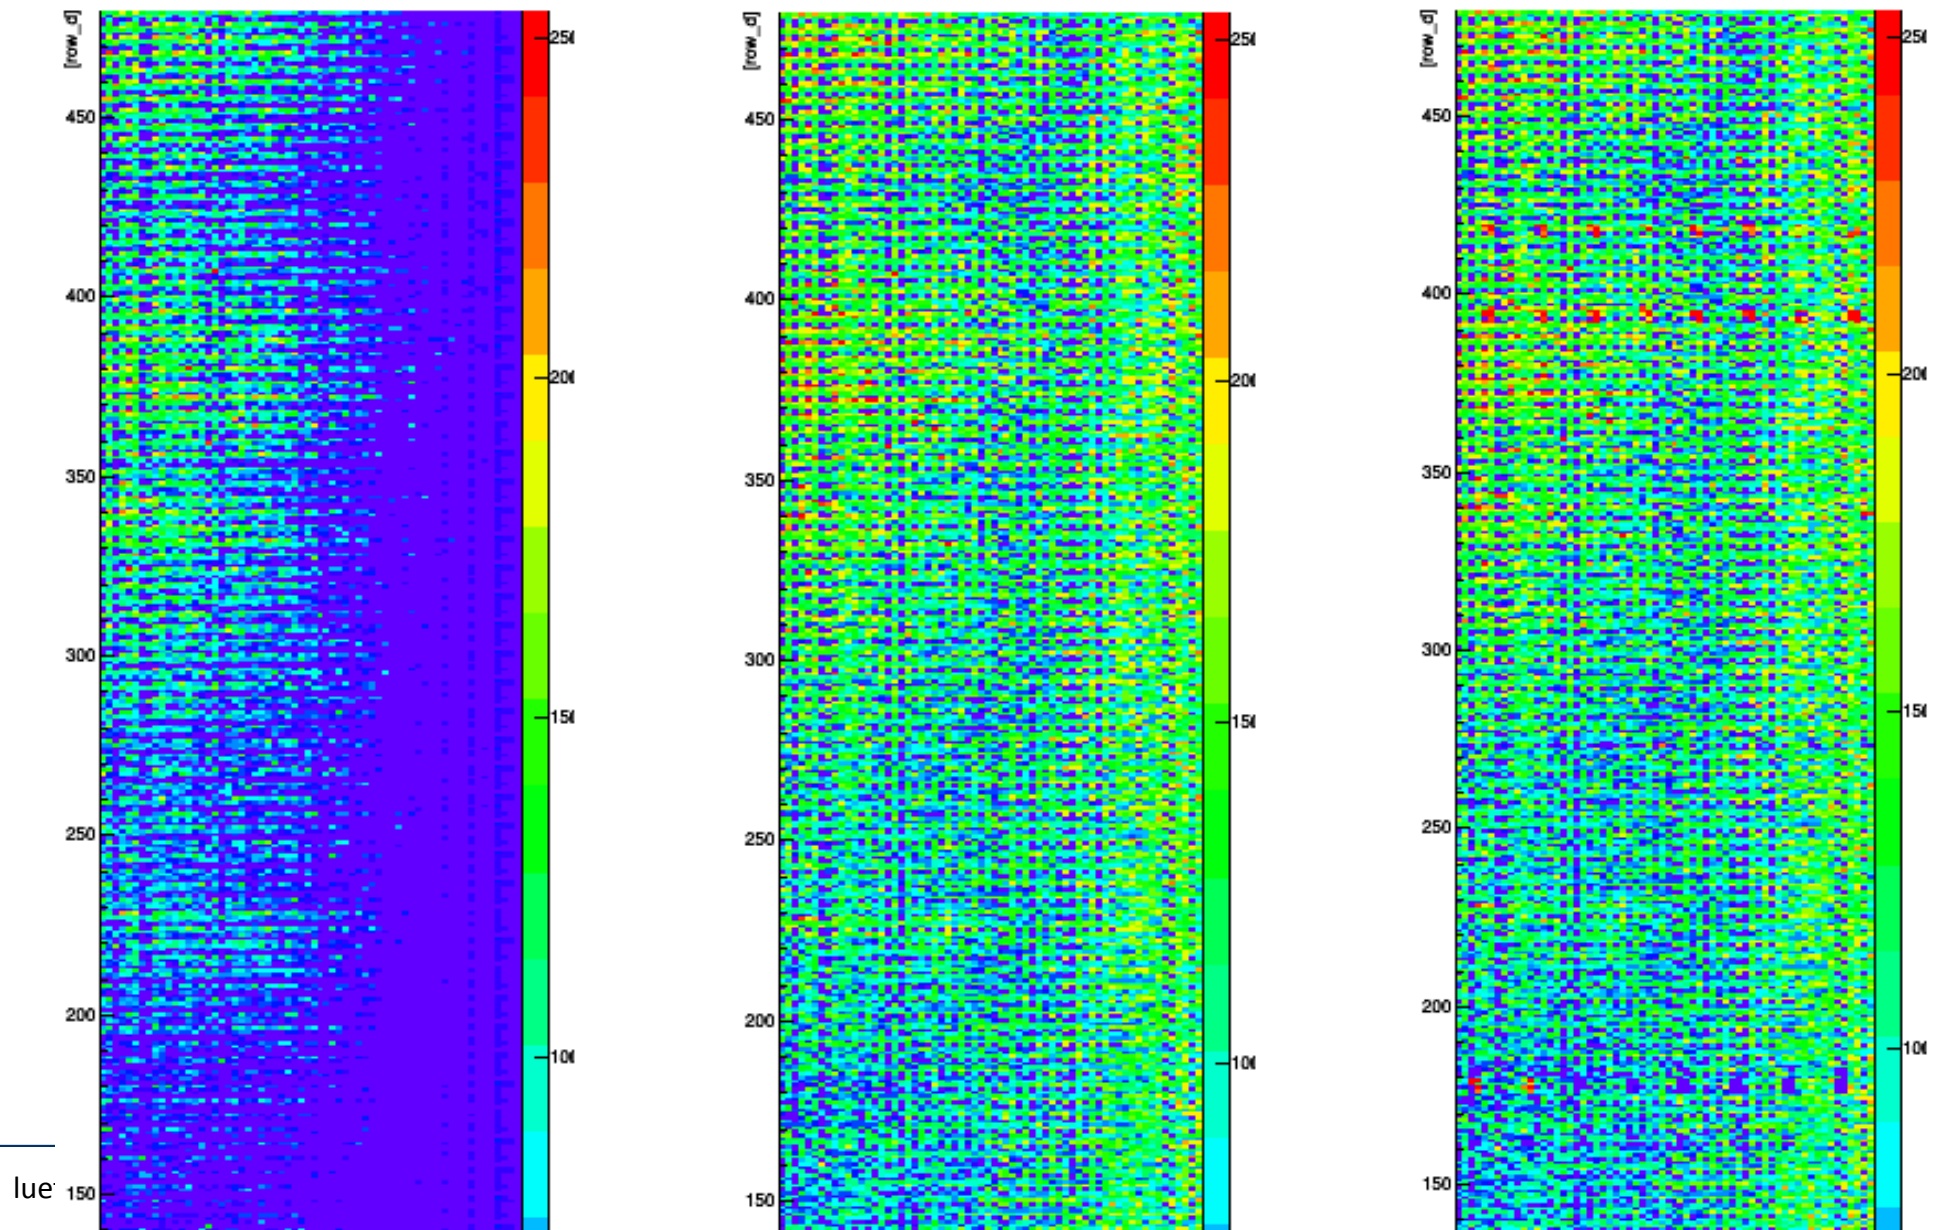
Offset DACs after a few frames

- Design Issues in DHP02:
 - Steering only works in ACQUISITION mode (not in AQUISITON TO MEM)
 - Data acquisition in DHP stops synchronously
 - 2 Bit DAC output from DHP stops **asynchronously**
 - Last written DAC Data stays on output line when DAC output is switched off
- DAC Values get overwritten when going from ACQUISITION mode into IDLE and back.
 - Solution: Reload Offset DAC data before taking raw data frame: Slow
- DAC Values get stuck at some point in the readout:
 - Solution: Clever Software which finds out good frames

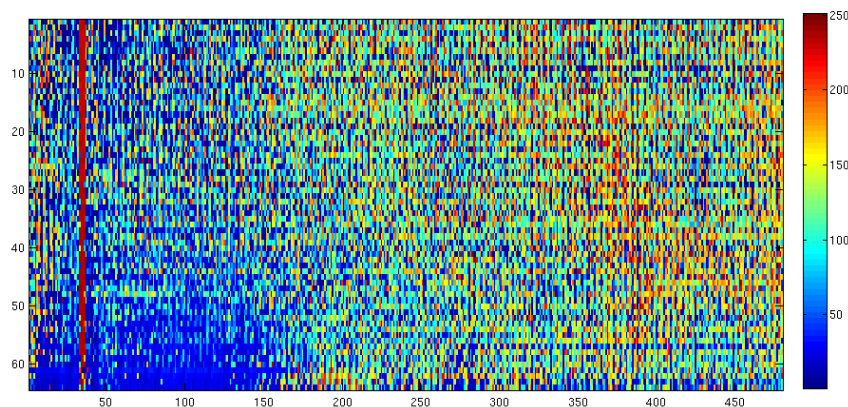
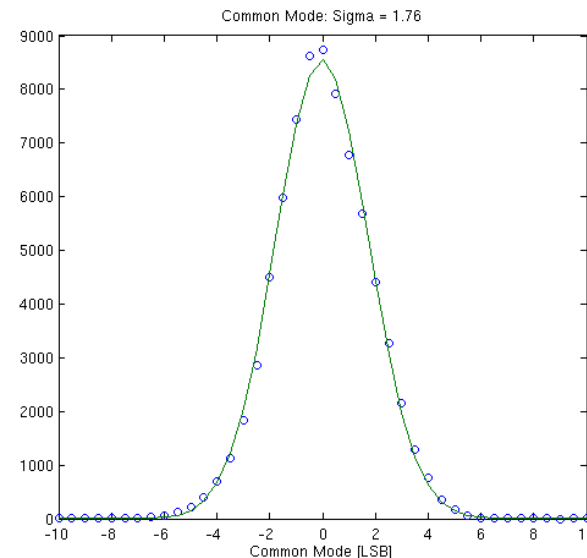
- Why is it needed?
 - Part of the Offset Data memory gets overwritten when taking raw data frame
 - Not all raw data frames are valid due to asynchronous stop of Offset output
- Idea: Take raw data in zero suppressed mode
 - Possible, if pedestal subtraction and common mode correction is switched of.
 - Buffer Depth of first FIFO: 16
 - Lost Data if more than 4 Gates are active at a time.
 - Possible solution: Cut matrix into pieces and take separate pedestals for each
 - Used solution: Trigger random parts of the matrix and reconstruct full pedestals from the data
