SMD @ NTC

J. Ayucar, G. Preve @ NTC

The situation at Pisa... (October 2014)

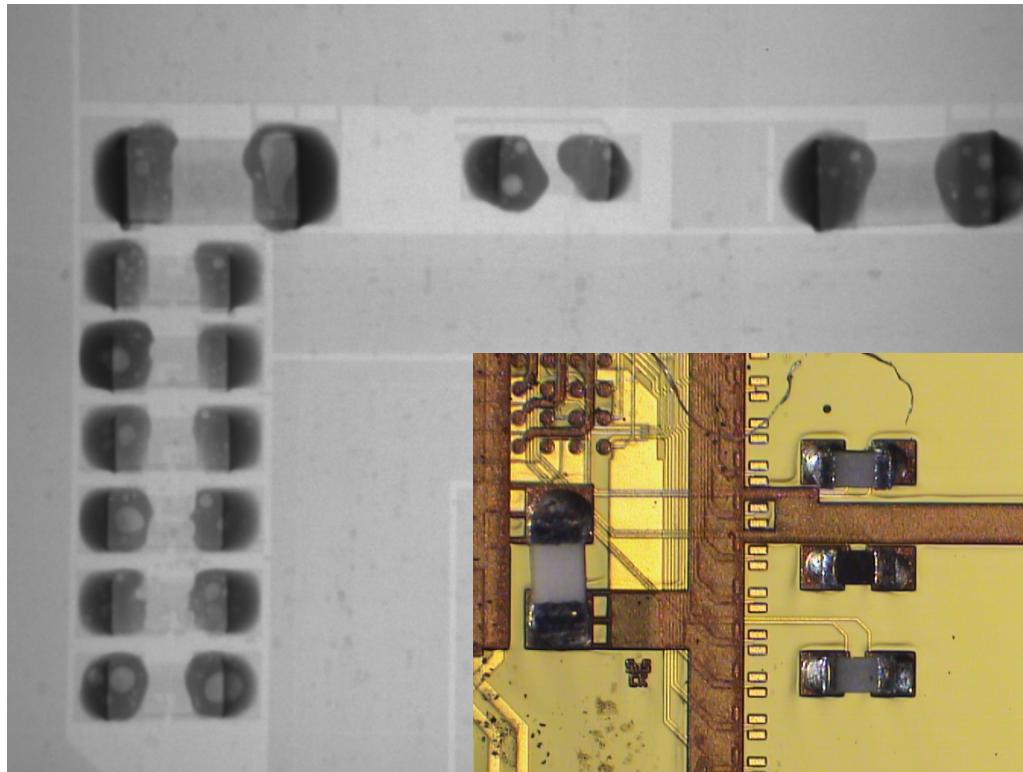
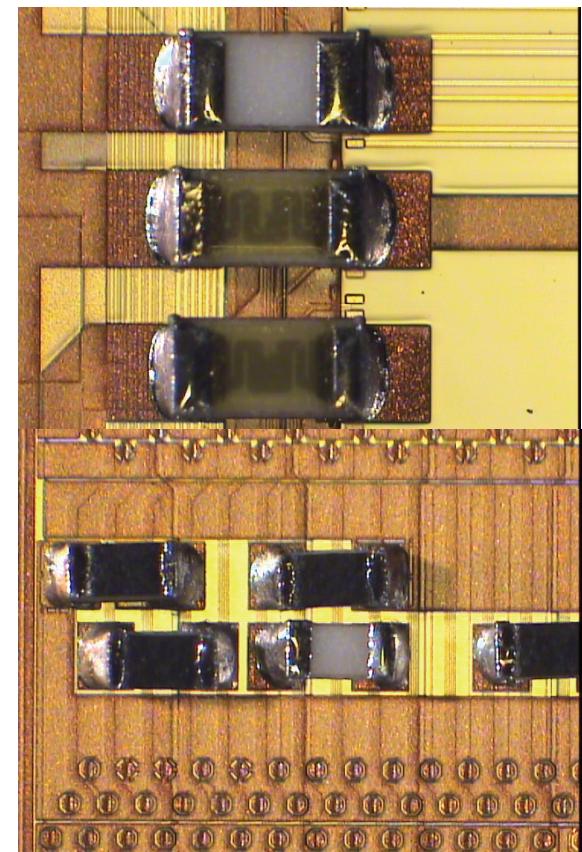
- ✓ Two e-mcm populated with SMDs
- ✓ Using SAC (SnAgCu) 150 µm solder balls
- ✓ Result not bad but still quite “artisanal”. Production needs something faster and less human-dependent...

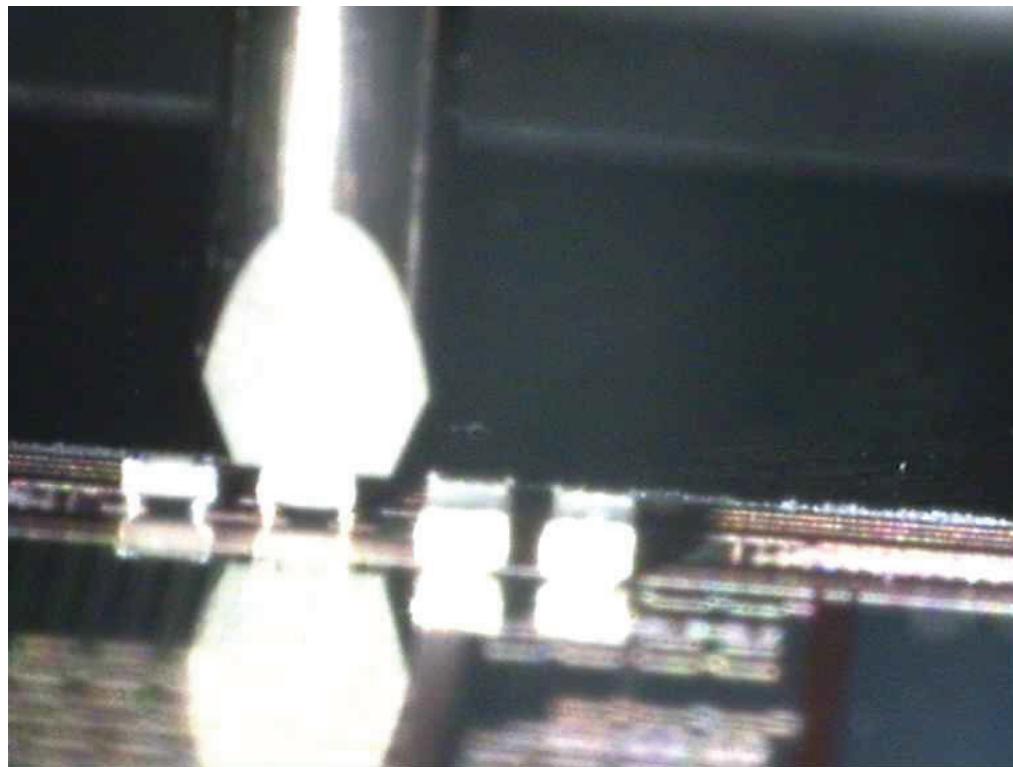
- ✓ Change to lead-tin solder with smaller melting temperature than bump bond at ASICs
- ✓ New tooling to place small components in between DCDs and DHPs
- ✓ All regions “accessible” to the FineTech pick & place machine.

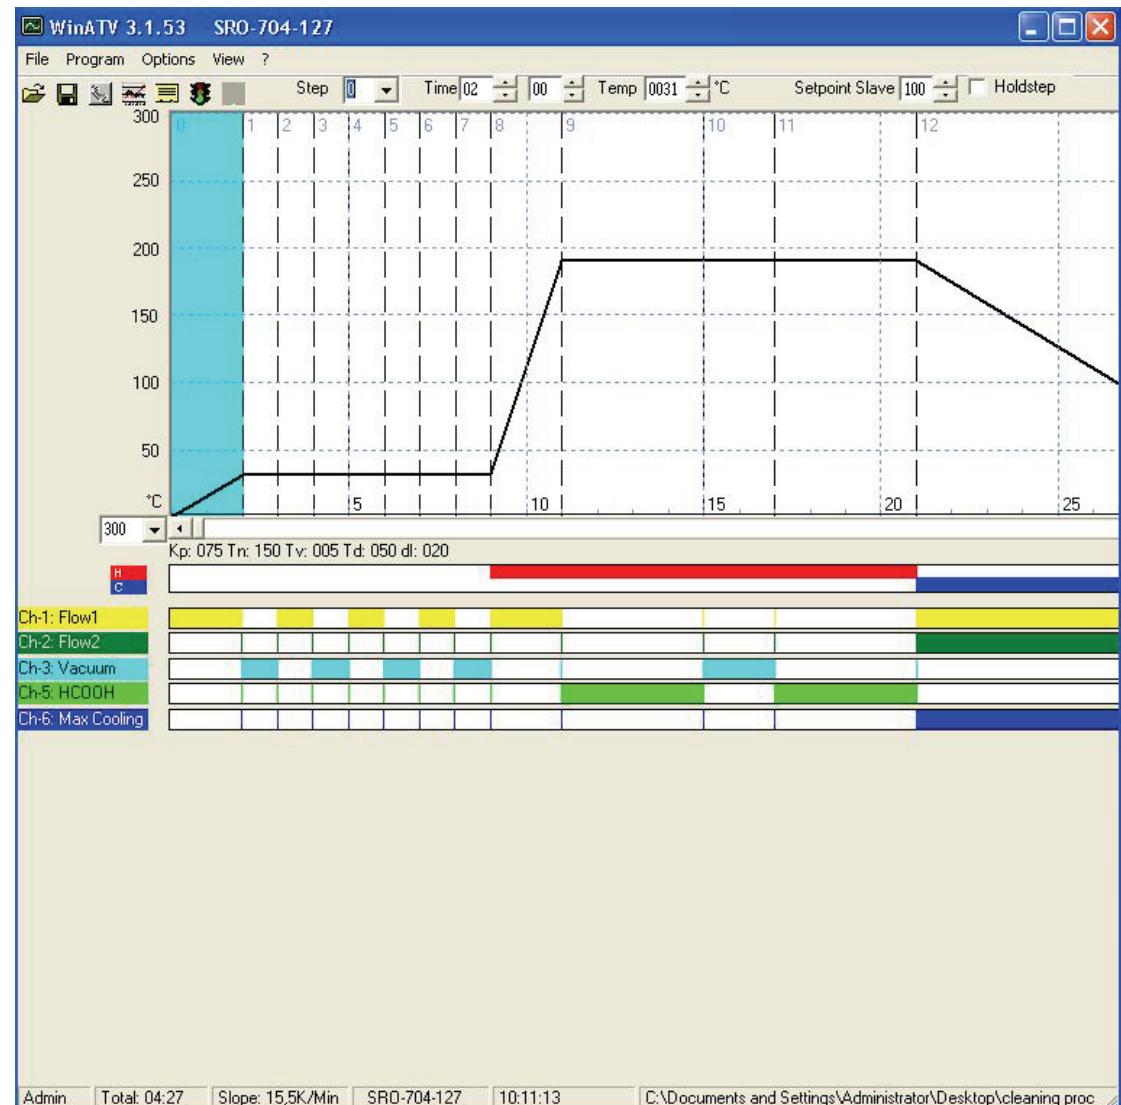
- ✓ Modules are first cleaned in an oven with formic acid to reduce the oxide
- ✓ Dummy samples are also put together with the e-mcm to monitor the process

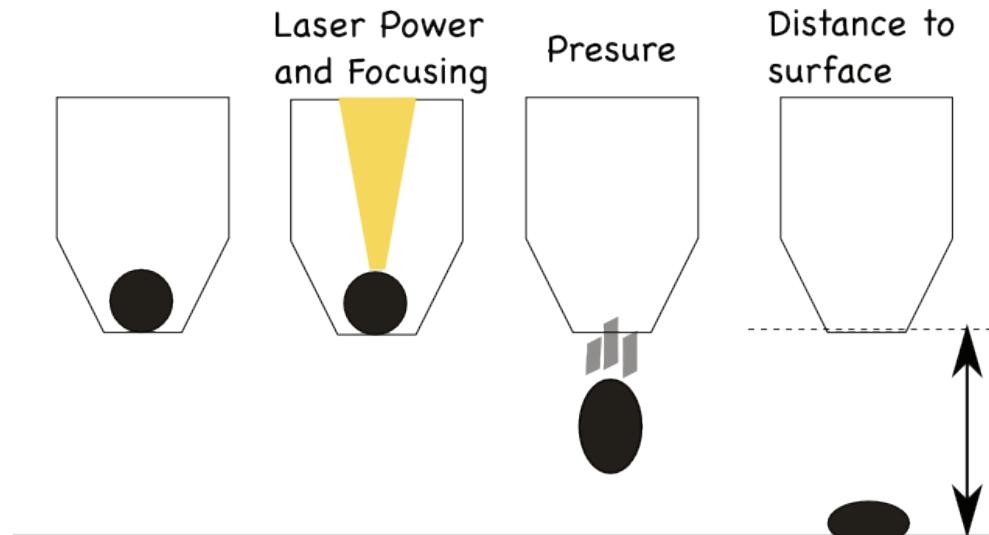
Bond level Z axis & Substrate Height

Distance to surface. This is a critical parameter as well. If too long, balls do not stay on the pad. Another indication of lack of power to meld the solder balls.

Laser Current 54 A Laser Pulse Width 20 ms

These values are at maximum. Lower values do not allow a decent ball placement. ...first indication that we do not have enough power to completely and perfectly melt the ball on the copper surface.

Feed Station Pressure 20 mbar

This parameter gives the nitrogen pressure that allows the spitting of the melted solder. A too high value may cool down the balls and a too low value prevents the balls from coming out...

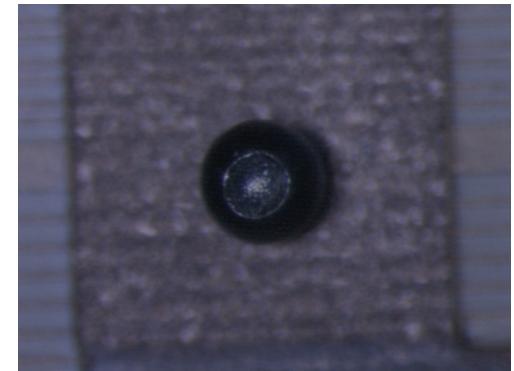
Almost there.

However, balls are just tacked on the pads.
NTC's PacTech is at the edge of performance

Wafer	No. of balls	Placed at 1 st try	Placed at 2 nd try	Not placed
30-2	20	18	2	
31-2	20	19	1	
17	20	20		
Ex	40	14	20	6
31-P1	20	18	2	
18-P1	20	17	3
