IPMI Updates and Plans

10th VXD Workshop Santander, 14.9.2016

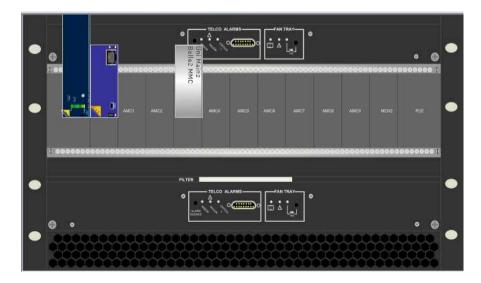
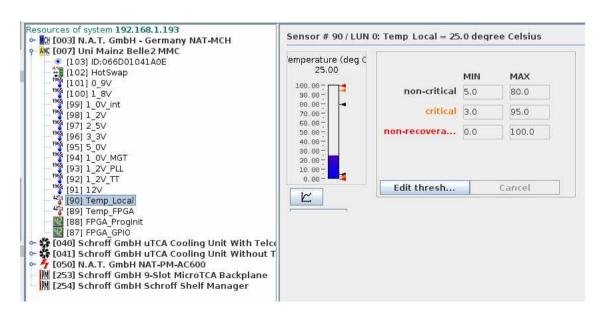
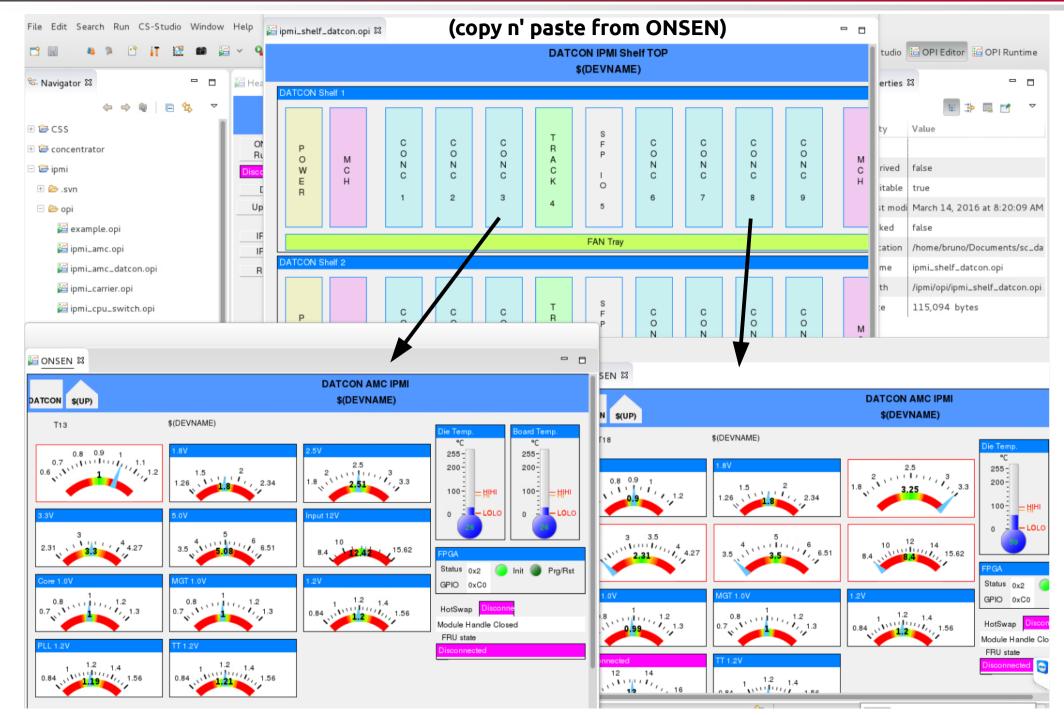
- Bonn (DATCON) has new shelf and shelf controller (MCH)
 - NAT (MCH-Base12-GbE)
 - Tested with MMC on ONSEN/DATCON boards.
 - Board is recognized and gets switched on by MCH, sensors are monitored
 - Database files and GUIs for MCH prepared.
 - Minor issues: NAT MCH behaves a bit different than Kontron MCH/ShMM; configuration issues?

(NAT view screen shots from Bruno)

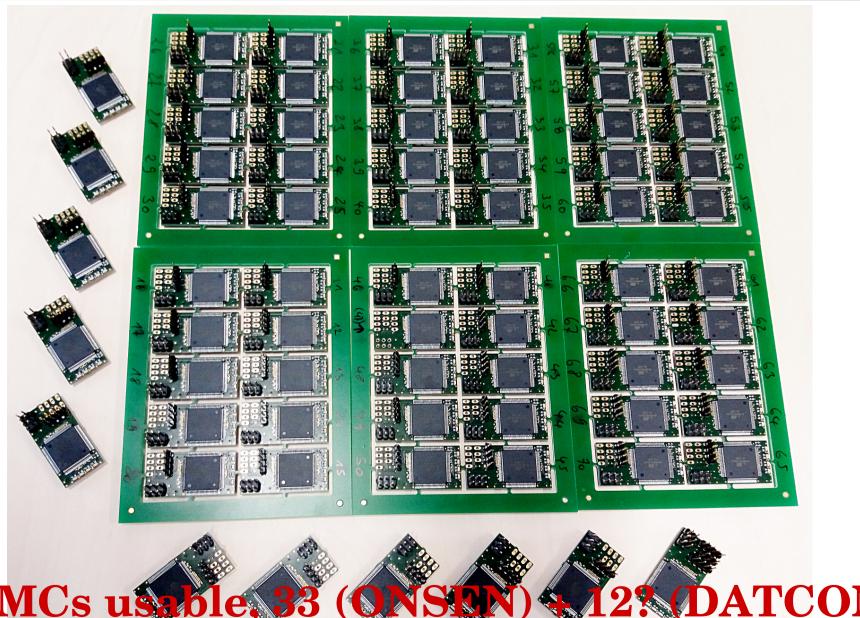
69 MMCs usable, 33 (ONSIDN) 12: (DATCON)

needed for Belle2 setup

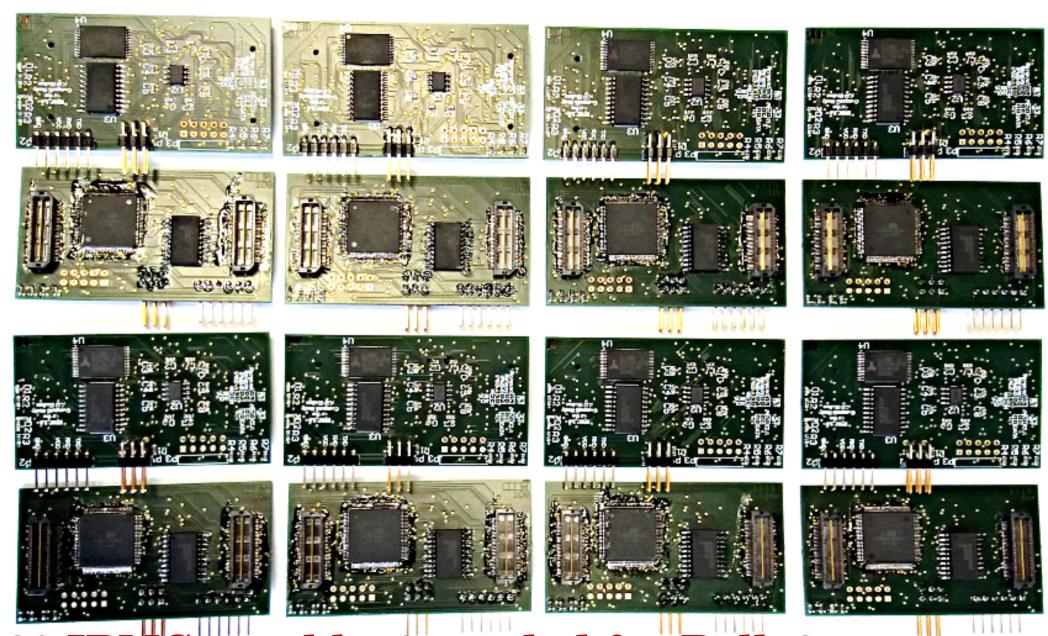
20 IPMCs usable, 9 needed for Belle2 setup

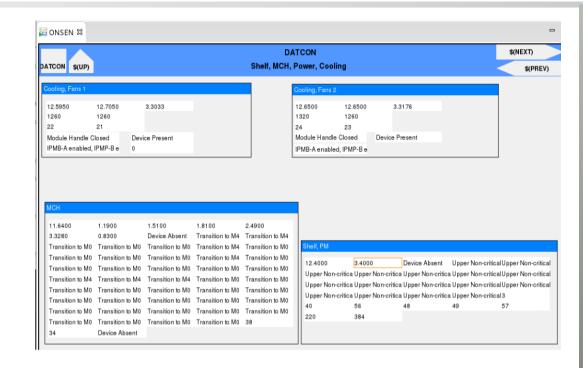
- All sensors added to GUI
- Labels and design is missing
