Status of FOS

Activities for Beast II.

Ringberg, May 30th 21st Depfet Workshop

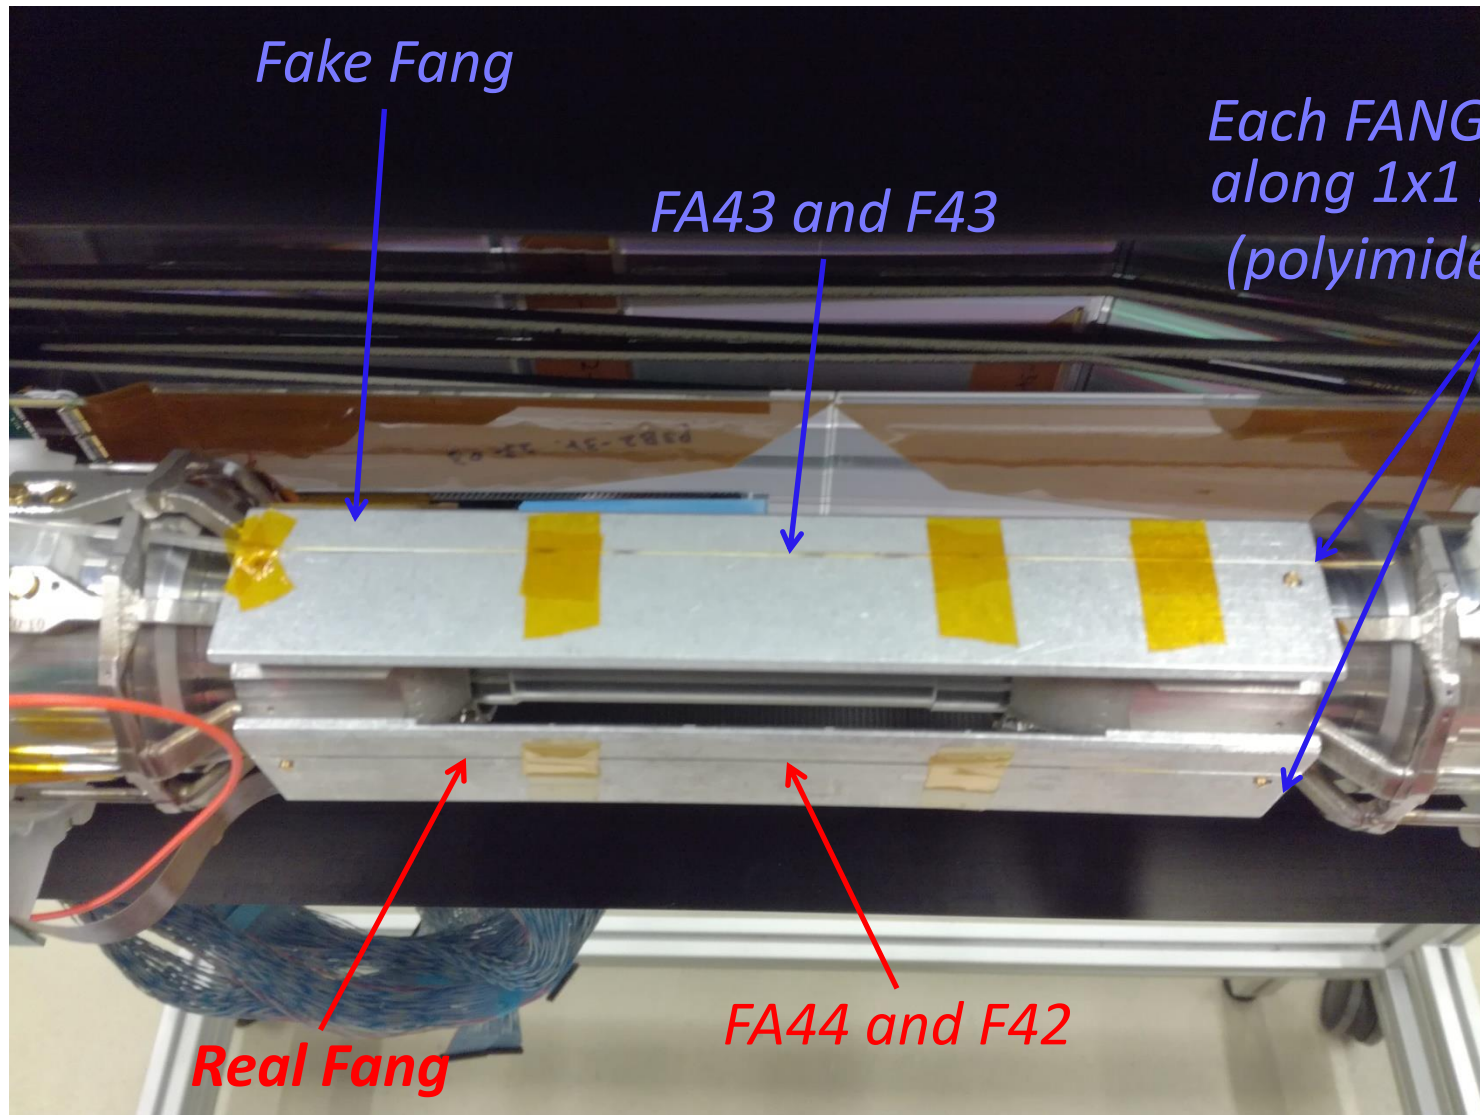
TB2017 FBG monitoring system

Fiber	Coating	Sensitive	Nº of sensors	Cable length
FA43	acrylate	T	3	3 meters
FA44	acrylate	T	3	3 meters
F43	polyimide	T +RH%	2	0.7 meters
F42	polyimide	T +RH%	1	0.7 meters

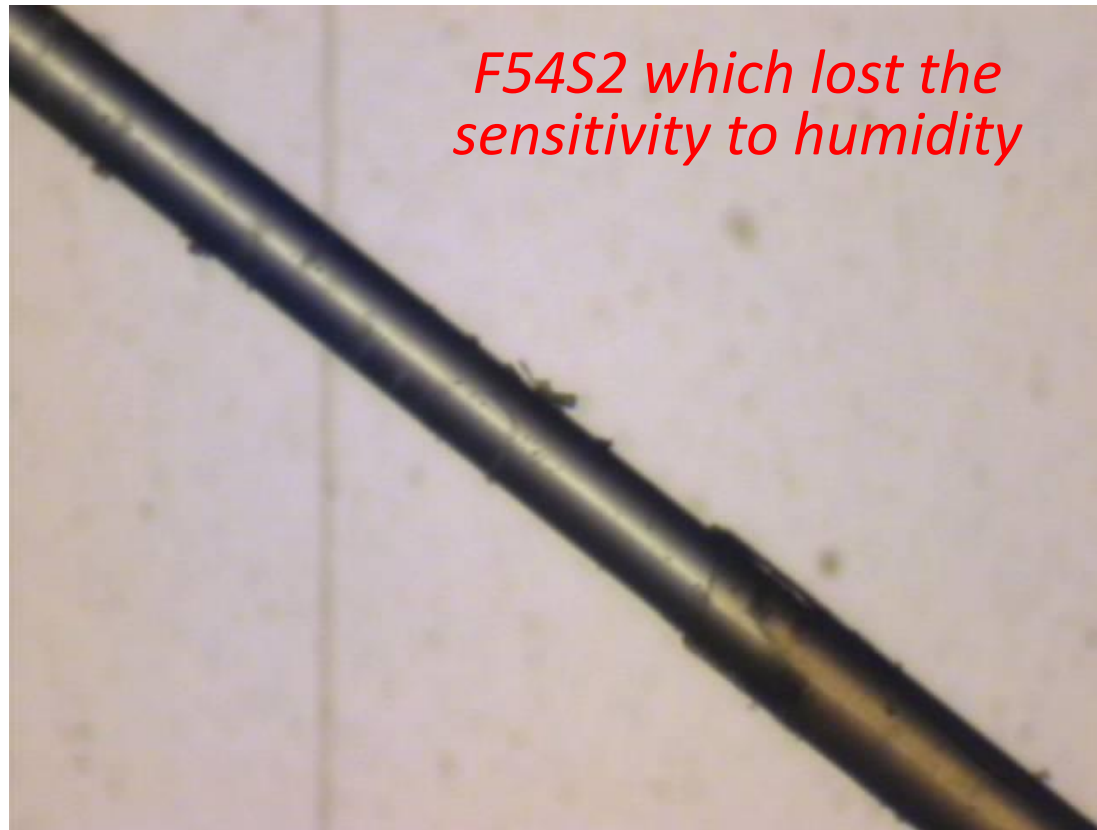
Fibers for Beast II TB 2017: coating damage

- Some problems with Humidity sensors. Coating damaged during fiber cutting inducing changes in the sensitivity.

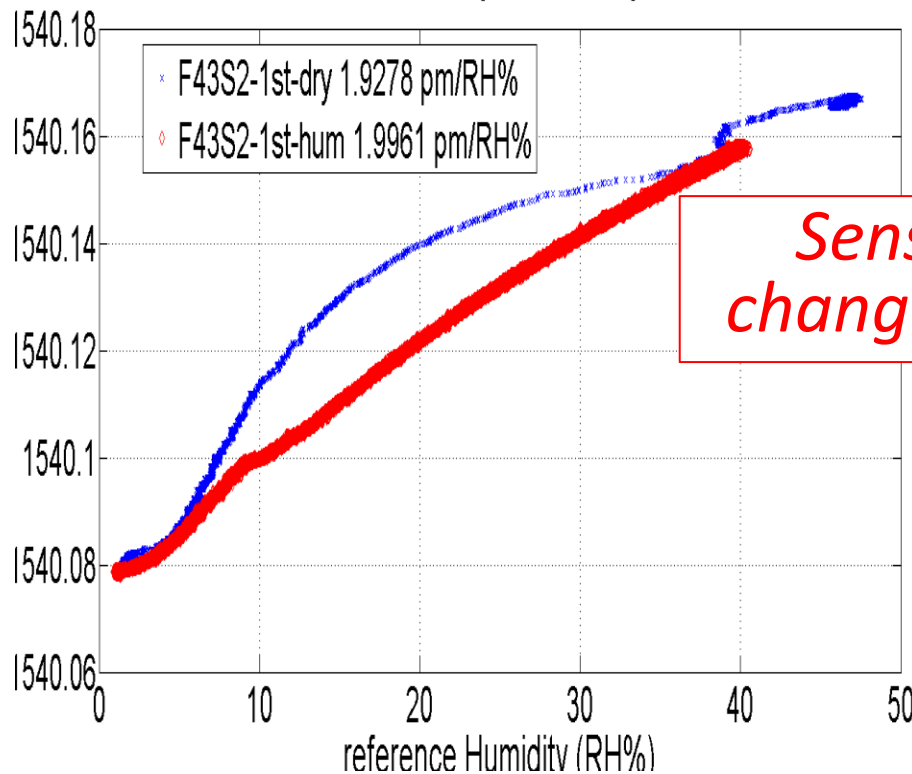
Before polyimide damage

- Comparison between humidity calibration before and after coating damage.

Fiber 43 sensor 2 sensitivity to humidity normalized 19.2°

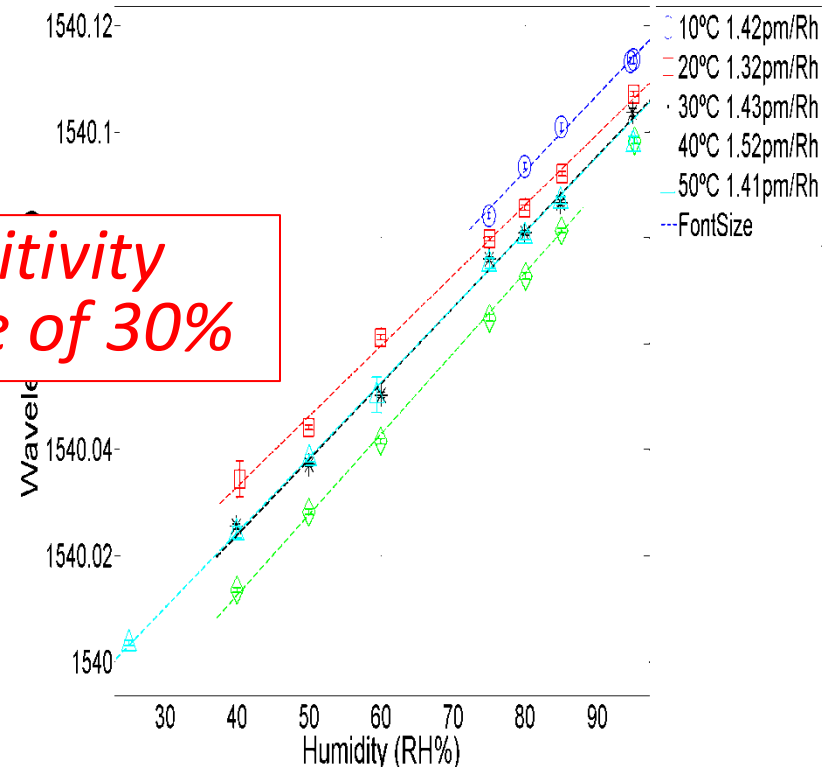
After polyimide damage

F43-S2 humidity calibration at different temperatures corr2

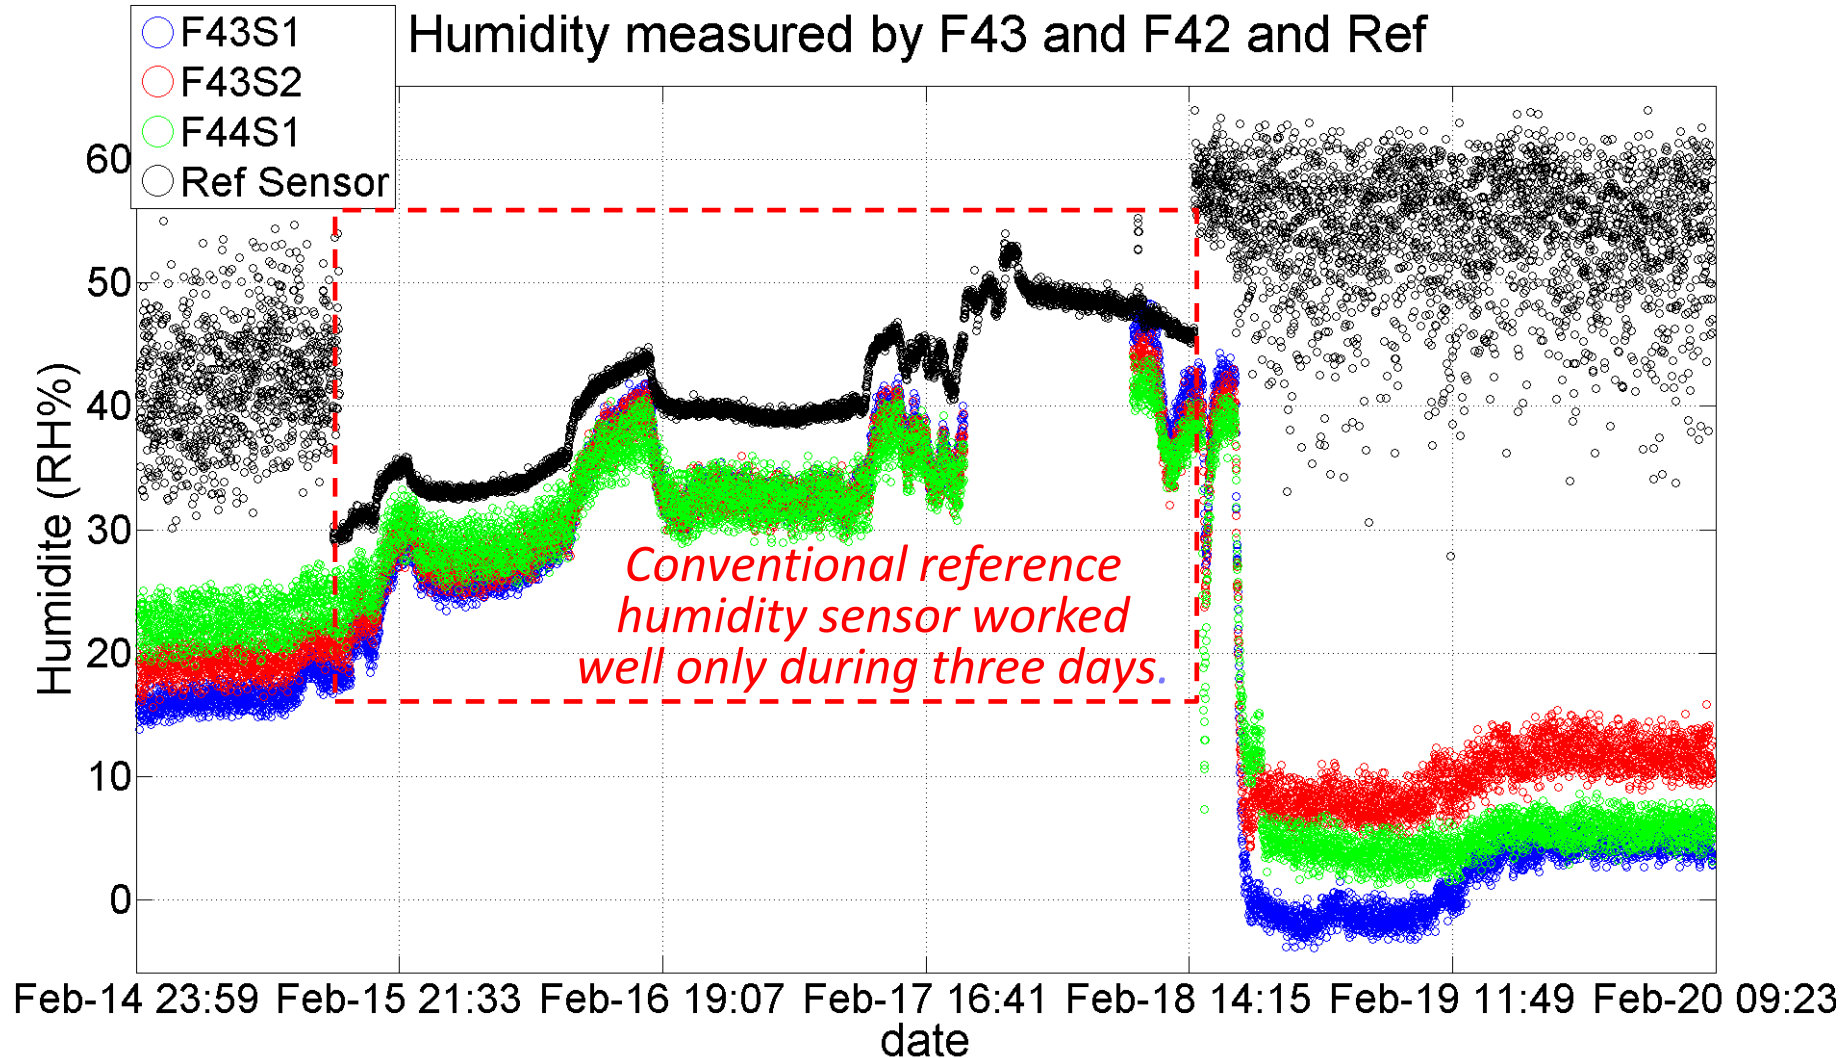
TB results: problems with humidity sensor

Measurements at ITA

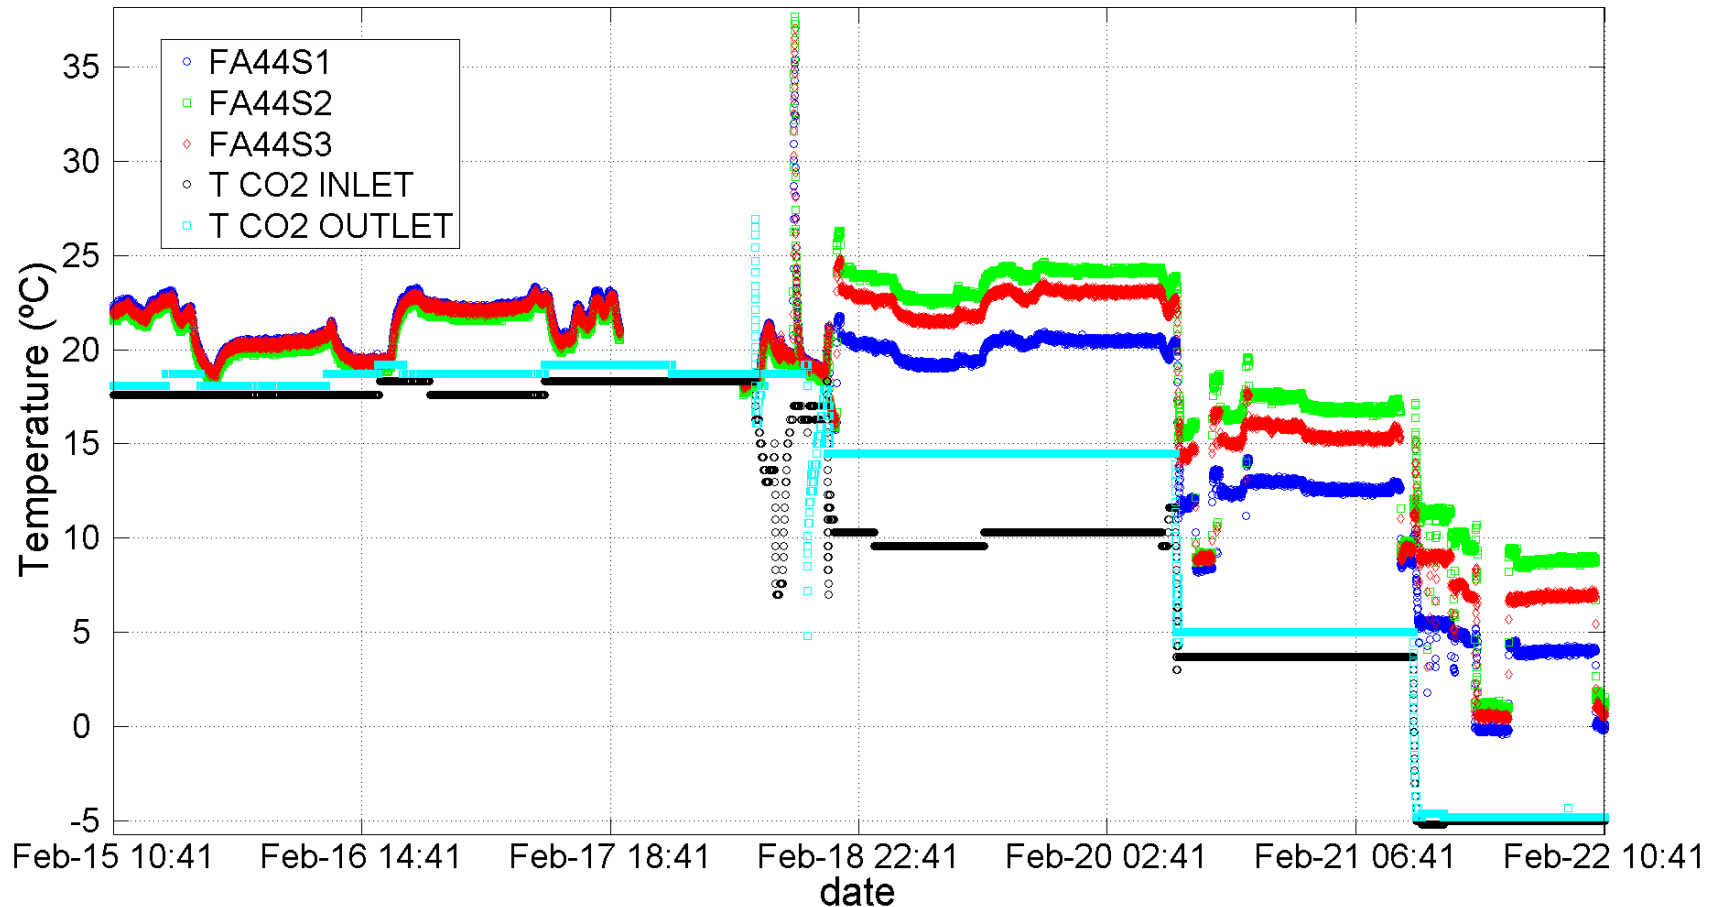
TB results: Temperature measurement

FA44 fiber mounted in real fang.

FA44 temperature comparison with CO2 cooling

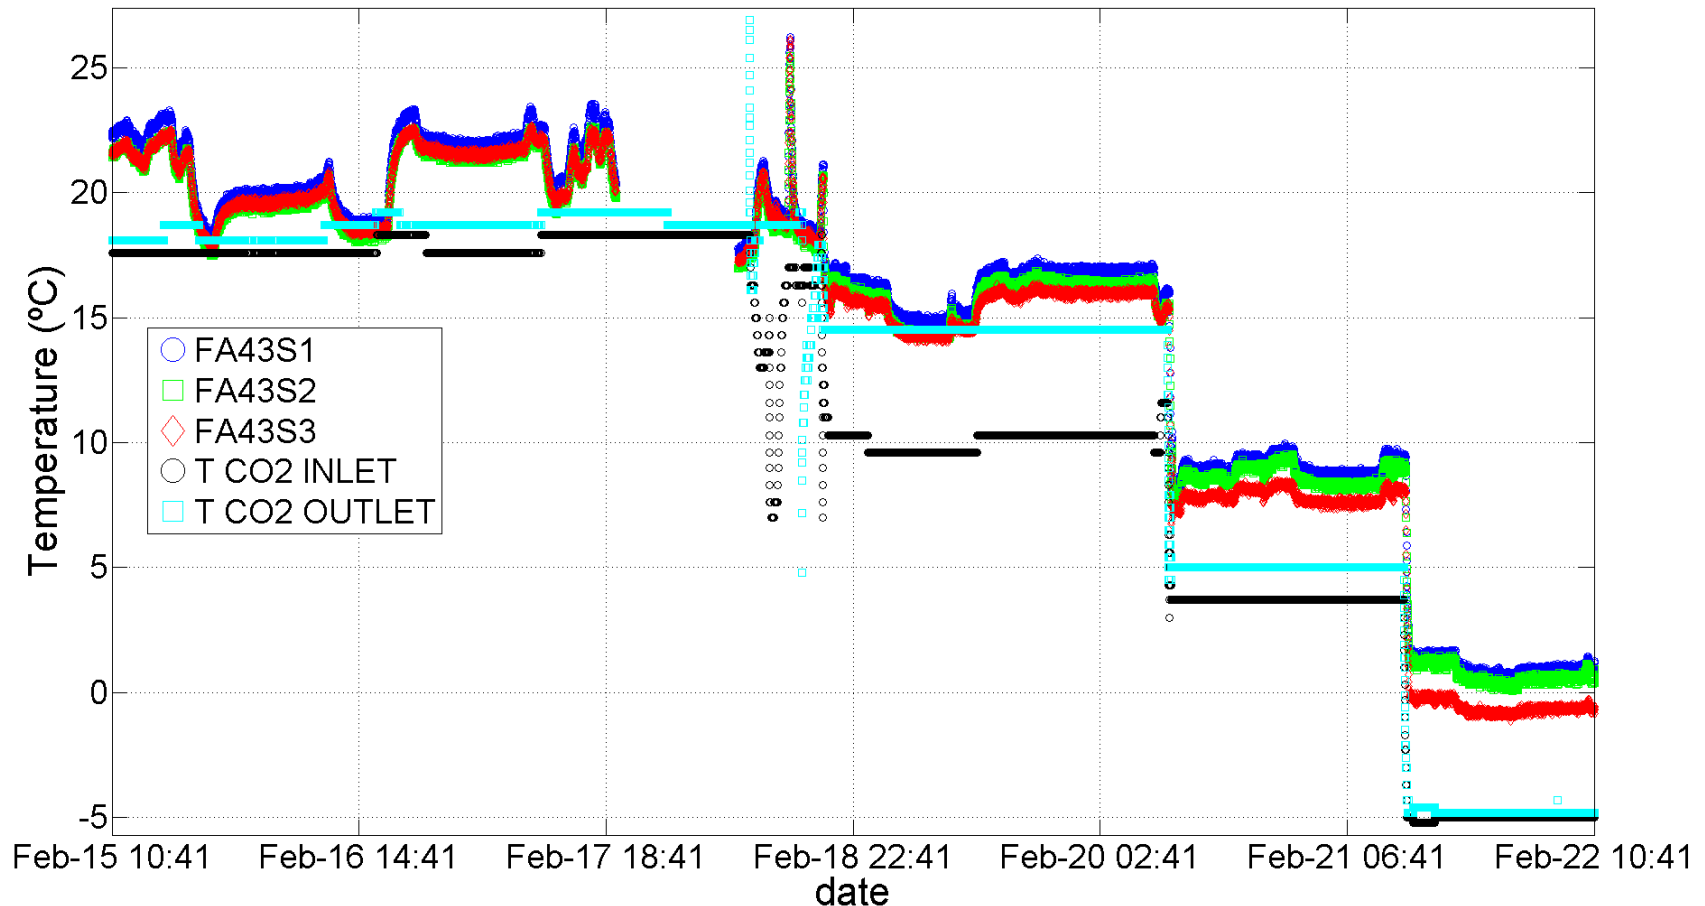
TB results: Temperature measurement

FA43 fiber mounted in fake fang.

FA43 temperature comparison with CO2 cooling

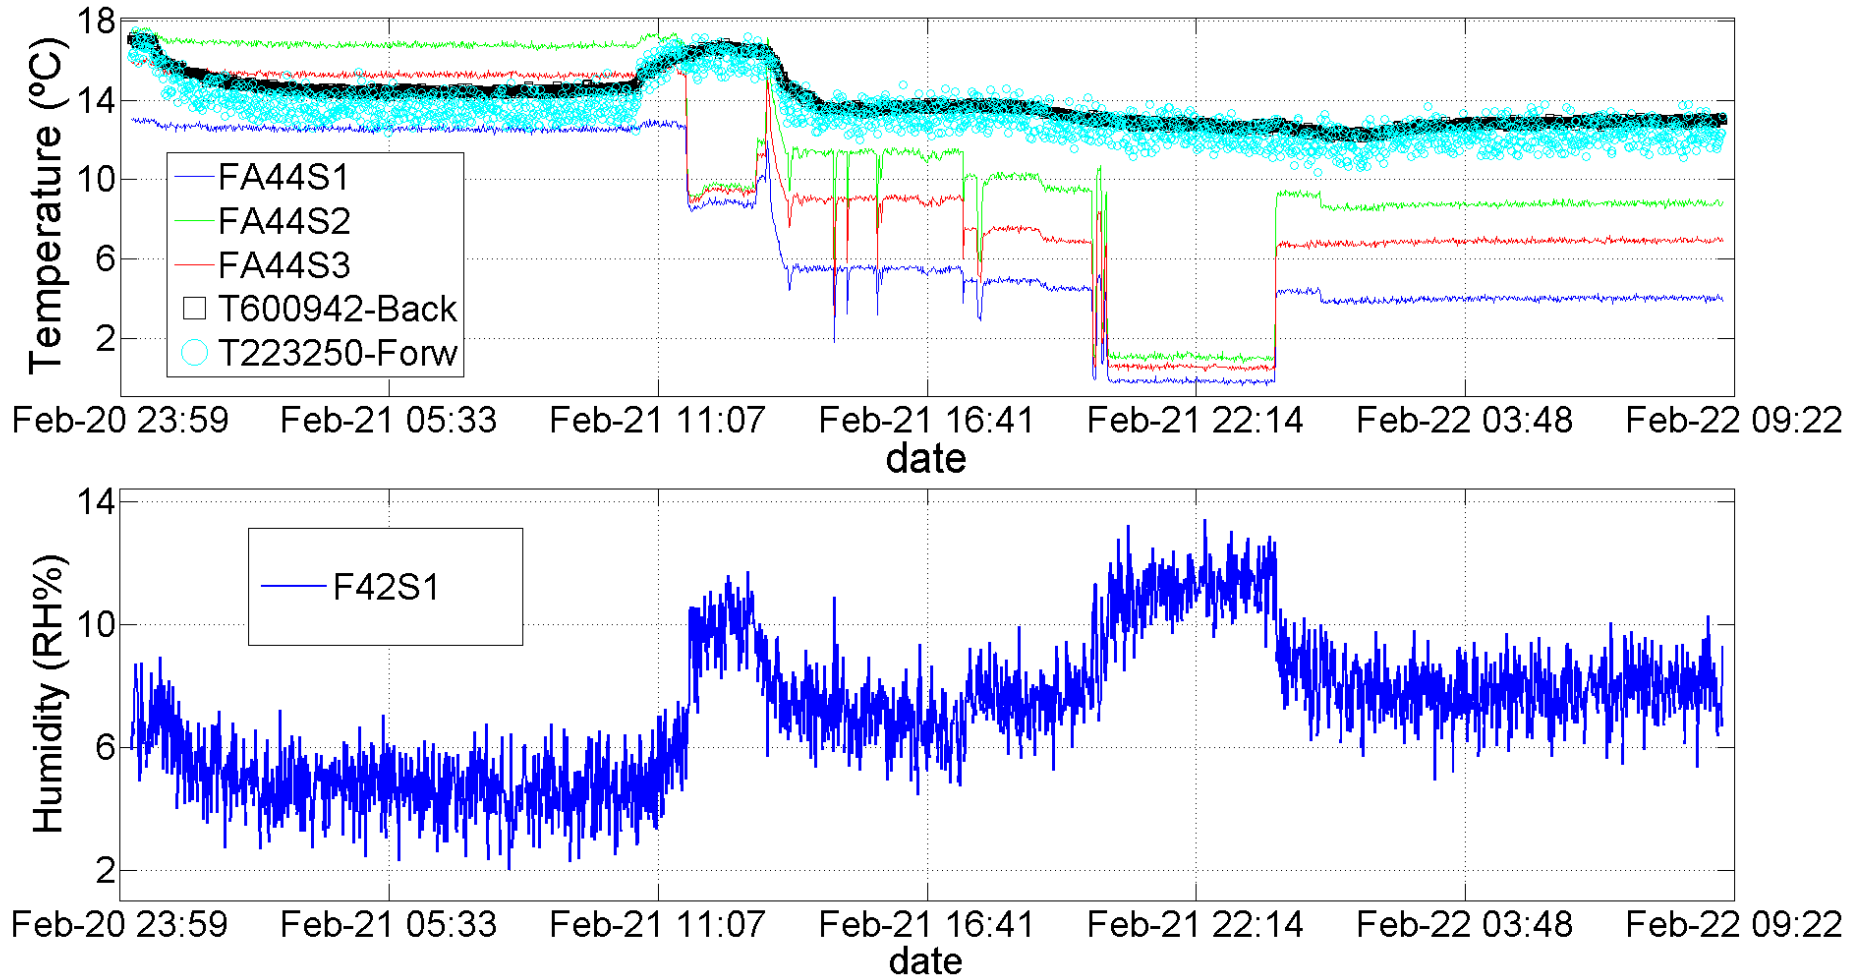
TB results: Humidity measurement

FA44 Temp and F42 Humidity measurement

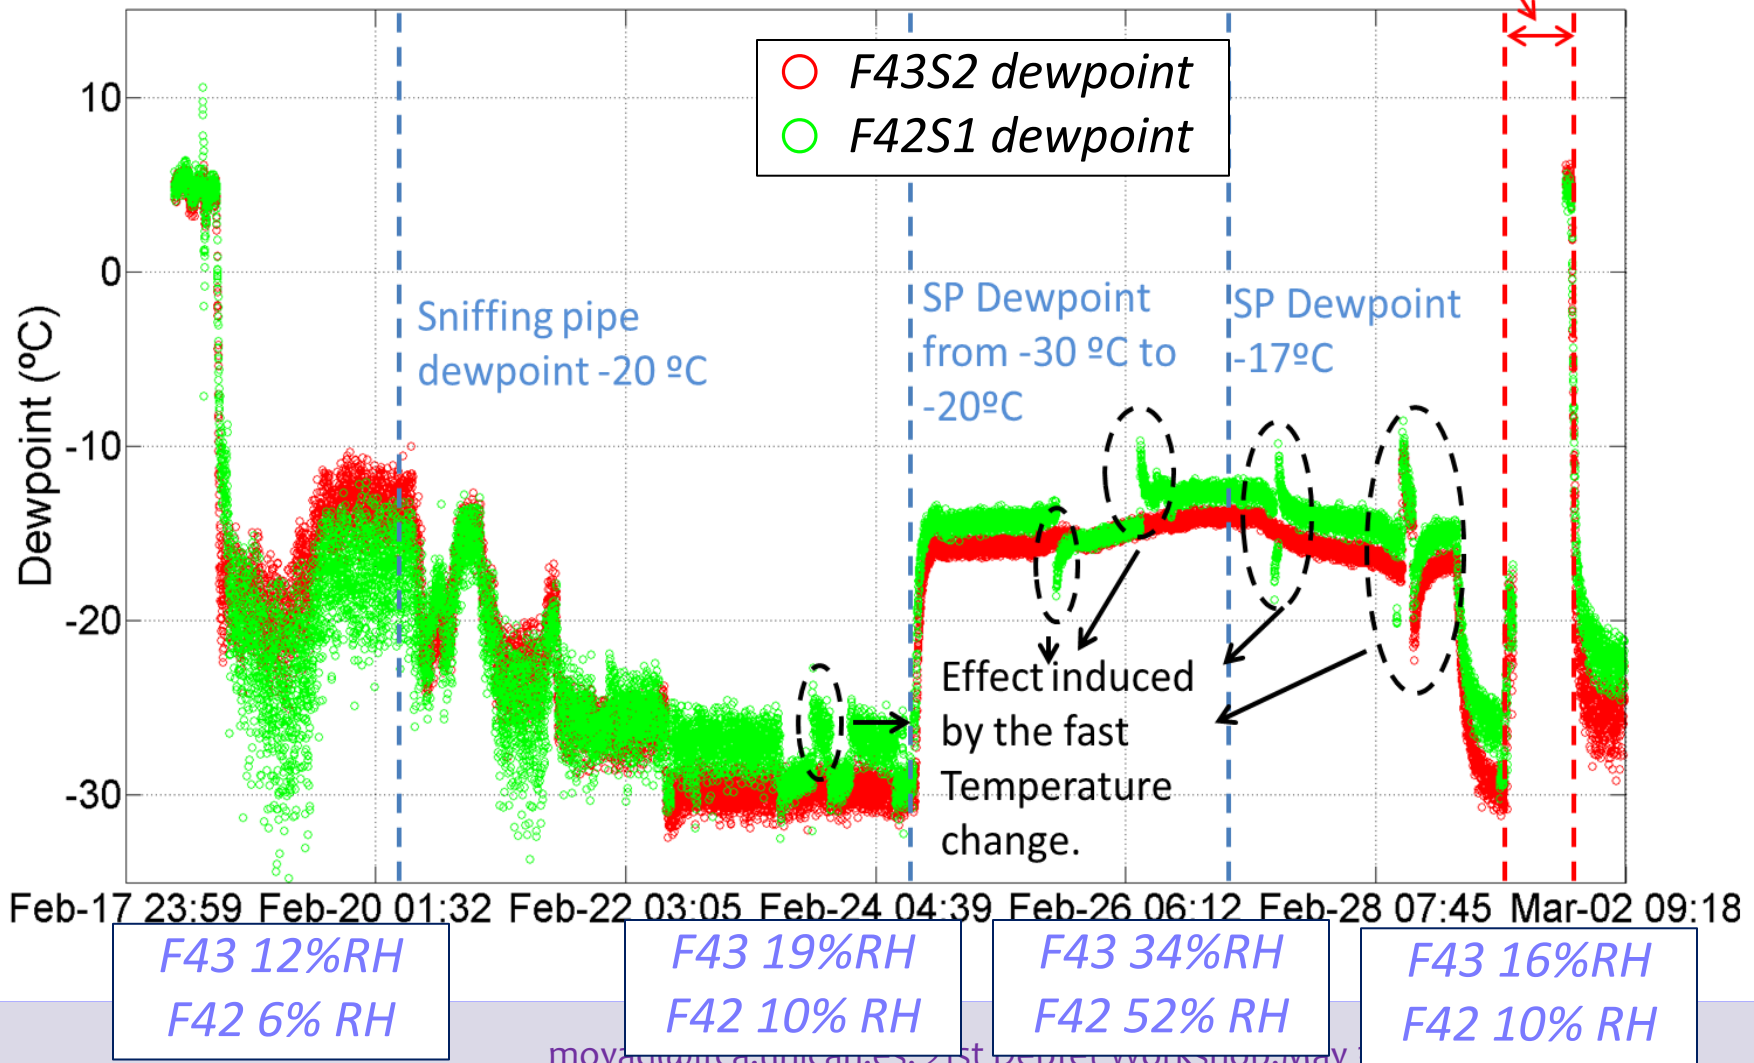
TB results: dew point measurement

Dewpoint measured by F43 and F42

- During last test beam we managed to monitor temperature, humidity and dew point in an accurate way.
 - Extreme caution when cutting the fiber in order not to damage the coating.
- We have started preparing for phase II.
 - New polyimide coated fibers received.
 - Will be irradiated up to 200 KGy in order to avoid radiation effect during Beast II measurement.
 - Fibers will be calibrated with temperature and humidity before and after irradiation.
 - New fibers guide manufactured for FANGs

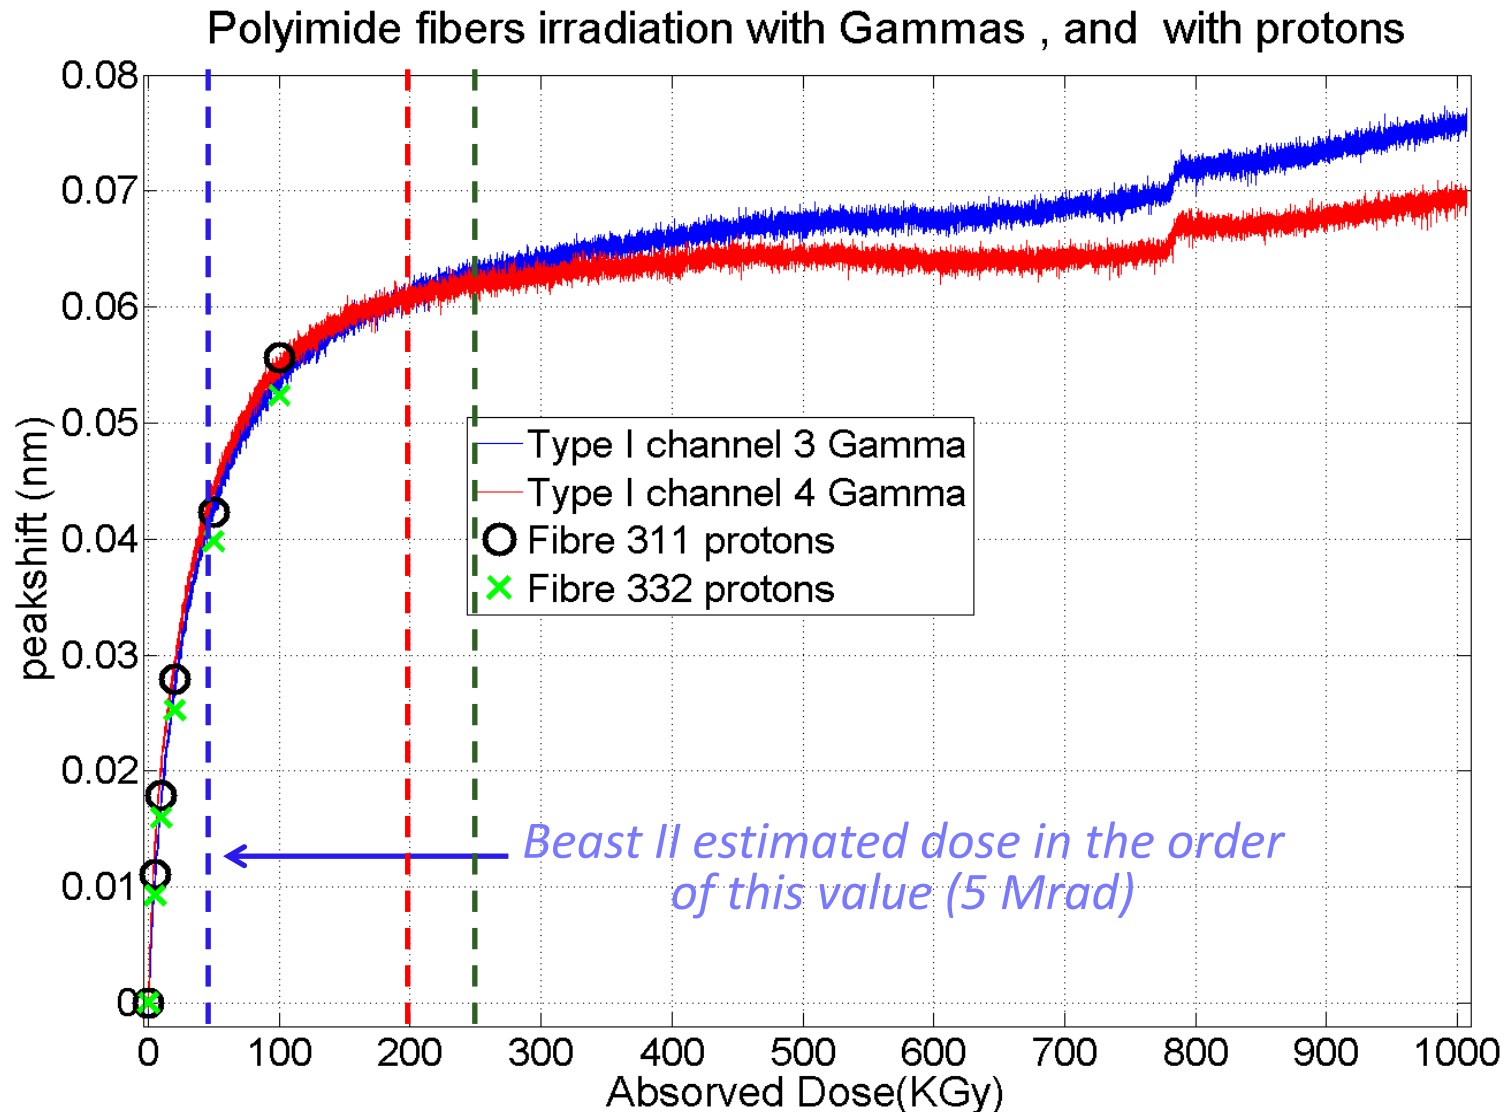
Irradiation up to 200 KGy

- New polyimide fibers bought and received at IFCA.
 - TB fibers coating is damaged (Reliability is not 100 % ,the behavior could change with time)
- We would like to irradiate the fibers up to 200 K Gy. in order to avoid radiation effects on temperature-humidity measurement during phase II.
- The patch cords to interconnect from docs are at Trieste
- Working in the readout and the DAQ.
- New fibers guide design and manufactured in order to insert the fibers in FANG backplane 1x1 mm Groove

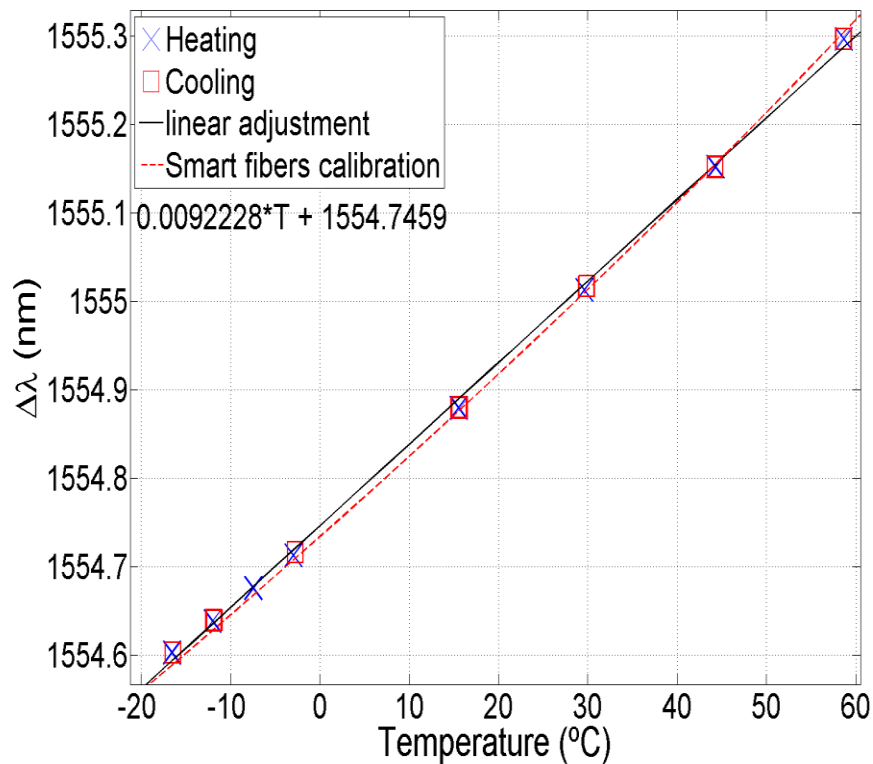
Temperature calibration A43S3

- Calibrated by the supplier in -30/60 °C range
- Results compared with our calibrations at IFCA. Difference below uncertainty.

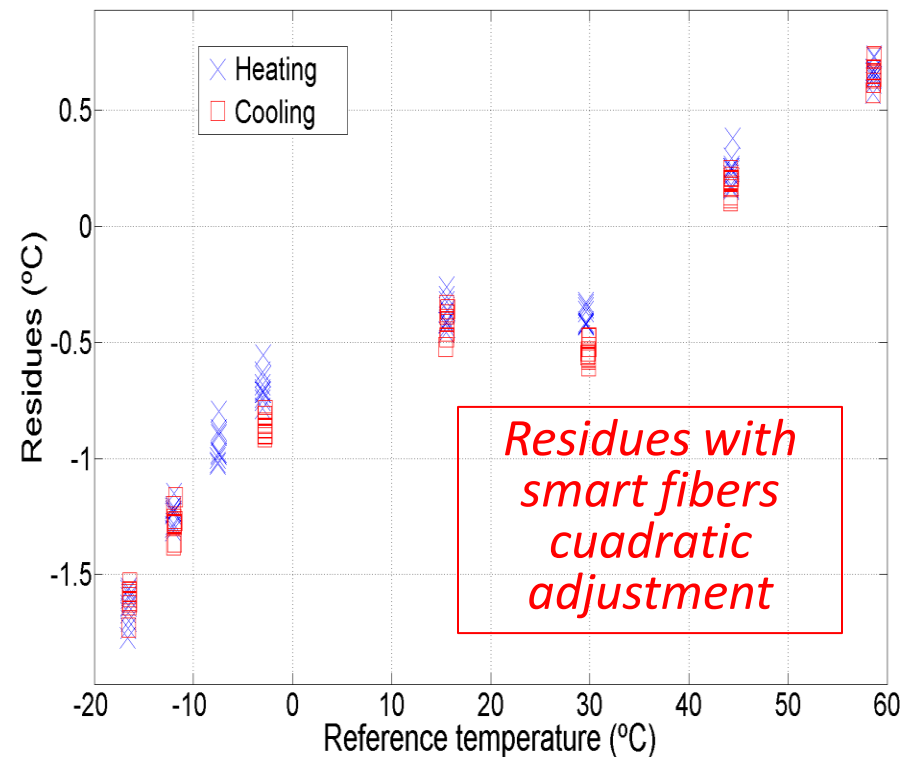
FA43S3 temperature calibration residues with smart-fibers curve

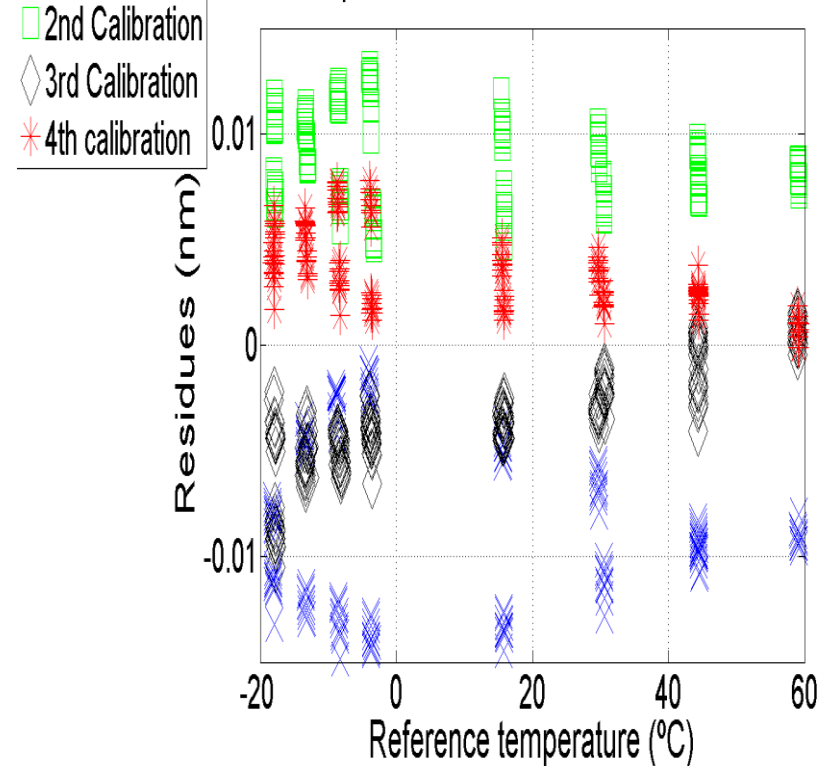
- ## Temperature calibration F42S1 under dry environment (1%

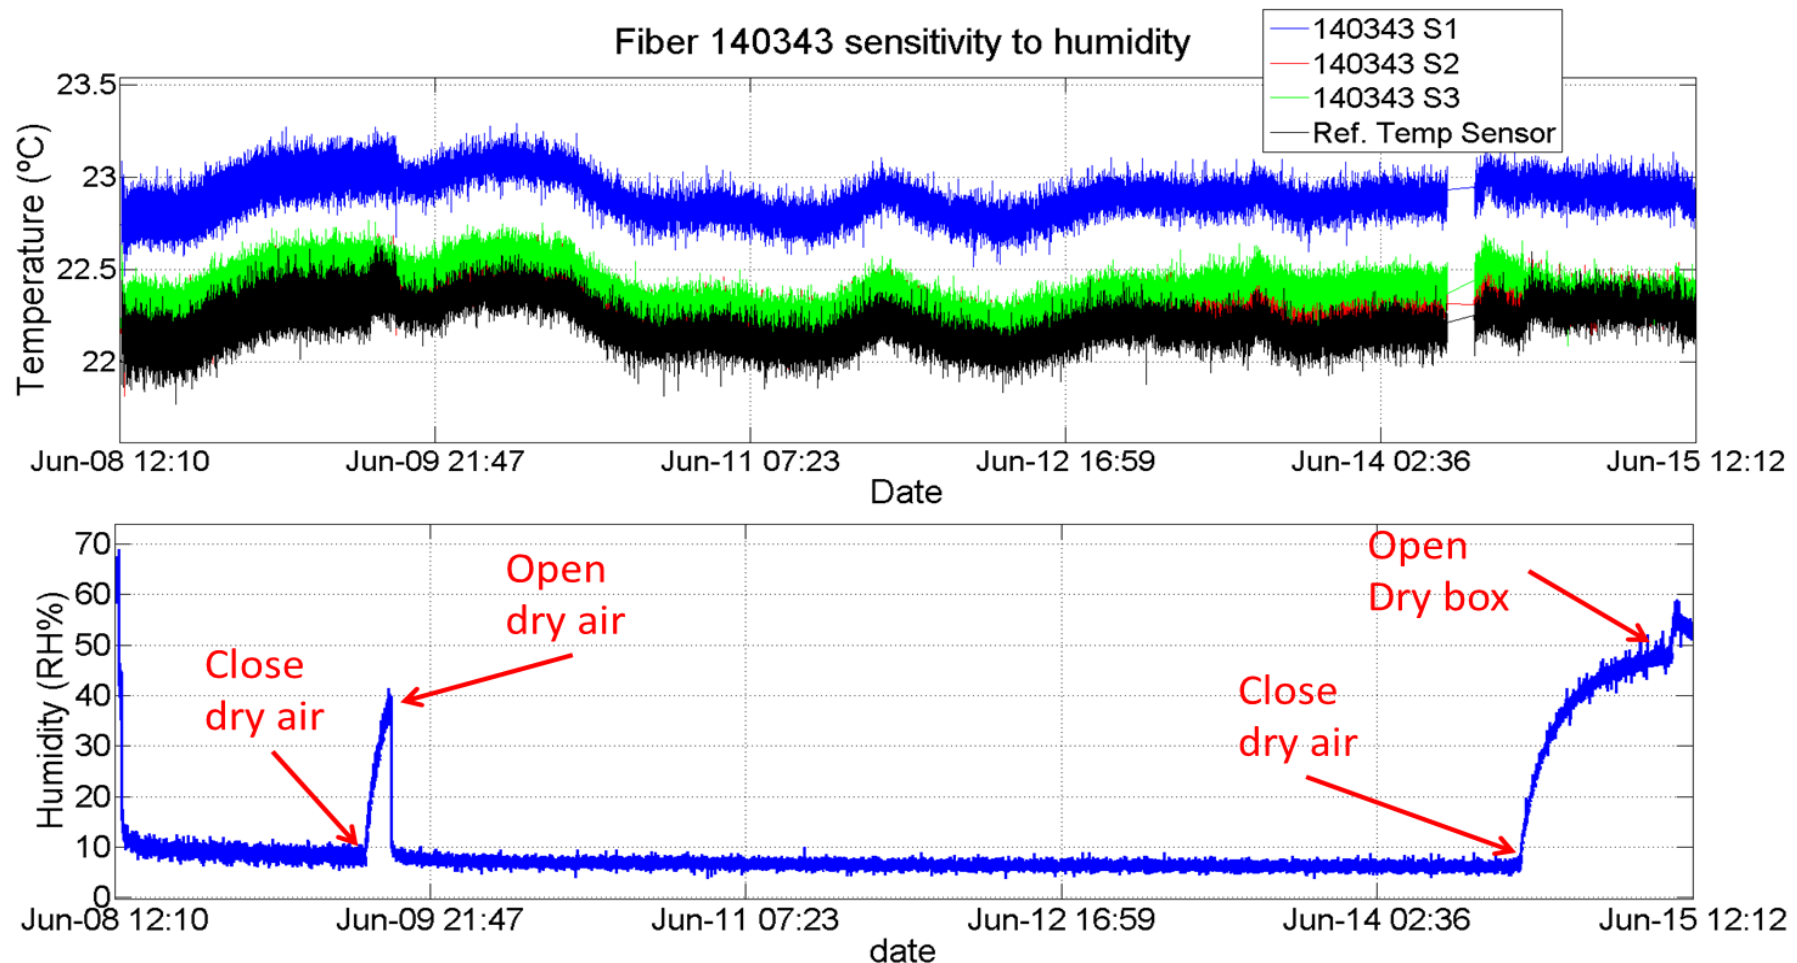
Acrylate fibers sensitivity to humidity

- Acrylate fibers under dry environment during six days without any effect in the signal.

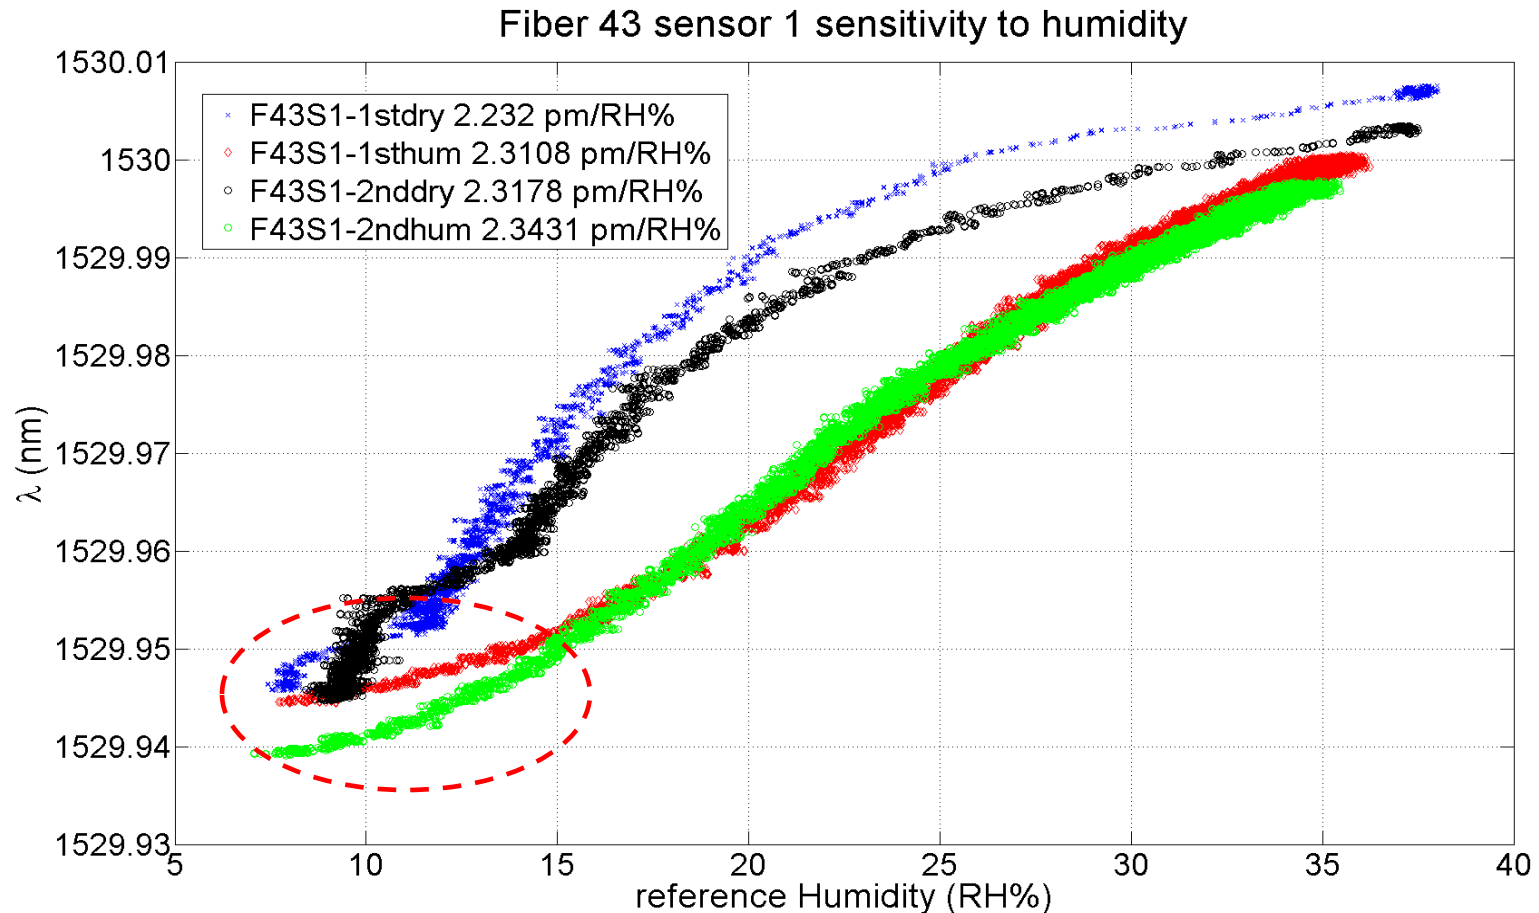
Polyimide fibers sensitivity to humidity

- F43 and F54 calibrated against humidity Before TB april 2016.

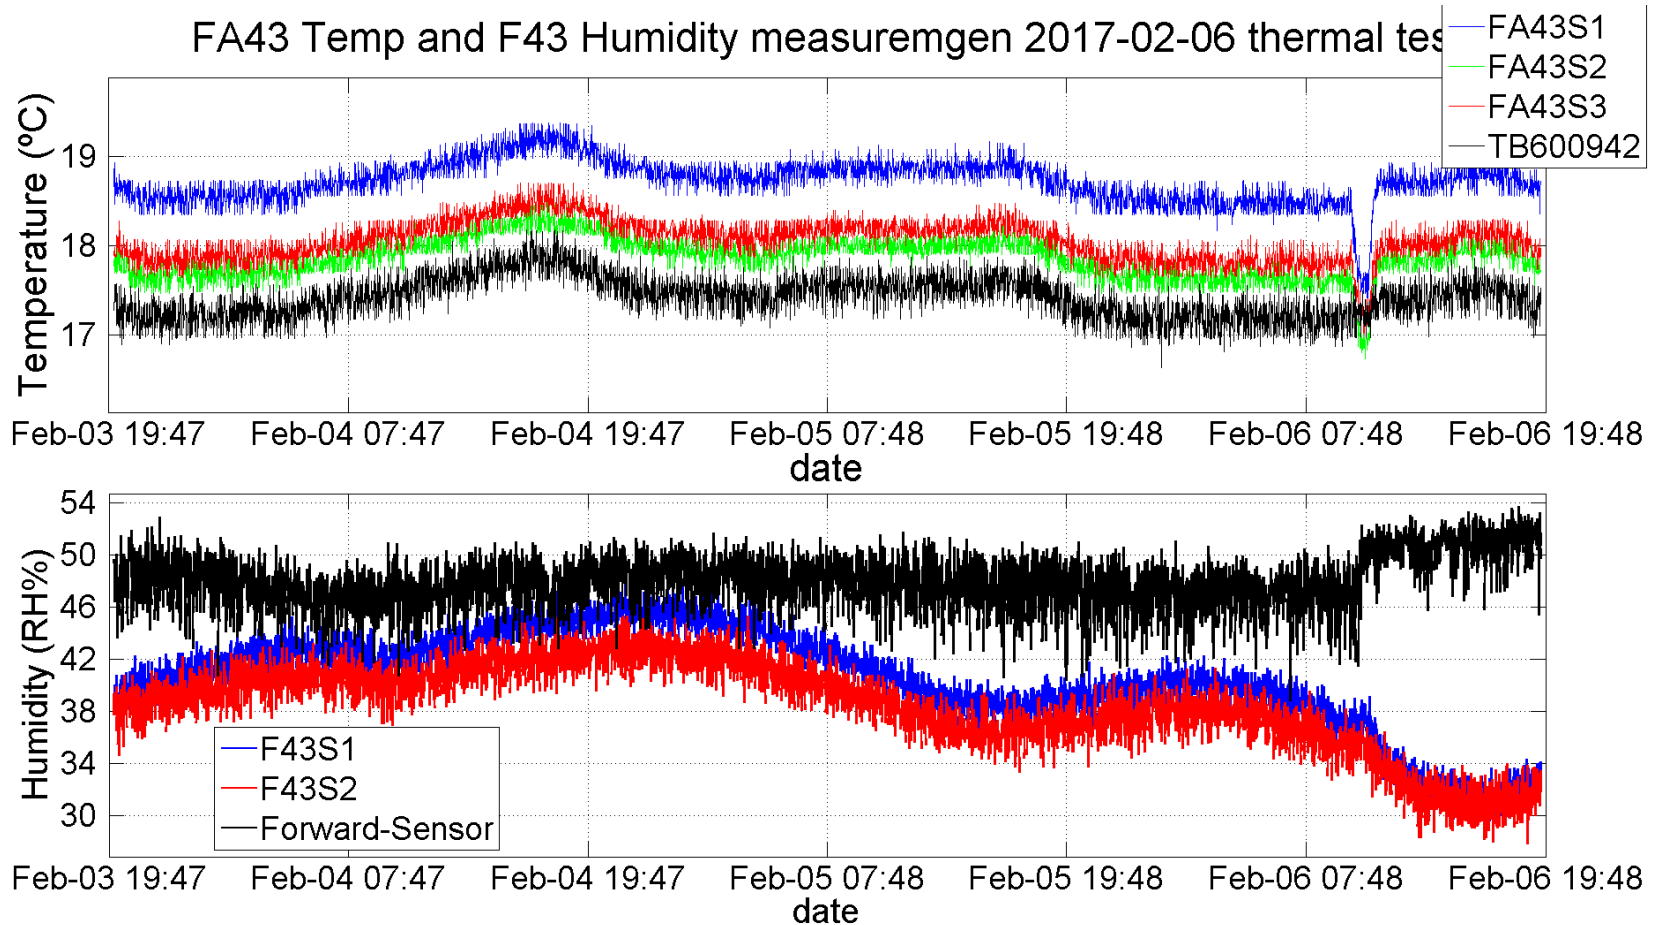
TB results

– Temperatur comparation reference
