ONSEN

(Online Selector Nodes)

Dennis Getzkow², Thomas Geßler², Wolfgang Kühn²,
Jens Sören Lange², Klemens Lautenbach², Zhen-An Liu¹,
Björn Spruck³, Jingzhou Zhao¹, (Leonard Koch², David
Münchow²), ¹IHEP Beijing, ²Univ. Giessen, ³Univ. Mainz

- Overview of PXD DAQ
- ONSEN
 - Hardware status
 - Full system test at Giessen, results
 - Processing basf2 events in ONSEN
 - Answer to questions, raised in BPAC report 10/2016

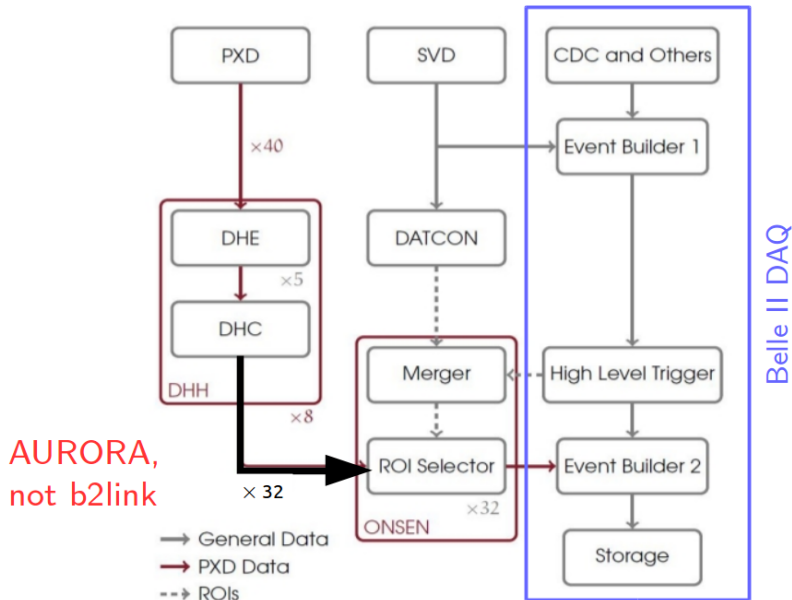
PXD DAQ Overview

PXD DAQ parameters

Trigger 30 kHz
(1/3 accept, 2/3 reject)

$\leq 3\%$ PXD occupancy
data input ≤ 21.6 GB/s

ROI selection
(region of interest)
HLT (SVD+CDC), PC farm
DATCON (SVD only), FPGA
logical OR (on ONSEN)
data reduction factor ≥ 10

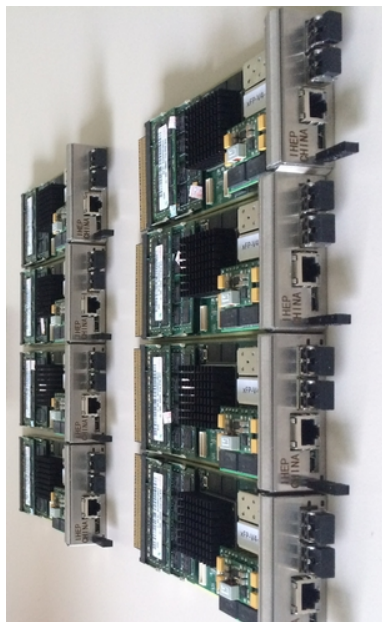
Status of ONSEN hardware

ONSEN AMC card

v4.0 (final)

Virtex-5 FX70T

2 optical links (6.25 Gbps)

GbE

DATCON AMC card

Virtex-5 LX50T

4 optical links (3.125 Gbps)

slow control / monitoring:
IPMI add-on boards (Mainz)

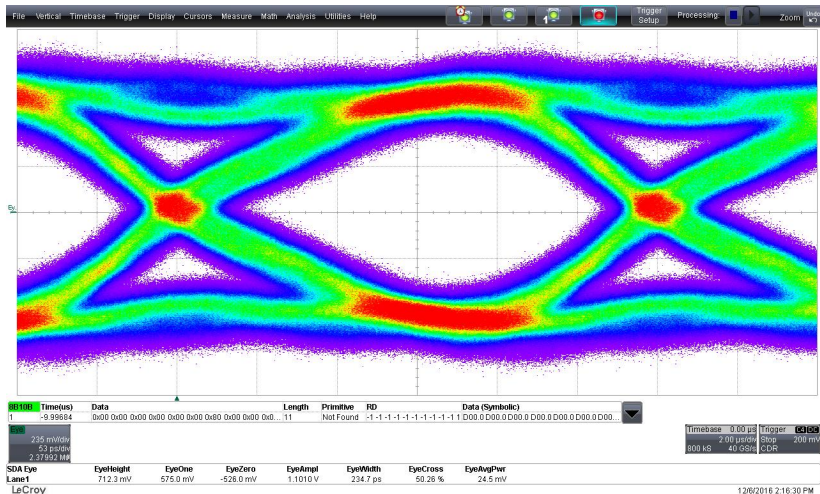
ATCA backplane eye diagram

- Connection Carrier FPGA AMC FPGA uses serial (LVDS) links
- Serial clock is distributed from Carrier to AMCs
- Clock/data phase shift is compensated by delay, determined by tuning
- Problem: strong delay difference between Carrier/AMC combinations (due to routing)
- Problem: small temperature drift of the delay
- Solution: online self-calibration mechanism vary delay, check if link is up or not

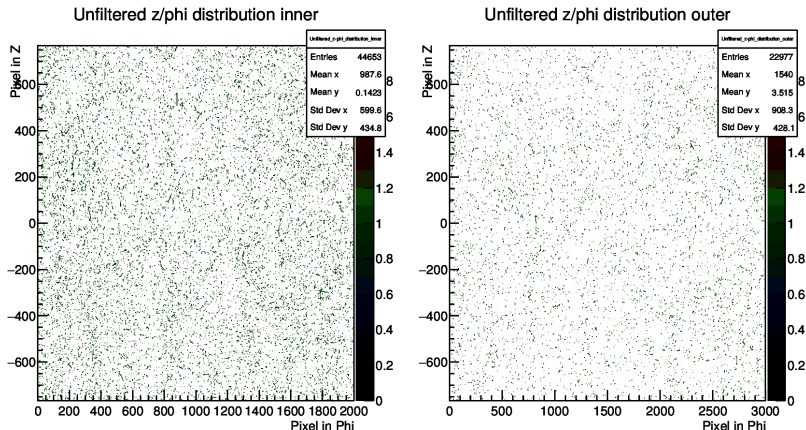
Processing basf2 MC physics events in ONSSEN

occupancy 0.8% (forward), 0.4% (backward), incl. background
BonnDAQ UDP limit 128 MB/s corresponds to 0.71%
(30 kHz)

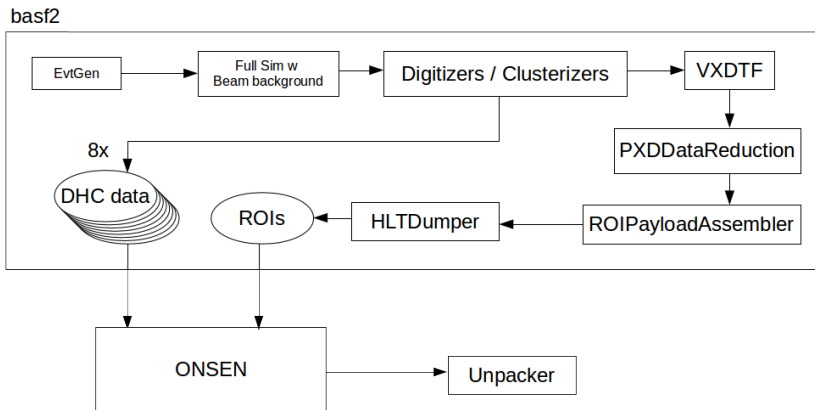
Processing basf2 MC physics events in ONSEN

Processing 5000 events (0.5 s of PXD data taking) and generate binary data required few days.
VXDTF1. Background MC8.

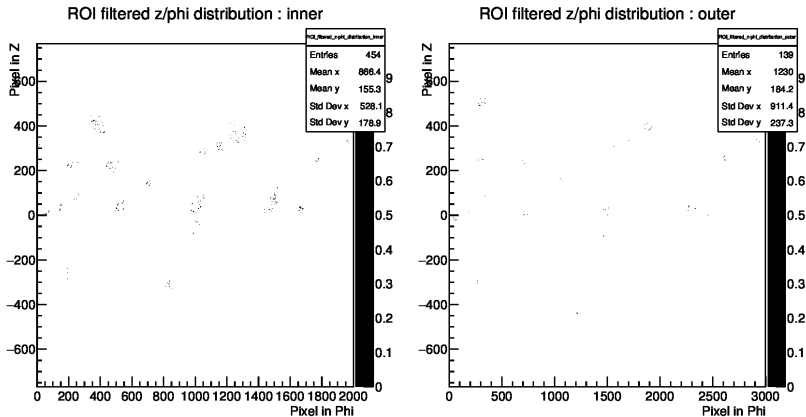
Processing basf2 MC physics events in ONSSEN

factor 98.3 (inner), 121.6 (outer)
requirement $\geq 10.0 \rightarrow$ may be released

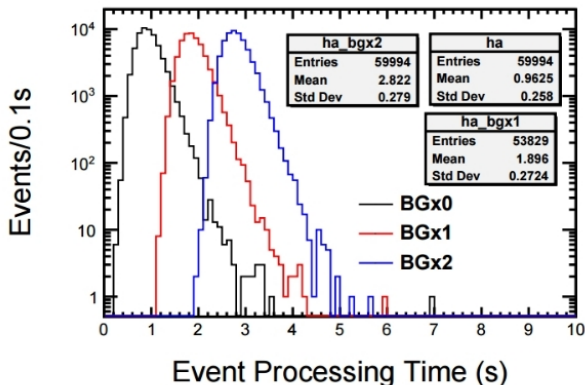
Belle II, HLT latency study

New results on HLT processing time, by Chunhua Li (Melbourne)
60.000 hadronic events (BB + udc)
For BGx2 only 4 events with $t > 5$ s

- Line 363, 364, Section Event builder
“The ONSEN buffering capabilities should be checked against the maximum estimated fluctuations.”
- HLT latency distribution from Belle ($\tau_{\text{average}}=1$ s, $\tau_{\text{max}}=5$ sec) confirmed by Chunhua Li (Melbourne) with MC for Belle II (see next slide)
- Full system test at Giessen
Worst case scenario: full data rate (3% occupancy), full trigger rate (30 kHz)
→ no buffer overflows (level $\leq 73\%$)

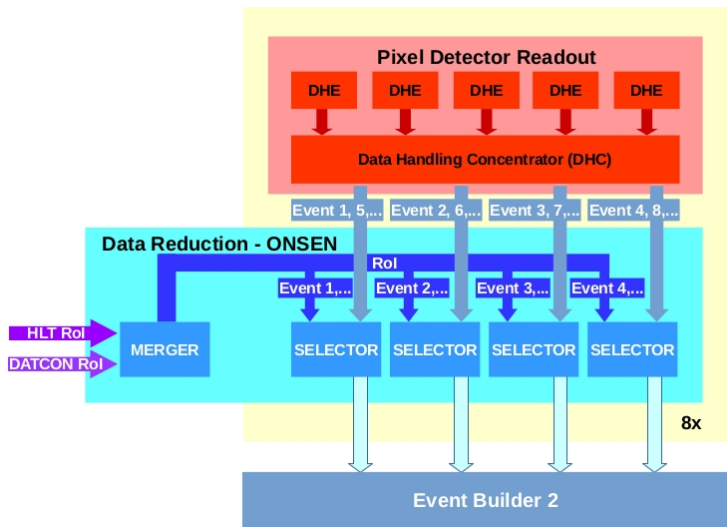
ROI distribution in phase 3

Uses additional "DHH ID filter" in front of ROI selector

(master thesis D. Getzkow)

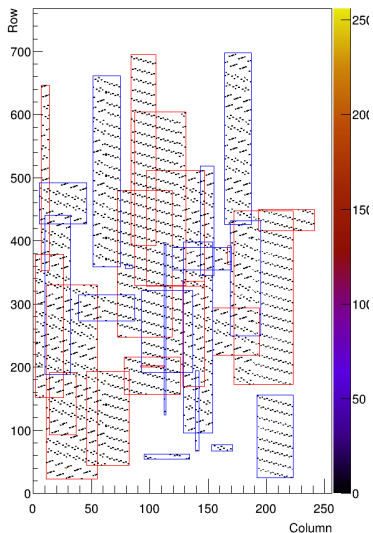
Test: HLT and DATCON ROIs.

Event 16, DHE 1.1.2 / DHE 3
